Comanche Peak Nuclear Power Plant
PWS #2130016
Comprehensive Compliance Investigation Findings Response
Track #418761

**LUMINANT COMANCHE PEAK NPP
PWS #2130016**

PRESSURE TANK INTERIOR SURFACE INSPECTION

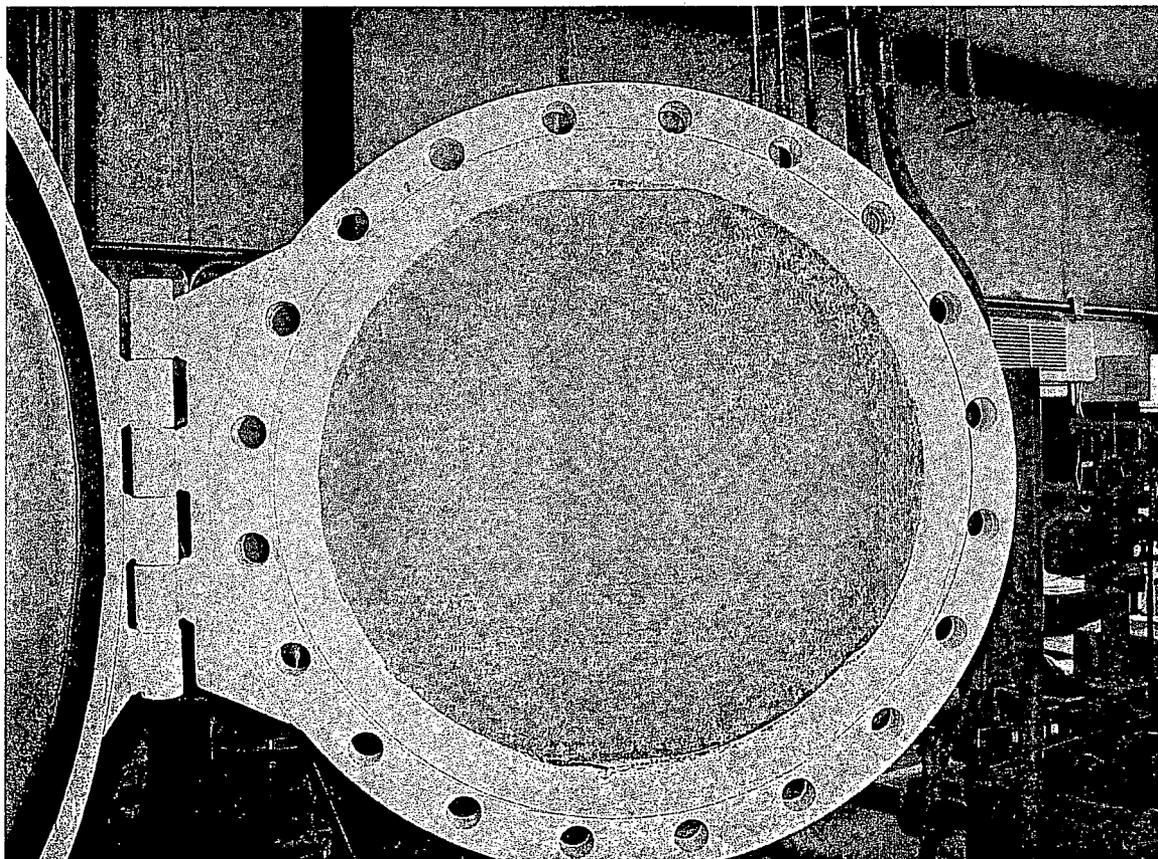
This is the inside of the man way cover

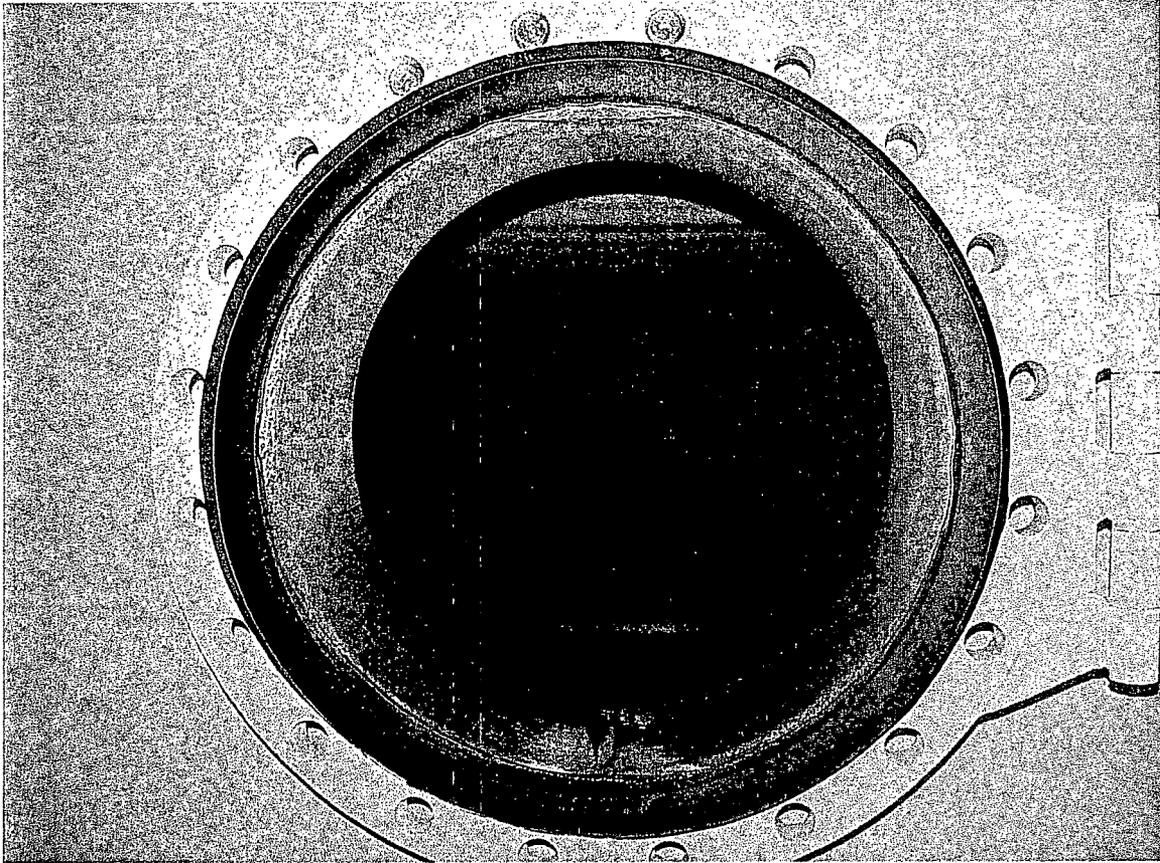
This photo shows the gasket and the man way opening

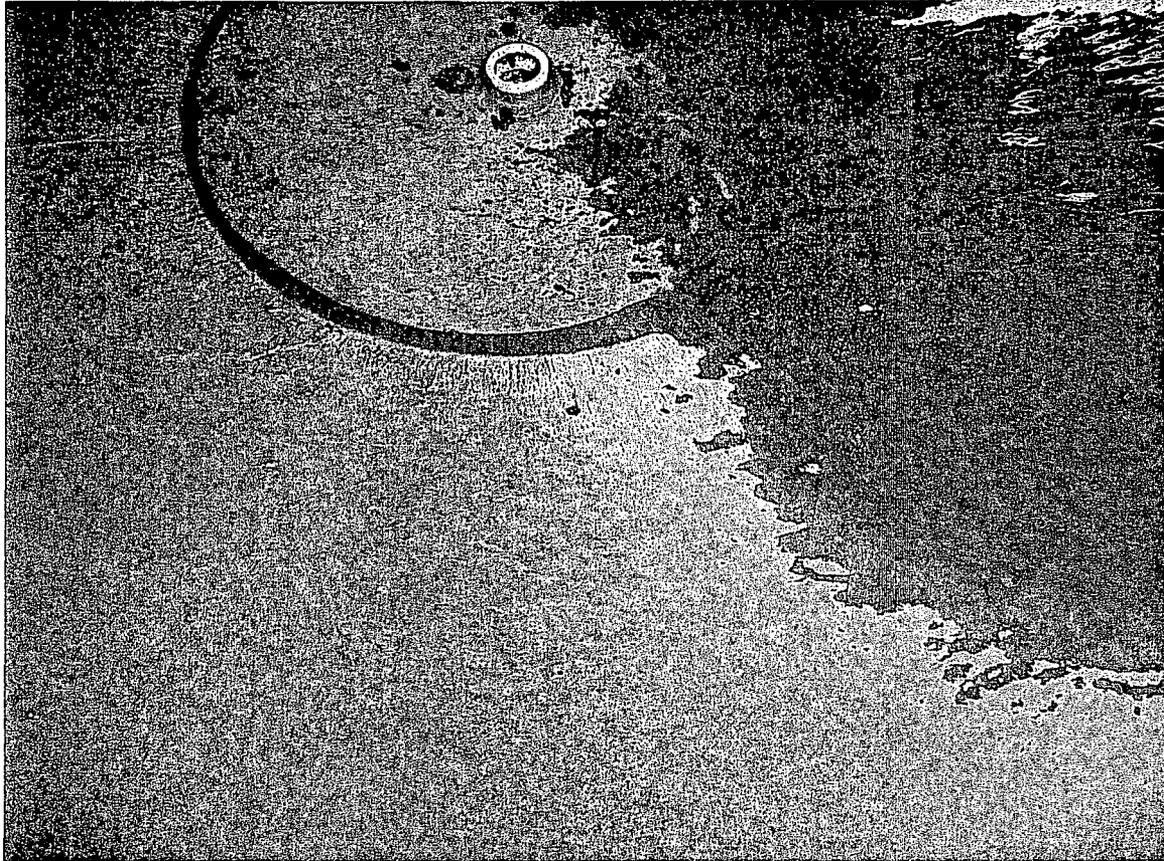
This is the bottom drain on the tank, with some residual silt.

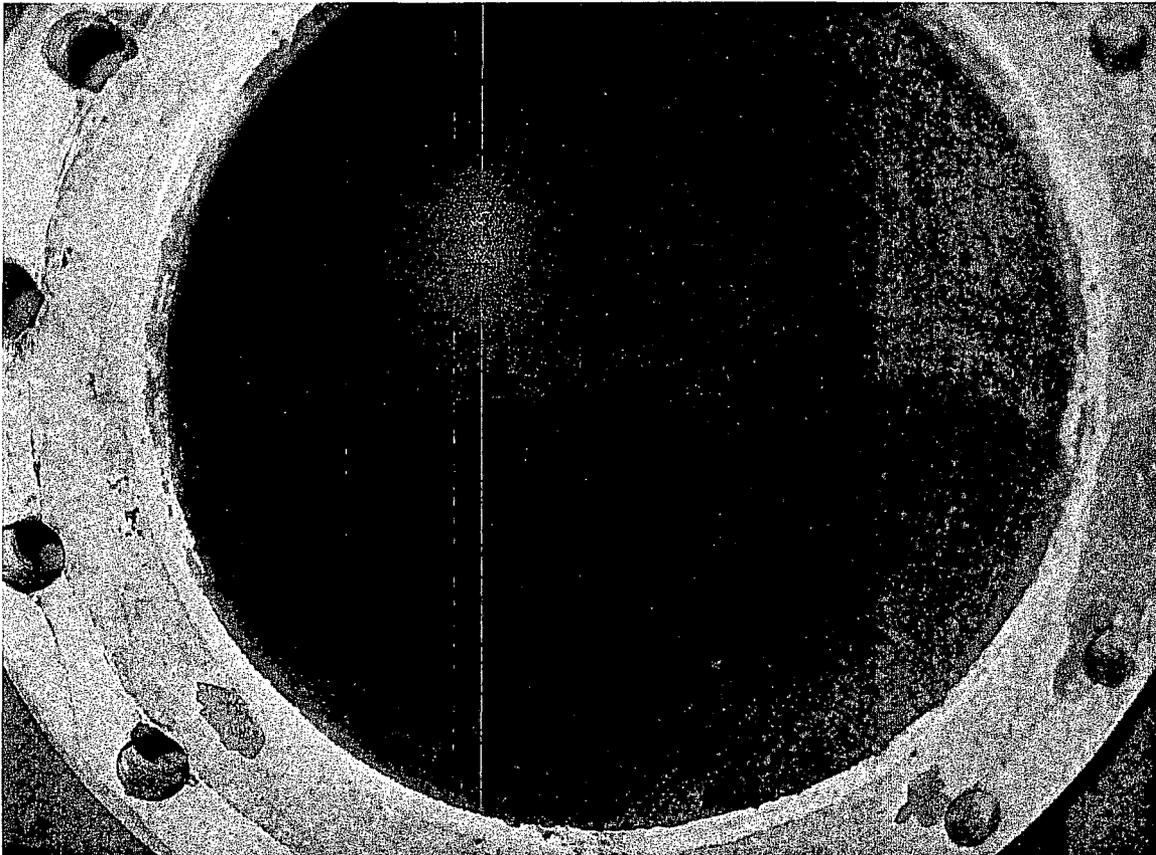
The access man way to the tank.

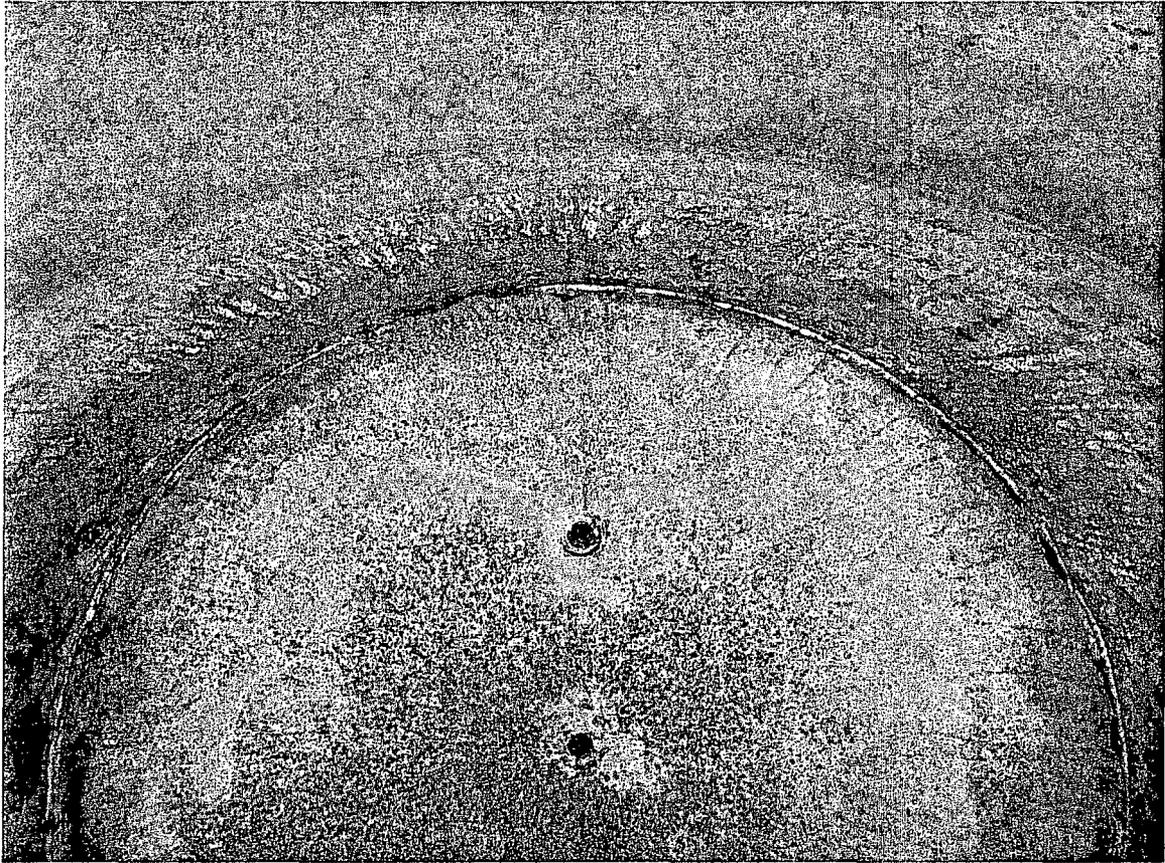
The interior of the tank looking up from the manway. The penetrations are for the nitrogen feed line (bottom of the picture), and the tank pressure relief valve (center of the picture).

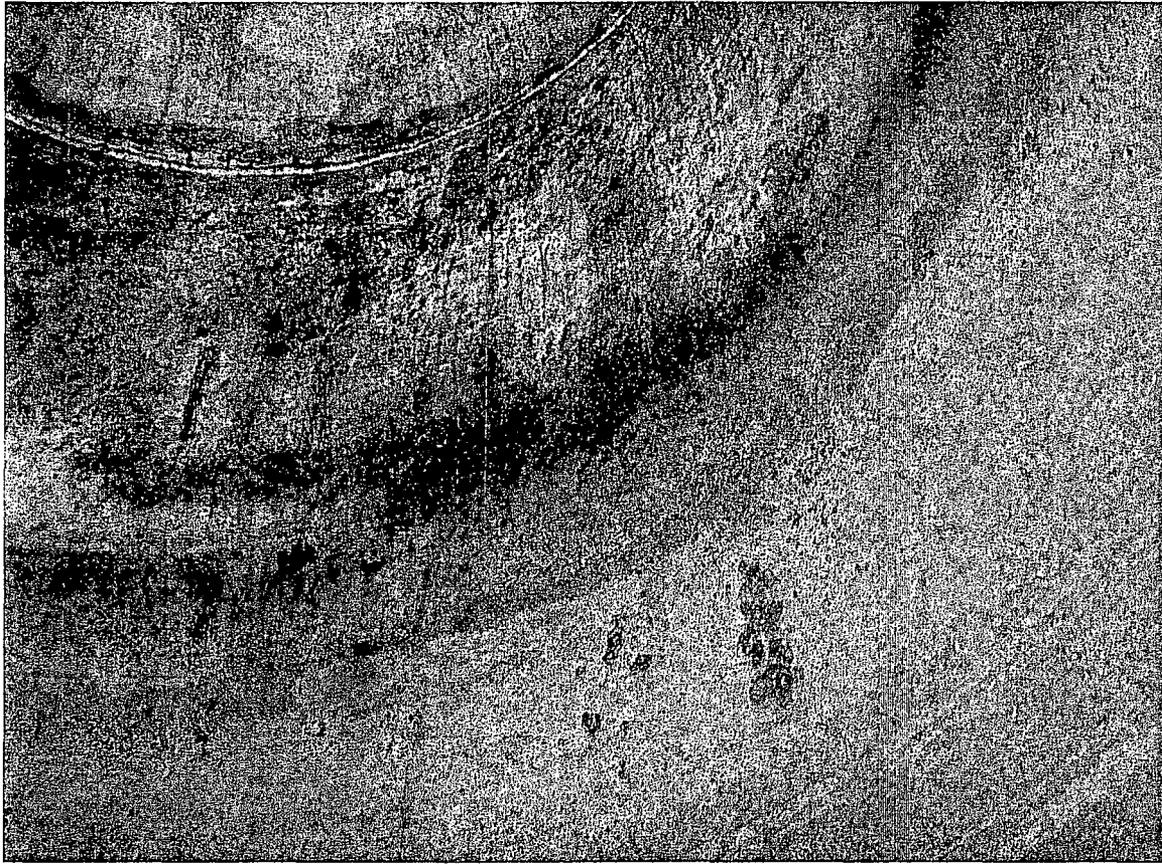
Looking up and right of the man way is the worst area of interior liner degradation in the tank. Notice the slight bubbling in the coating. (upper center of the picture)
