WESTINGHOUSE ELECTRIC COMPANY LLC
COLUMBIA FUEL FABRICATION FACILITY

PRESENTATION TO THE
U.S. NUCLEAR REGULATORY COMMISSION

PRE-DECISIONAL ENFORCEMENT CONFERENCE
NRC INSPECTION REPORT NO. 70-1151/2010-202

January 21, 2011

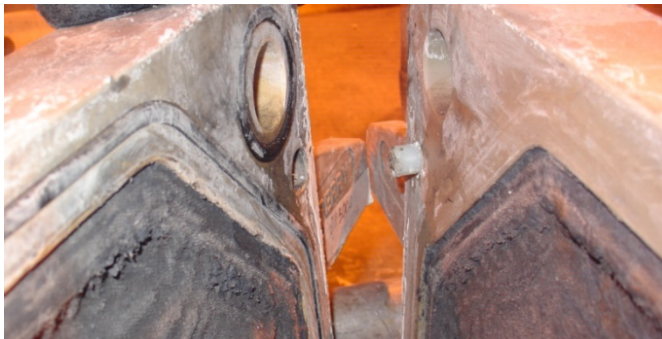
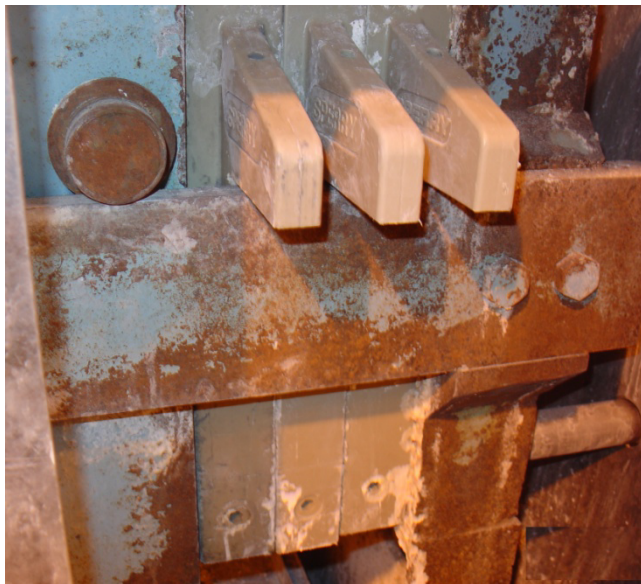
Event Overview

- The Integral Fuel Burnable Absorber (IFBA) Filter Press did not meet the design criteria when the “peg” passive design feature failed.
- Westinghouse self identified the issue during troubleshooting activities and promptly reported the issue to the NRC.
- Safety significance was low:
 - Uranium concentration is well below criticality safety limits.
 - The number of plates installed never exceeded the authorized number of plates.

- Filter press operations were stopped. Causal Analysis was completed.
- Revised the IFBA filter press analysis (established double contingency & IROFS) and the filter press plate design was upgraded, before restart was authorized. *[Complete September 2010]*
- URRS filter press replaced with safe geometry centrifuge (credible scenarios, double contingency & IROFS). *[Complete November 2010]*
- Incorporated findings and lessons learned from event and causal analysis into training case studies for Nuclear Safety Qualification Training, Environmental Health and Safety (EH&S) Certification Training, Knowledge Worker and Operations Human Performance training, as appropriate. *[Complete December 2010]*

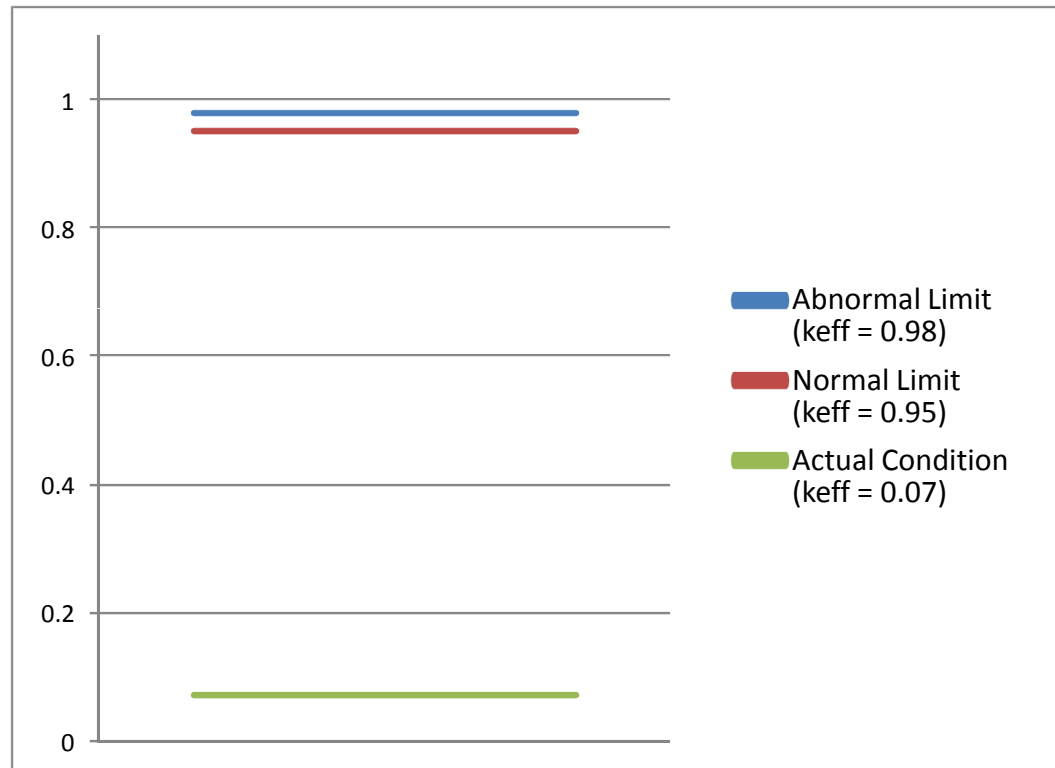
K_{eff} Actual Situation

Event Safety Significance
