Comanche Peak Training Center
PWS #2130037
Comprehensive Compliance Investigation Findings Response
Track #419001

COMANCHE PEAK TRAINING CENTER
PWS #2130037

Alleged Violation:

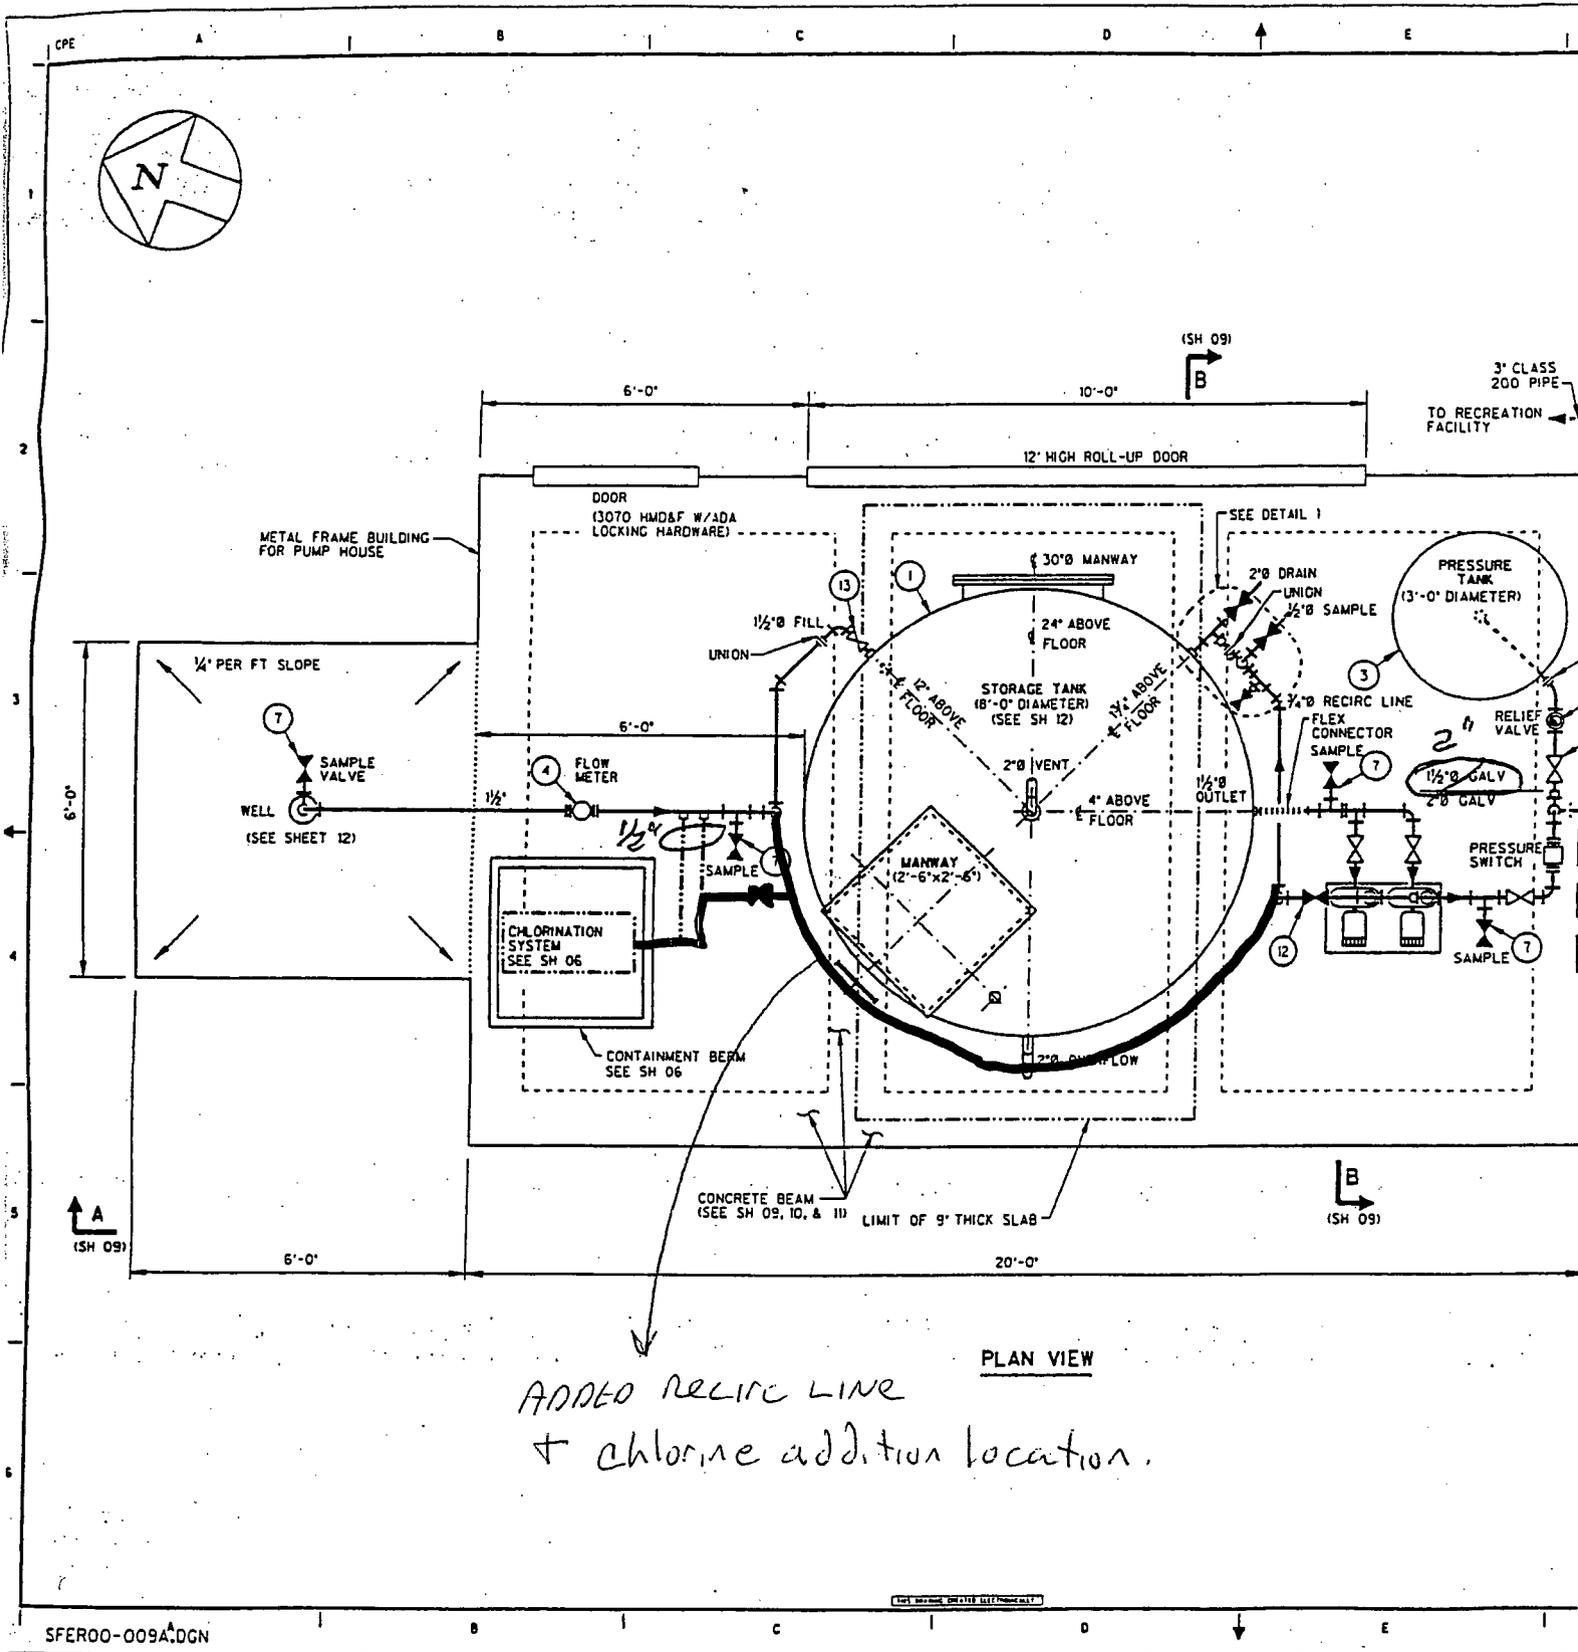
FIGURE 1

The attached photos, and drawing, (figure 1), show the recirc line where the chlorine is added to the system. The flow from the well is split and goes both directions through the recirc line adding chlorine when the well is pumping. A receptacle on the wall was discovered to be wired to start the chlorine addition pump when the well is running, and injecting chlorine as required. The connection of the chlorine pump to the recirc line, instead of the line from the well is superior, because it also allows for addition of chlorine when the well is not operating, by allowing the use of a recirc pump and recirc configuration. Since the well will sometimes go nearly a month without adding water to the tank, this ability to add chlorine when the well is not pumping is critical to maintaining adequate chlorine residual.

The recirculation piping is now being left valved in-line with the tank inlet. This valve alignment allows for a free flow of well water to flow to both the tank inlet point as well as to the opposite side of the tank via the recirculation piping. The hypochlorite pump is now controlled through an electrical outlet which is energized at the same time as the well pump when it receives the tank low level signal. Leaving the hypochlorite pump in the "RUN" setting, will result in hypochlorite injection whenever the pump's electrical supply is energized. This results in hypochlorite feed to raw well water prior to the storage tank. With well water entering the tank at two points, some of the raw water will enter the tank unchlorinated, but the tank will always be simultaneously receiving chlorinated water from the other inlet point. Manual recirculation hypochlorination continues to be performed as needed as it was prior to this alignment.

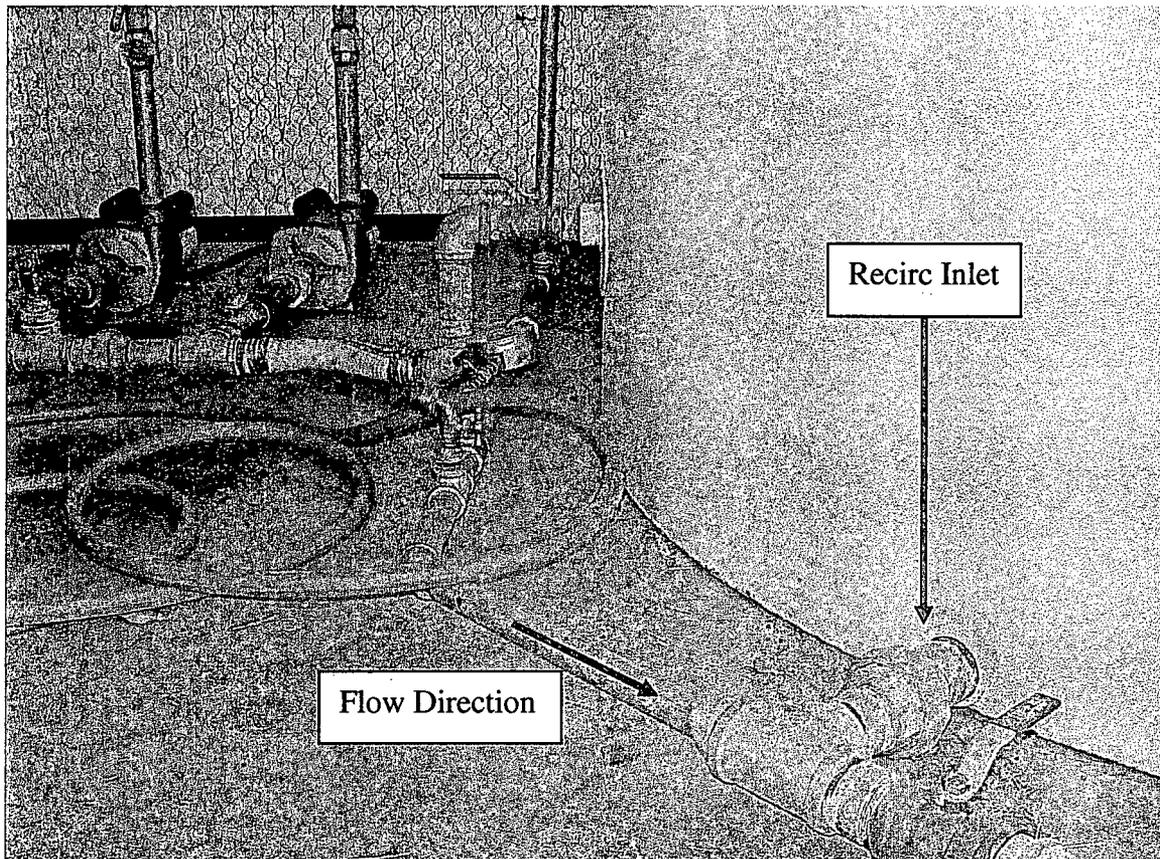
This photo shows the south side of the tank with the recirc line entering the tank

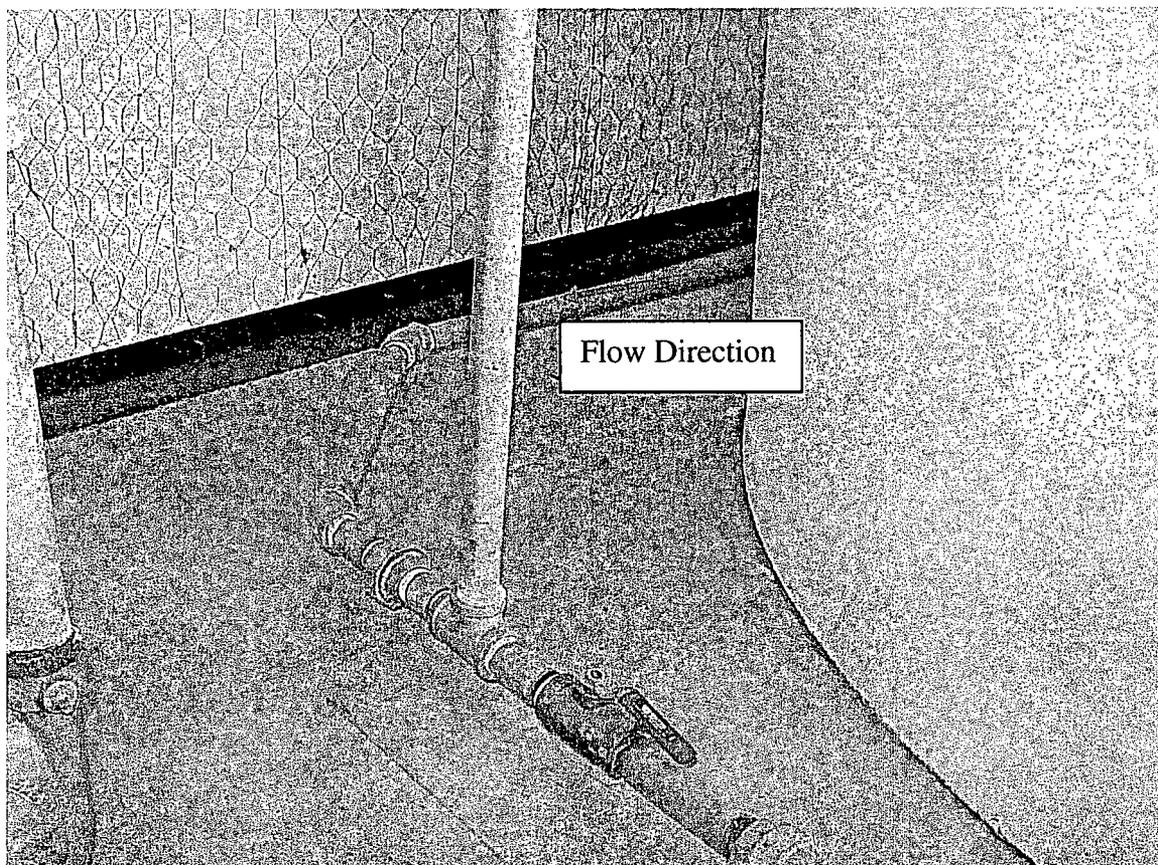
This is the recirc line as it goes around the tank from the south to the west side

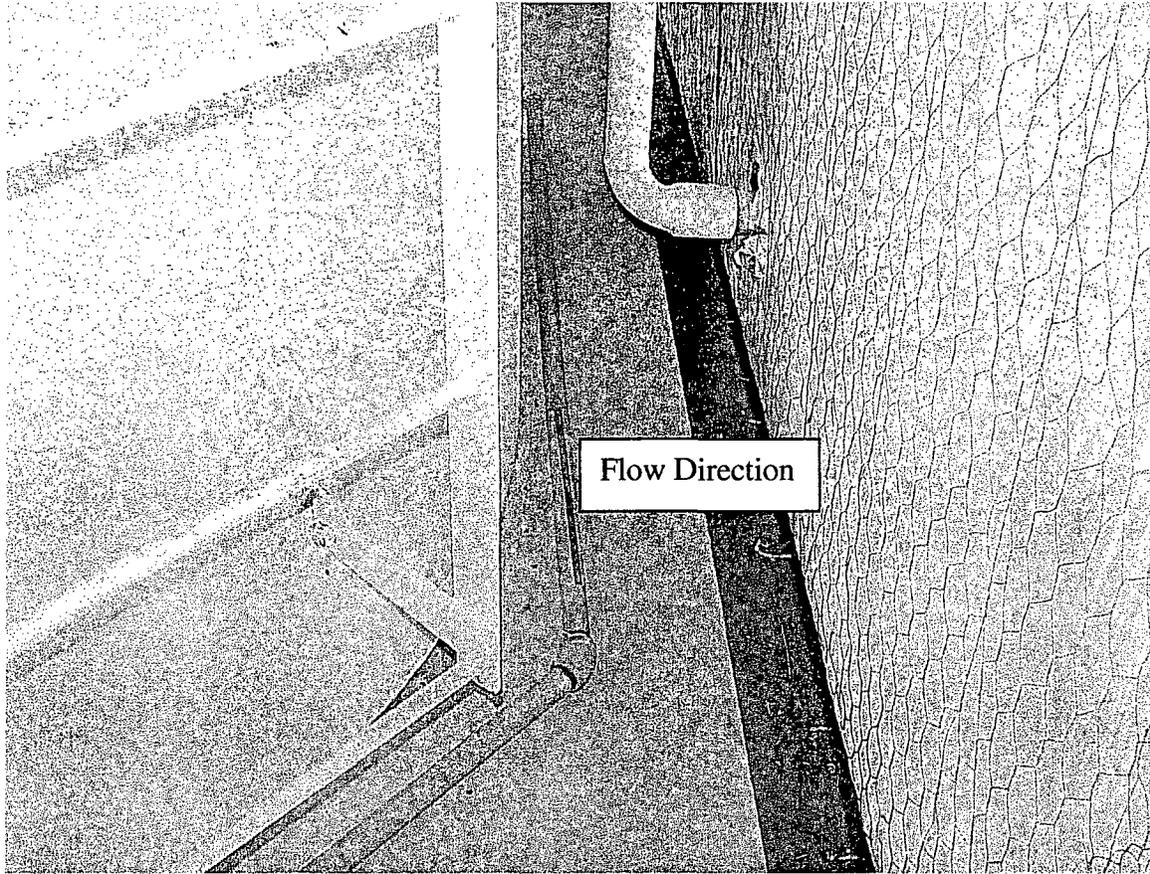
This is the recirc line coming around the tank from the west side to the north side

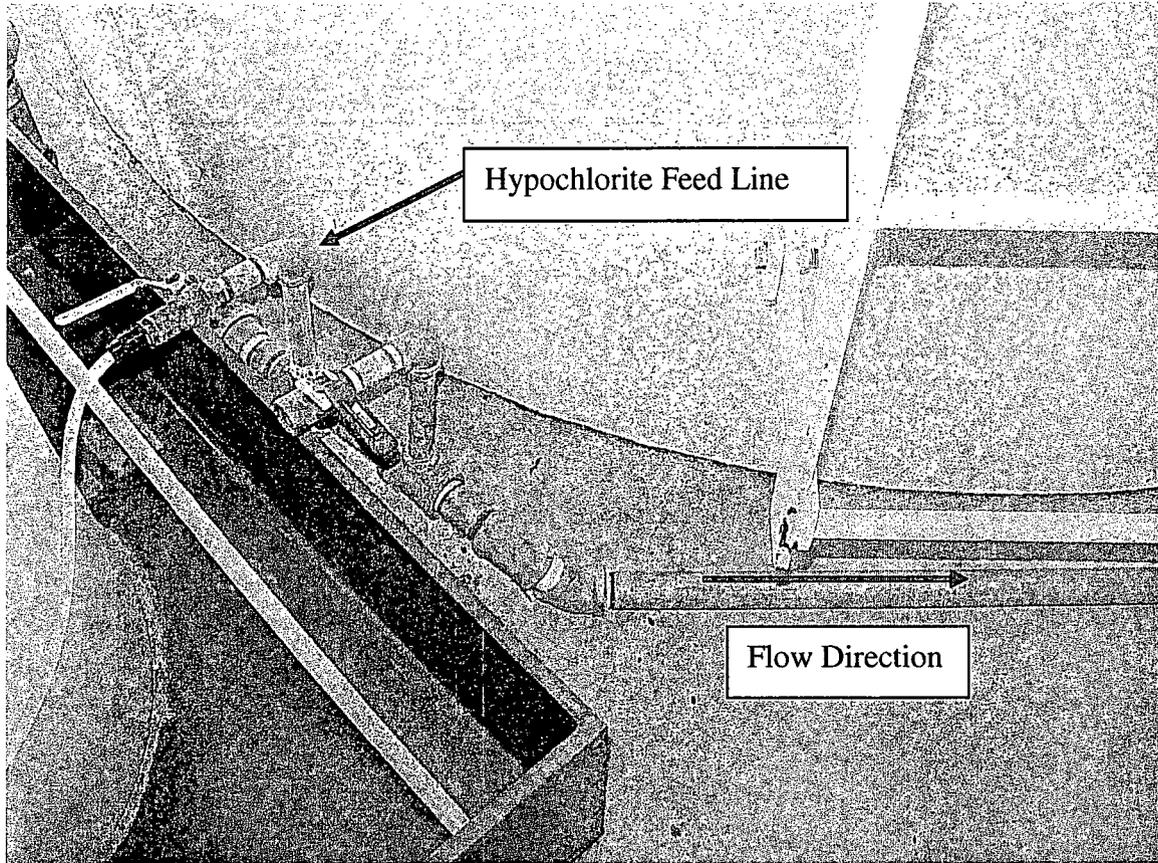
The recirc line on the north side of the tank, showing the chlorine addition connection

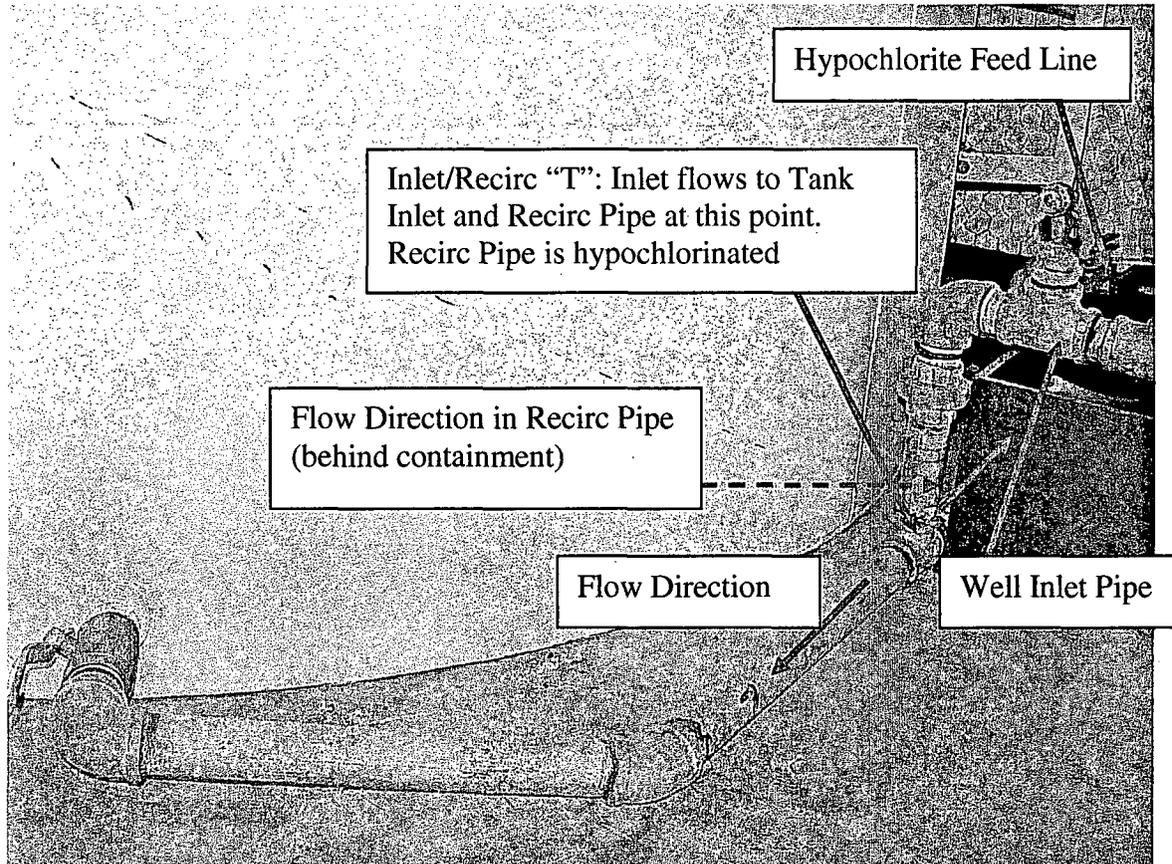
The other end of the recirc line. The pipe in the middle left is where the well adds water to the system. Notice that if necessary to provide flow in both directions to the tank, that the valve in the lower right may be throttled or closed to insure chlorine addition via the recirc line to the tank.
