Subject: INTERIM REPORT  
Flowserve, Limit switch on Limitorque Actuators, Type SMB-00 and Type SMB-2-06

Subject: Final Report for CAR 25500-73903 / Part 21 Evaluation of Geared Limit Switch (NRC Event # 46403)

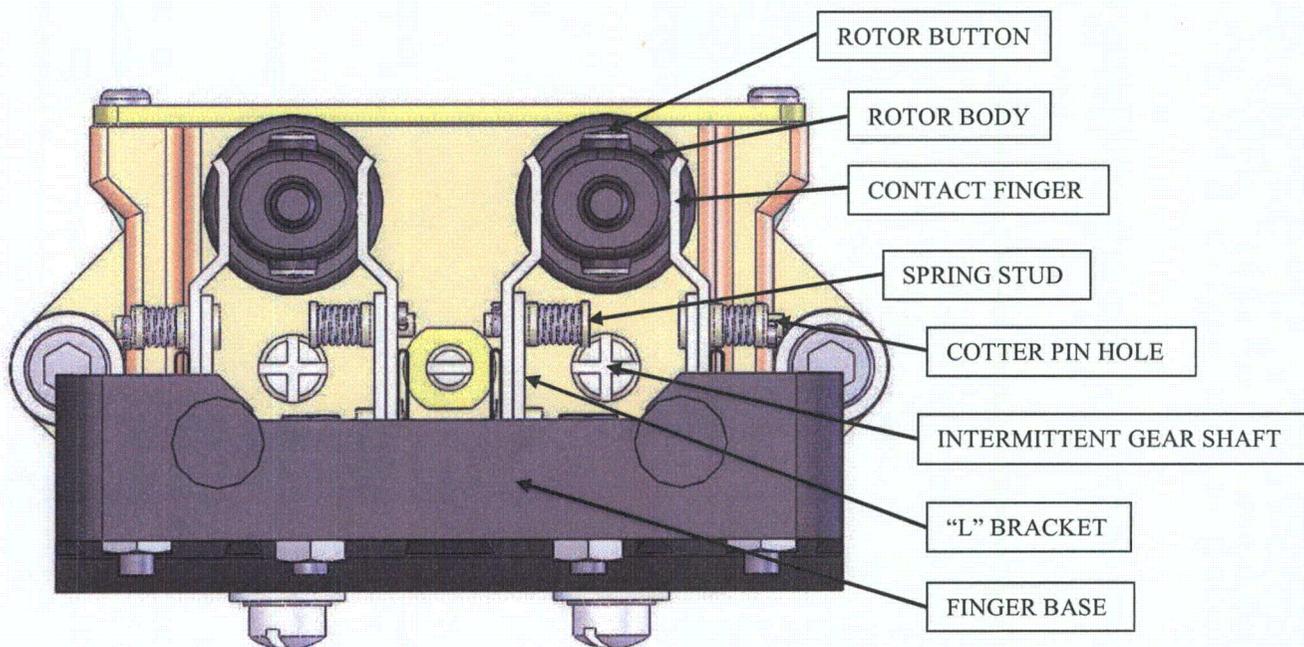
**Model shows finger assemblies touching rotor body in the electrically open position**

The model below should be utilized by Velan as a guideline for visual inspection to confirm proper switch operability. The assembly should be inspected to ensure that there is proper contact with the rotor body. Adjustments to the "L" bracket are permissible.

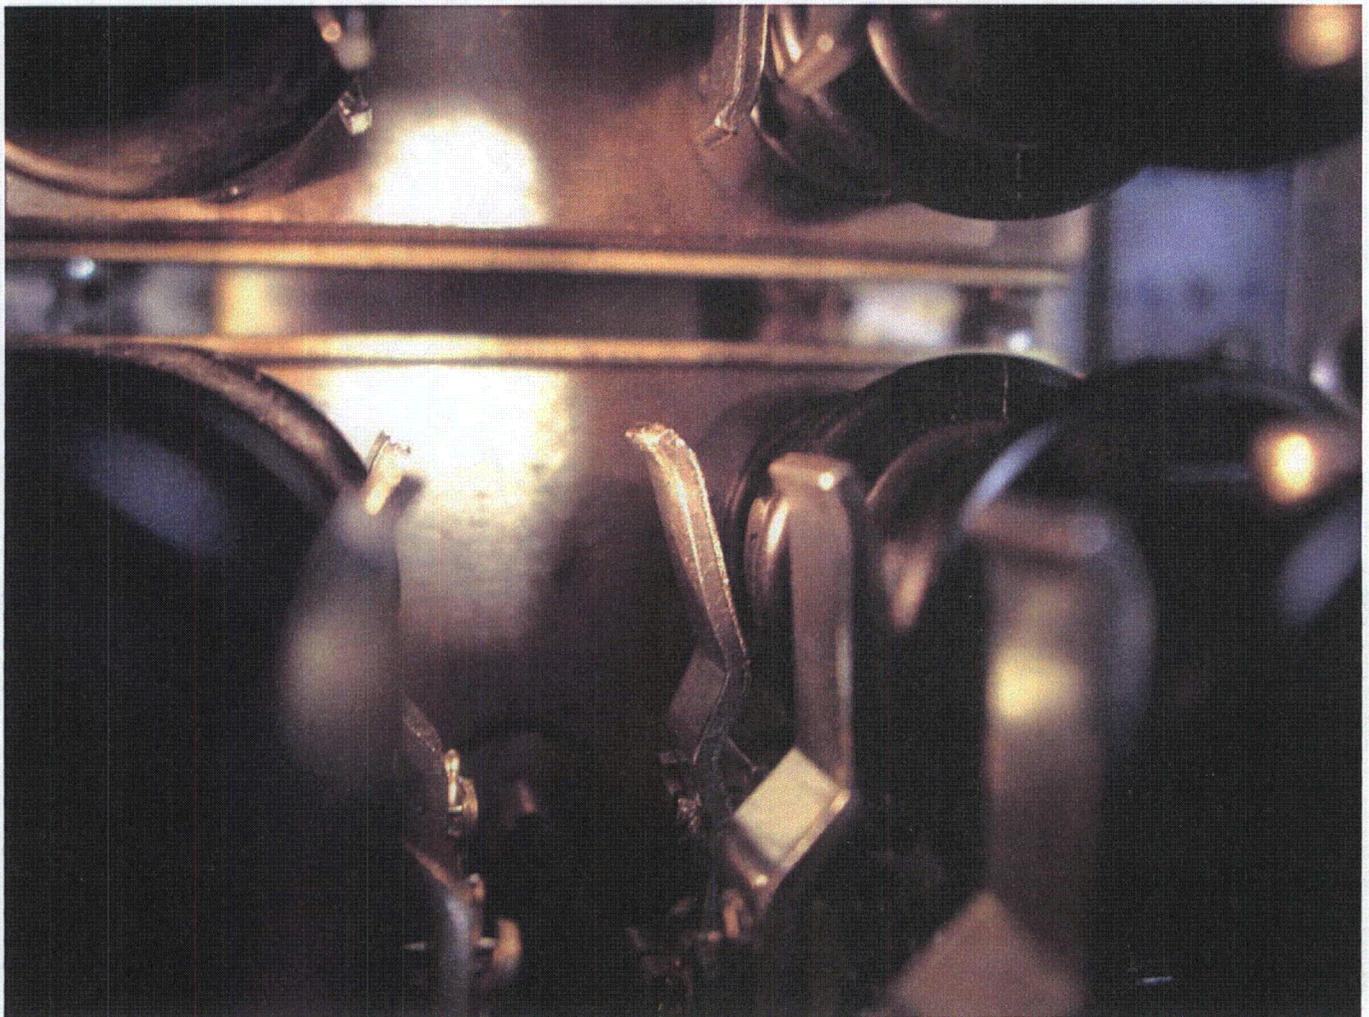
VELAN PHOTO 2525

- 2525 and 2526 showed a contact bent at the base near the setting screw
- 2527 showed a very tight finger assembly with minimal spring action
- 2641 and 2642 showed a finger assembly farthest from the base with minimal if any contact with the rotor button.
- 2528 showed a finger assembly with normal spring action.

The bent finger condition that was noticed in photos 2525 and 2526 was evaluated and found that the finger was so severely bent that it would not make contact with the rotor button in the closed state. It is Flowserve's opinion that this damage could have been caused by a flat bladed screw driver catching on the rivet head during the switch setting process. While turning the intermittent gear shaft it is possible for the rotating blade of a flat bladed screw driver to contact the spring stud on the contact arm. This creates a bending moment resulting in the contact arm bending at the point where the spring stud passes through the contact arm. Once discovered, this failure mechanism was repeated in multiple trial tests. Subsequent 3-D modeling of the switch assembly reinforced this finding by identifying the contact area of a screwdriver with the spring stud. The photos below show the bent rivet from the above finger assembly and scarring on the head of the rivet.

Based upon this evaluation the following corrective actions have been implemented. The individual switch components have been reviewed and all critical inspection dimensions have been identified. The relevant in-process inspection plan has been reviewed and is being modified to include a visual inspection step to confirm that the finger contact arm is touching the rotor body in the electrically open state. This additional inspection will be documented on existing inspection form L-193.

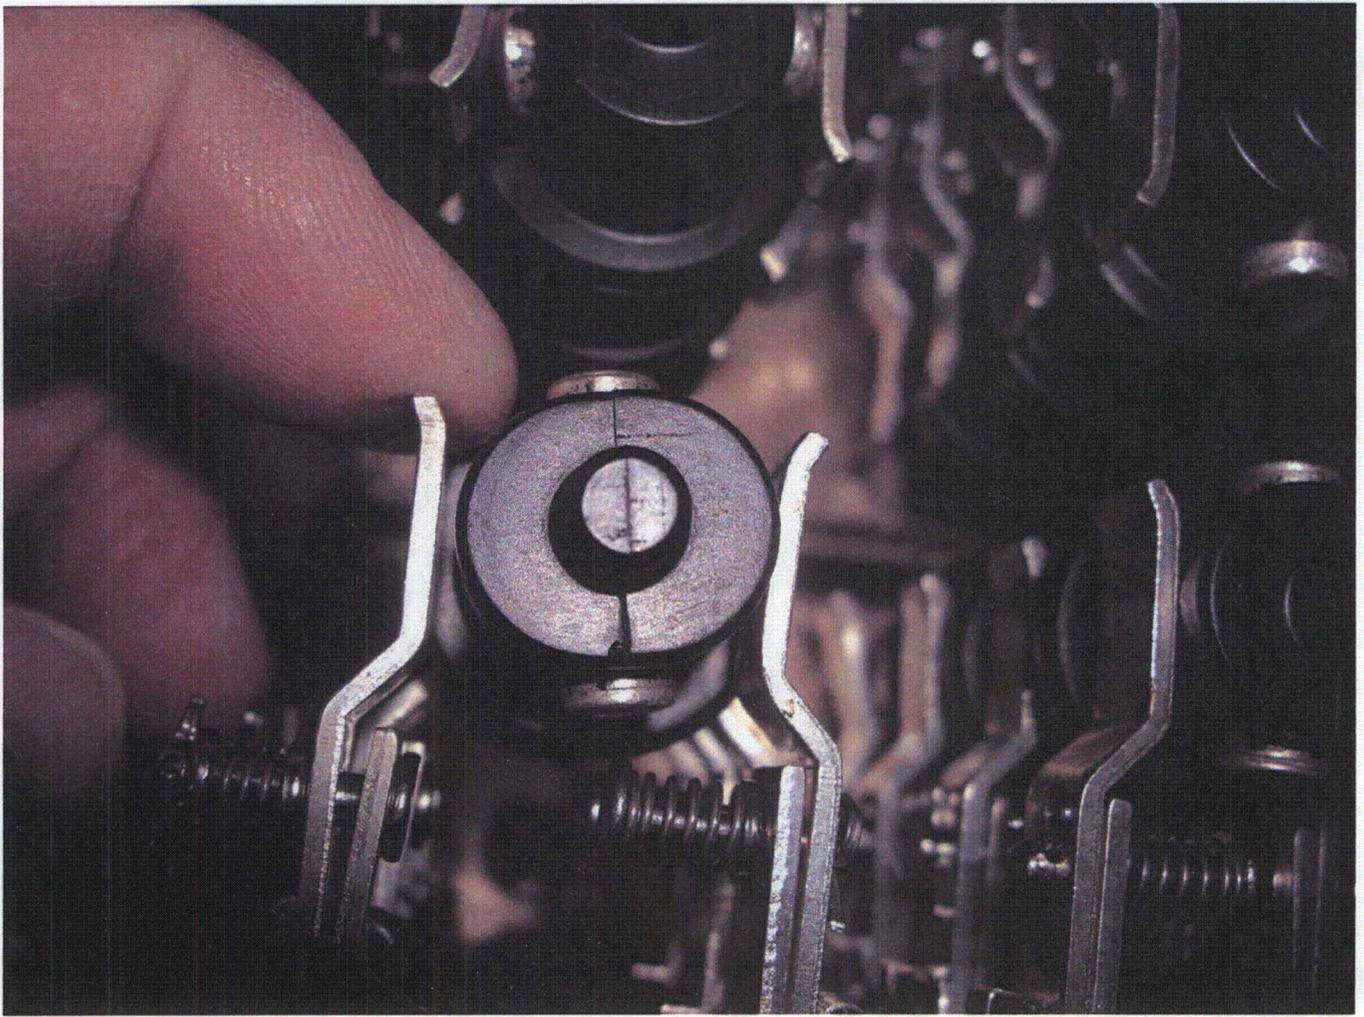
VELAN PHOTO 2527

The tight finger condition that was shown in photo 2527 was found to be caused by the clearance hole in the finger for the rivet to be on the low side of the print tolerance and some of the samples measured showed the hole diameter slightly smaller than tolerance. It was found through the engineering evaluation and 3-D modeling that this tight condition could possibly occur even if the hole diameter was to specification and at the minimal print tolerance. We tested multiple finger assemblies with completely tight to minimal spring action for 3,300 cycles and found no loss of continuity or bending of the contact fingers. Based upon this testing, it was

determined that producing a bent finger contact cannot occur during normal cycling operation of the switch even if the finger assembly is tight with no spring action.

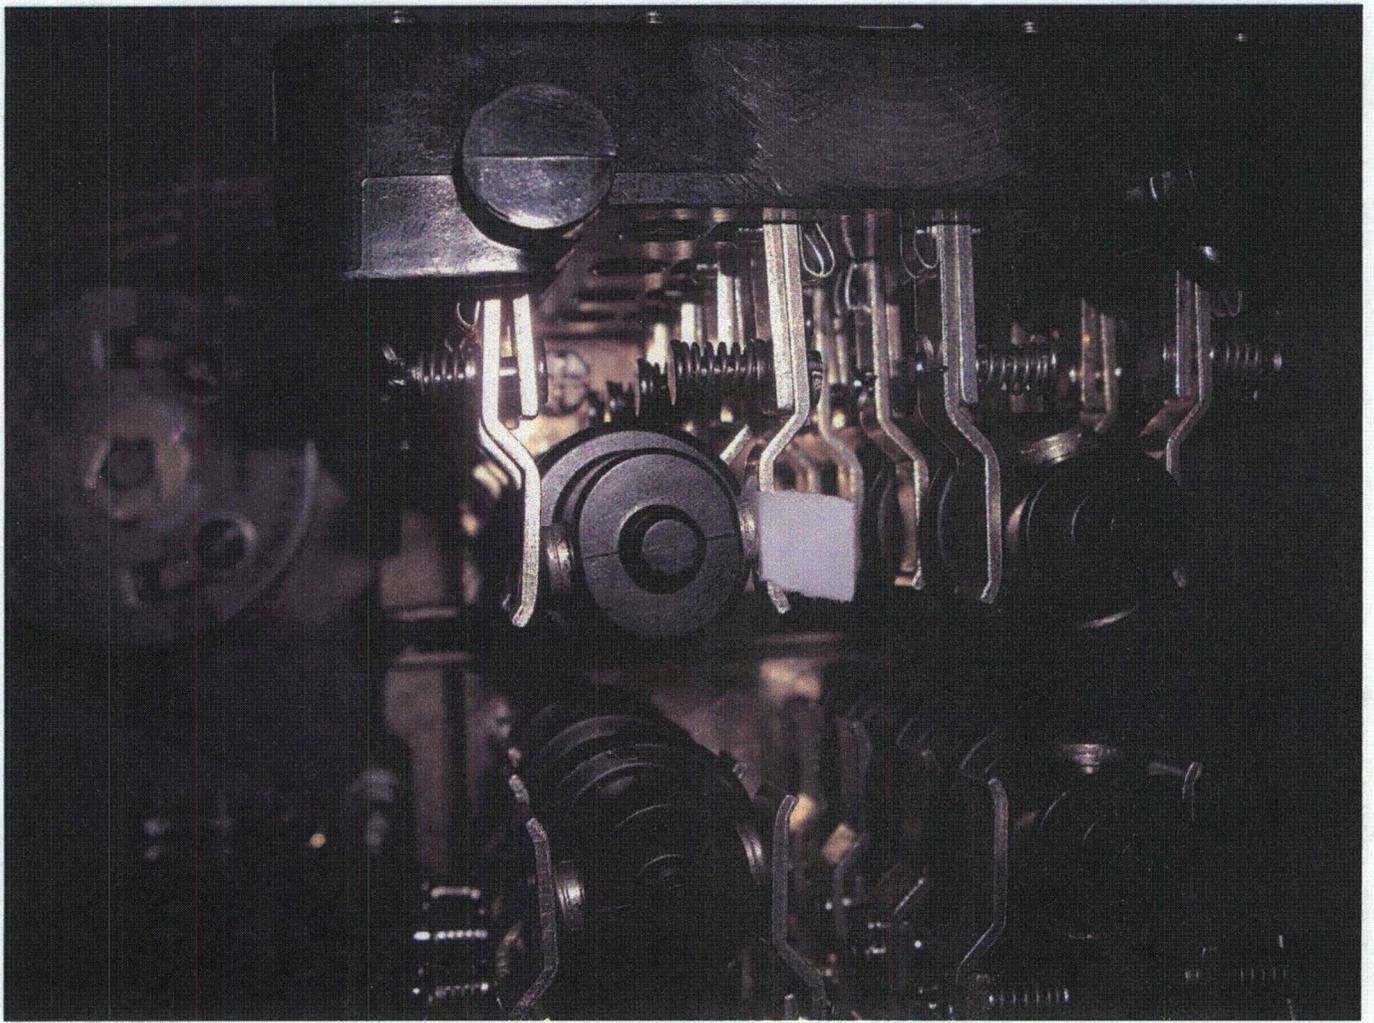
VELAN PHOTO 2641

The switch that had the condition depicted in photos 2641 and 2642 was tested as received and passed over 2,000 cycles with no loss of continuity. This switch finger was found to have very minimal contact with the button in the closed position as a result of the "L" bracket of the finger assembly being bent. This condition allowed for minute contact with the button but the finger assembly would stay stationary when the switch went to the closed position. The finger assembly was not tight and had full spring deflection. Unfortunately we did not notice this condition upon the initial testing which may have been the cause for the intermittent loss of continuity at Velan. This finger assembly was subsequently adjusted properly so the finger was touching the rotor body in the electrically open state and the switch was tested an additional 3,300 cycles with no loss of continuity.

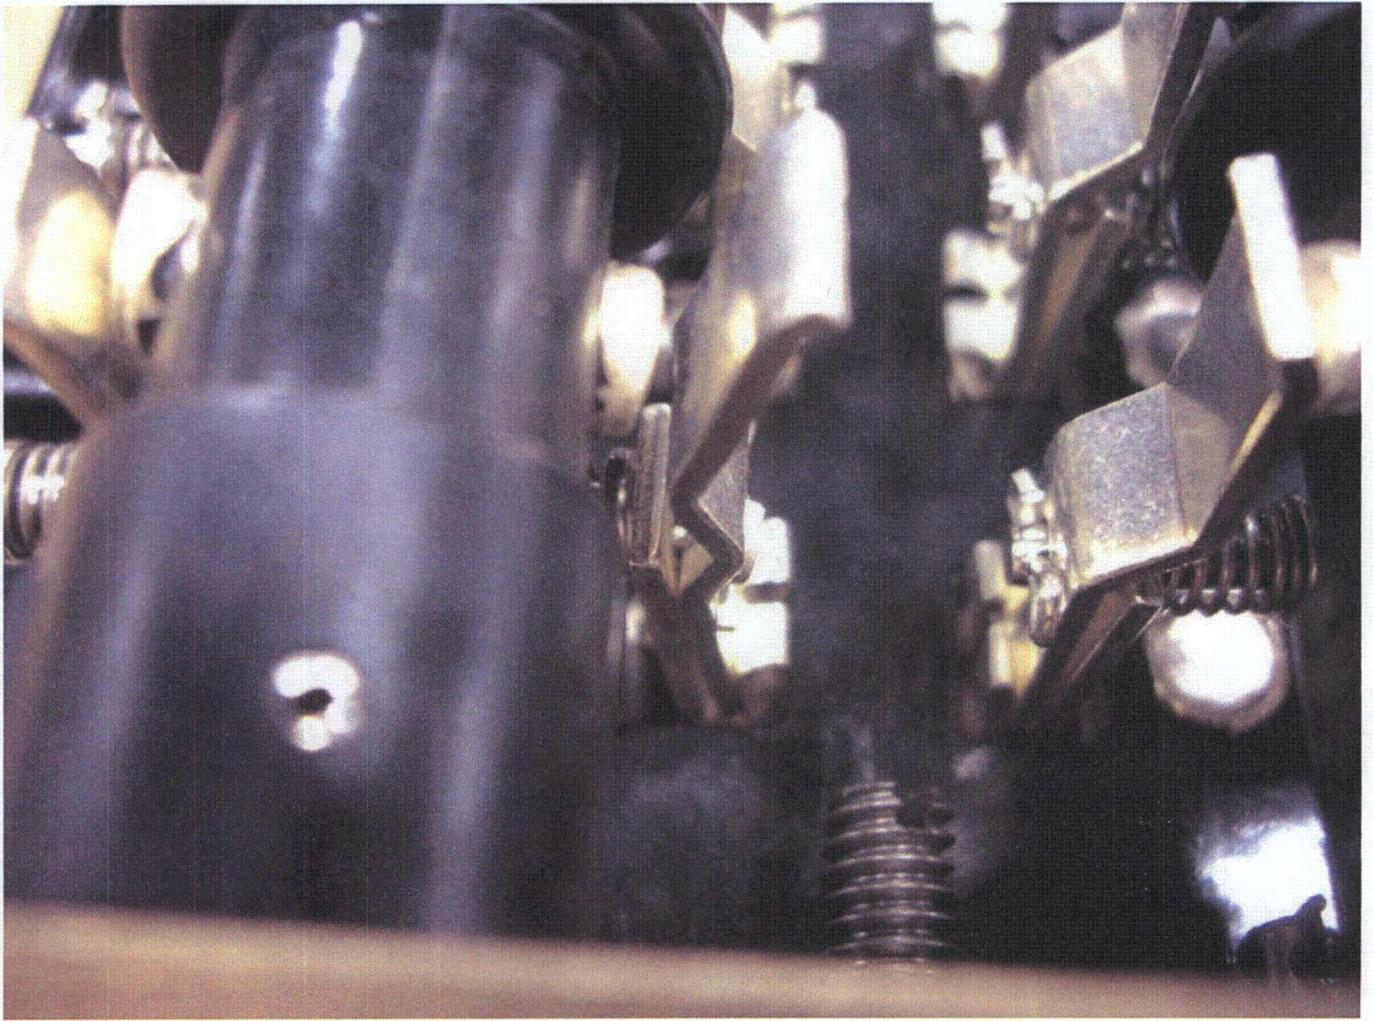
VELAN PHOTO 2652

Visual inspections and macro photography of the finger assembly 4L of switch in photo 2652 revealed a very severe bend in the finger and spring stud, and severe deformation of the cotter pin hole. The scuffing on the top of the head indicates a strong screw driver rotation in the opposite direction. This again supports the argument of a flat blade screwdriver being used (see photos below).

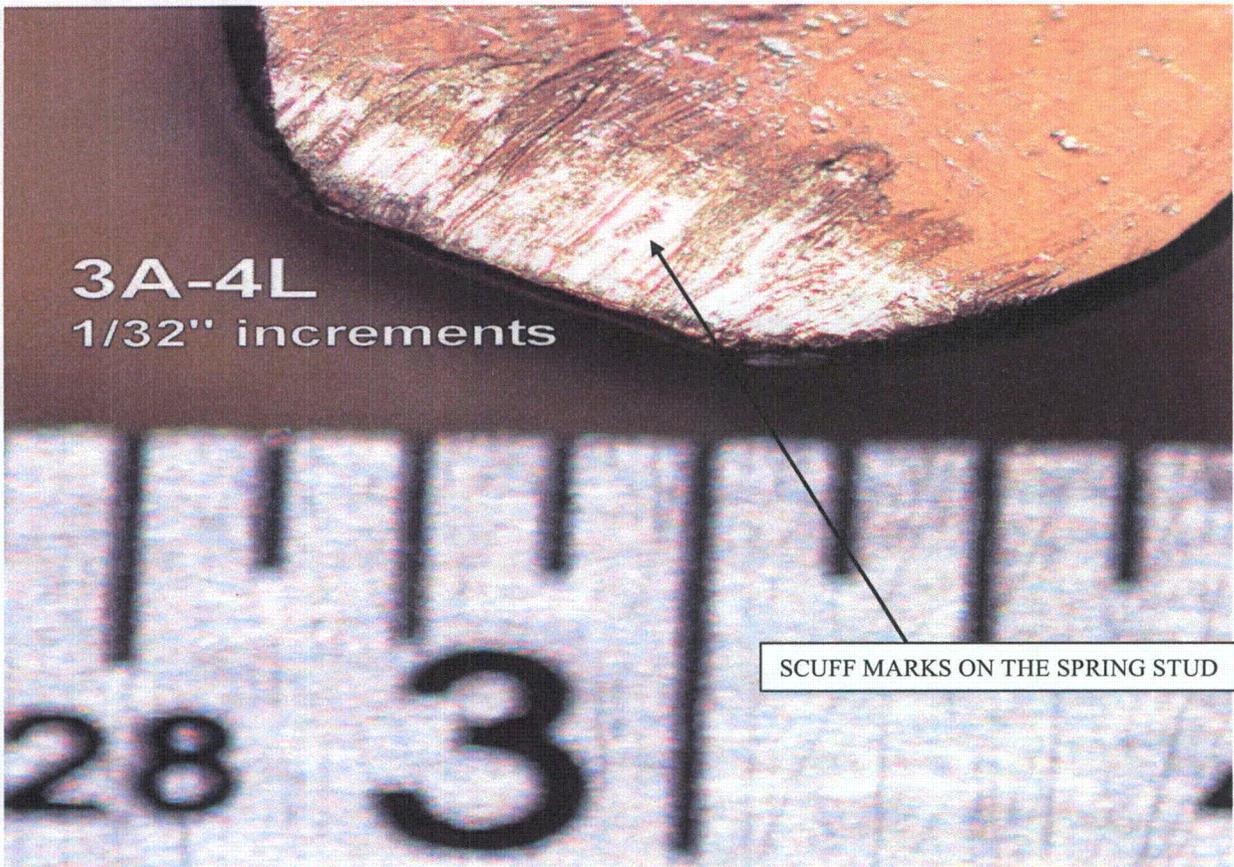
3A-4L

DAMAGE FROM A SCREW DRIVER BLADE

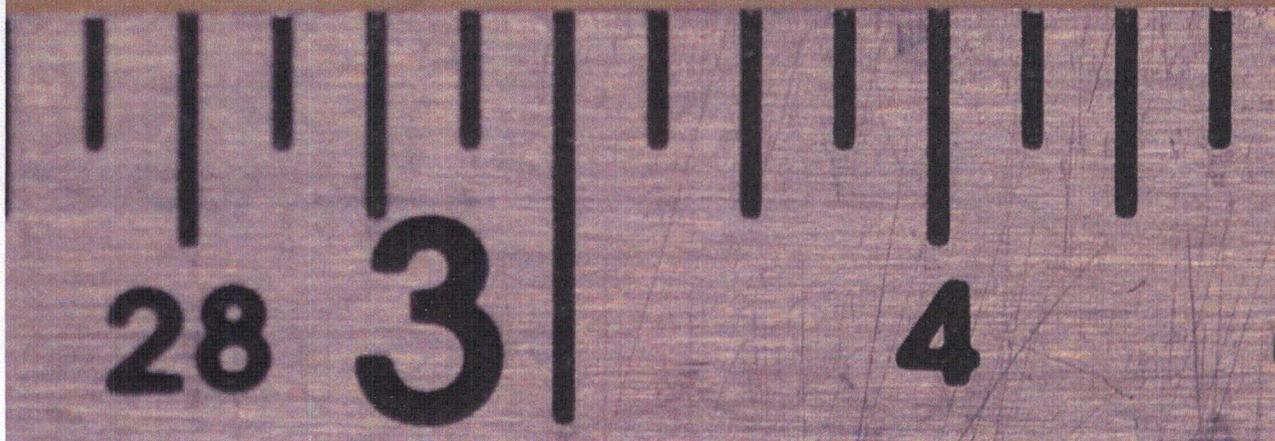
3A-4L

BENT SPRING STUD WITH DAMAGE TO  
THE COTTER PIN HOLE

DAMAGE TO HEAD OF SPRING STUD
