TEST REPORT

REPORT NO. 45918-01
OUR JOB NO. 45918
YOUR P. O. NO. 84YLFP22
CONTRACT N/A
PAGE 1 of 52 PAGE REPORT
DATE February 21, 1997

VIBRATION TESTING OF AN ES-2 SHIPPING CONTAINER

Lockheed Martin Energy Systems, Inc.
Oak Ridge, TN

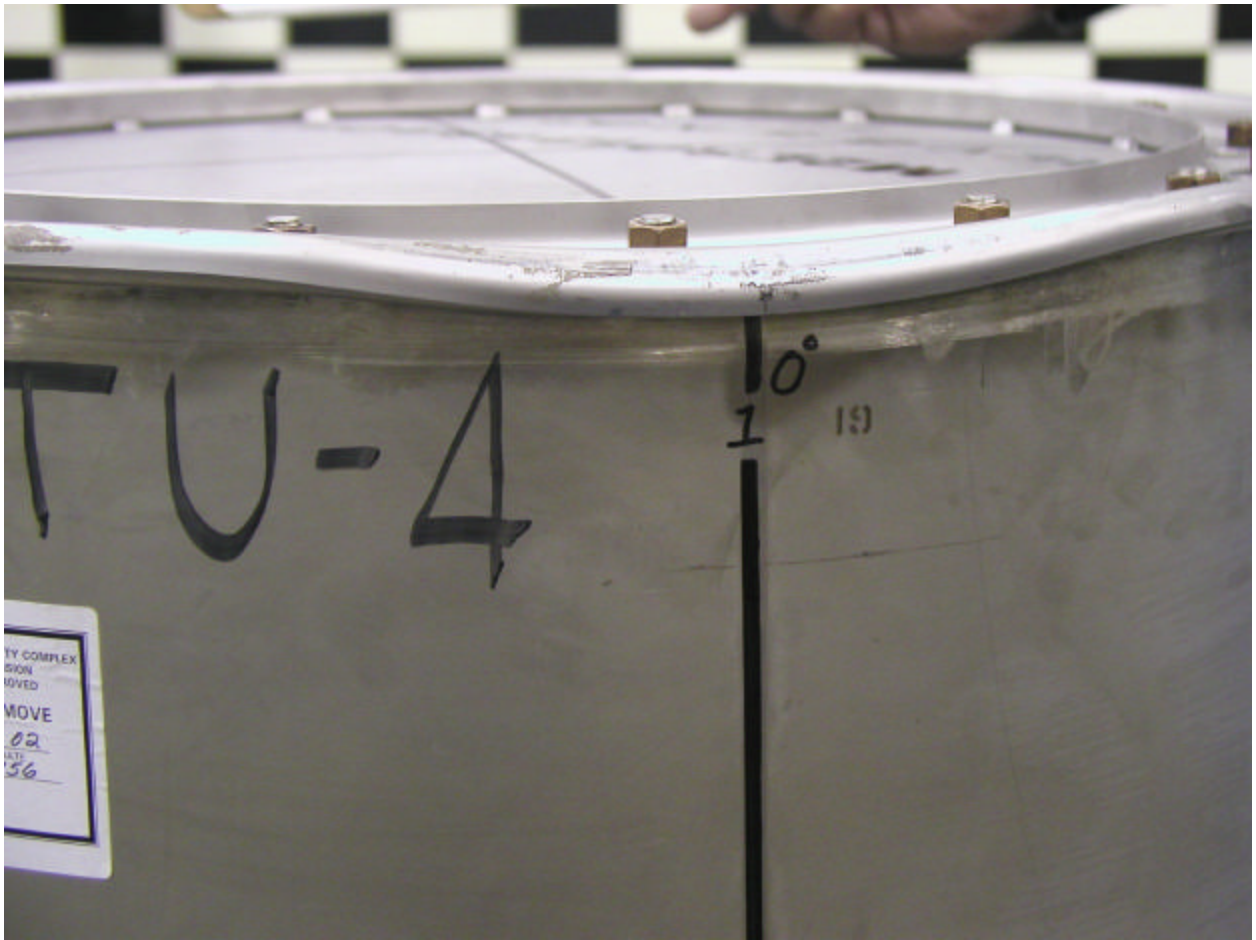
Impacting on the top edge of the package produced a flat area in the top ring of about 7-5/8 inches and bend down approximately 1/4 inch from its original position. The package then fell over and slightly flattened the bottom when it hit the impacting surface. Figure 3-3 shows the damage to the top ring, at the 0° line, caused by the impact.

Because the top ring flattened as well as bent, the diameter of the package diminished from an original diametric measurement of 23-9/16 to 23-7/16 inches in package TU-2 and from 23-9/16 to 23-1/2 inches in package TU-4. Additional detailed sketches of the damage and measurements of these packages is given in the Test Form 4 data sheets in Appendices B and D for packages TU-2 and TU-4 respectively.

Figure 3-3 Photo of the damage to the top ring on the closure of TU-4 resulting from the NCT drop test.

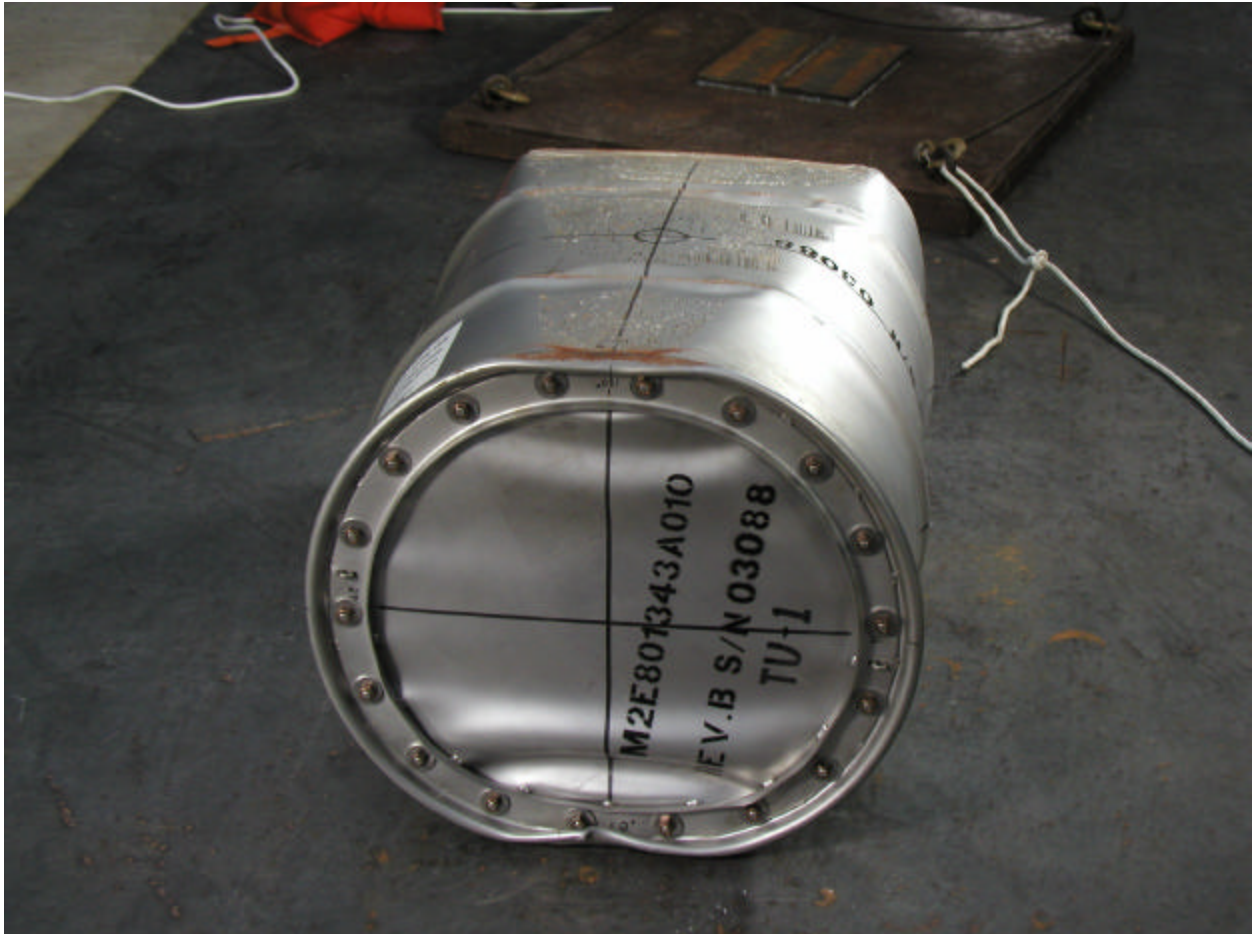
Figure 3-8 shows the damage caused to the 180° line area of the drum as viewed from the drum top and the 500-kg impacting weight in the background. Note that the drum is flattened more at the bottom than at the top of the drum demonstrating that the

Figure 3-8 Results of the dynamic crush test as viewed from the top end of TU-1.

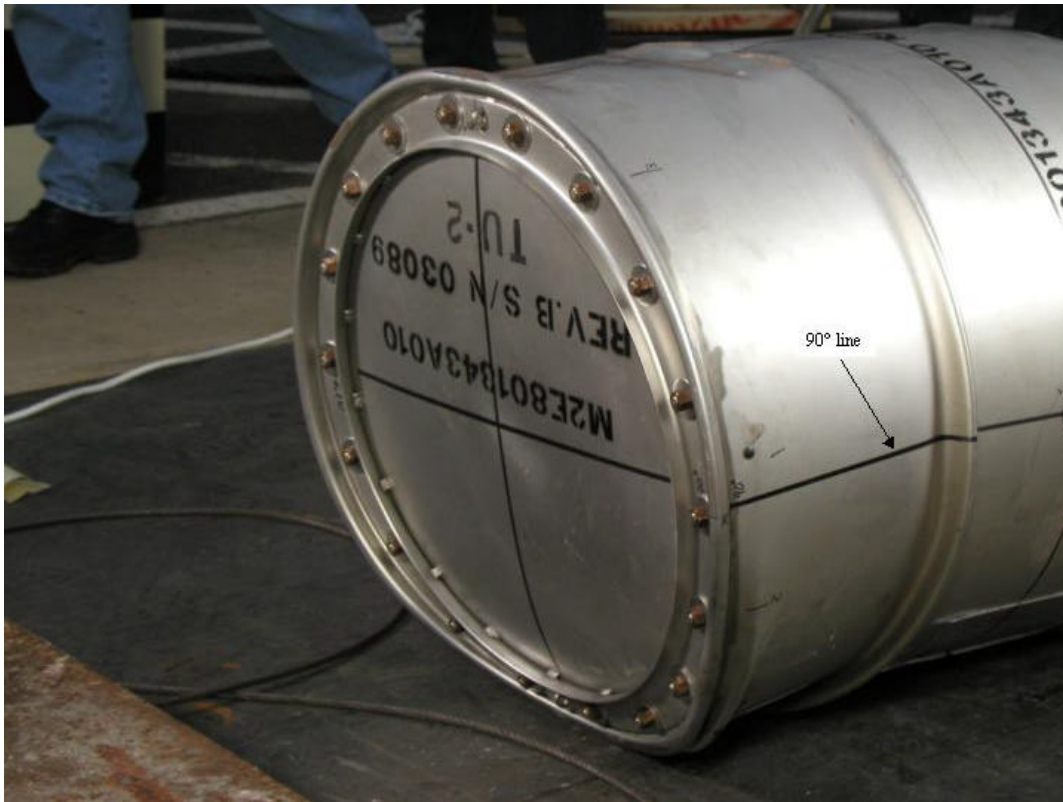
The damaged area of the top of the package is shown in Figure 3-11. This damage is much less due to the heavier structural members in the lid area. Note that in this photo there is a slight change to the originally straight 90° line drawn on the side of the package starting at about the top rolling hoop. The angle was measured to be approximately 7° from its original vertical position and was caused by the compression of the steel drum at the top rolling hoop at the 0° line at the time of impact of the steel plate on the package. This compression, in turn, caused the entire top of the package to bend slightly. The physical damage to the lid area is rather minor. Details of the damage are sketched on Test Form 6 in Appendix B.

Figure 3-11 Damaged top of TU-2 resulting from the dynamic crush test.

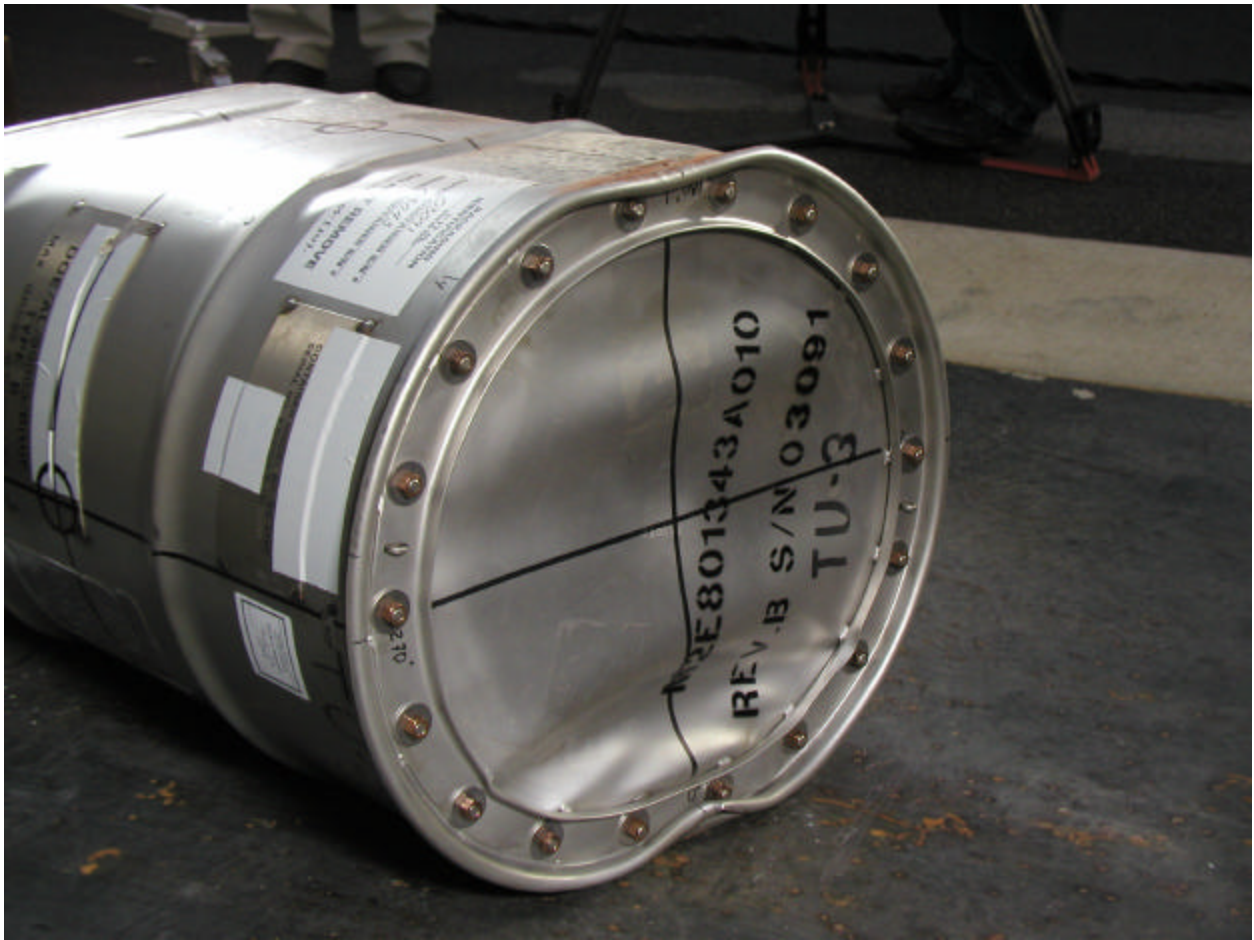
The impact caused the package along the 180° line to be flattened and increased the flattened surface along the 0° line that had been resting on the surface of the impact pad. Table 3-5 presents the measurements of the flats that were produced at four different locations on the 0° side and the 180° side of TU-3. The flat dimensions on the 0° side shown in Table 3-5 may be compared to similar measurements noted in Table 3-1 that were made at the same location on TU-3 following the NCT 4-ft drop test. The measurement data for this crush test were recorded on Test Form 6 in Appendix C.

Figure 3-12 Results of the dynamic crush test as viewed from the top end of TU-3.

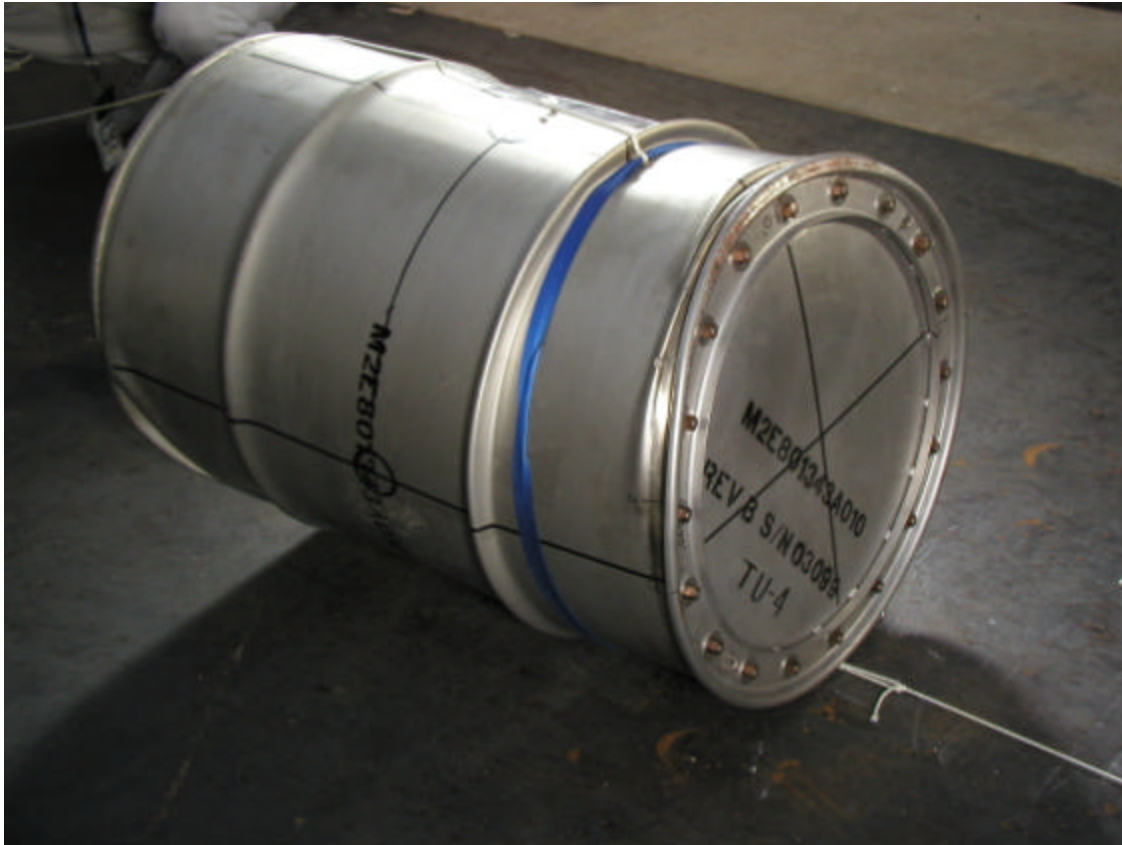
Figure 3-14 shows the resulting damage to the top of the package following the impact of the steel plate on the package. The impact caused the steel drum at the 0° line and the top rolling hoop to buckle and fold. This is a structurally weaker area caused by the presence of the rolling hoop in the drum. The impact also caused the top lid of the package to crush along the 0° line with the result that this side of the drum shortened slightly.

Figure 3-14 Results of the dynamic crush test as viewed from the top end of TU-4.

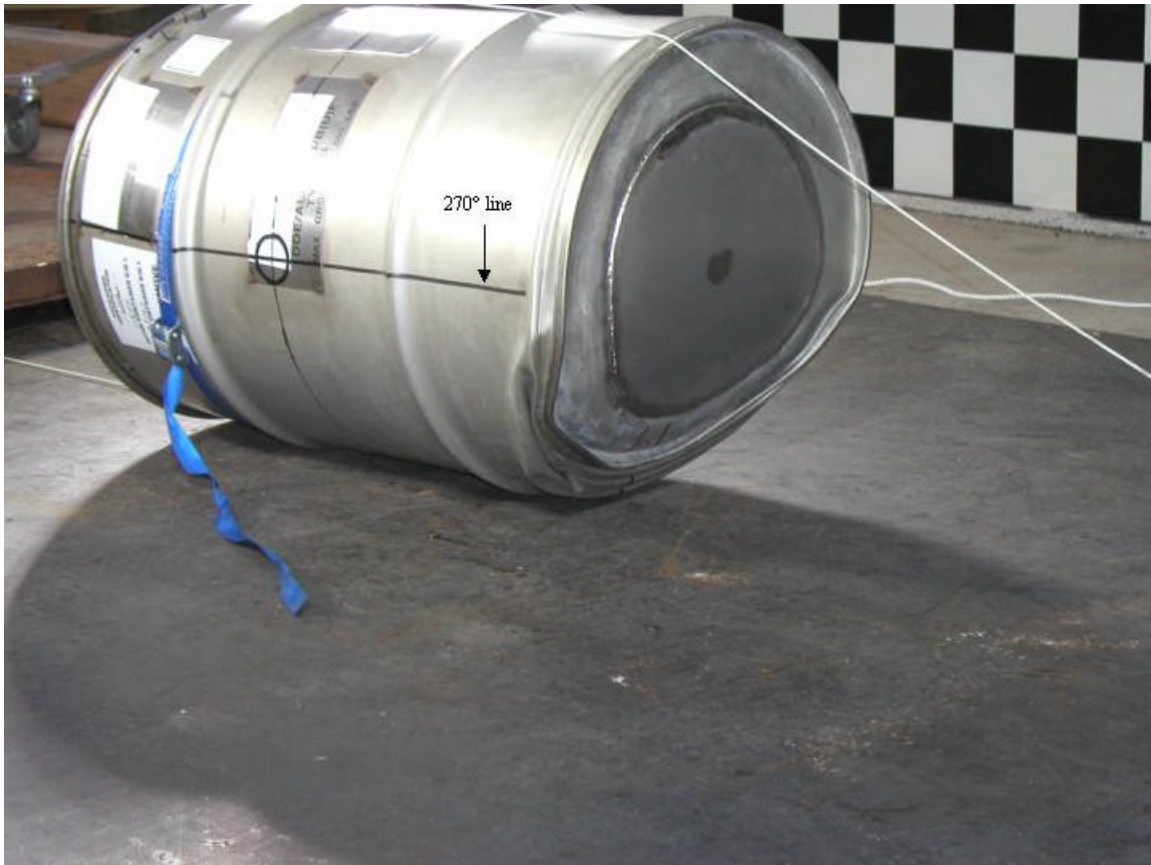
Note that in Figure 3-15 the 270° line appears to be slightly bent at the top rolling hoop. This angle was measured to be 4°. This is interesting since this is the same area that TU-2 produced a bend in the drum as a result of the crush test, but TU-4 was set up on the drop pad upside-down from the position of the TU-2 test unit. The difference in the angles produced (7° for TU-2 as compared with 4° for TU-4) is understandable since the TU-2 test unit underwent a 9-m HAC free drop test and thus sustained more damage prior to being subjected to the crush test.

Figure 3-15 Results of the dynamic crush test as viewed from the bottom end of TU-4.

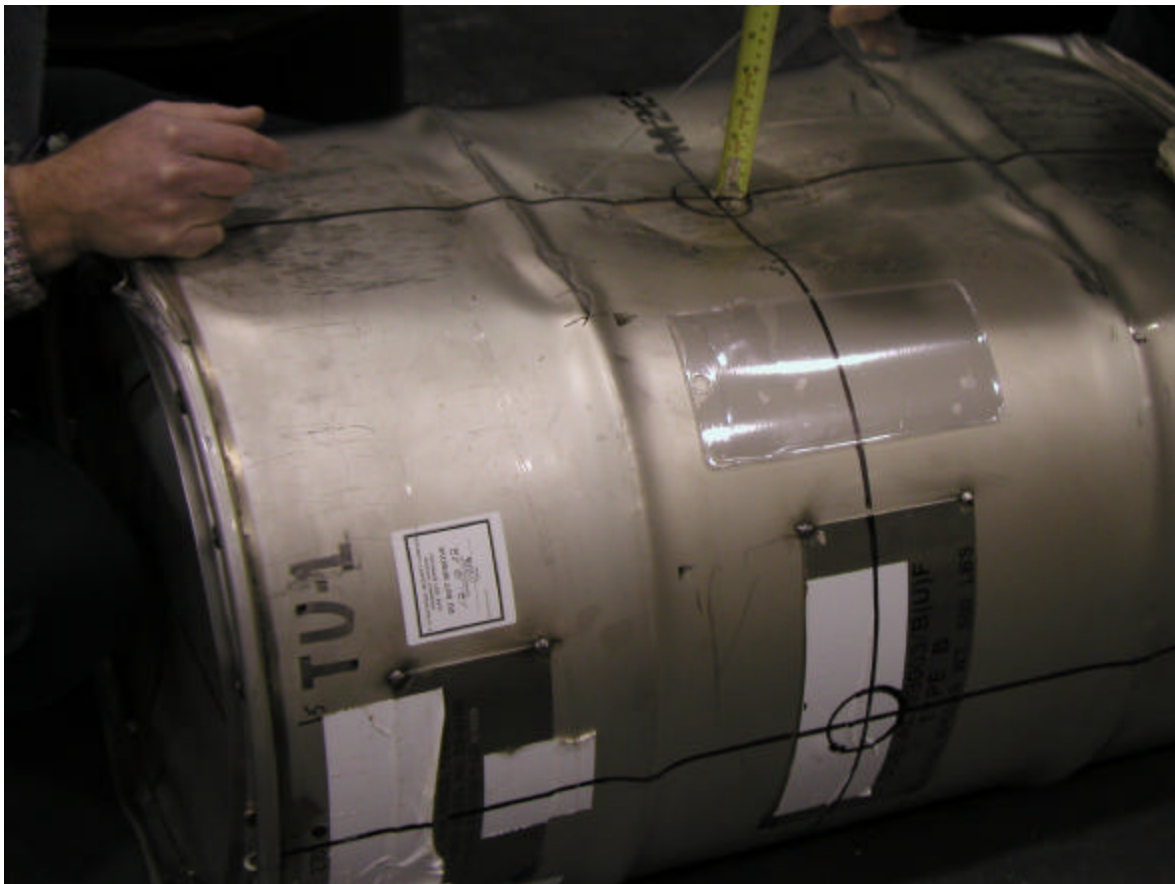
The resulting impact produced an indentation in the side of the steel drum, but did not puncture it (See Figure 3-16). The damage was observed to cover a circular-shaped area approximately 23 cm (9 inches) in diameter. A straightedge was laid across the indentation along the 0° line and the depth of the indentation was measured to be about 1.4 cm (9/16 inch). The diameter of the drum was measured from the center of the punch mark and the 0° line to the 180° line and found to be $18\text{--}7/8$ inches. The original diameter of the drum was about $22\text{--}1/2$ inches. The dimensional data for this test was recorded on Test Form 7 in Appendix A.

Figure 3-16 Damage produced in the first puncture test of TU-1.

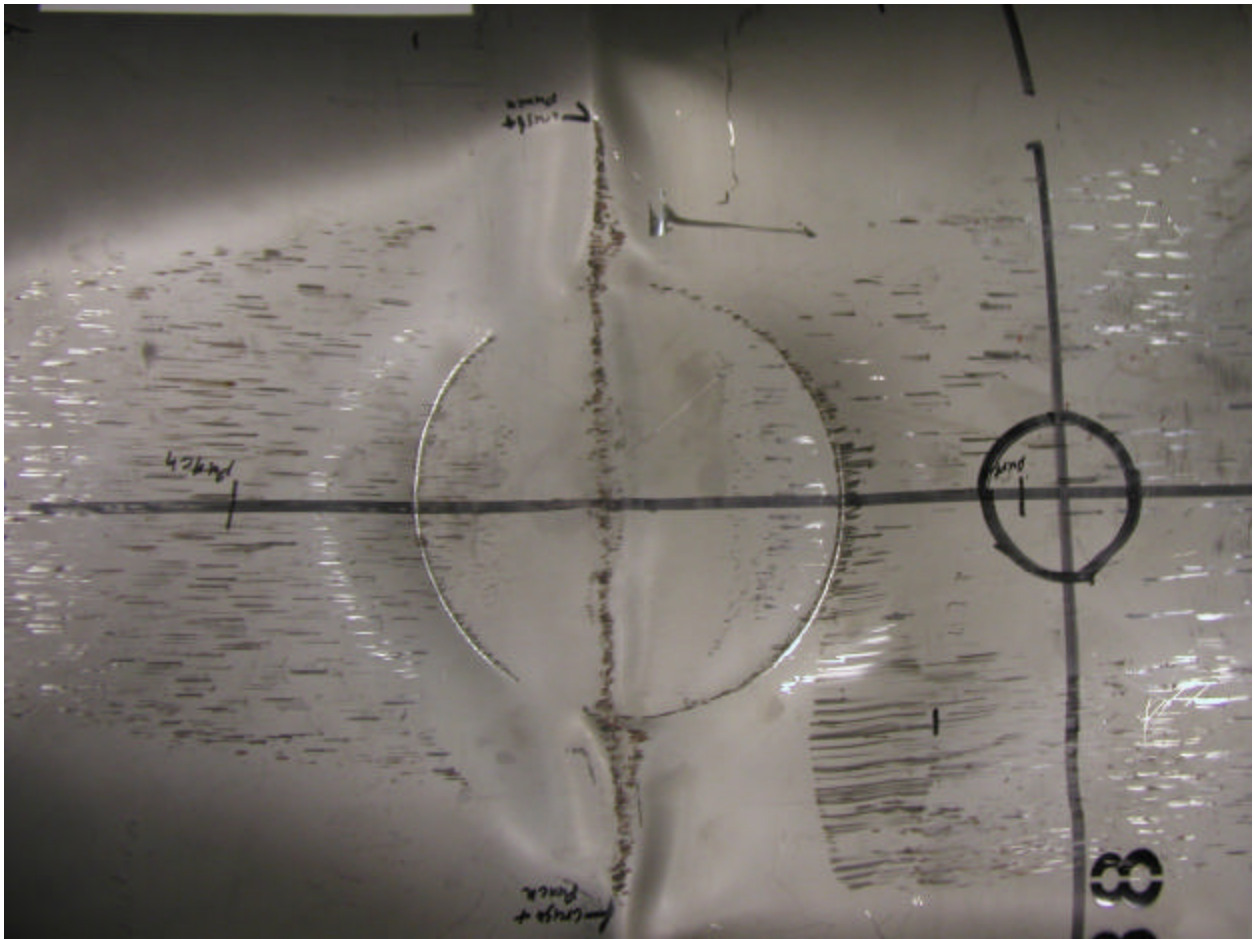
The resulting impact produced an indentation in the side of the steel drum, but did not puncture it (See Figure 3-17). The damage was observed to cover a circular-shaped area approximately 27.3 cm (10-3/4 inches) in diameter. A straightedge was laid across the indentation along the 180° line and the depth of the indentation was measured to be about 1.3 cm (1/2 inch). The diameter of the drum was measured from the center of the punch mark and the 180° line to the 0° line and found to be 18-7/8 inches. The original diameter of the drum at the top rolling hoop was 23-3/8 inches. The dimensional data for this test was recorded on Test Form 7A in Appendix A.

Figure 3-17 Damage produced in the second puncture test of TU-1.

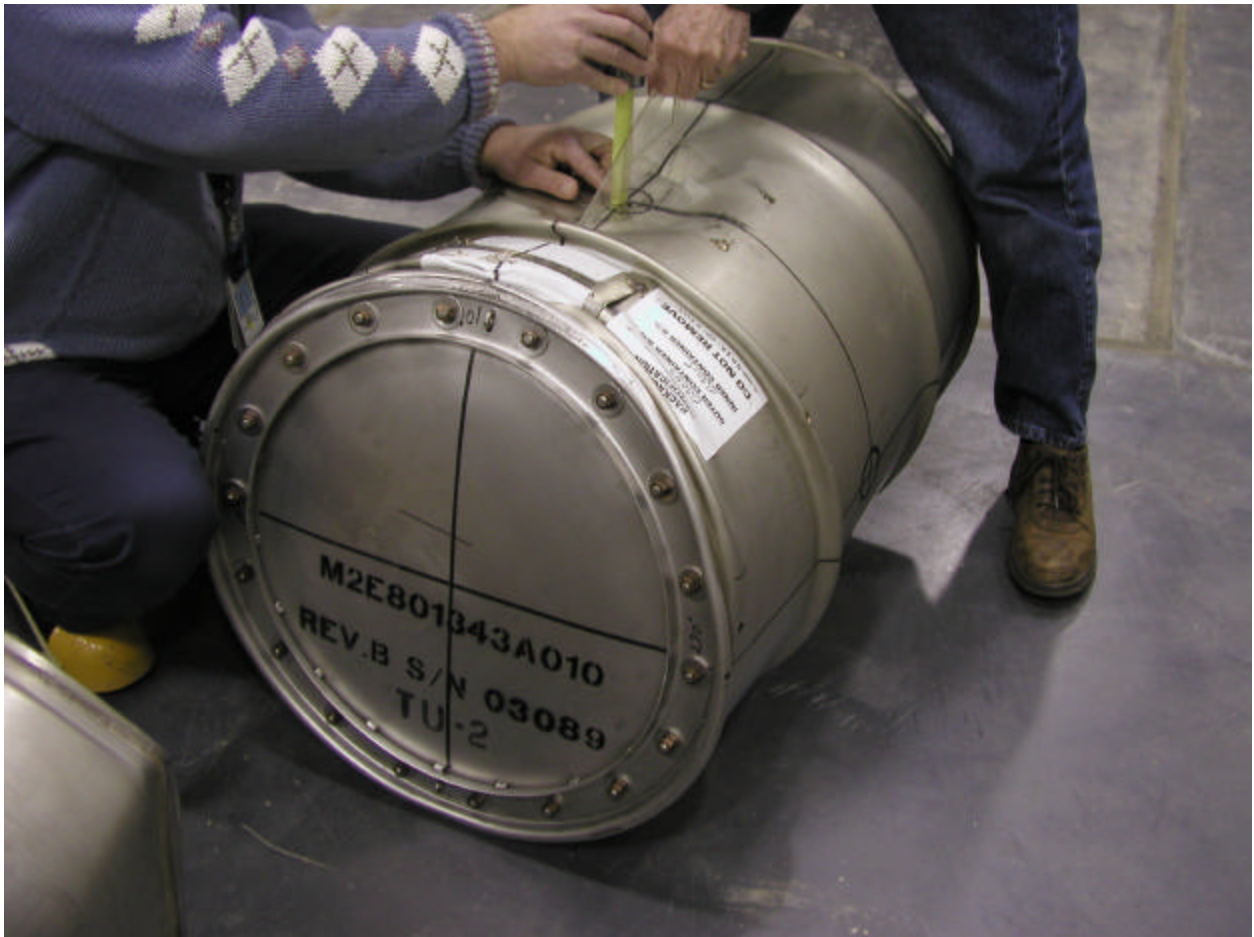
diameter of about 22 cm (8-5/8 inches). A straightedge was laid across the indentation along the 0° line and the depth of the indentation was measured to be about 1.6 cm (5/8 inch). The diameter of the drum was measured from the center of the punch mark on the 0° line to the 180° line and found to be 53.5 cm (21-1/16 inches). The original diameter of the drum was about 22-1/2 inches measured at the same location. Data for the punch test of TU-2 is given on Test Form 7 data sheet in Appendix B.

Figure 3-18 Measuring the indentation produced in the puncture test of TU-2.

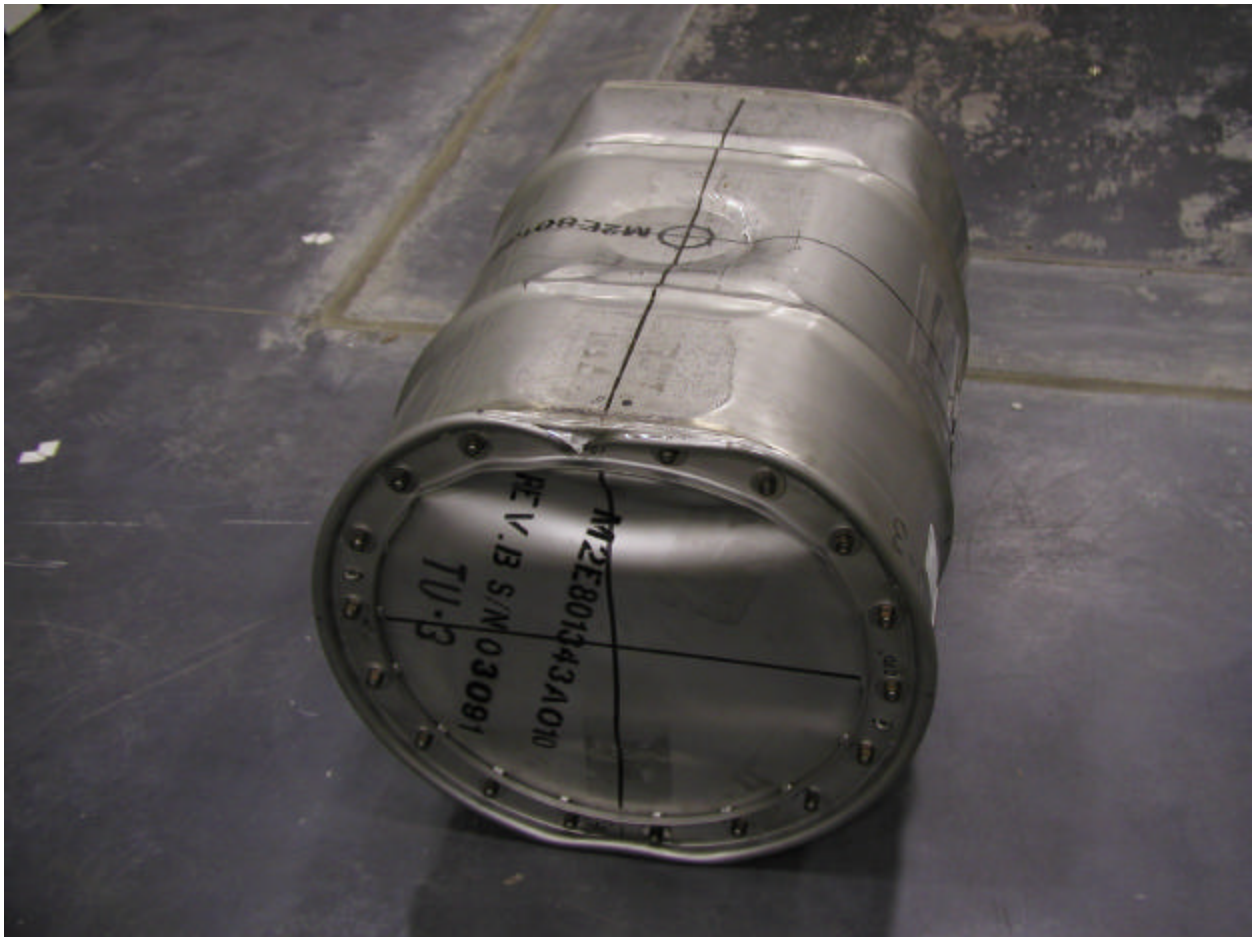
mark and the 0° line to the 180° line and found to be 19-1/4 inches. The original diameter of the drum was about 22-1/2 inches. Data for the punch test of TU-3 is given on Test Form 7 data sheet in Appendix C.

Figure 3-19 Damage produced from previous tests plus the punch test of TU-3.

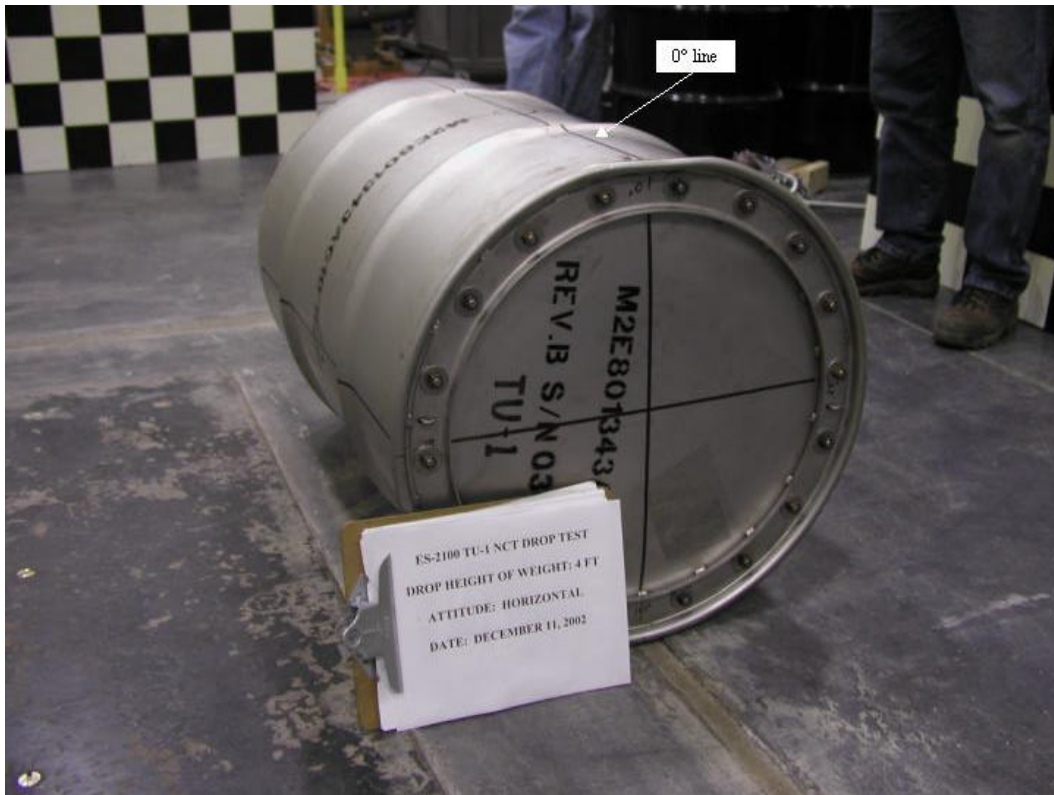
Figure E 11. Top end view of damage to TU-1 on the 0° line – package has been rolled 180°.

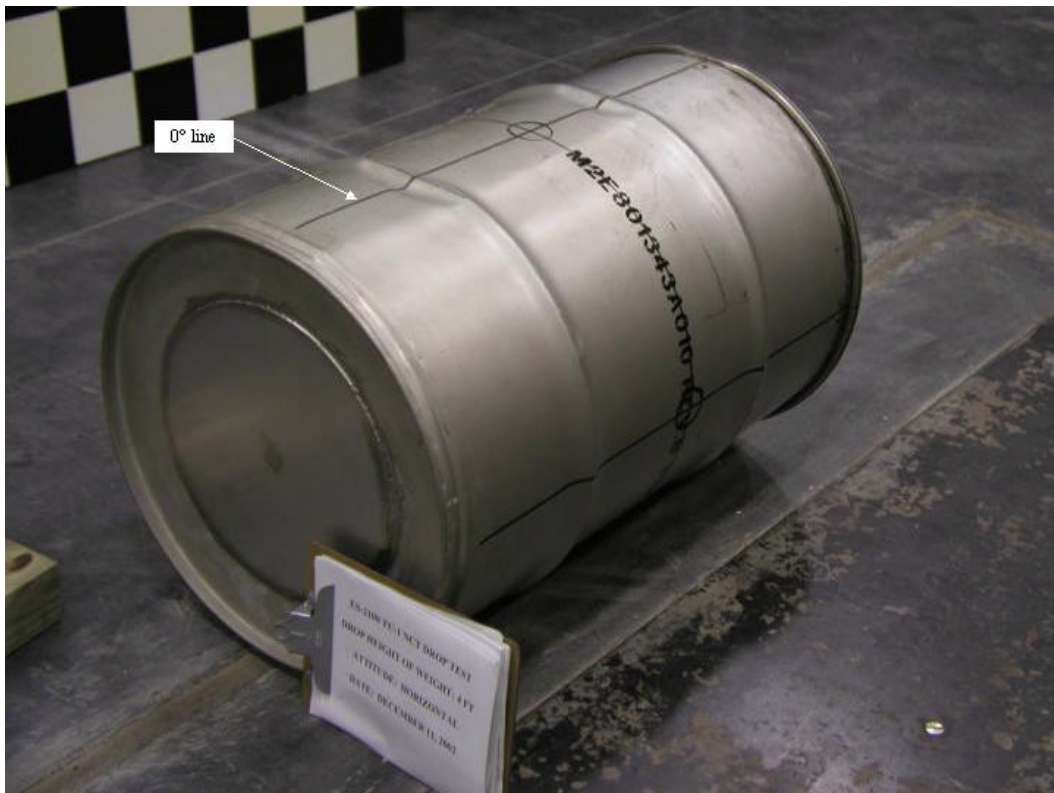
Figure E 12. Bottom end view of damage to TU-1 on the 0° line – package has been rolled 180°.

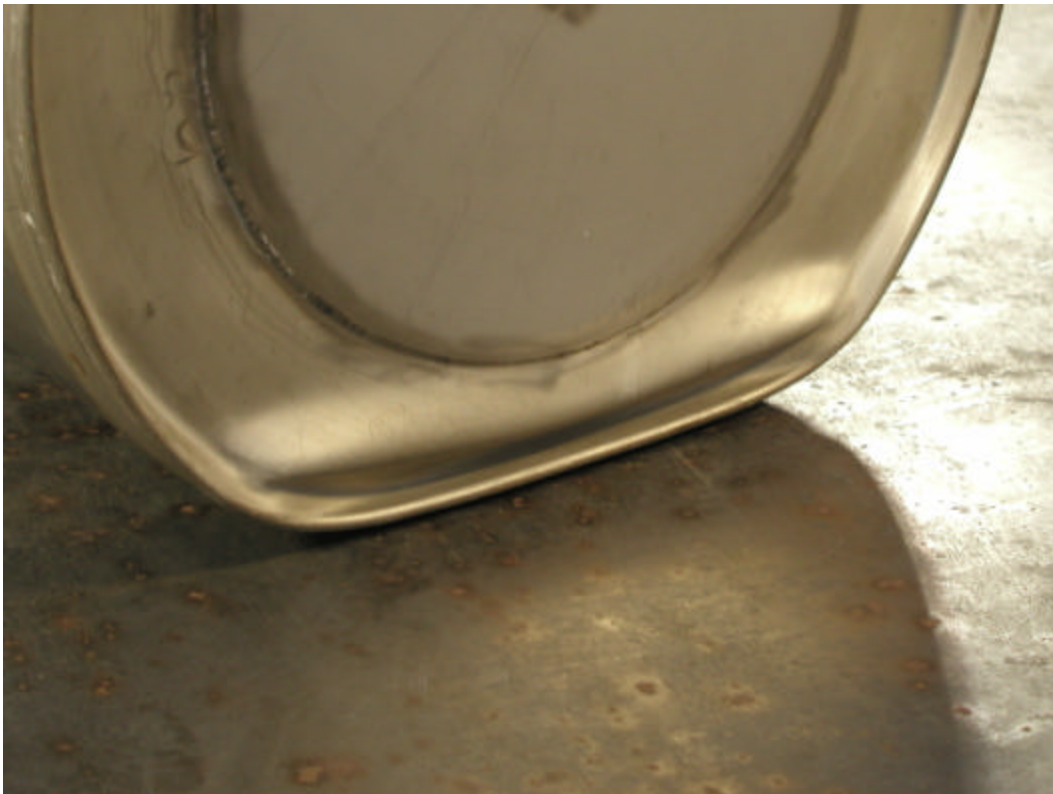
Figure E 16. Close-up of damage to the bottom area.

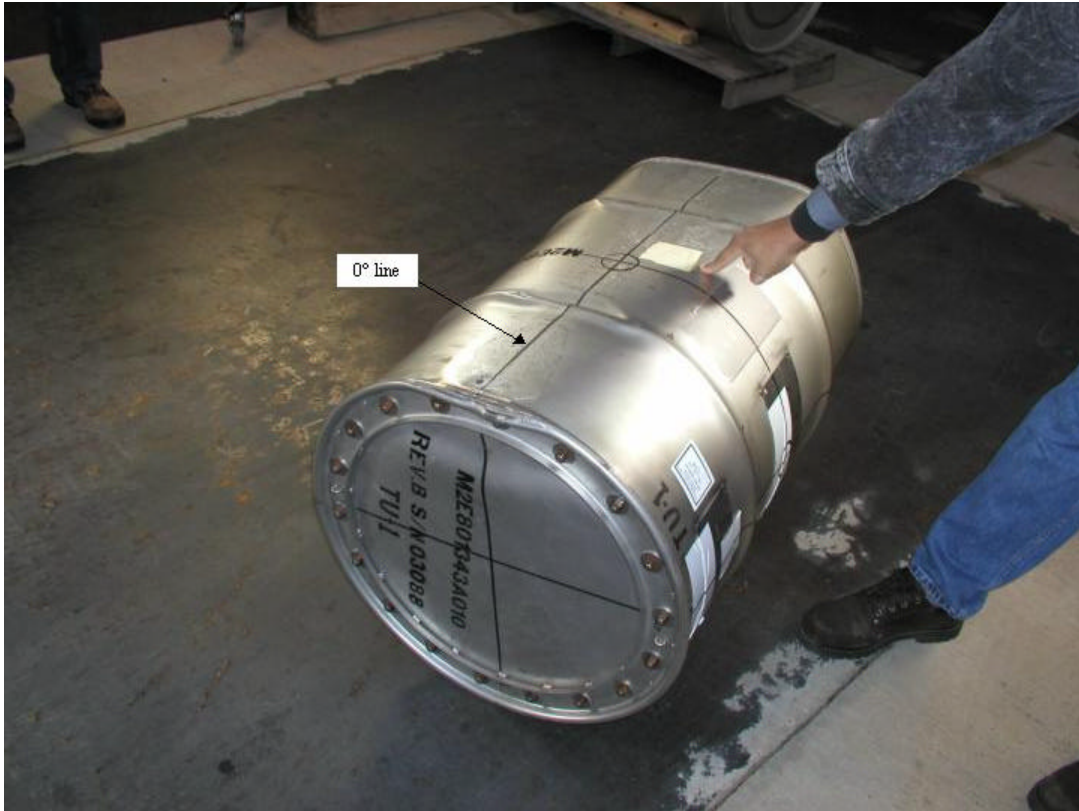
Figure E 17. View of damage along the 0° line from lid end.

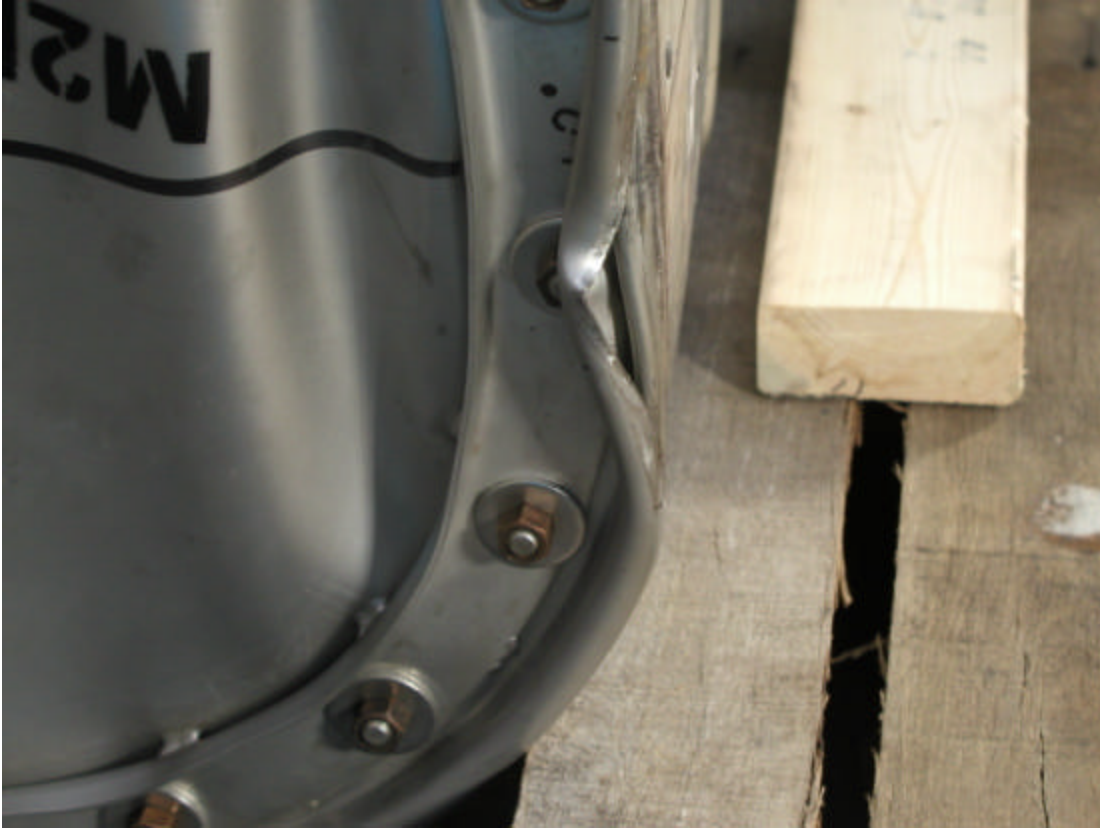
Figure E 23. Detail of damage to the lid at the 0° line after the crush test.

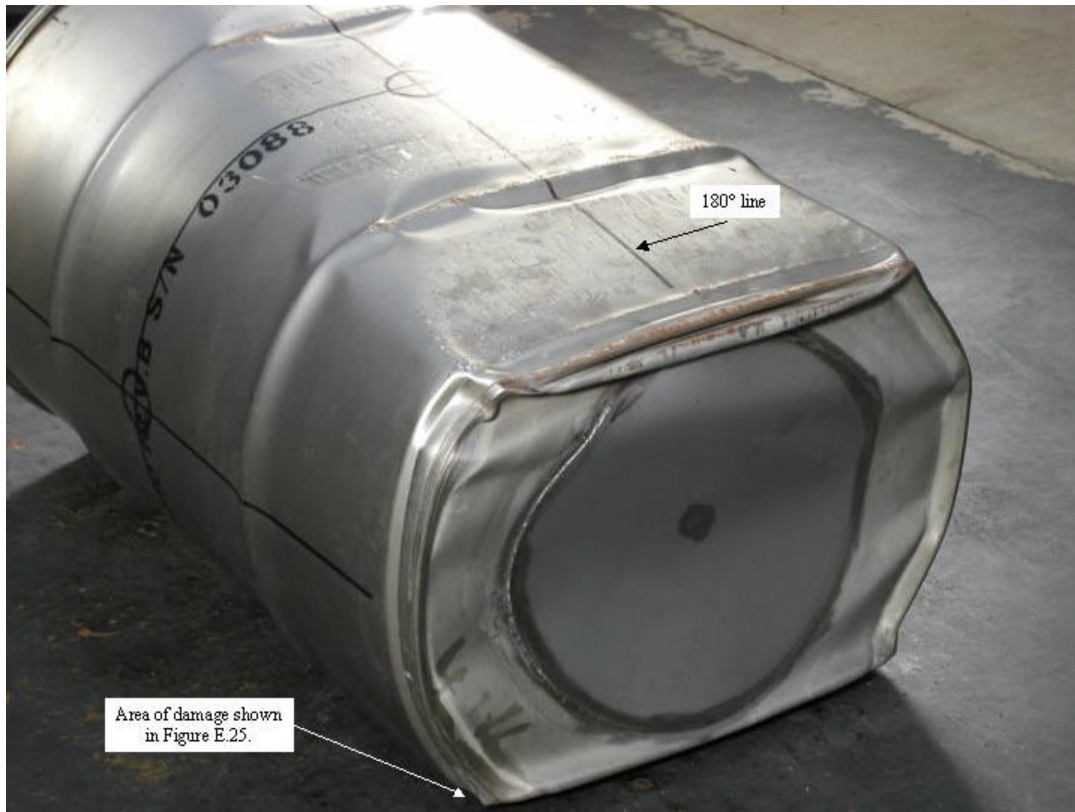
Figure E 24. Results of the crush test on the bottom end with 500-kg weight impacting on the 180° line.

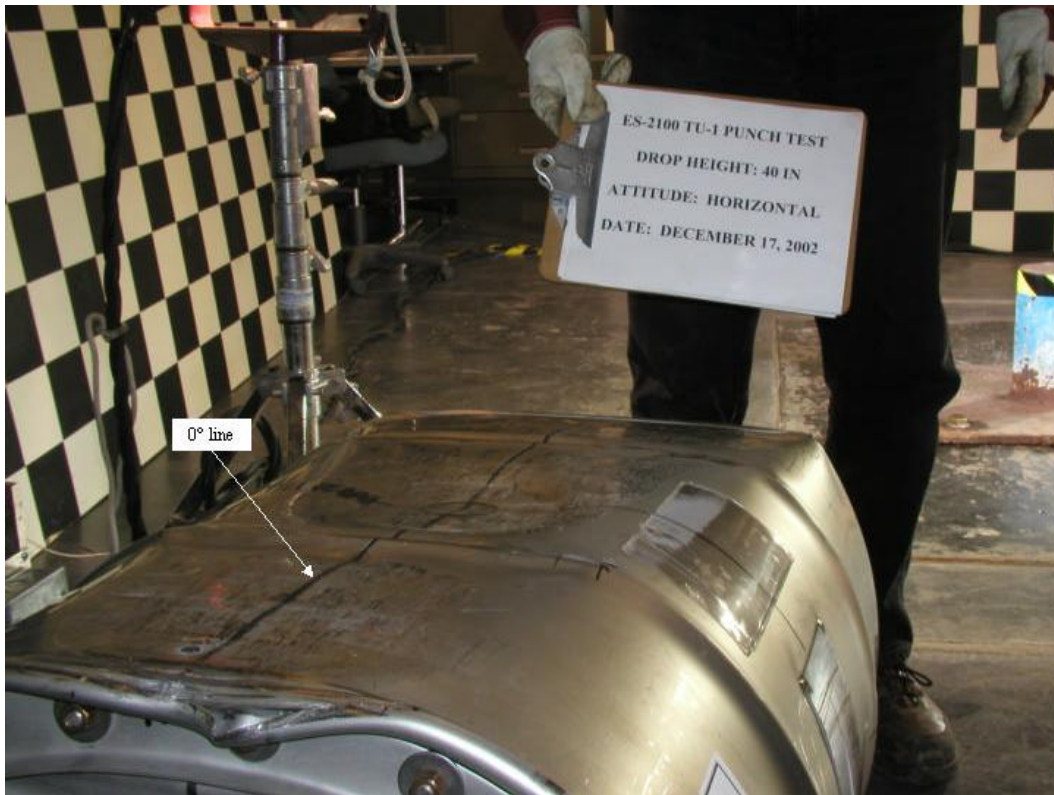
Figure E.28. Damage to TU-1 from the drop onto a punch over the CG on the 0° line.

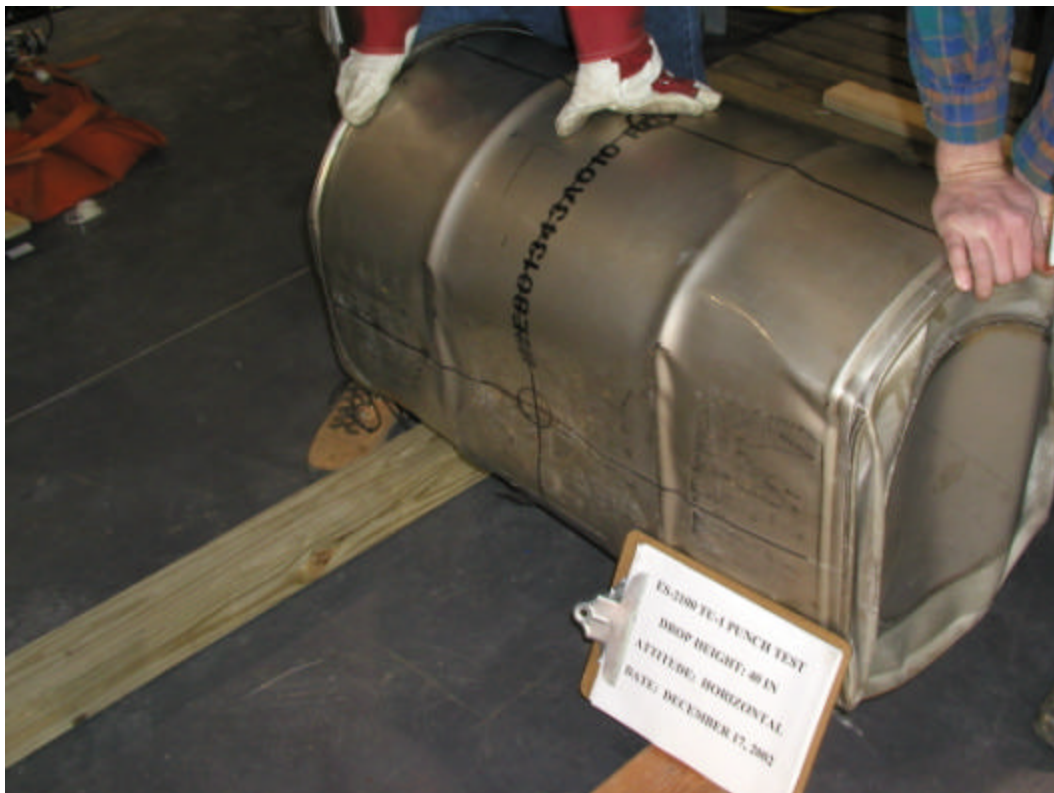
Figure E.29. Side view of the damage from a drop on a punch over the CG on the 0° line.

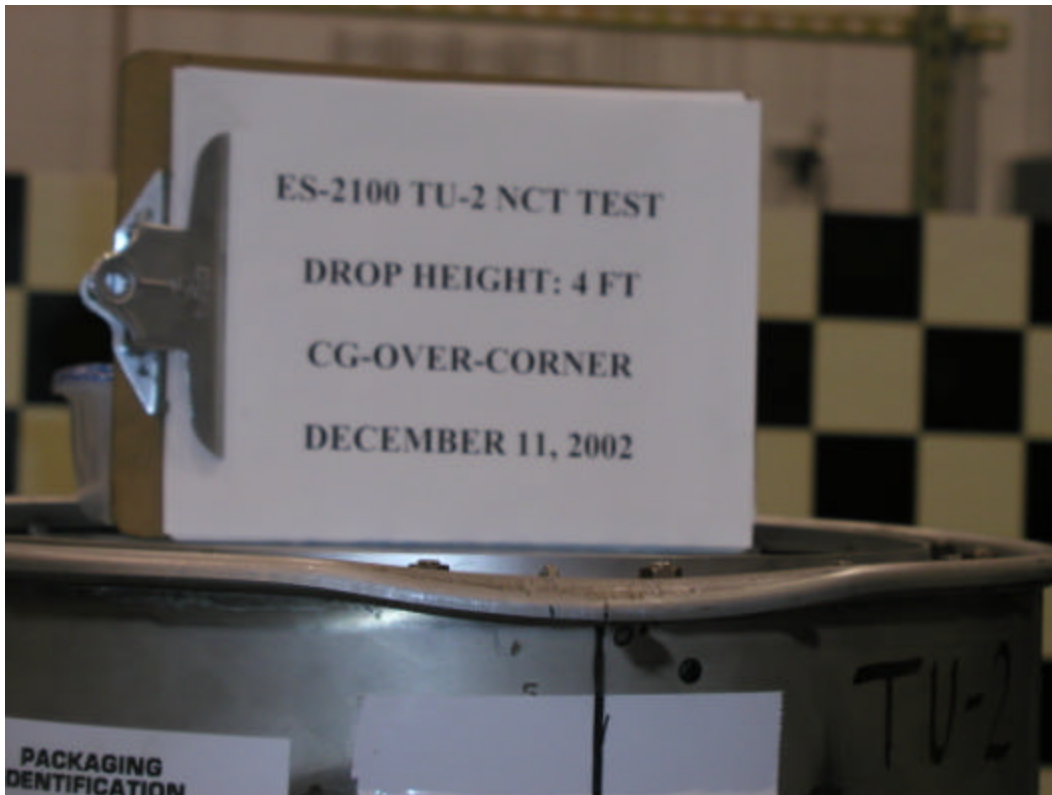
Figure F 17. Close-up of damage to edge of the lid from the CG-over-top-corner drop – front view.

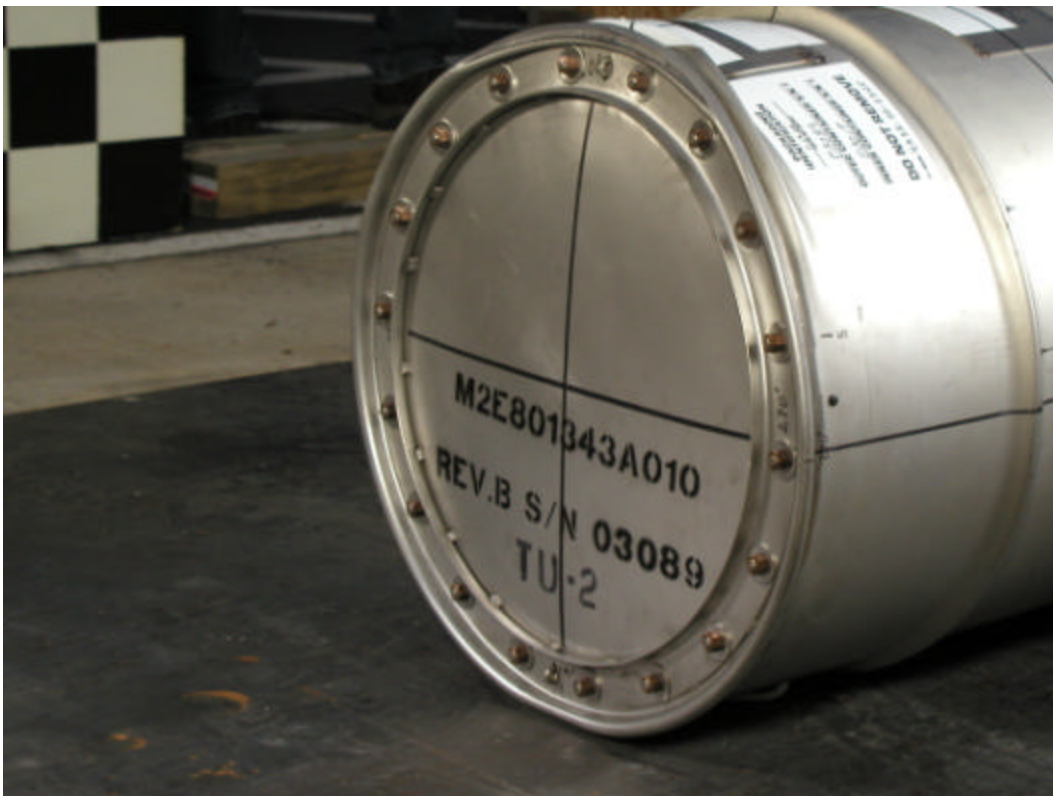
Figure F 22. Close-up of damage to the lid area.

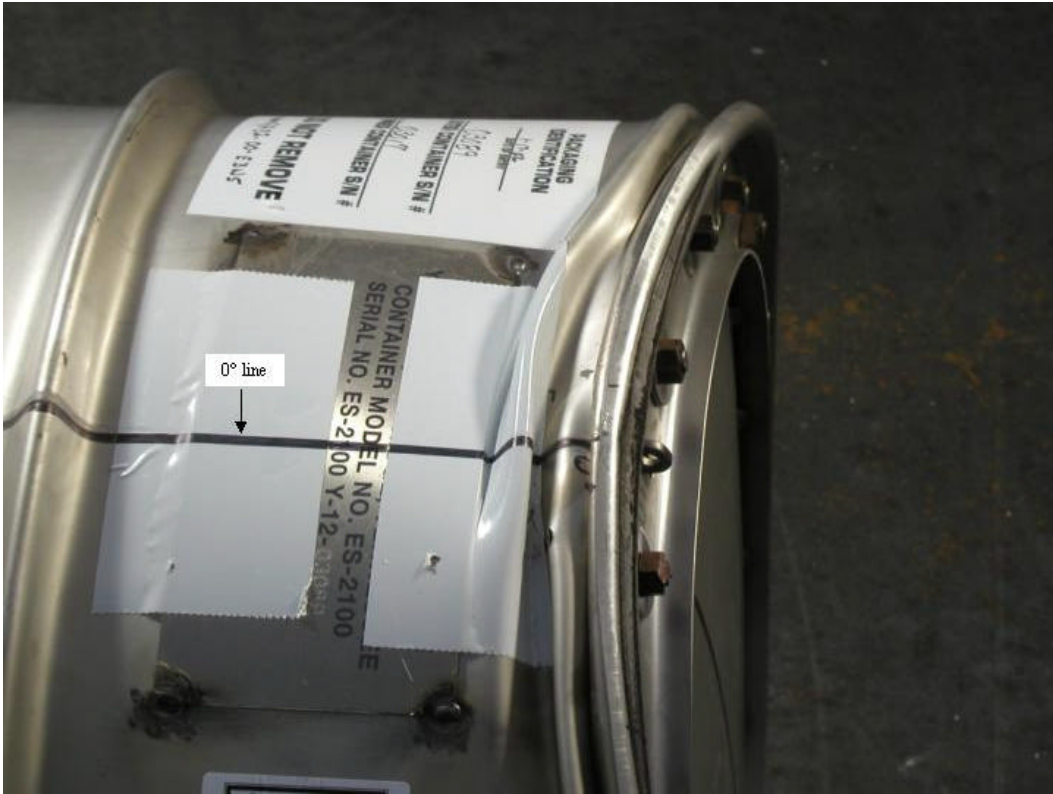
Figure F 23. Close-up of damage to the lid area from the HAC 30-ft drop at the 0° line.

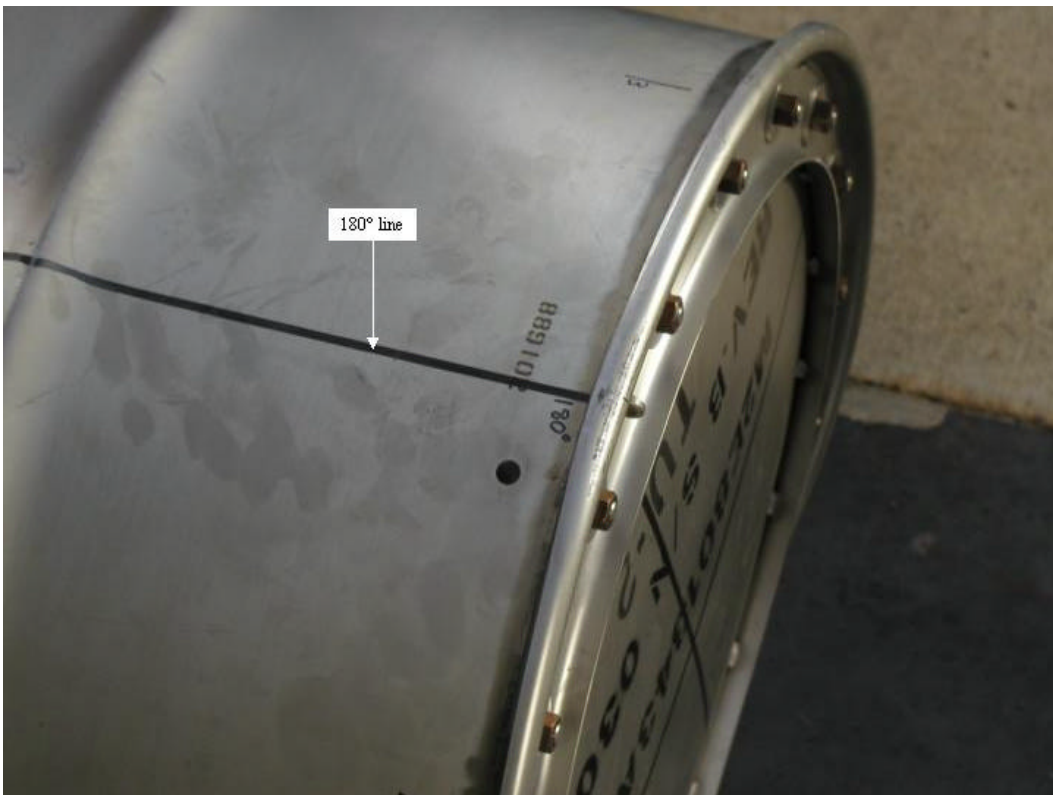
Figure F 24. Close-up of damage to the lid area from the HAC 30-ft drop at the 180° line.
