TEST REPORT

REPORT NO. 45918-01
OUR JOB NO. 45918
YOUR P. O. NO. 84YLFP22
CONTRACT N/A
PAGE 1 of 52 PAGE REPORT
DATE February 21, 1997

VIBRATION TESTING OF AN ES-2 SHIPPING CONTAINER

Lockheed Martin Energy Systems, Inc.
Oak Ridge, TN

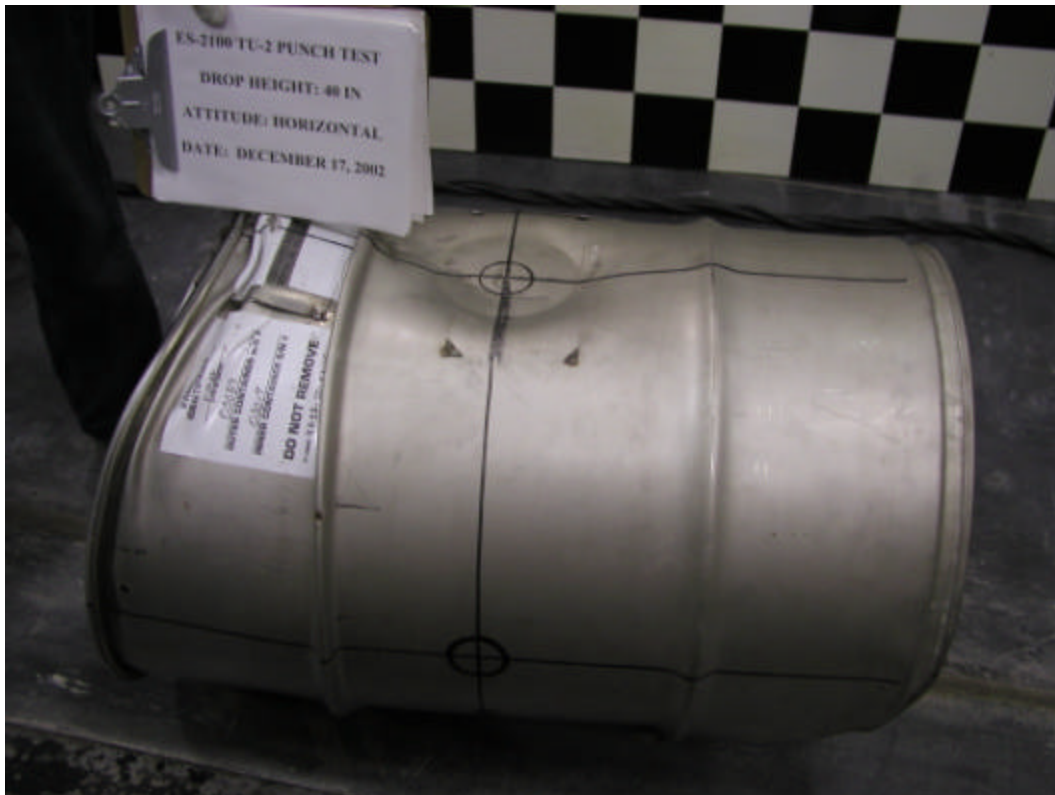
Figure F 36. Damage to TU-2 from the drop onto a punch over the CG on the 0° line.

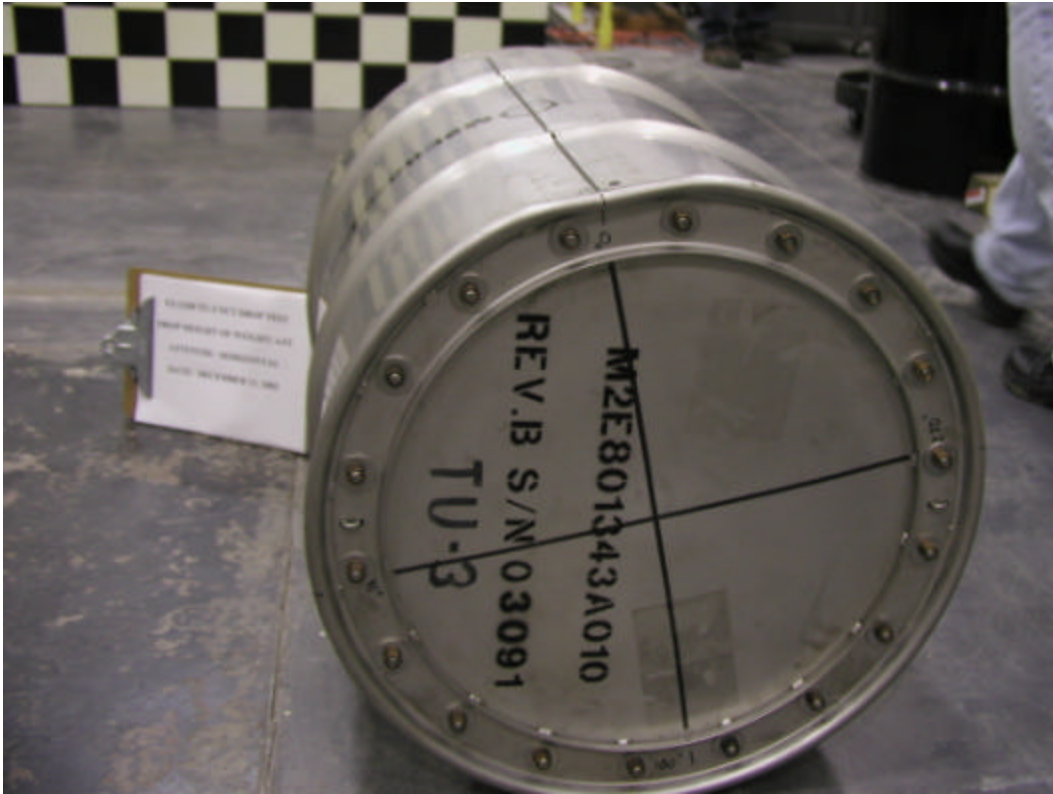
Figure G 11. Top end view of damage to TU-3 on the 0° line – package has been rolled 180°.

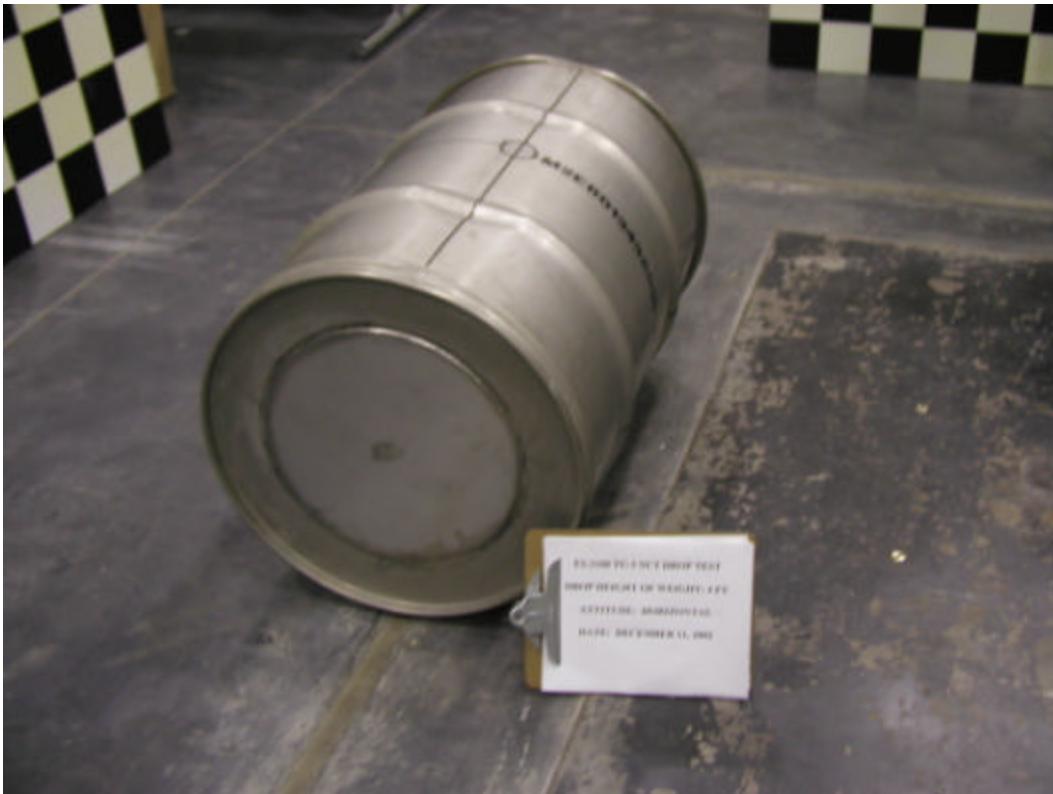
Figure G 12. Bottom end view of damage to TU-3 on the 0° line – package has been rolled 180°.

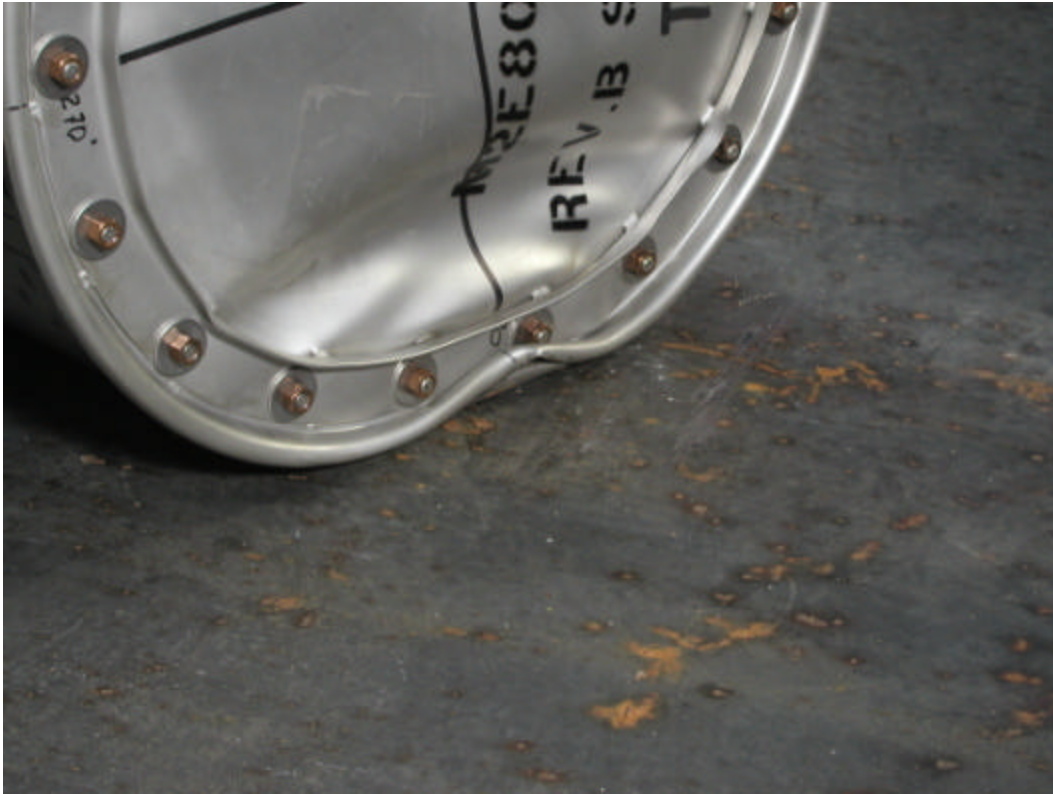
Figure G 15. Close up of damage to the lid end on the 0° line from the crush test.

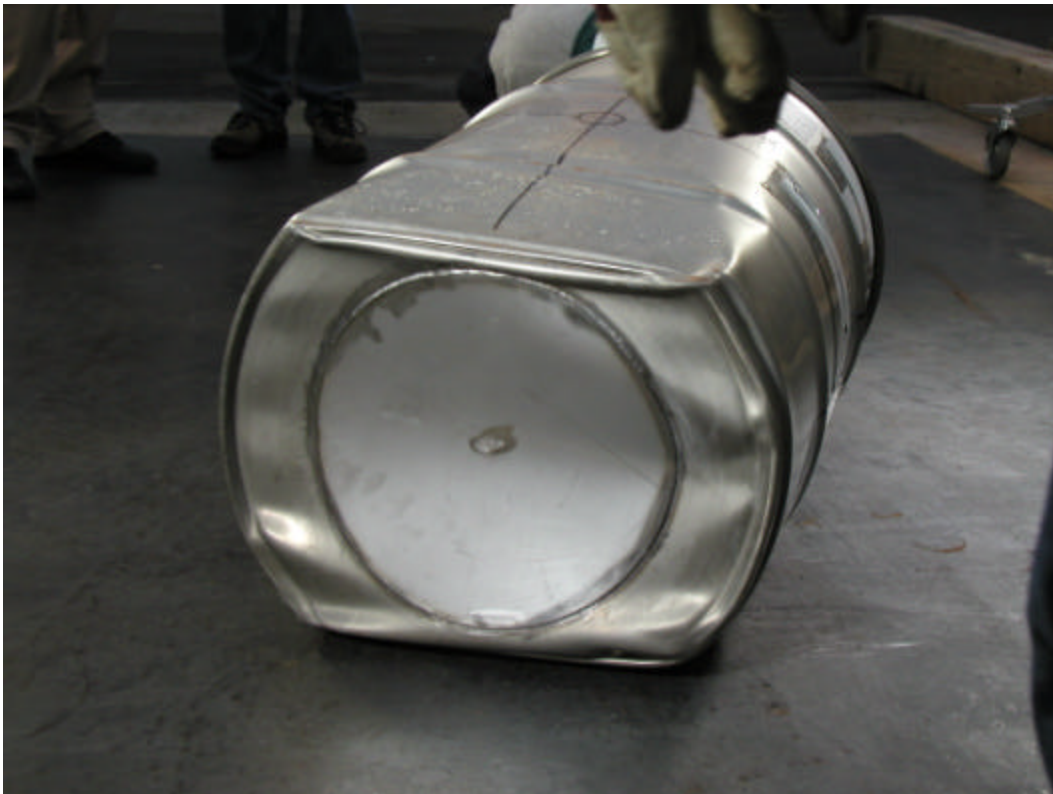
Figure G 16. Damage to the bottom end of TU-3 from the crush test – the 180° line is on top.

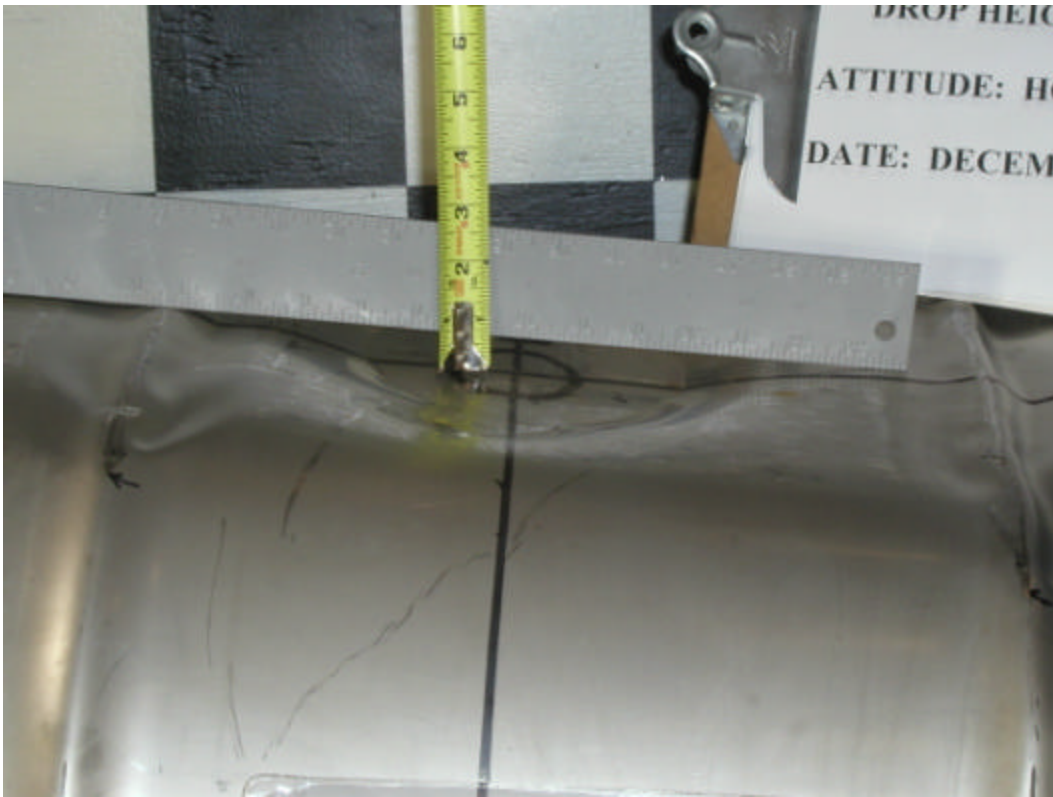
Figure G 19. Measurement of indentation caused by the punch test of TU-3.

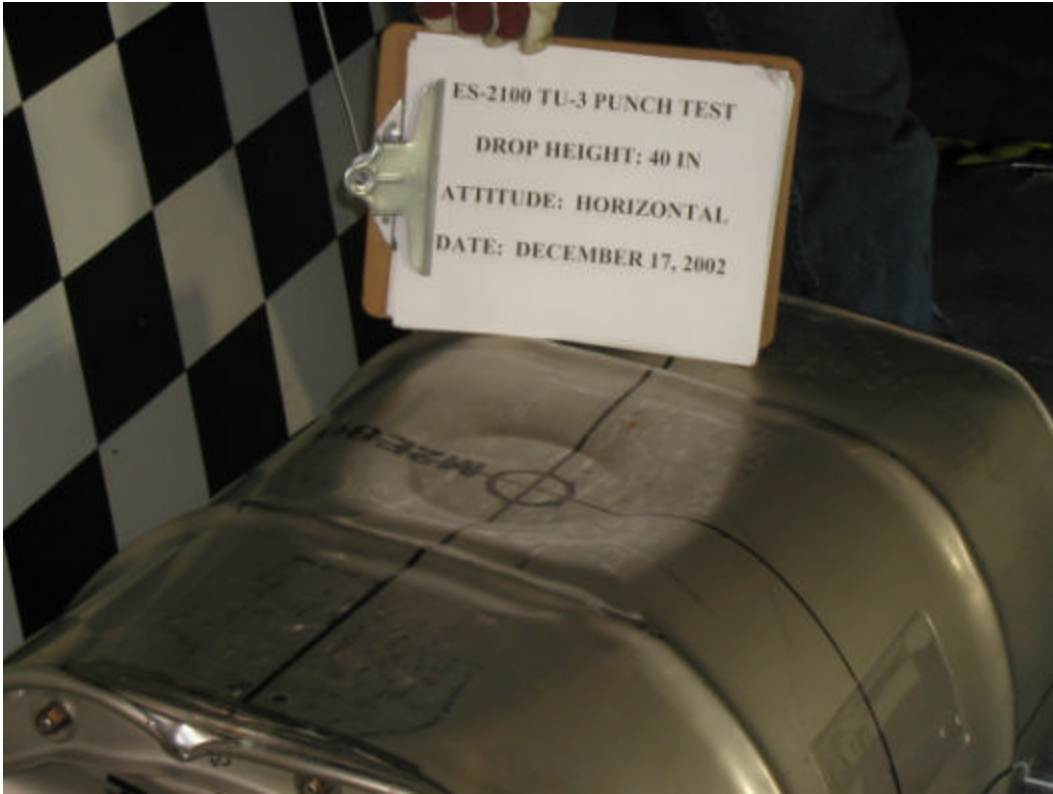
Figure G 20. Damage to TU-3 from the drop onto a punch over the CG on the 0° line.

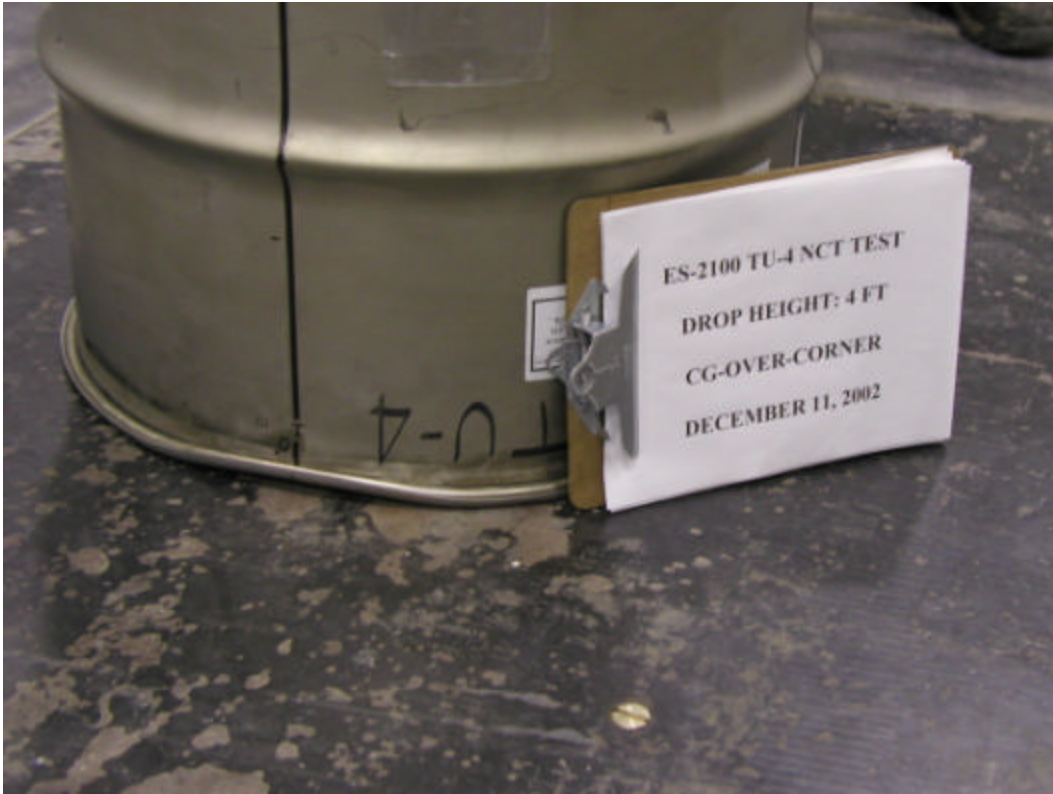
Figure H 13. Damage to lid end from the NCT CG-over-corner drop.

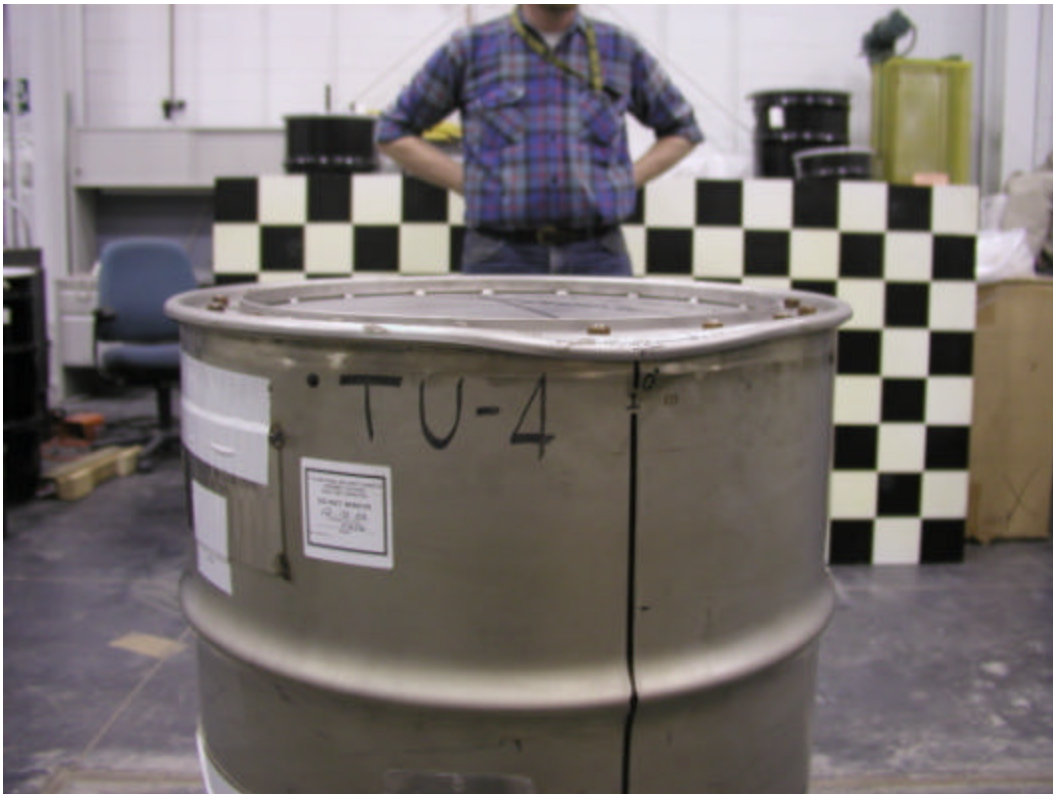
Figure H 14. Top view of damage to the lid from the NCT CG-over-corner drop.

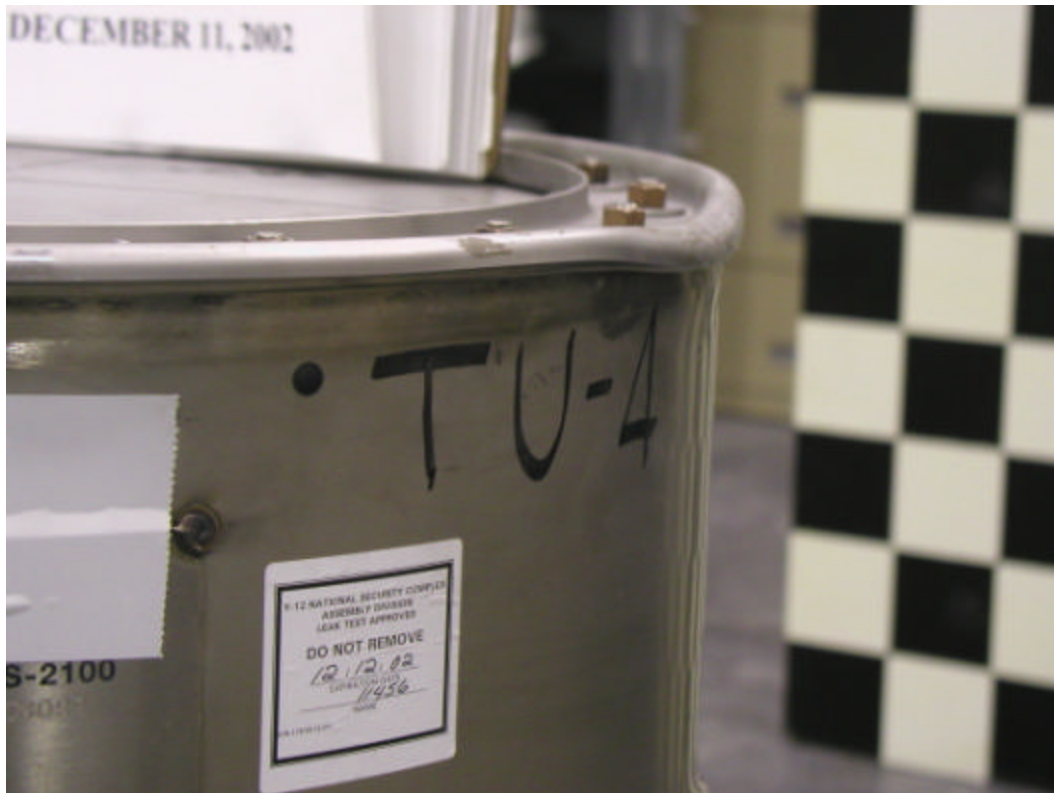
Figure H 15. Close-up of damage of the lid from the CG-over-corner drop – left side view.

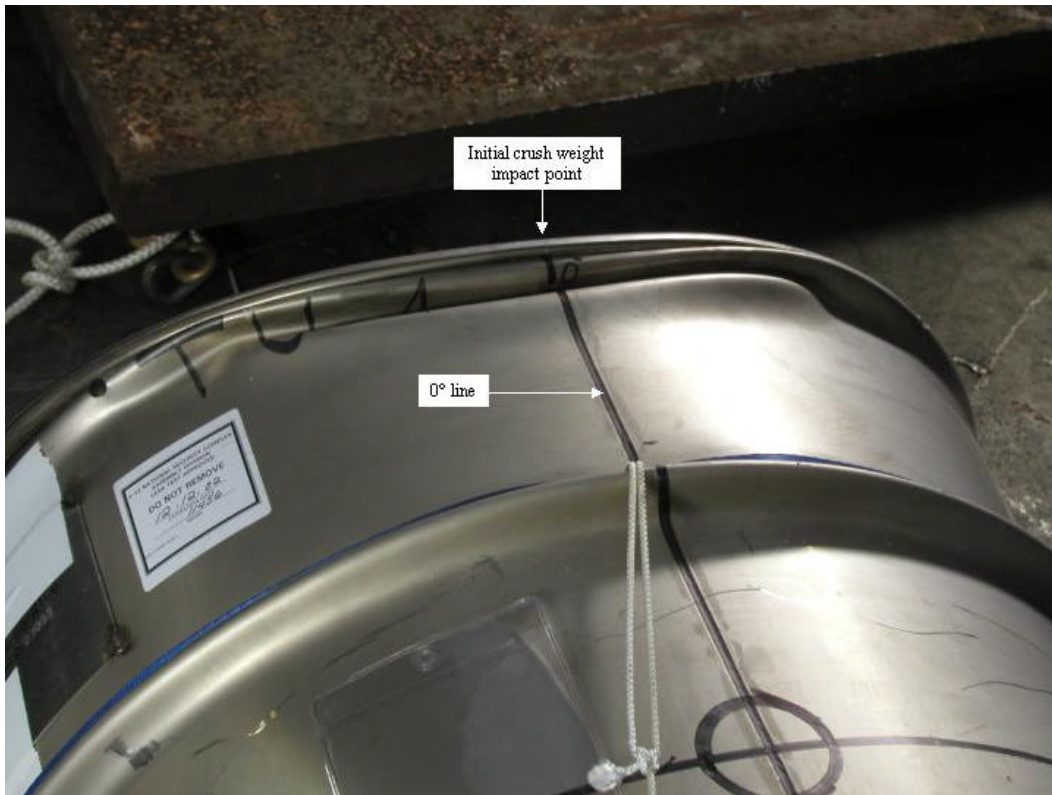
Figure H 22. Detail of top lid damage at the 0° line.

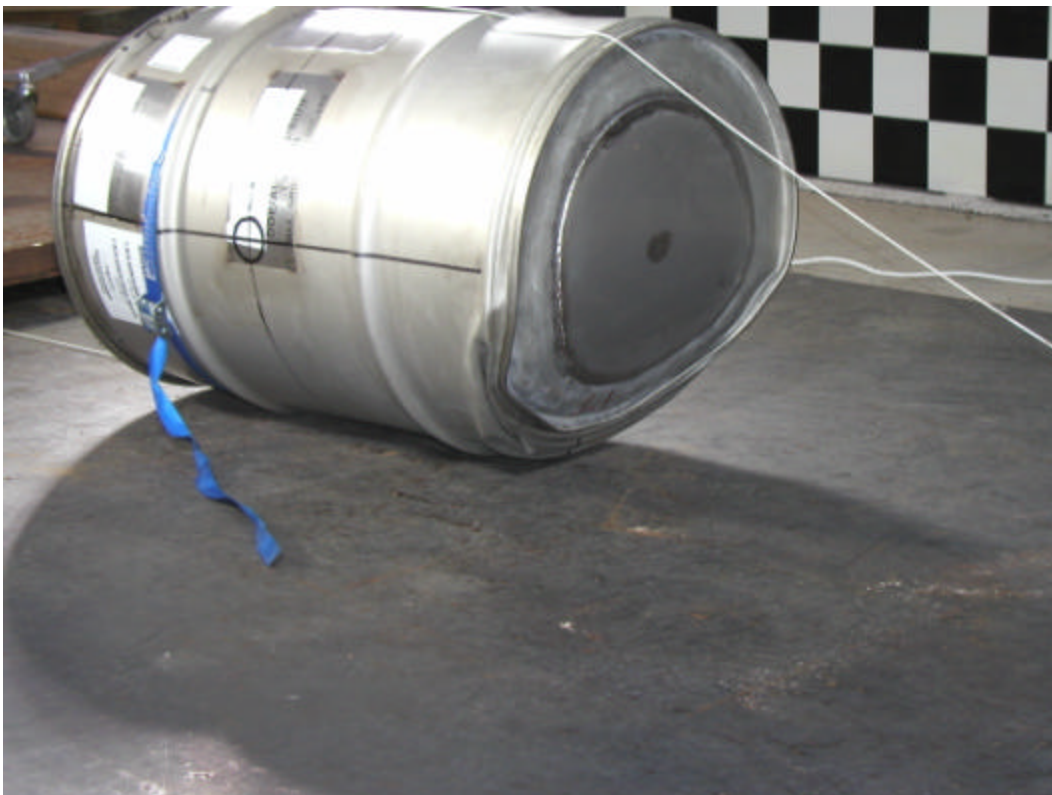
Figure H 23. View of damage to the bottom of TU-4 from the crush test.

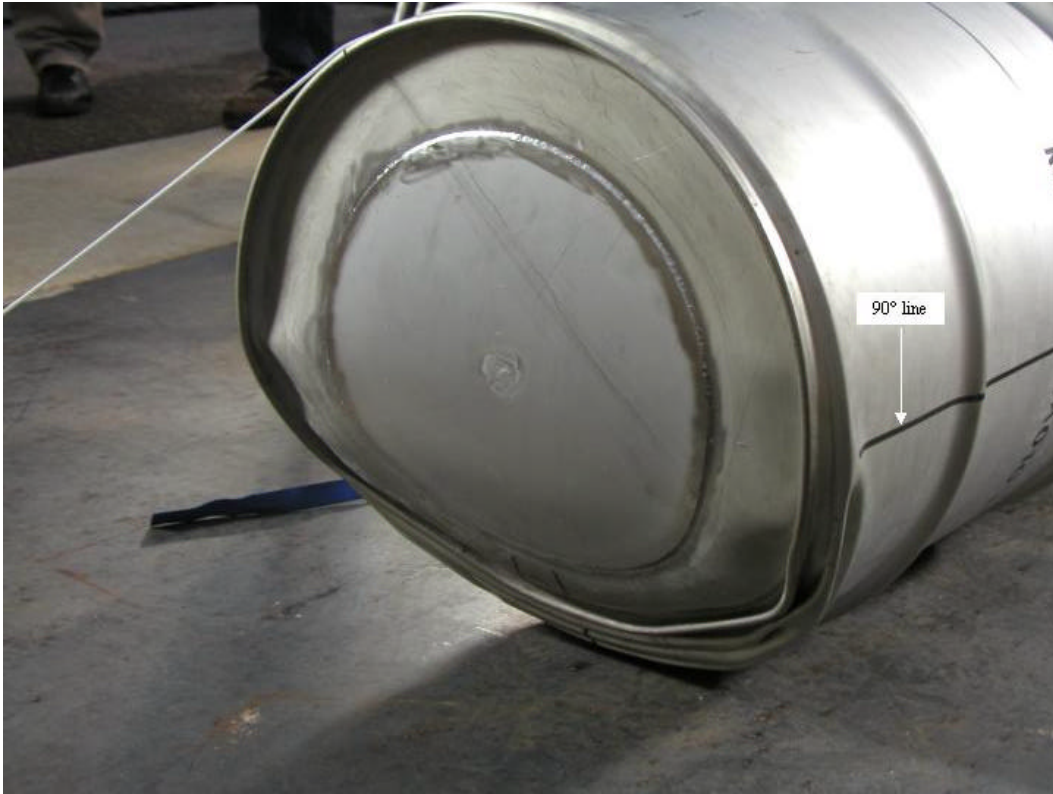
Figure H 24. Close-up of damage to the bottom of TU-4 from the crush test.

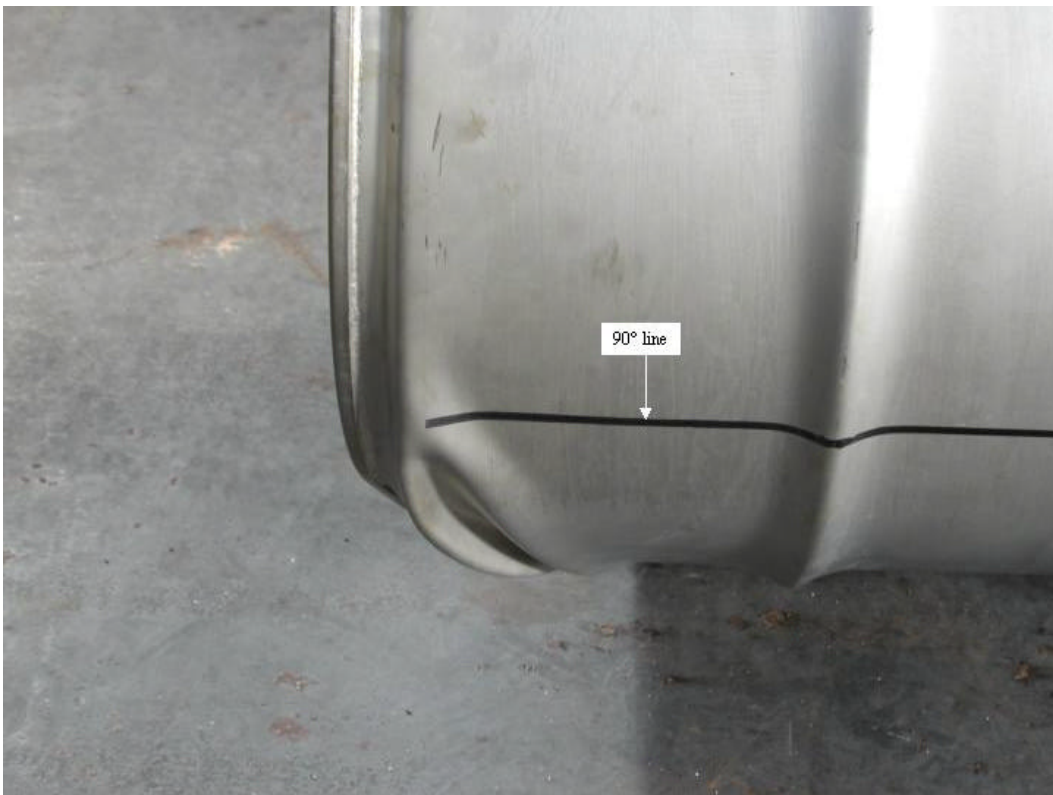
Figure H 25. Detail of the damage to the bottom of TU-4 from the crush test.

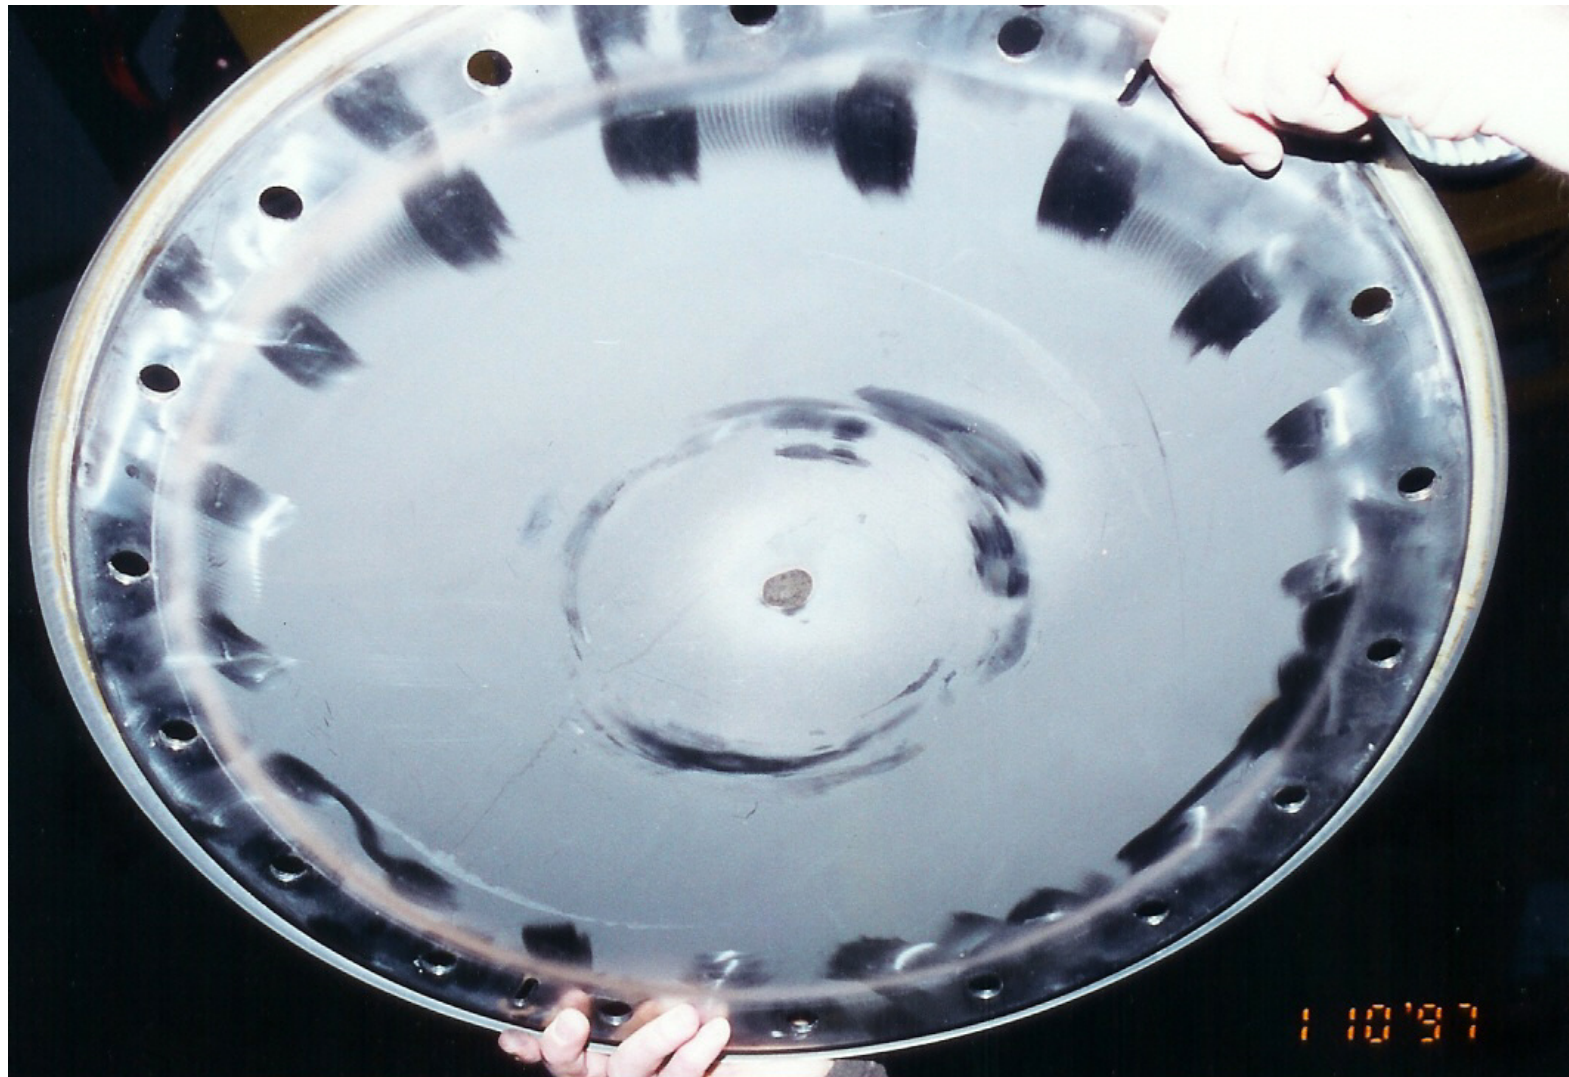
Top Plug after vibration testing show metal dust and some wear spots

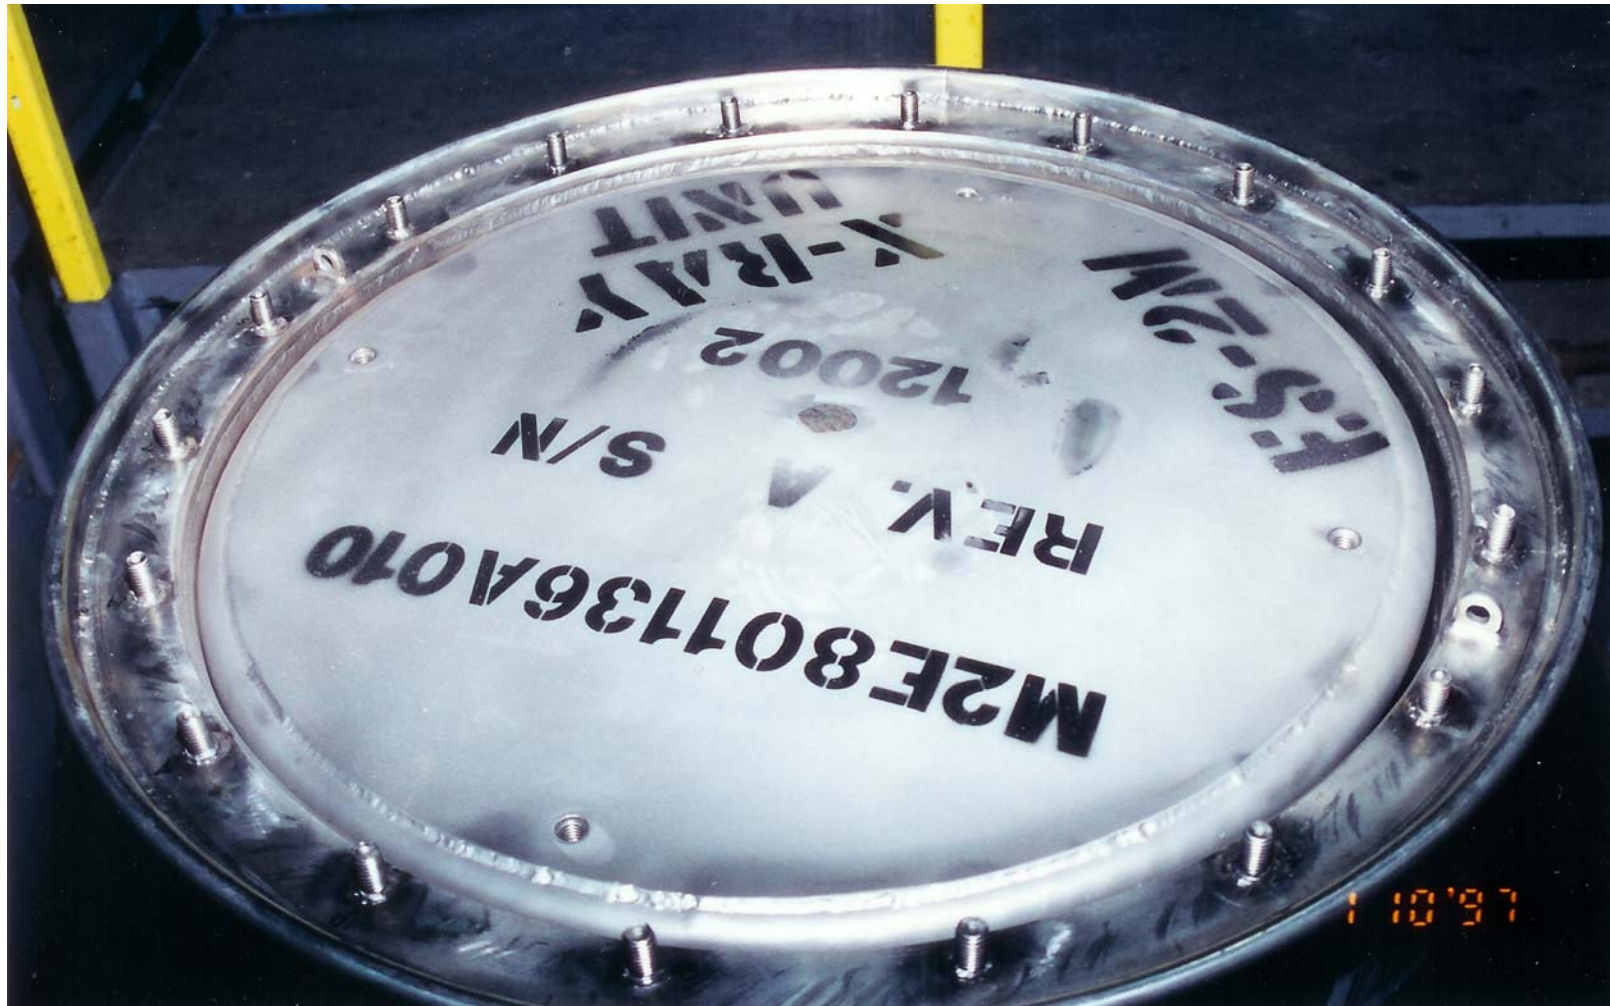
Top Plug after vibration testing show metal dust and some wear spots

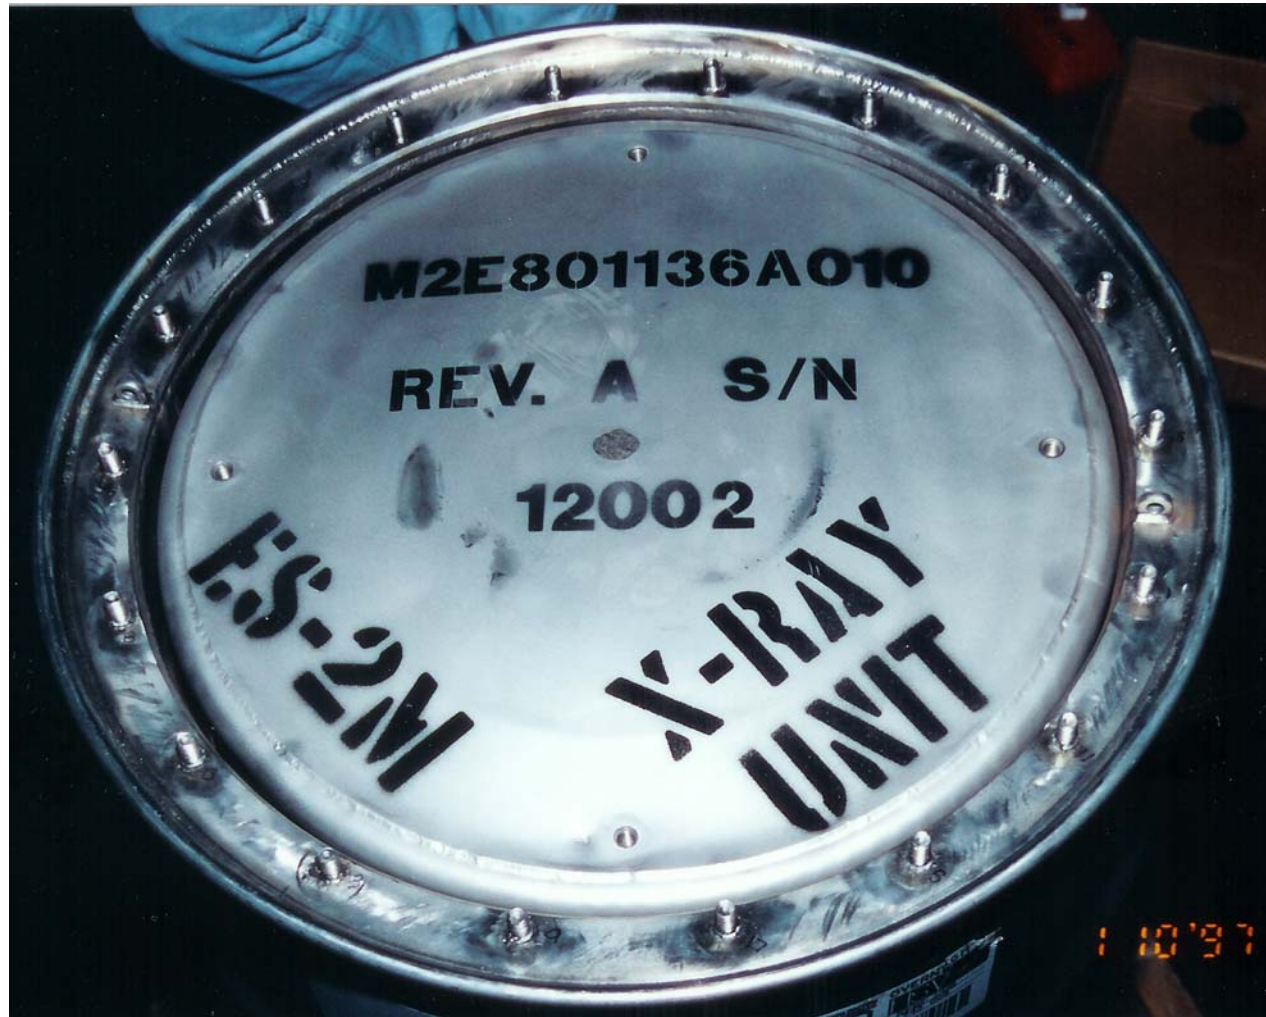
Top Plug after vibration testing show metal dust and some wear spots

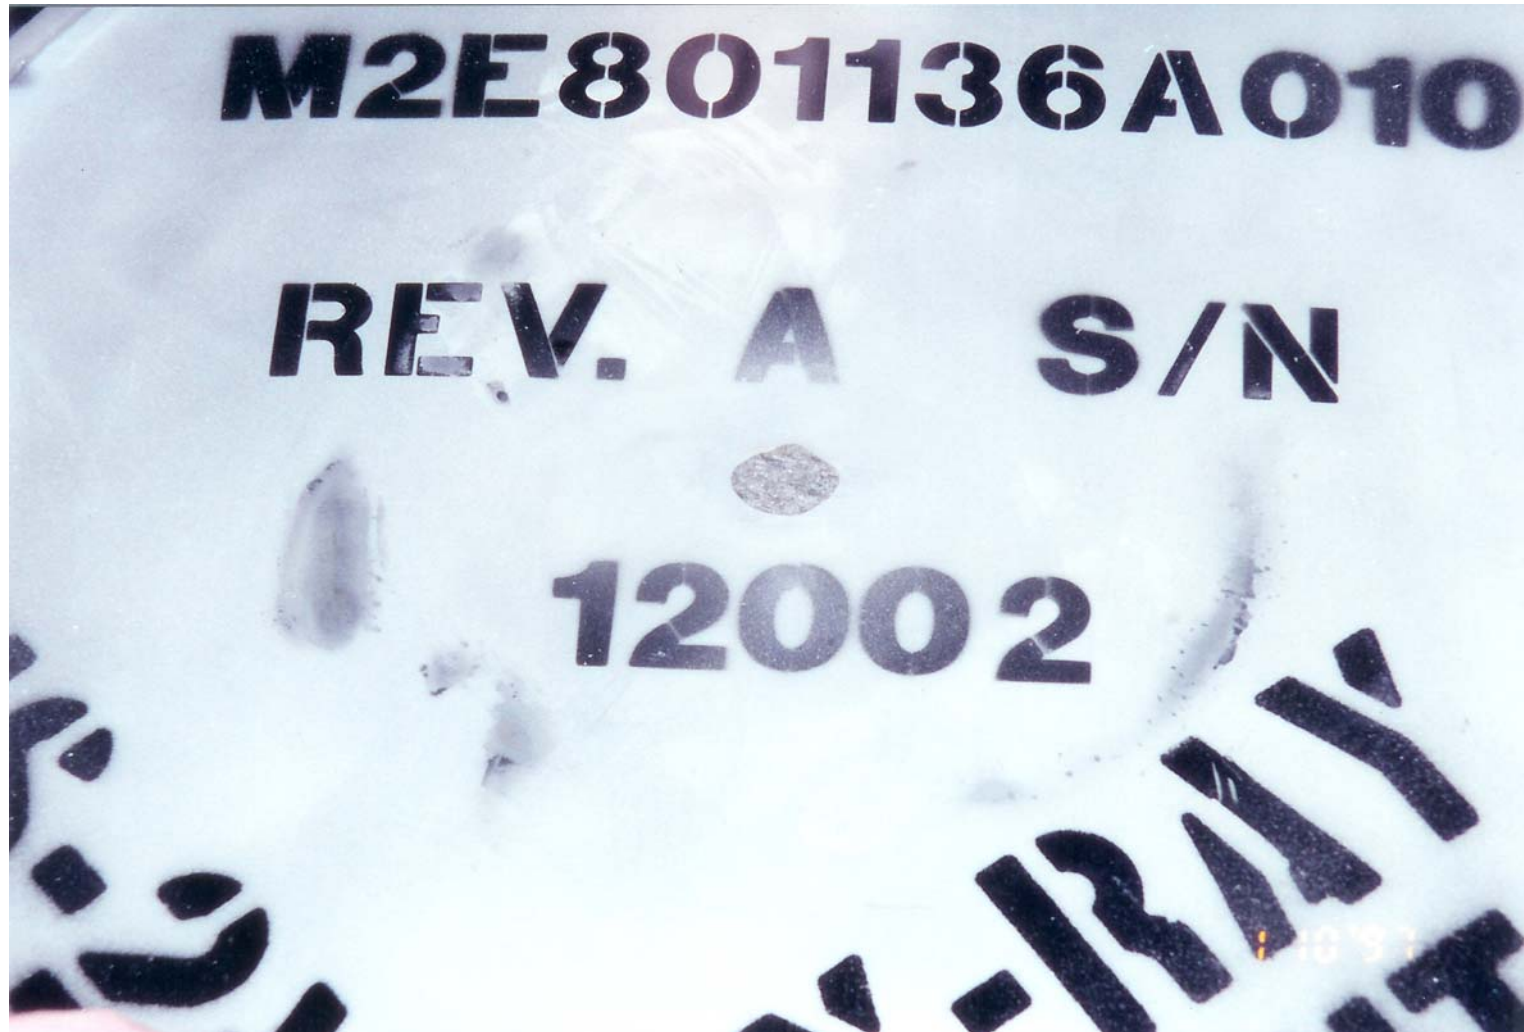
Bottom of the Top Plug showing metal to metal wear after testing

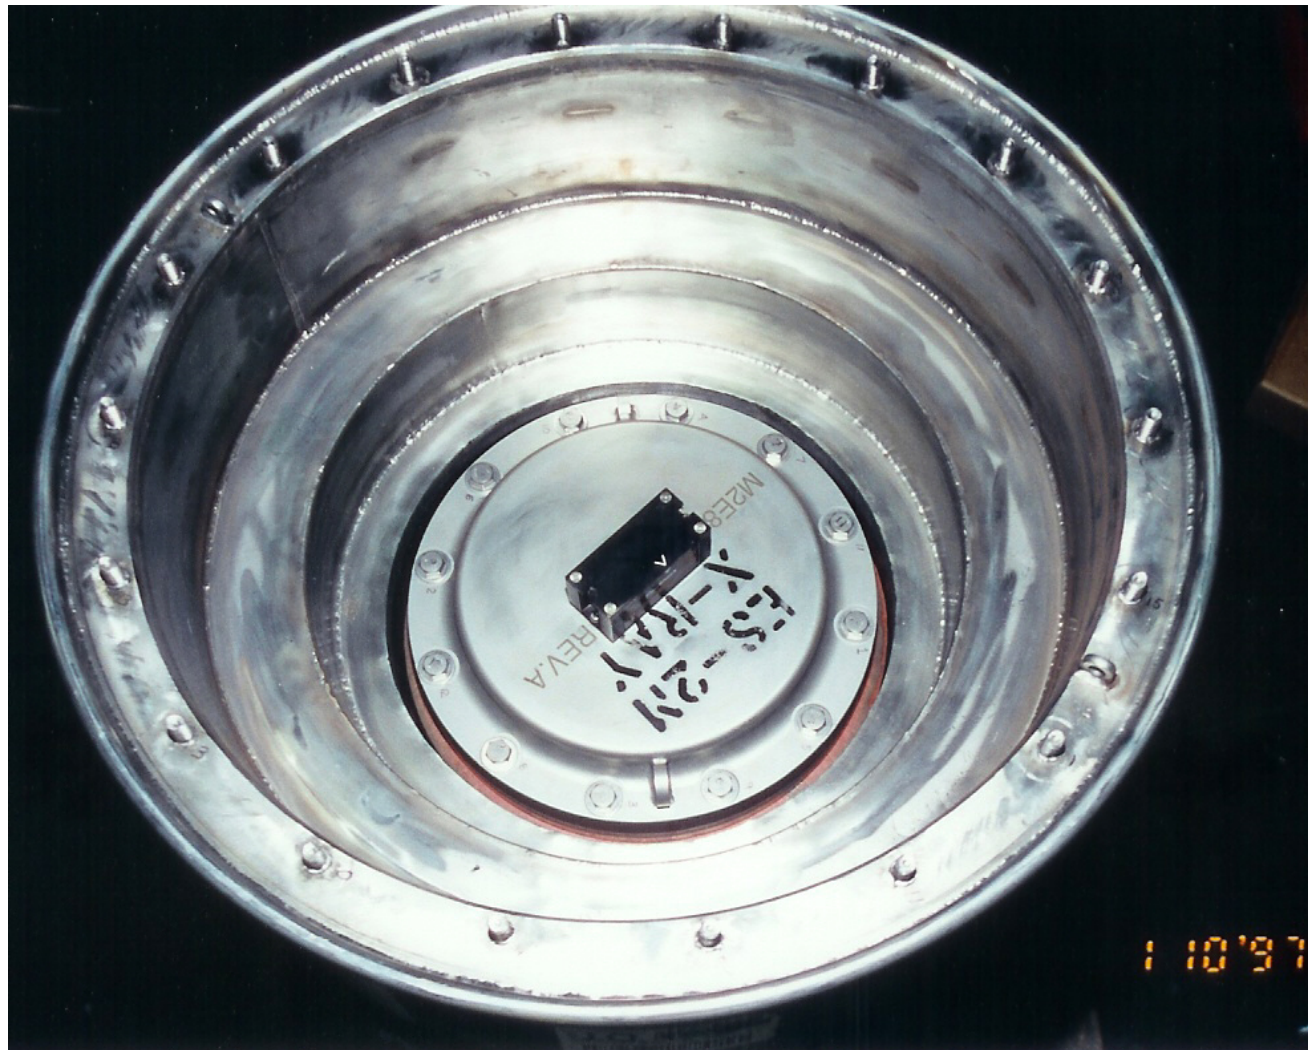
After testing the Leak Check port plug is loose and vibrated off its threads

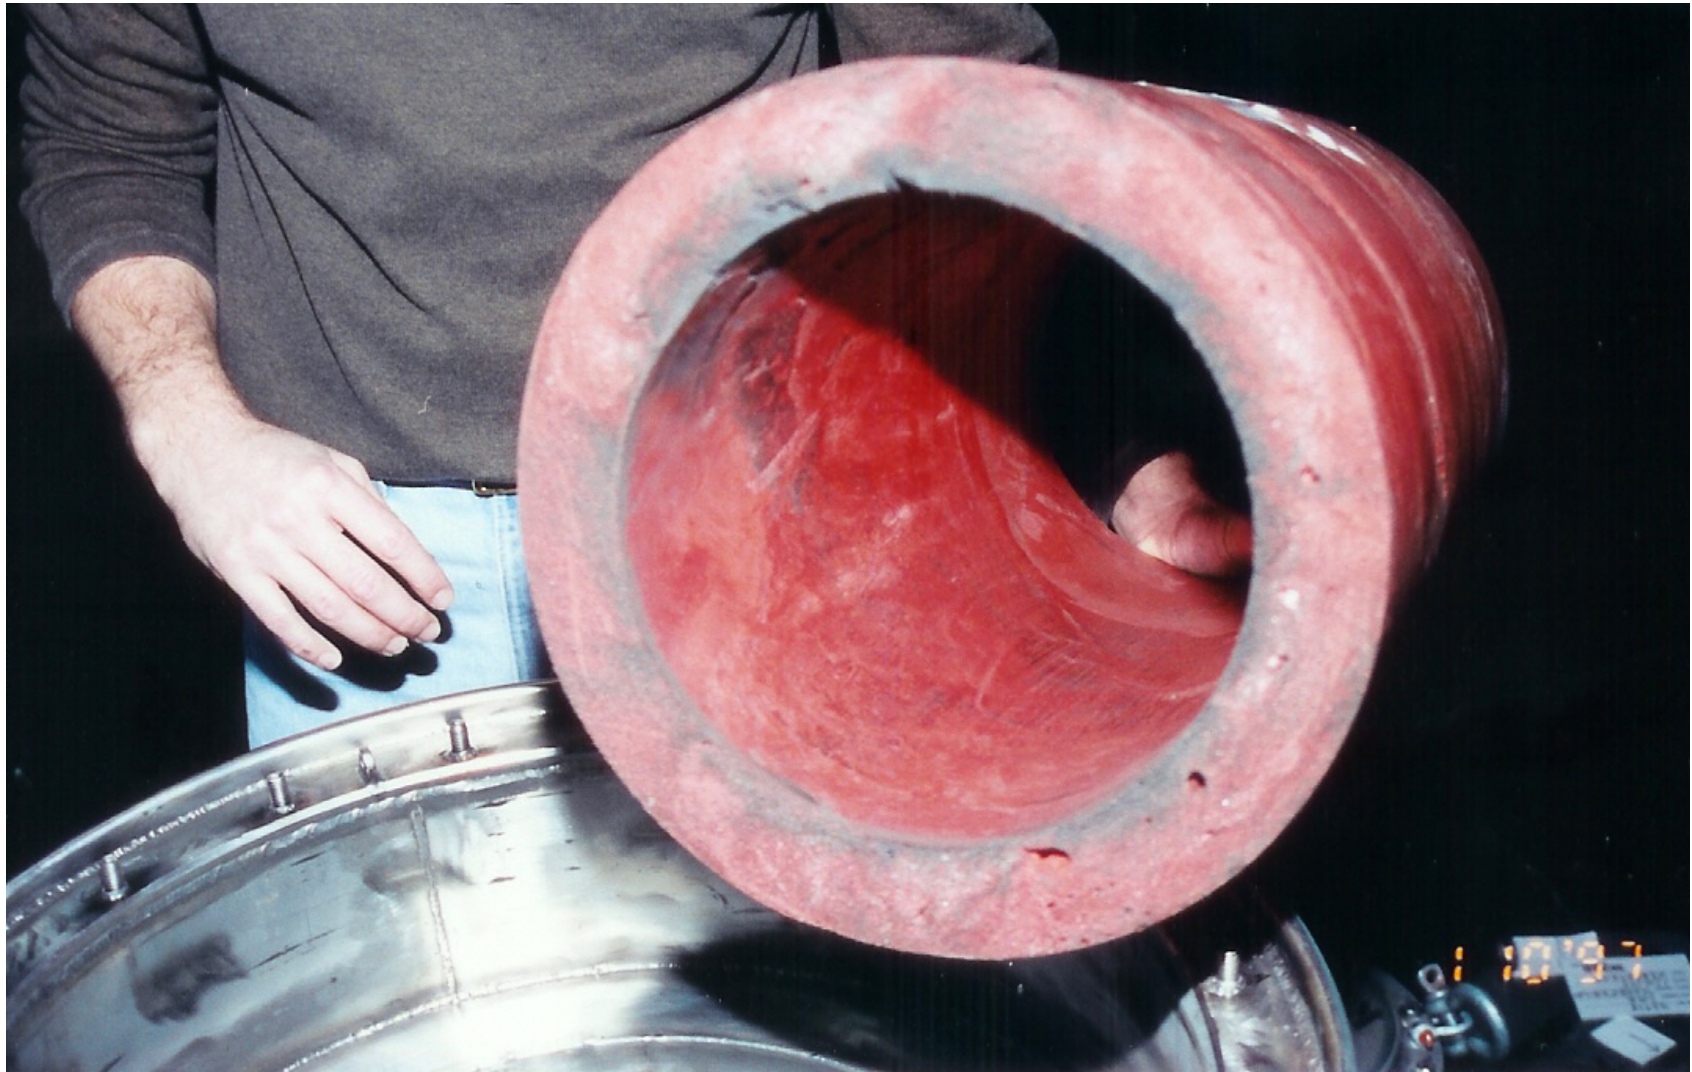
Inner Liner after testing showing some metal wear at the bottom

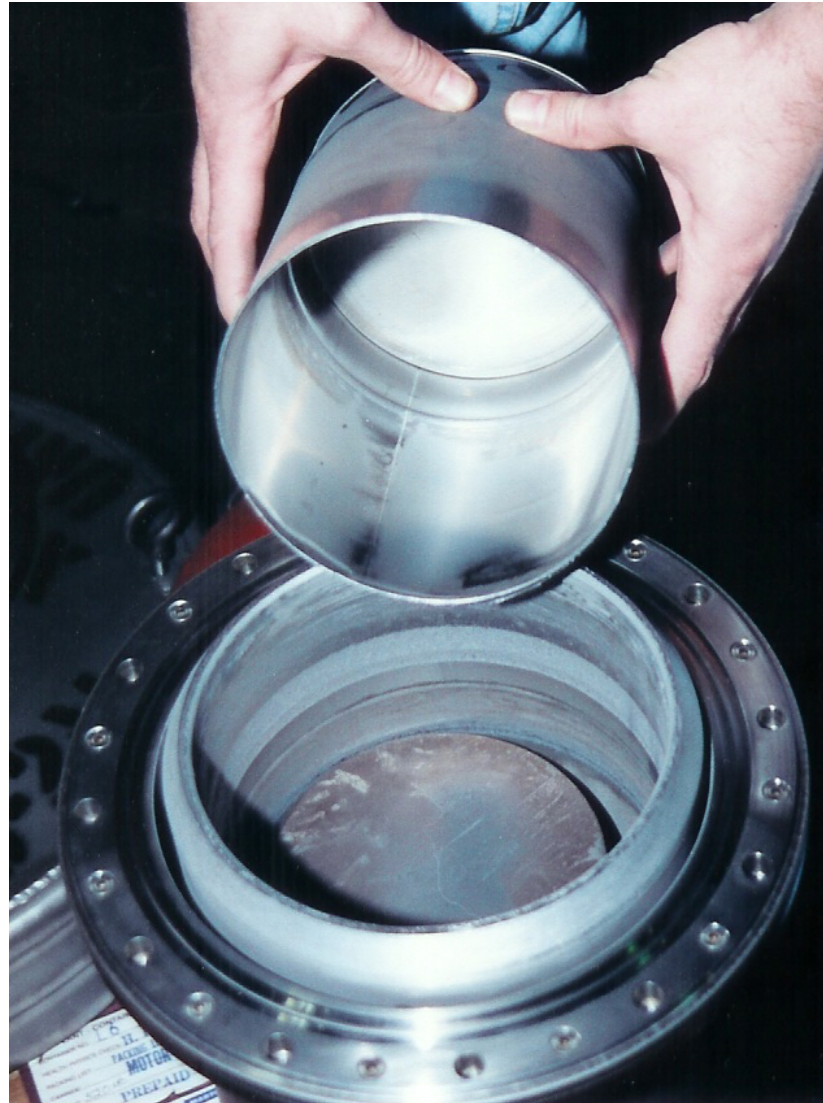
Top can damage to bottom head crimp after testing
