UNITED STATES  
NUCLEAR REGULATORY COMMISSION  
OFFICE OF NUCLEAR MATERIAL SAFETY AND SAFEGUARDS  
WASHINGTON, D.C. 20555

NRC INFORMATION NOTICE 2011-06:    ERRONEOUS CRITICALITY ALARM  
MONITORING SIGNAL CAUSED BY INCORRECT  
DATA ACQUISITION MODULE CONFIGURATION

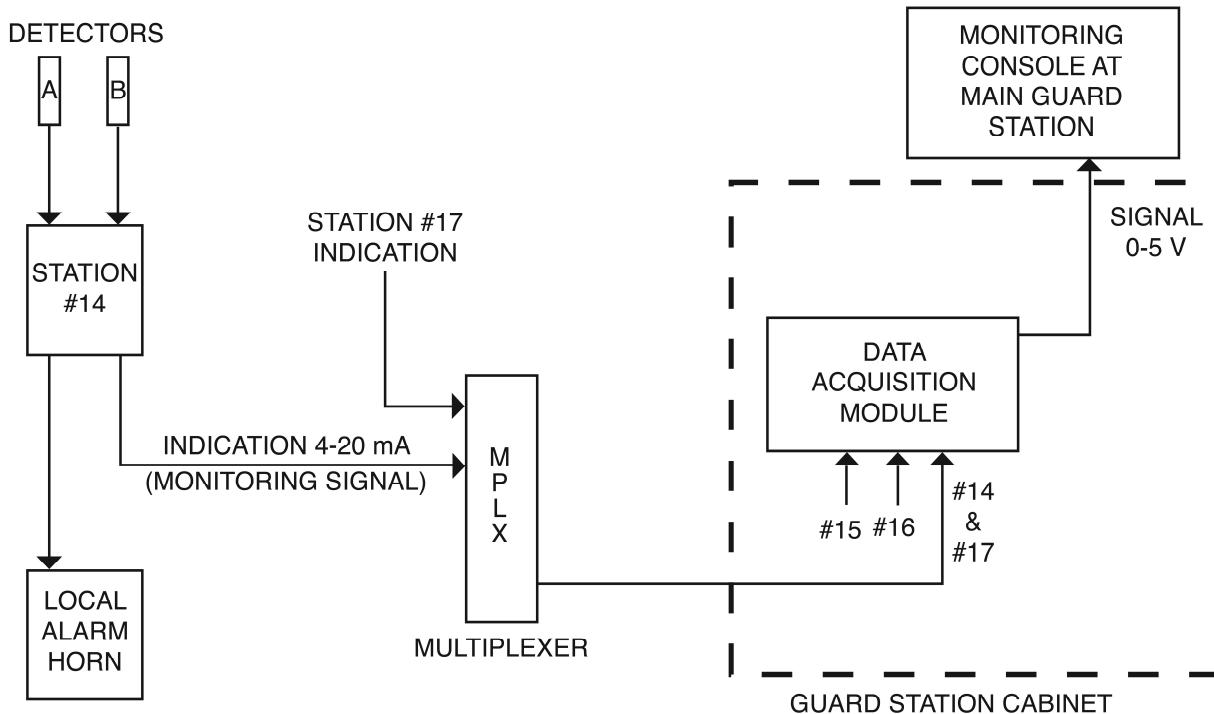
**Figure 1**  
**Criticality Alarm Circuit**

During a routine maintenance operation on one of the circuits, the licensee upgraded the software for both data acquisition modules. Following completion of the maintenance operation, the licensee successfully tested the circuit on which the maintenance had been performed. Several months later, the licensee performed routine scheduled calibration on the other circuit and determined that the monitoring signal was incorrect. The calibration was performed several times with a 50 mRem source and the monitoring console readouts were as low as 15 mRem.

The licensee determined that the reason for the incorrect signal readout was that the data acquisition module for that circuit had originally been configured with a jumper that incorporated a 10 kHz filter. The previous software controlling the data acquisition module had instructions to slow the channel scan to allow an interchannel delay which allowed the signals time to settle so that correct readouts were received at the monitoring console. The upgraded software eliminated the interchannel delay and the resulting signal was unstable with the readout significantly less than the actual source. The other circuit was unaffected because the filtering had never been enabled.

NRC is concerned about adequate configuration of electronic components during initial installation in safety system or safety-related applications. In some cases, as shown in the above situation, the configuration problem may not be detected for years due to a subsequent change or other circumstance. NRC expects that licensee management measures will assure proper initial configuration of electronic components.

NRC requires management measures at fuel cycle licensees to maintain consistency between design requirements, the physical configuration, and the facility documentation. Failure to adequately configure electronic components prior to operation of a safety system or equipment can result in failure to establish necessary controls or compromise of established controls. NRC safety inspections routinely review licensee management measures to determine how well they ensure the availability and reliability of IROFS. These inspections include review of licensee change management procedures to ensure that analytical assumptions are not compromised during or after implementation. Vendor specifications for electronic component configuration might be inspected during an operational readiness review.
