Westinghouse Electric Company
Nuclear Fuel
Columbia Fuel Site
P.O. Drawer R
Columbia, South Carolina 29250
USA

Your ref: Docket No. 71-9297
Our ref: LTR-LCPT-11-3

SUBJECT: Event Report - Docket 71-9297, Certificate of Compliance USA/9297/AF-96,
TRAVELLER Shipping Package

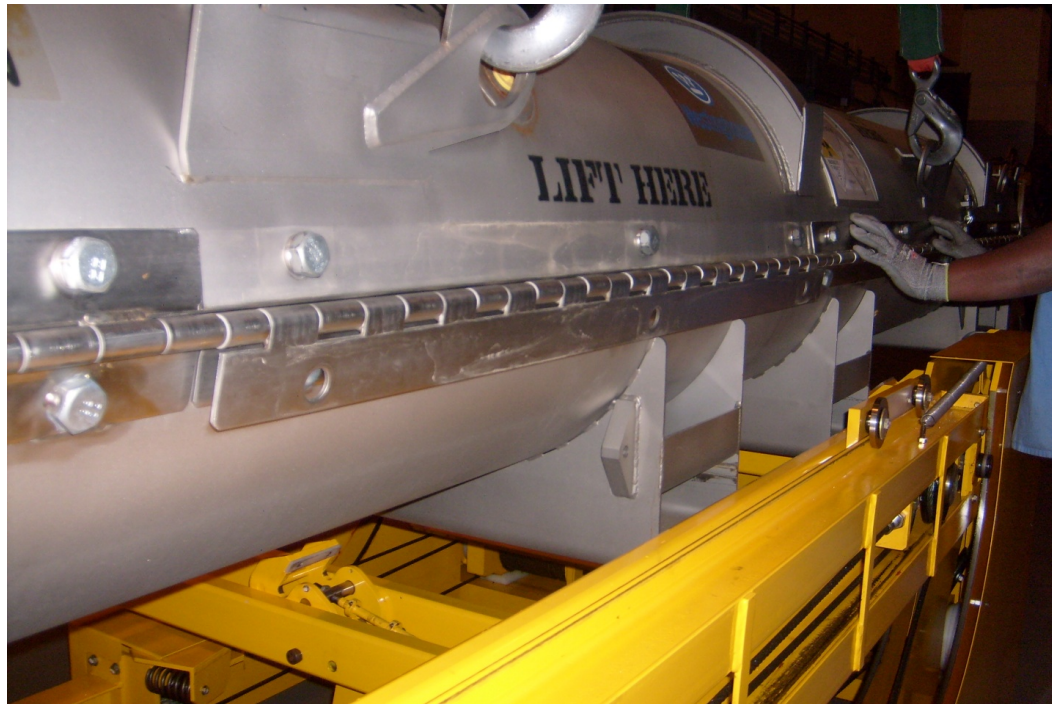
A fuel assembly was loaded in a TRAVELLER package at the Westinghouse Columbia Fuel Fabrication Facility (CFFF) on November 12, 2010. The package was shipped to a nuclear power plant facility and arrived on December 7, 2010. On or about December 8, 2010, operators at the facility noticed during operations to remove the fuel assembly from the package that a section of the hinge was not secured properly. As shown in Figure 1, three bolts

intended to secure the hinge section were installed, but the hinge was not attached to the upper outer-pack. Representatives from the nuclear power plant facility immediately informed Westinghouse of this package condition. The package was transported a distance of approximately 850 miles from CFFF to the nuclear power plant facility, and was in transit for 2 days.

Figure 1 – TRAVELLER package closure hinge condition as transported

Administrative controls failed to ensure the package closure was properly installed prior to shipment. The administrative steps in the procedure and quality control instructions (QCI) were intended to ensure proper installation of the closure, such that closure bolts secure the hinge section to the upper outer-pack.

The operator and QC inspector failed to notice that not all bolts were installed through the hinge connections. The packing check list along with the detailed operating procedure requires one operator to install the closure bolts and then have another operator check that the bolts are installed. The procedure and checklist requires QC inspector to verify proper operation of the torque wrench and verify installation of the closure hinge bolts. It appears this step wrench was not correctly performed.

The maximum load is imposed on the bolts during a side impact, slap down orientation. The safety factor for the bolts is 1.12 for the bounding TRAVELLER XL worst bolt. Failure to fasten the section of hinge reduces the number of bolts from 12 to 9 on one side of the outer-pack. This would increase the actual stress on the remaining 21 bolts (9 on one side and 12 on the opposite side) by approximately a factor of 1.15 which reduces the safety factor to less than 1. The reduction of the safety factor to less than 1 implies that one or more of the remaining bolts may fail under load imposed by the side impact.

Failure to secure a section of the closure hinge may have resulted in opening the gap on one side of the package during a fire. There would not have been a path for hot gases to flow

Procedures and checklists were revised to emphasize verification of the proper installation of the closure hinge on both sides of the package.
