**Homestake Mining Company
Grants Project
Large Tailings Facility
Stormwater Downdrains Project**

Cibola County, New Mexico

Duran Bokich Enterprises, LLC

01 December 2010

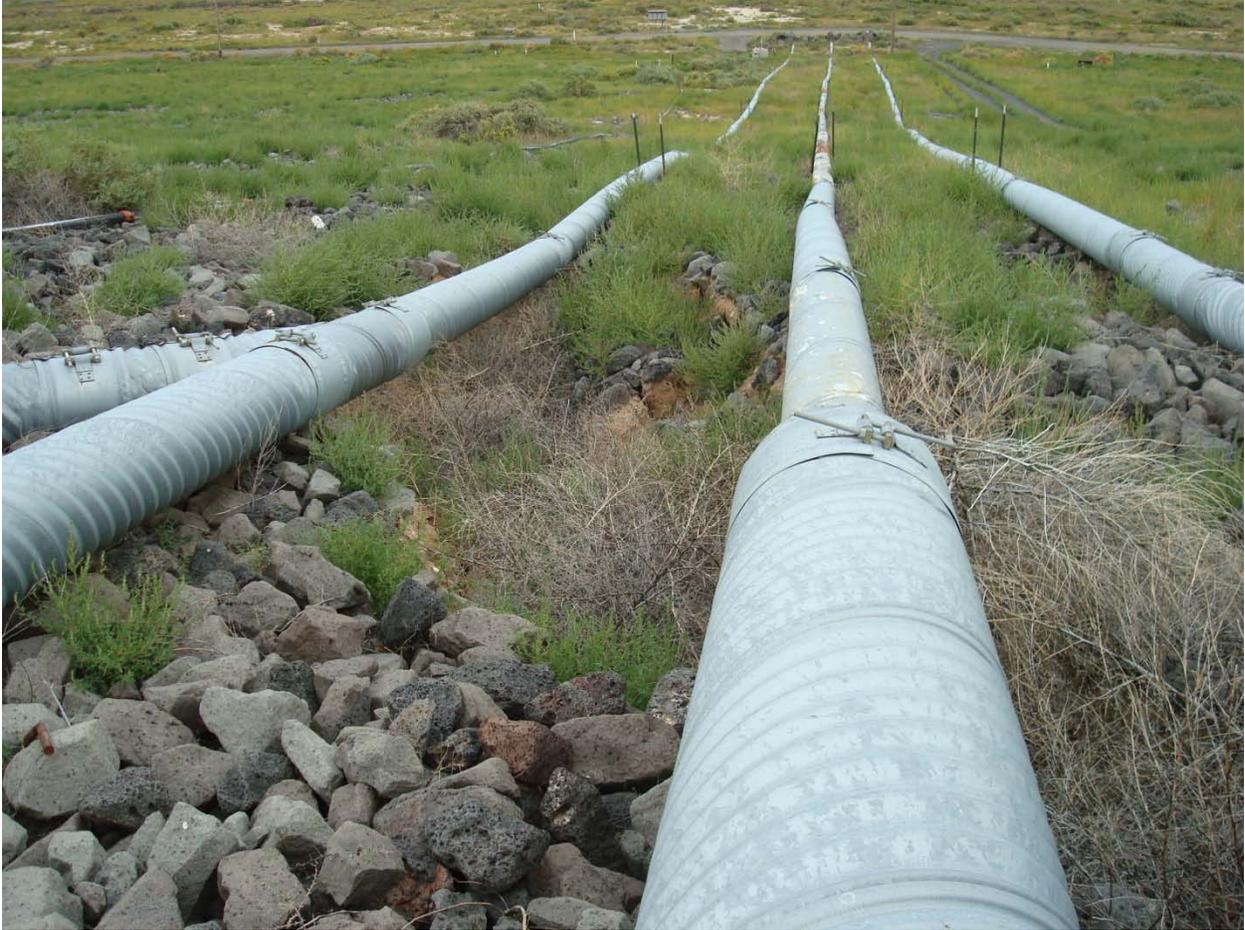
This project was to replace the existing CSP downdrain system with a continuous High Density Polyethylene (HDPE) plastic pipe. This was done to further reduce the potential for water erosion of the side slopes due to leakage of stormwater from the joints in the CSP downdrains.

Figure 2. Existing Corrugated Steel Pipe Stormwater Downdrains. South side triple pipe. Note CSP joint connectors and potential for leakage. Shown left to right are Drains No. 10, No. 9 and No. 8.

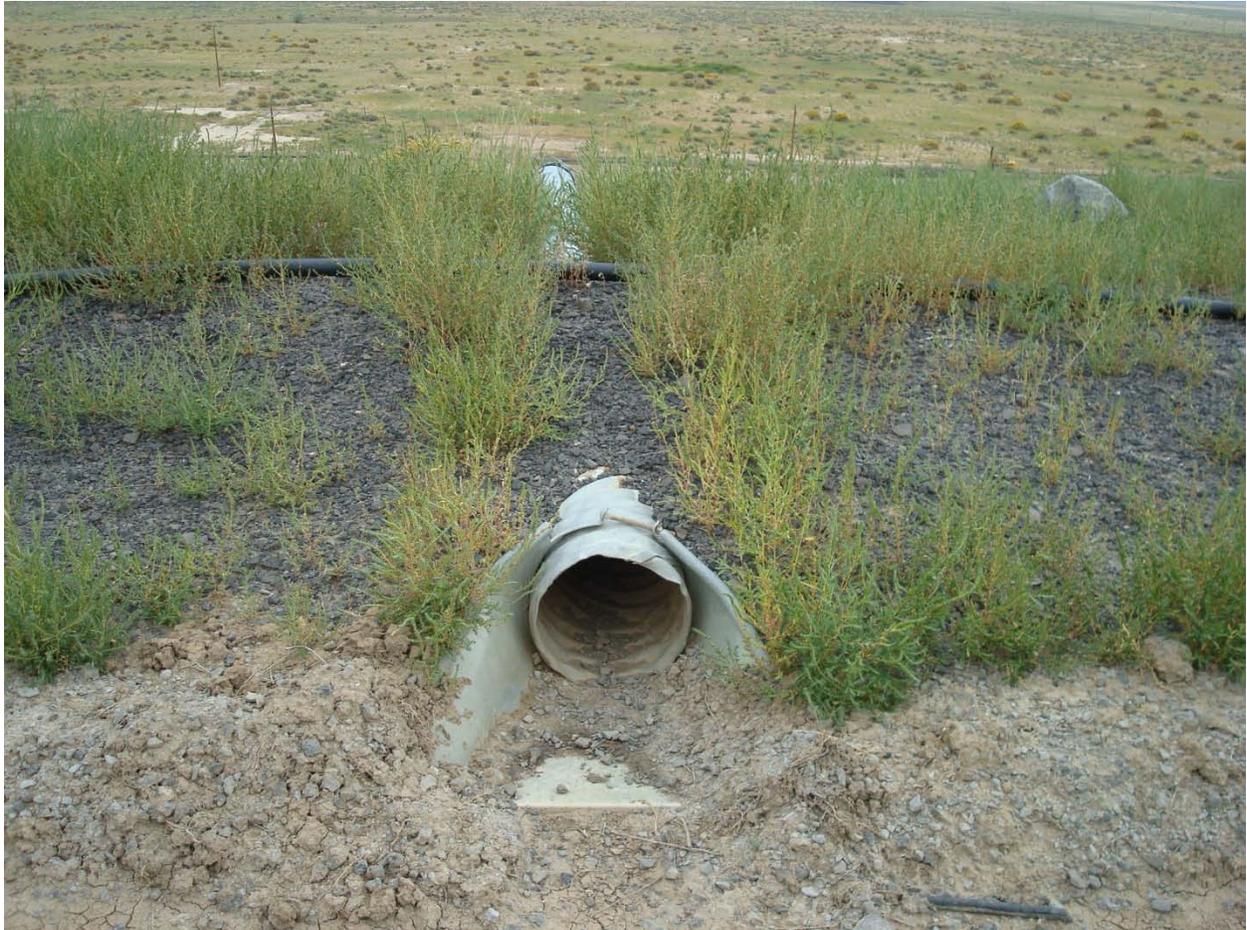
Figure 3. Existing CSP Downdrain pipe inlet, Drain No. 7.
