FM Notification Report Serial Number 10-06

Fairbanks Morse Engine

10CFR 21.21 (d)(3)(ii) Notification

Aluminum bearings that were shipped for the OP EDG that are suspect for linear indications are as follows:

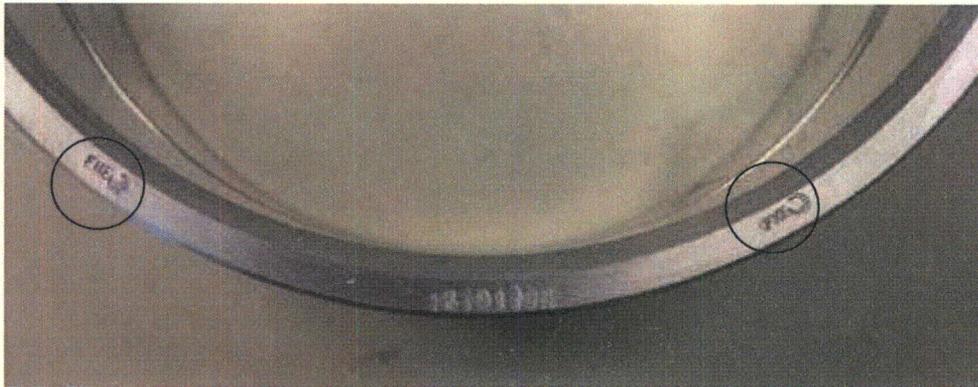
All bearings that are suspect for linear indications are stamped with two FM swirl logos as shown in the photo. Linear indications have only occurred on bearings machined from the latest permanent mold castings which are identified with two FM swirl logos as shown:

All aluminum OP bearings stamped with a double FME logo, as listed in the previous table, are suspect for having linear indications and should be returned to FME for inspection.

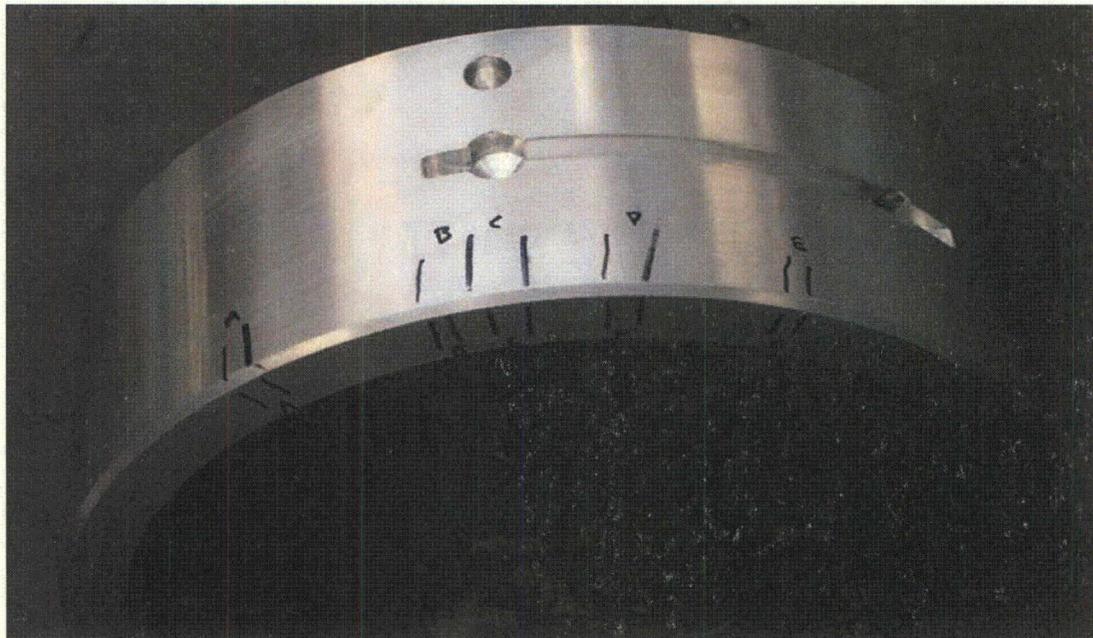
Linear indications (hot tears) were observed on one main bearing by the FM production inspector. The indications were only on one edge of the bearing. The indications went across the entire edge and extended about 1 inch deep into the bearing, being visible on the outside diameter and the inside diameter for about 1 inch. Subsequent 100% liquid penetrant inspection (PT) of all finished bearings in stock has found linear indications on 13 of 454 bearings (3% reject rate) made from permanent mold castings.

The following photo shows the location of the linear indications marked along one edge of the bearing:

The root cause of the problem occurs during the casting of the aluminum material in the permanent mold. The linear indications occur only on one edge of the casting, which has been identified as the bottom of the casting. During the cooling and solidification of the molten material poured into the permanent mold tool, the material shrinks and must be continuously replenished with molten material from the top of the casting. If the top of the casting solidifies before the bottom, there is no additional molten material available from the top to feed the bottom as it cools and shrinks, resulting in tears (hot tears) to the material on the bottom of the casting. It is suspected these hot tears are occurring due to improper cooling of the mold tool core. Because there are no cooling passages within the solid mold tool core, the core becomes progressively hotter throughout the production run until the core reaches a temperature hot enough to cause the hot tears.

As additional permanent corrective action, the FM supplier is adding air cooling passages to the permanent mold tool cores prior to any additional castings being poured. Core cooling creates directional solidification of the casting, from the inside to the outside and from the bottom to the top. Future production runs of bearings from new castings will be stamped with an FM lot number that traces to the supplier casting heat number and allows tracking the effectiveness of the corrective actions.

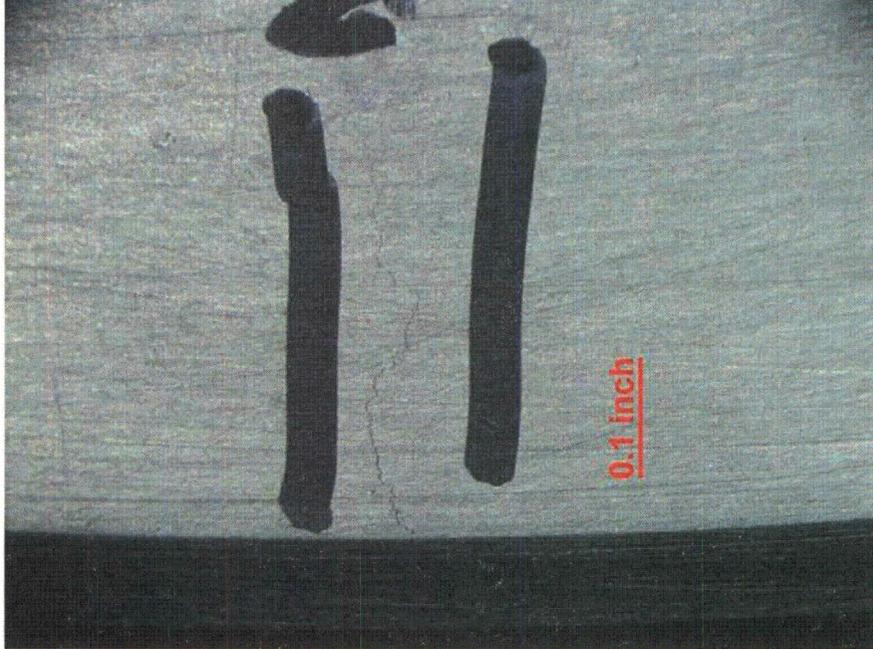
The following photomicrograph at 7X magnification shows a visually apparent linear indication:

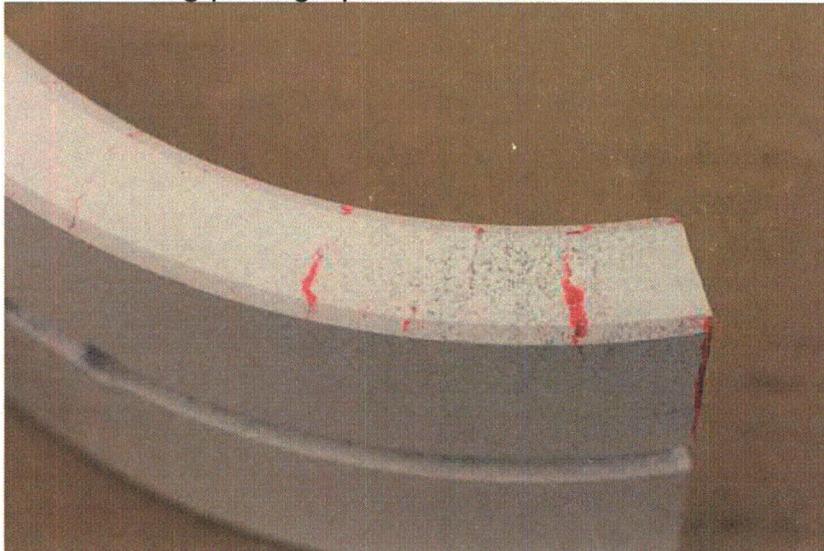
The following photograph shows linear indications observed by PT:
