RE: Irigaray-Christensen Operations 2010 Annual Inspection Report, Permit No. 478

ANNUAL INSPECTION REPORT

Subject: Uranium One, USA's Irigaray and Christensen In Situ Uranium Operations

Date of Inspection: October 20, 2010

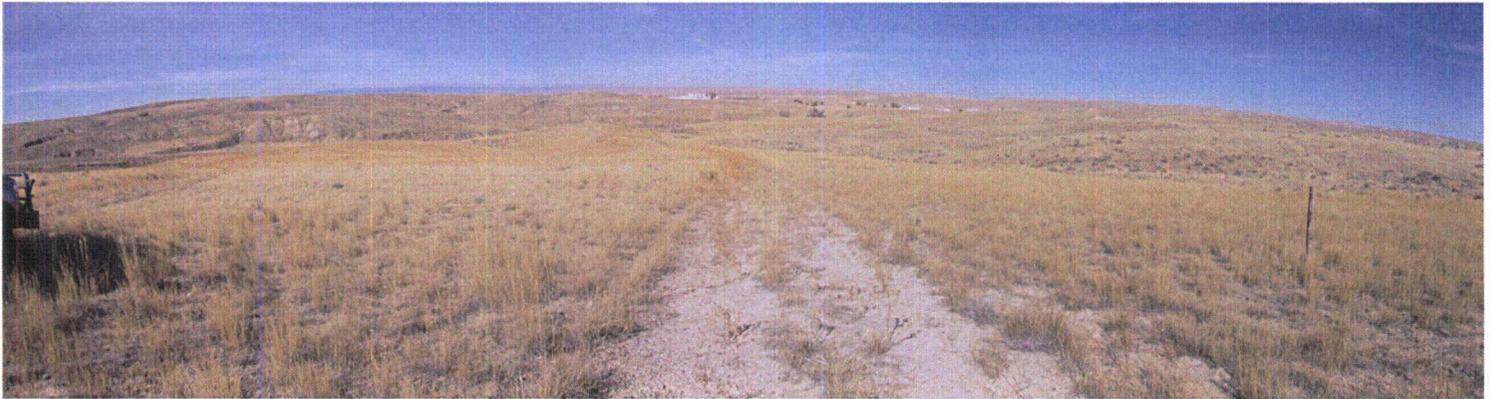
In Units 7, 8 and 9, the well field buildings, buried trunklines and manholes leading to the buried trunklines have been removed (Photo No. 1). The buried pipelines leading to each well in Unit 7 have now been removed as well. A few wellheads remain to mark the locations of the buried piping that remains in the ground in Units 8 and 9.

Photo No. 1 Looking northwest to north across Irigaray Well Field Units 9 and 8 where all injection and recover wells have been sealed and the well heads cut off below the ground surface the areas backfilled. Only a few plugged monitor wells remain visible. Work is still on-going to remove the buried piping and wiring in Units 8 and 9.

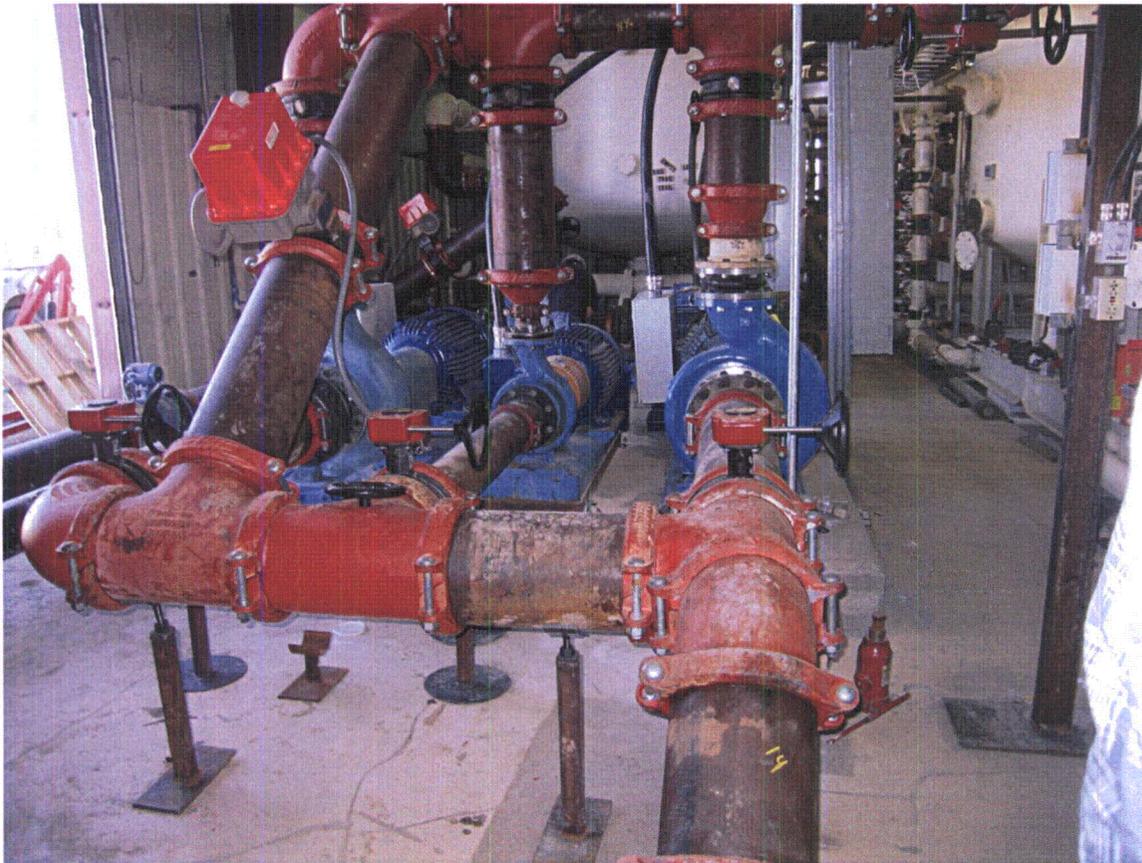
The plant equipment is being refurbished in anticipation of restart. The main well field circulation pumps and associated piping has been replaced or refurbished (Photo No. 2) as have the sand filters and tanks. The control room has been remodeled and new equipment installed.

Photo No. 2 View of main circulation pumps and piping in Christensen Ranch satellite plant which have recently been rebuilt, refurbished or replaced.

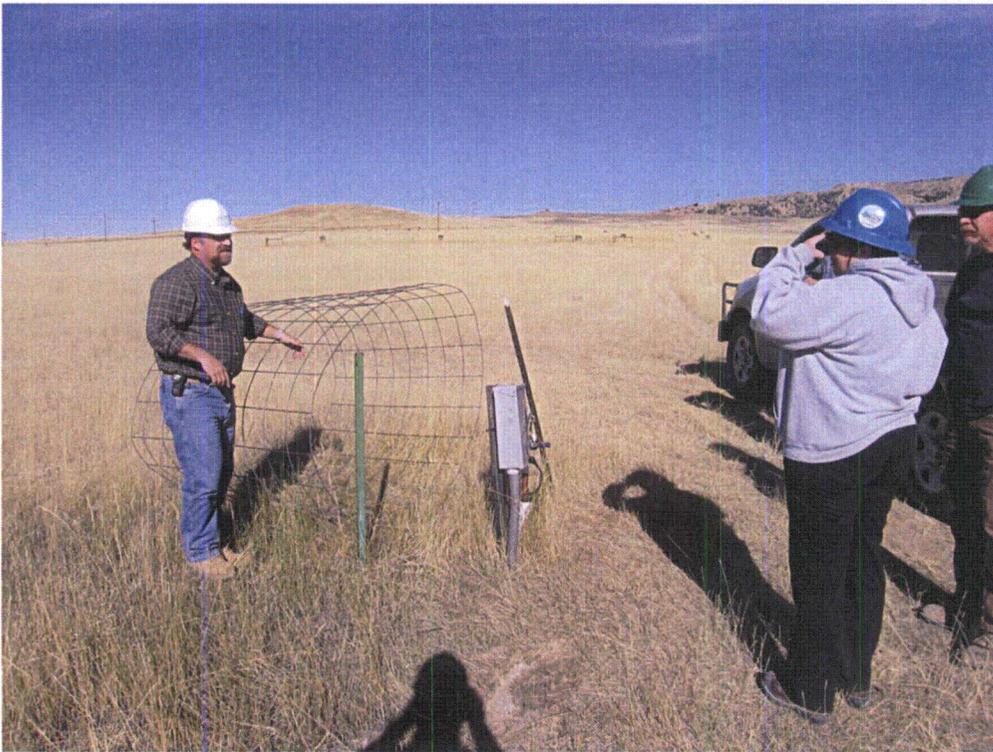
The surface portion of this perimeter monitor well was inspected. The well has been in excursion status since 2004. The well lies downgradient of Unit 5 and portions of the well field extend from its northeast to its south and southwest, partially enclosing it (Photos Nos. 3 and 4).

Photo No. 3
Looking at Monitor Well 5MW66 in Christensen Ranch Well Field Unit 5. The northern lobe of Unit 5 can be seen in distance beyond well.

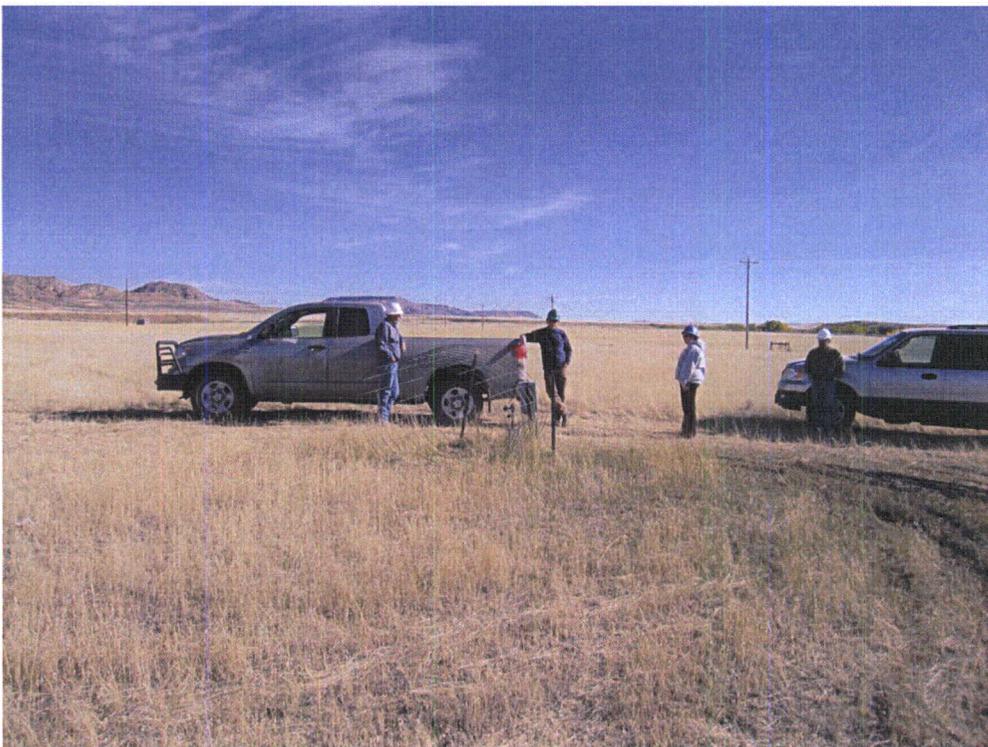
Photo No. 4
Looking south at Monitor Well 5MW66 in Unit 5. Other portions of Unit 5 are partially visible in the left and right distances.

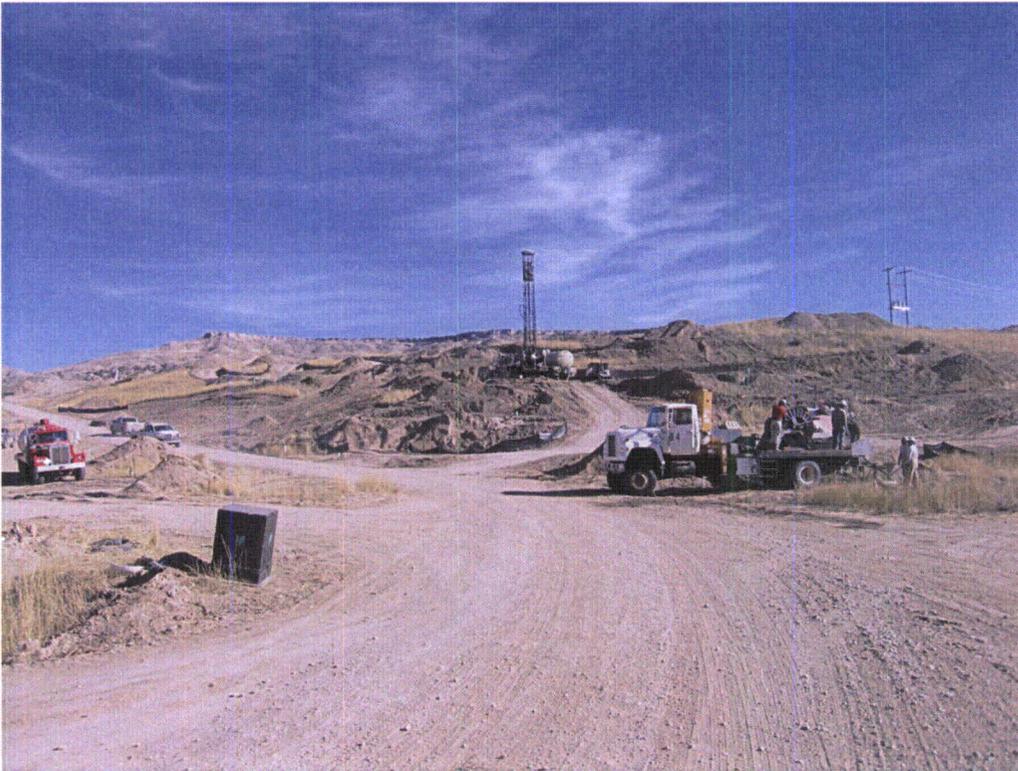
Photo No. 5

The Well Field Unit 7 data package was approved on September 13, 2010, clearing the way for resumption of mining operations late in 2010 or early in 2011. The day of the inspection, a reported 14 drill rigs were running in Unit 7. The well field area has been extensively affected with roads, trenches and drill pads constructed over most of the surface of the unit (Photo No. 5). Some affected areas along the drainage running east to west through the northern portion of Unit 7 have been recontoured and regraded and sediment fences have been placed in strategic areas along the drainage (Photo 5).

Looking east at on-going Well Field Unit 7 development with new roads, well pads and drilling underway. Some regrading of disturbed ground and a sediment fence can be seen in the far left distance.

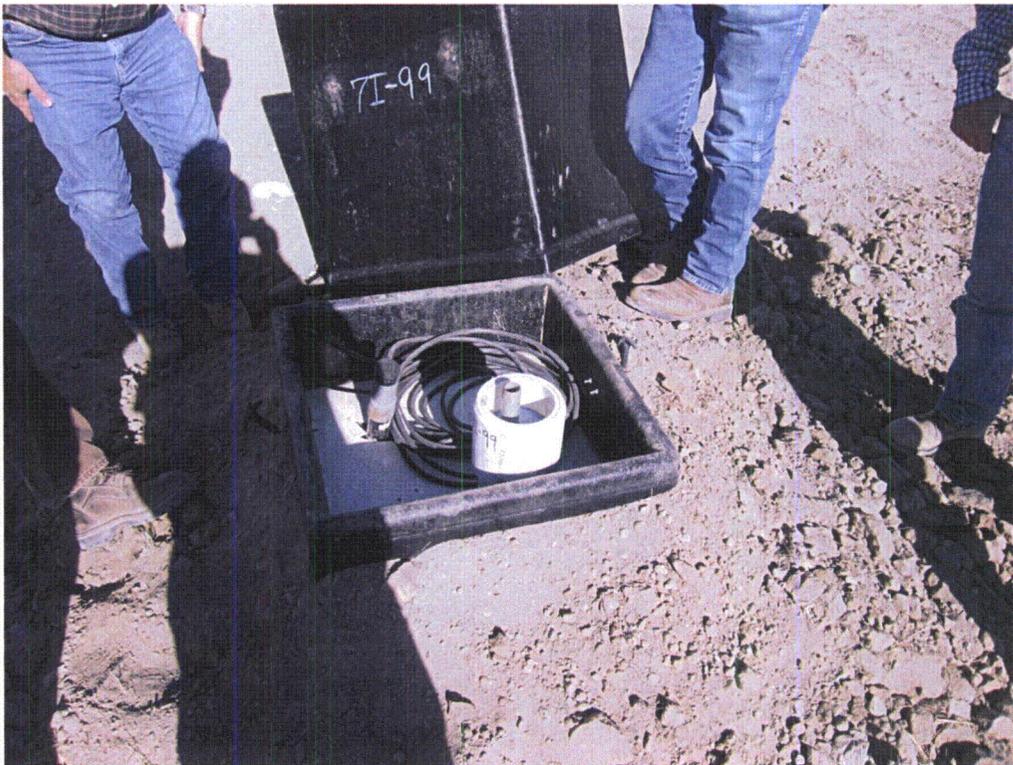
Photo No. 6

The injection and recovery wells being installed in Unit 7 will have new design well boxes. Unlike the older boxes, these will have closed bottoms and sensors in the bottoms of each box that will detect leaking fluids and send alerts to the control room (Photo No. 6).

View of new-style well box which covers the well head of injection and production wells. Unlike previous well boxes, this type has a impervious bottom and a sensor that will signal the control room if fluids are detected in the bottom of the box.

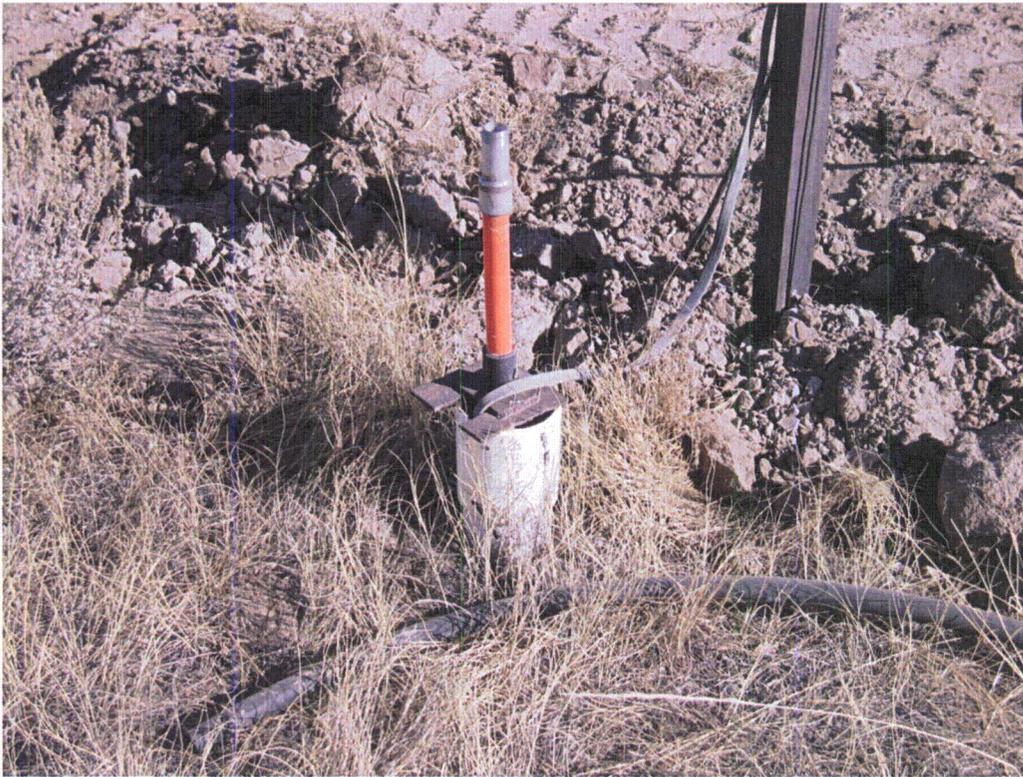
Photo No. 7

The construction of monitor wells at Christensen Ranch was discussed. The current method of closing the top of the well with a notched steel plate which supports the weight of the pump and production pipe is not in compliance with Land Quality Division NonCoal Rules and Regulations, Chapter 11, Section 6(b)(ii). This section requires the well opening be closed to

prevent the introduction of undesirable material into the well. The current practice leaves a gap needed for the power cable but could also allow entry of rodents, snakes and insects.

View of a monitor well with a cover of a style used at Irigaray and Christensen Ranch operations for decades. This style is no longer acceptable because new LQD regulations require well heads to be sealed against contamination and the intrusion of animals and insects.

Mr. Arbogast offered an alternative whereby two plates would be used with the notched sides facing that would cover any gaps. I told him I thought this arrangement would satisfy the regulations.

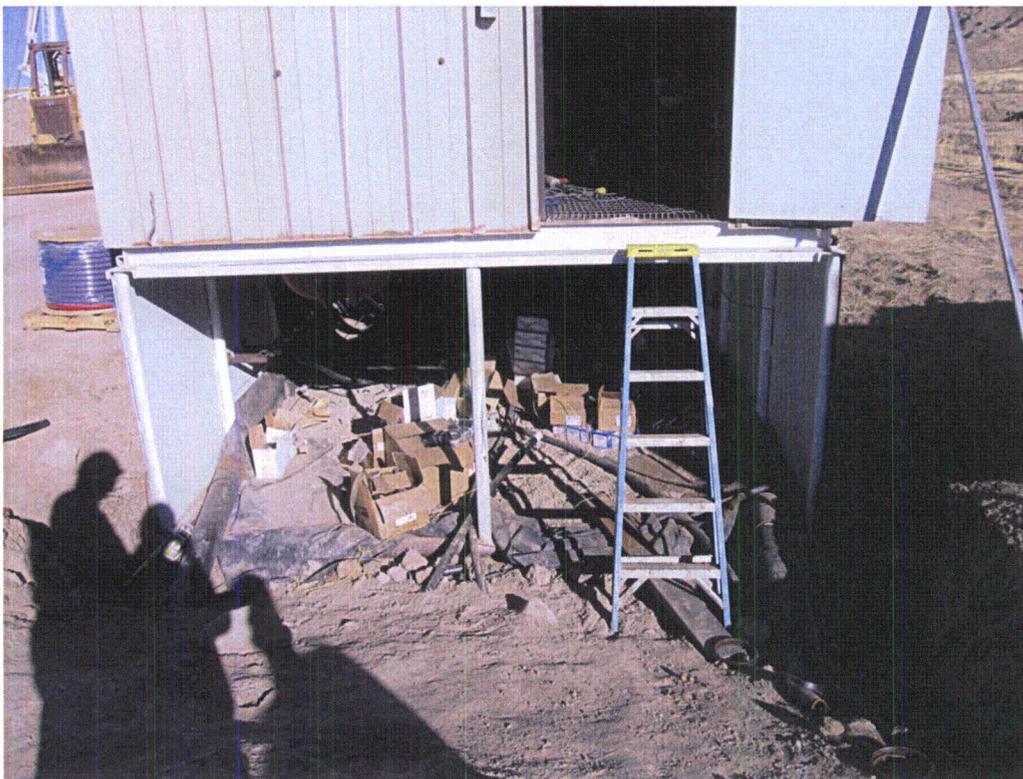
Photo No. 8

The module buildings will have grated floors overlying "basements" lined with polymer sheeting that will contain any fluids that might leak from the many plumbing connections in each building. Sensors will be installed in these "basements" to detect any spills.

View of a header house under construction. Note the polymer liner at the bottom which will contain any fluids leaked by the plumbing to be installed above in the header house.

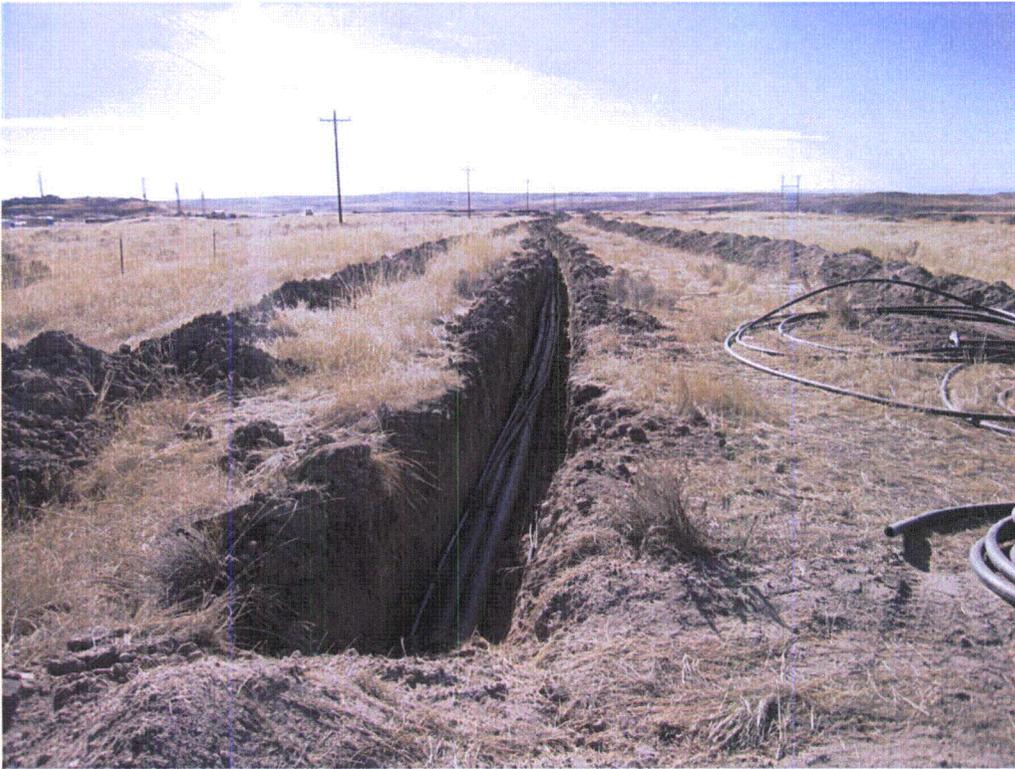
Photo No. 9

Where excavations for mudpit or pipeline trenches have been made, topsoil has been separated from subsoil and placed in separate stockpiles with identification signs on the topsoil (Photos Nos. 9 and 10). Some topsoil has also been salvaged from roadways and module building areas, but in relatively small amounts.

Looking west along trunkline which will connect a header house with the main trunklines that led to the satellite plant. The trench cut by a backhoe holds both flowlines for the barren and pregnant lixiviant along with oxygen lines and communication lines. Windrows hold the topsoil and subsoil on either side of the trench.

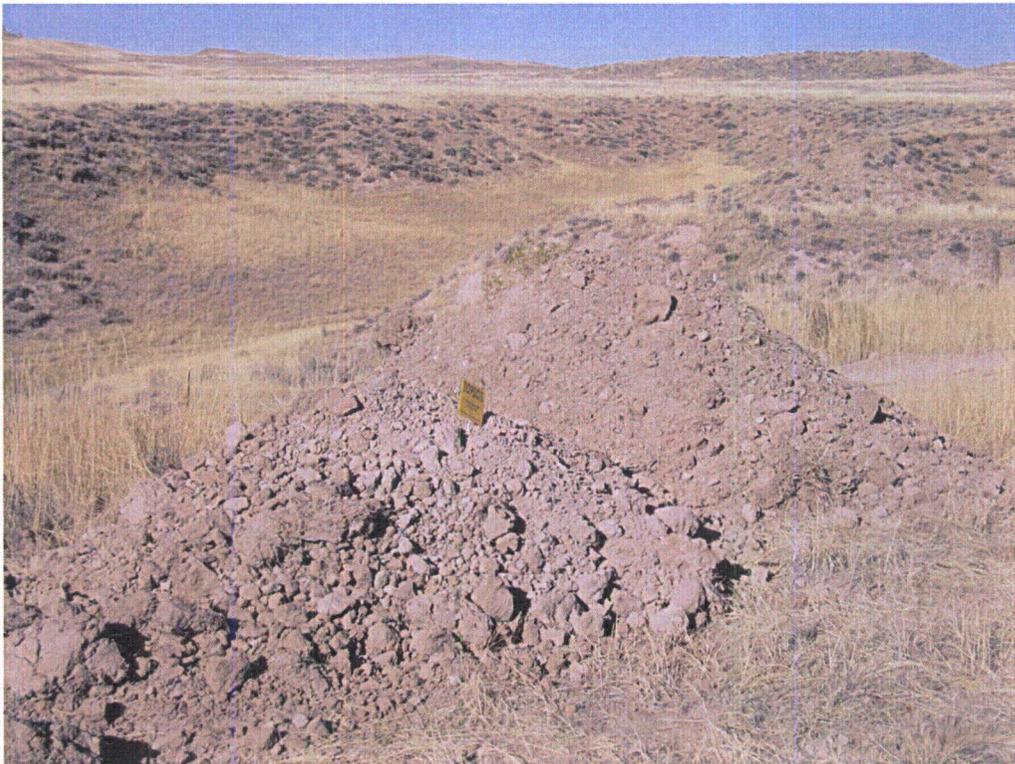
Photo No. 10

View of stockpiles from mudpit used during drilling operations. Topsoil has been placed in smaller stockpile in front marked by small yellow topsoil sign and larger subsoil stockpile in back.

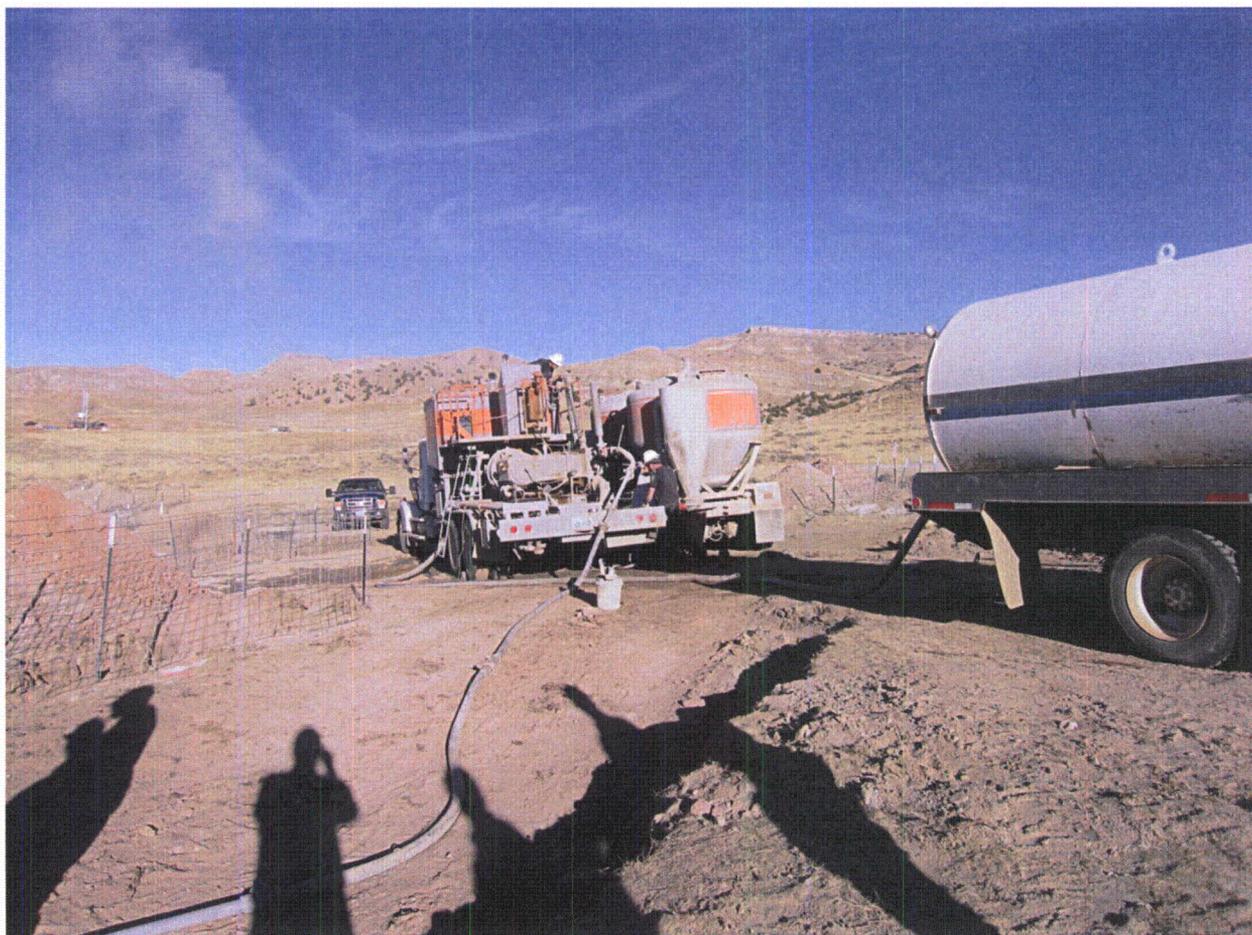
Cementing of one well was observed and the cement weight was measured. The return cement was measured at 12.2 pounds per gallon, not bad for return cement which can be expected to be diluted somewhat.

Photo No. 13 View of well cementing operations in Well Field Unit 7. Left truck holds the cementing unit and a bulk truck with cement is located to its right. The truck at right supplies water to mix with the cement.
