**SUBJECT: MCGUIRE NUCLEAR STATION, UNIT 1 – RELIEF 09-MN-002, REVISION 1,
FOR A PROPOSED ALTERNATIVE TO DELAY THE UPDATE TO THE CODE
OF RECORD FOR THE FOURTH 10-YEAR INSERVICE INSPECTION (ISI)
INTERVAL (TAC NO. ME4870)**

SAFETY EVALUATION BY THE OFFICE OF NUCLEAR REACTOR REGULATION

REPAIR OF BURIED SERVICE WATER PIPING

RELIEF NO. 09-MN-002, REVISION 1

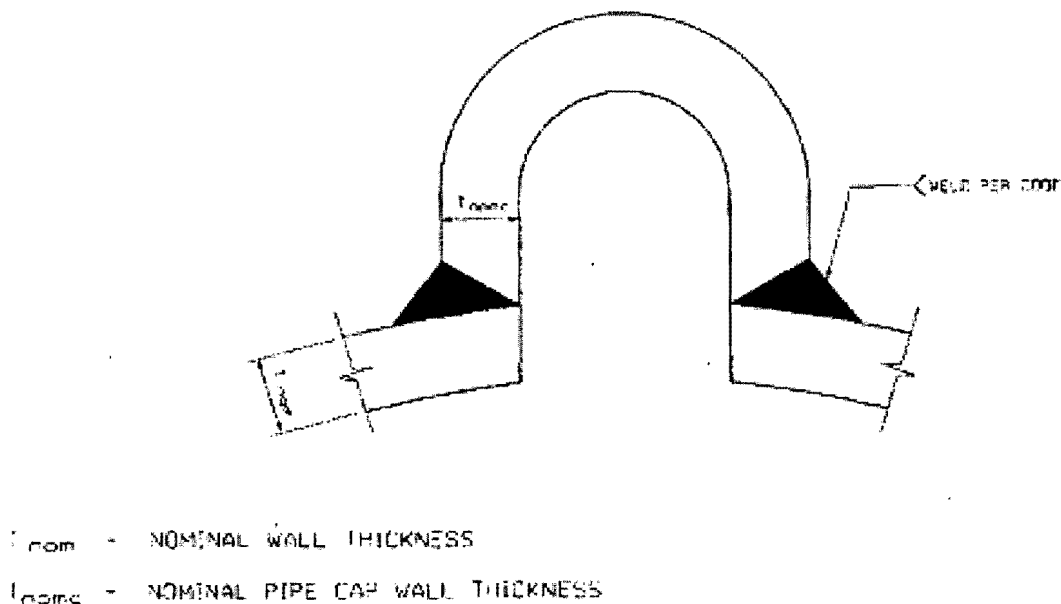
Figure 1 (Example of Code-Compliant Repair)

The NRC staff has evaluated other repair alternatives. The RN piping is ASME Code Class 3 and meets the requirements of moderate energy piping found in Generic Letter (GL) 90-05, "Guidance For Performing Temporary Non-Code Repair of ASME Code Class 1, 2, and 3 Piping" (Reference 7). Use of the provisions of GL 90-05 is inappropriate for McGuire 1 and 2 RN piping since the RN piping is shared between two units and cannot be isolated, and GL 90-05 requires performing a Code-compliant repair at the next outage exceeding 30 days. Similarly, use of Code Case N-513-3 (Reference 8) for a temporary repair also requires a Code-compliant repair be made within a time period not exceeding 26 months from the initial discovery of the condition. NRC Regulatory Guide 1.147 conditions the use of ASME Code Case N-513-3 such that the repair or replacement activity temporarily deferred under the provisions of this Code Case shall be performed during the next scheduled outage. As a result, use of either of these alternatives would require a mid-cycle shutdown of one unit that would present hardship.

The NRC staff notes the general design similarity to a Code-compliant repair, Figure 1. The NRC staff finds that the proposed design has several advantages over the Code-compliant repair of Figure 1. First, the application of corrosion protection within the encapsulation after pressure testing inhibits corrosion on the interior of the encapsulation as well as the remaining pipe wall within the bounds of the encapsulation. In addition, the remaining pipe wall material, while performing no structural function, provides an additional corrosion allowance in comparison to the design configuration of the Code-compliant repair (Figure 1). The NRC staff concludes that the proposed alternative encapsulation design is acceptable.
