BLRD-50-439/81-23

BELLEFONTE NUCLEAR PLANT UNIT 2 - LACK OF REBAR AT MAIN STEAM FLUED HEAD -
BLRD-50-439/81-23 - FIRST INTERIM REPORT

ENCLOSURE
BELLEFONTE NUCLEAR PLANT UNIT 2
LACK OF REBAR AT MAIN STEAM FLUED HEAD
BLRD-50-439/81-23
10 CFR 50.55(e)
FIRST INTERIM REPORT

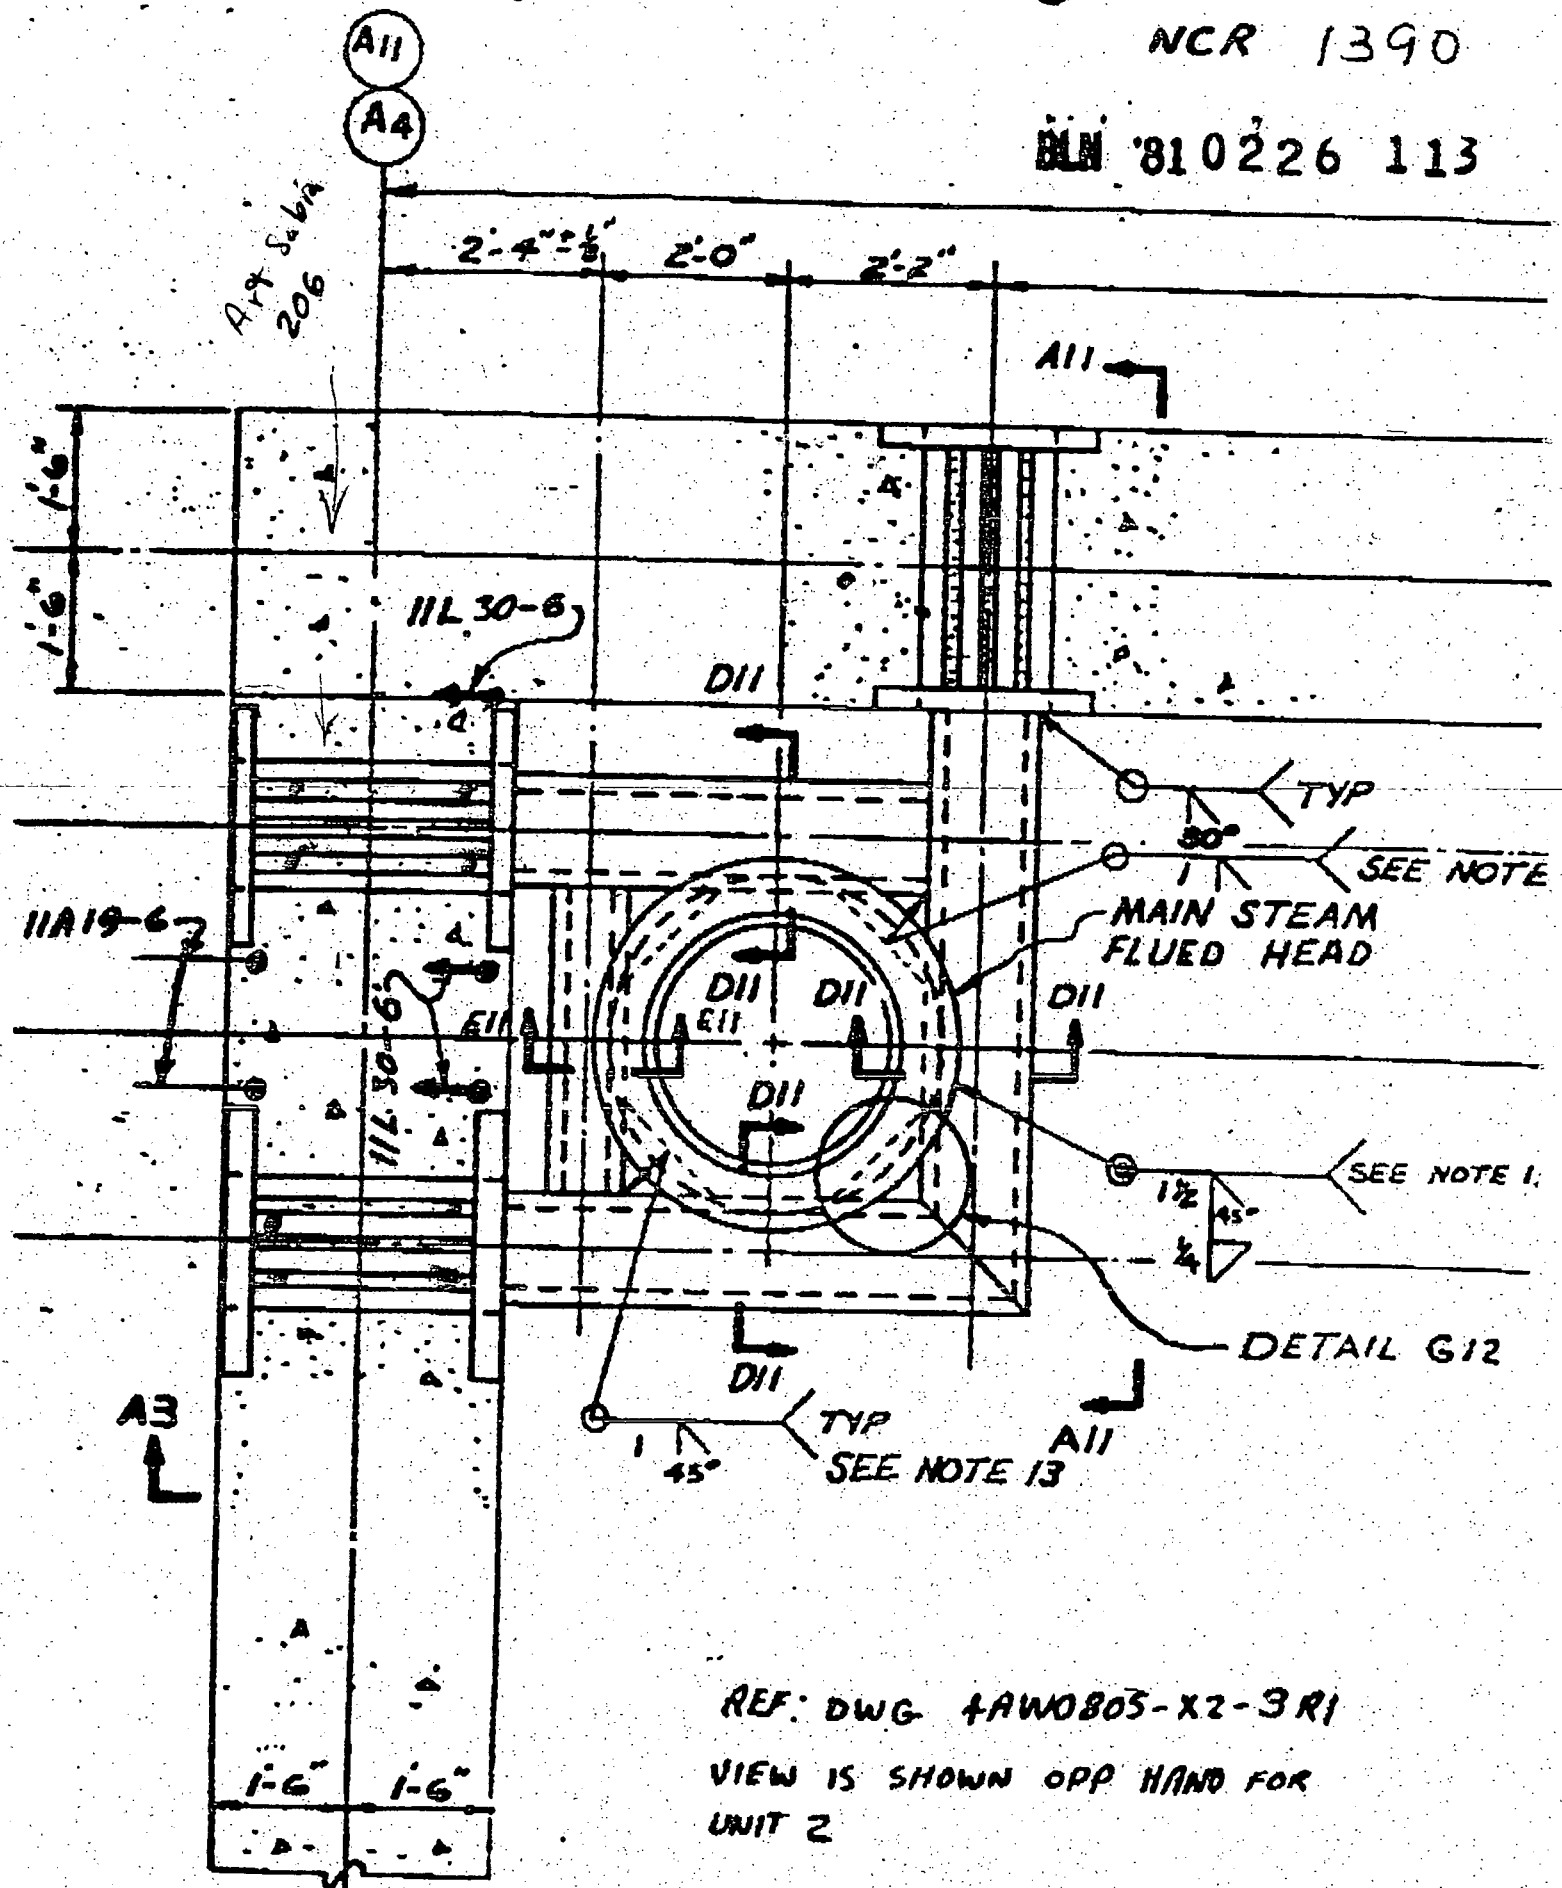
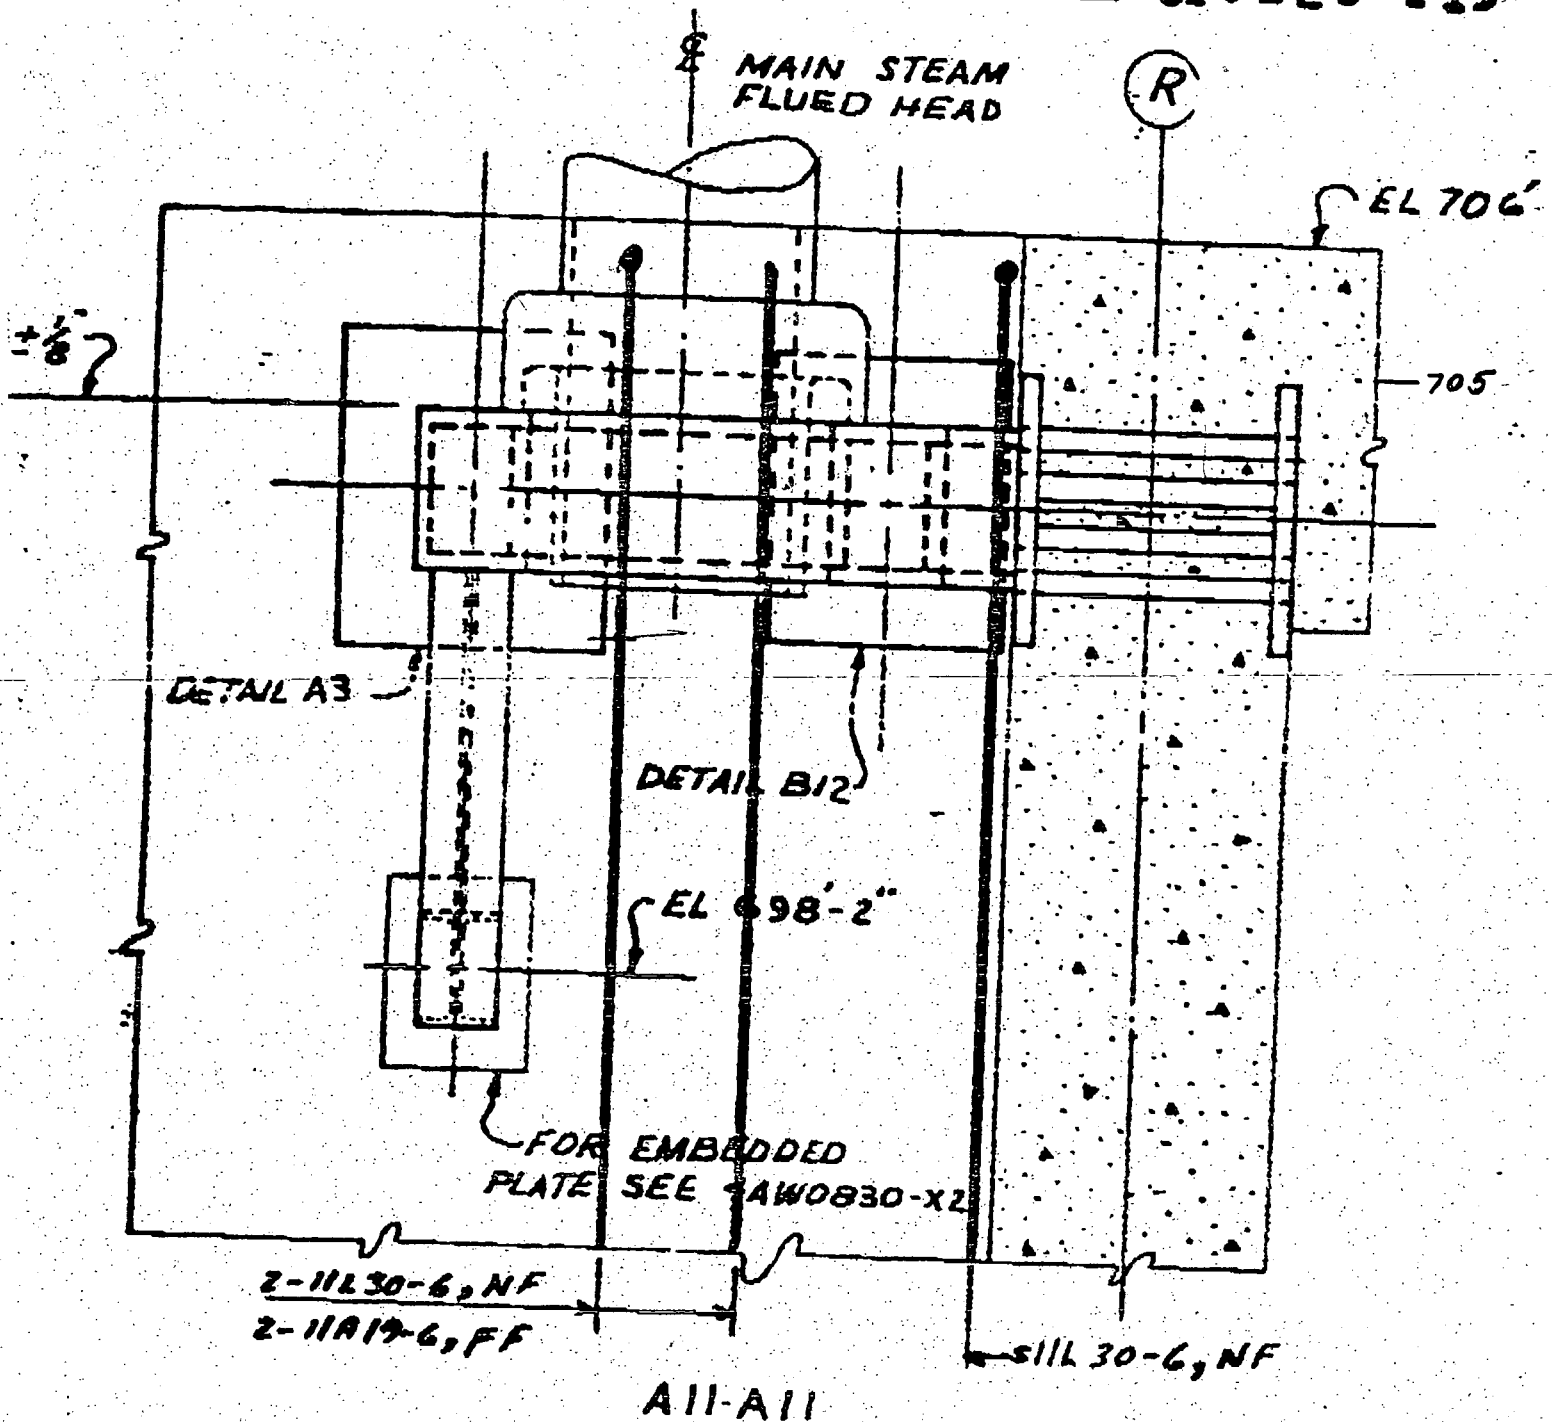
REF: DWG 1AW0803-X2-3R1
VIEW IS SHOWN OPP HAND FOR
UNIT 2

The discrepancy was discovered while chipping concrete, in accordance with the disposition of NCR 1308, to determine the locations of steel reinforcing bars (11A19-6 and 11L30-6) at the main steam flued head supports (see attached drawings). Chipping revealed that these bars are not present between said supports. Additionally, it was discovered that additional reinforcing bars which should lace between the anchor plate support bars were cut off below the supports. The extent and cause of the deficiency is unknown at this time.

Chipping will continue until exact location and configuration of the reinforcing bars are determined.

The remaining anchor assemblies in unit 2 will be chipped out and checked for the same type of rebar problems. In addition, two anchor assemblies will be checked in unit 1. (1) One located 6'-6" north of A4 column line wall in R column line wall and (2) One located in wall 3'-6" east of R column line wall and 8' north of column line A3.

When the efforts to determine the extent and cause of the deficiency are complete, appropriate corrective actions will be initiated.
