BELLEFONTE NUCLEAR PLANT UNIT 1
VOIDS IN UNIT 1 PRIMARY CONTAINMENT DOME
NCR'S 1061 AND 1070
10 CFR 50.55(e)
FIRST INTERIM REPORT

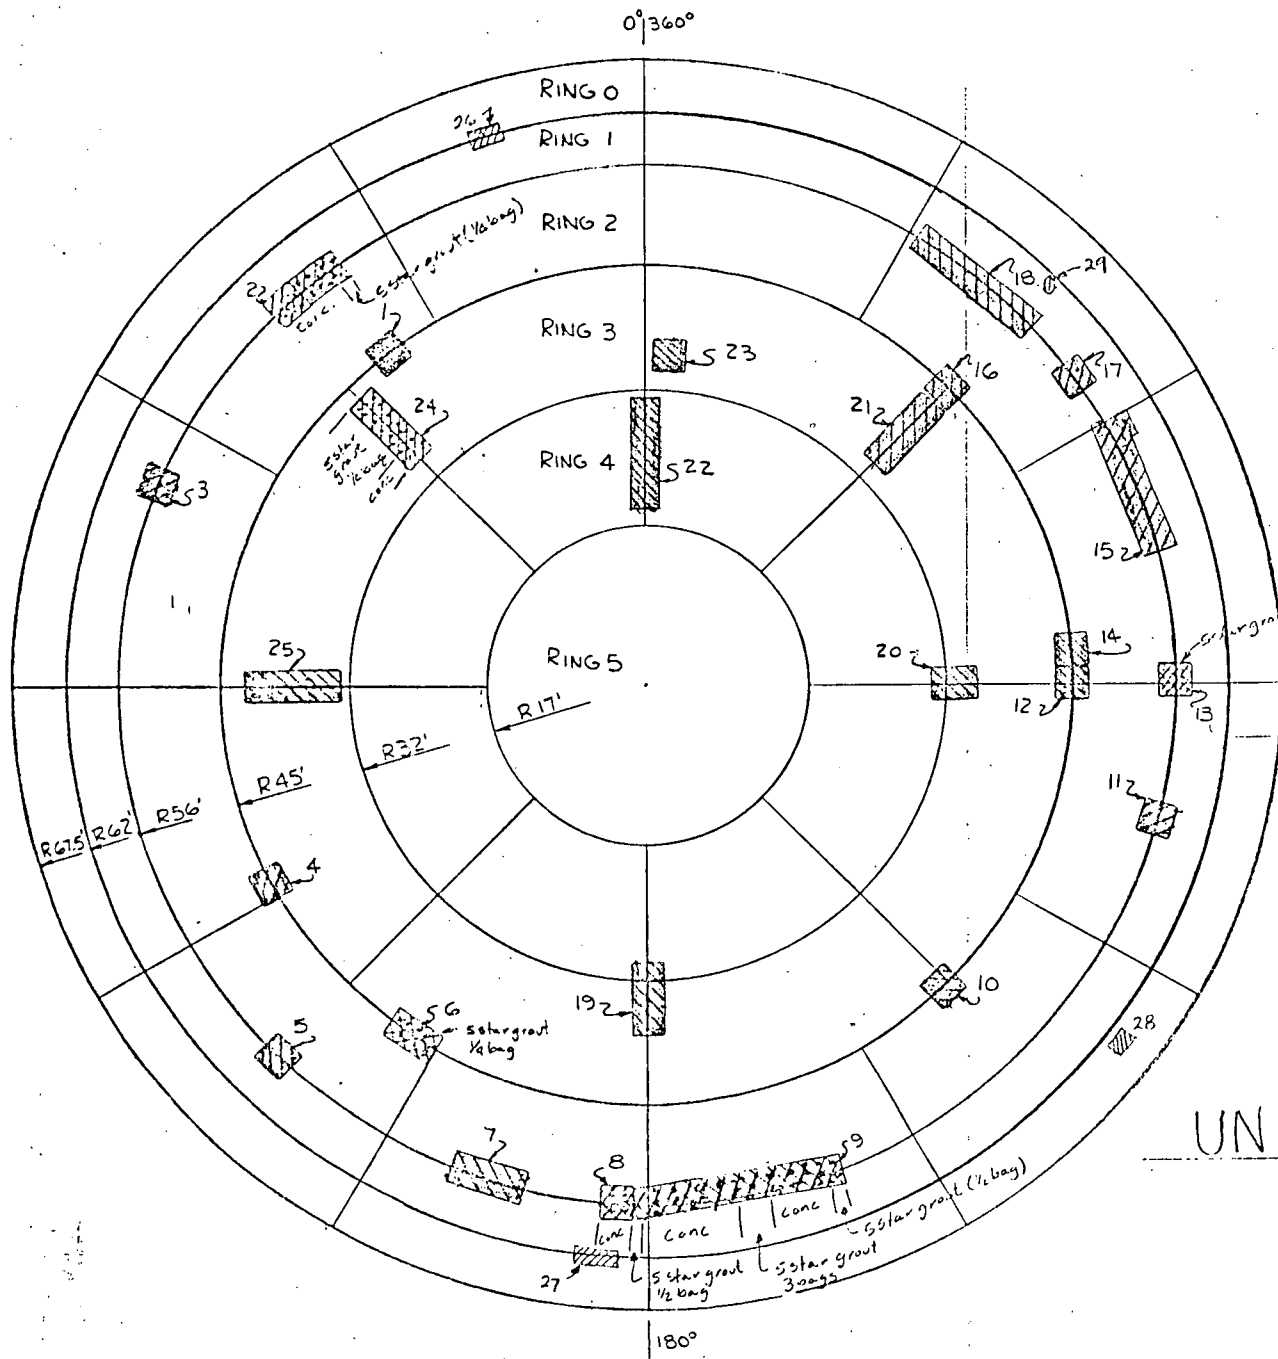
UNIT 1 DOME

Note: Chipped areas were repaired with job concrete.
Attachment 1 shows the general location and size of the suspected areas.
Areas 26-29 show the location for the voids described in Nonconformance 1070.

Nos refer to chipping permit locations.

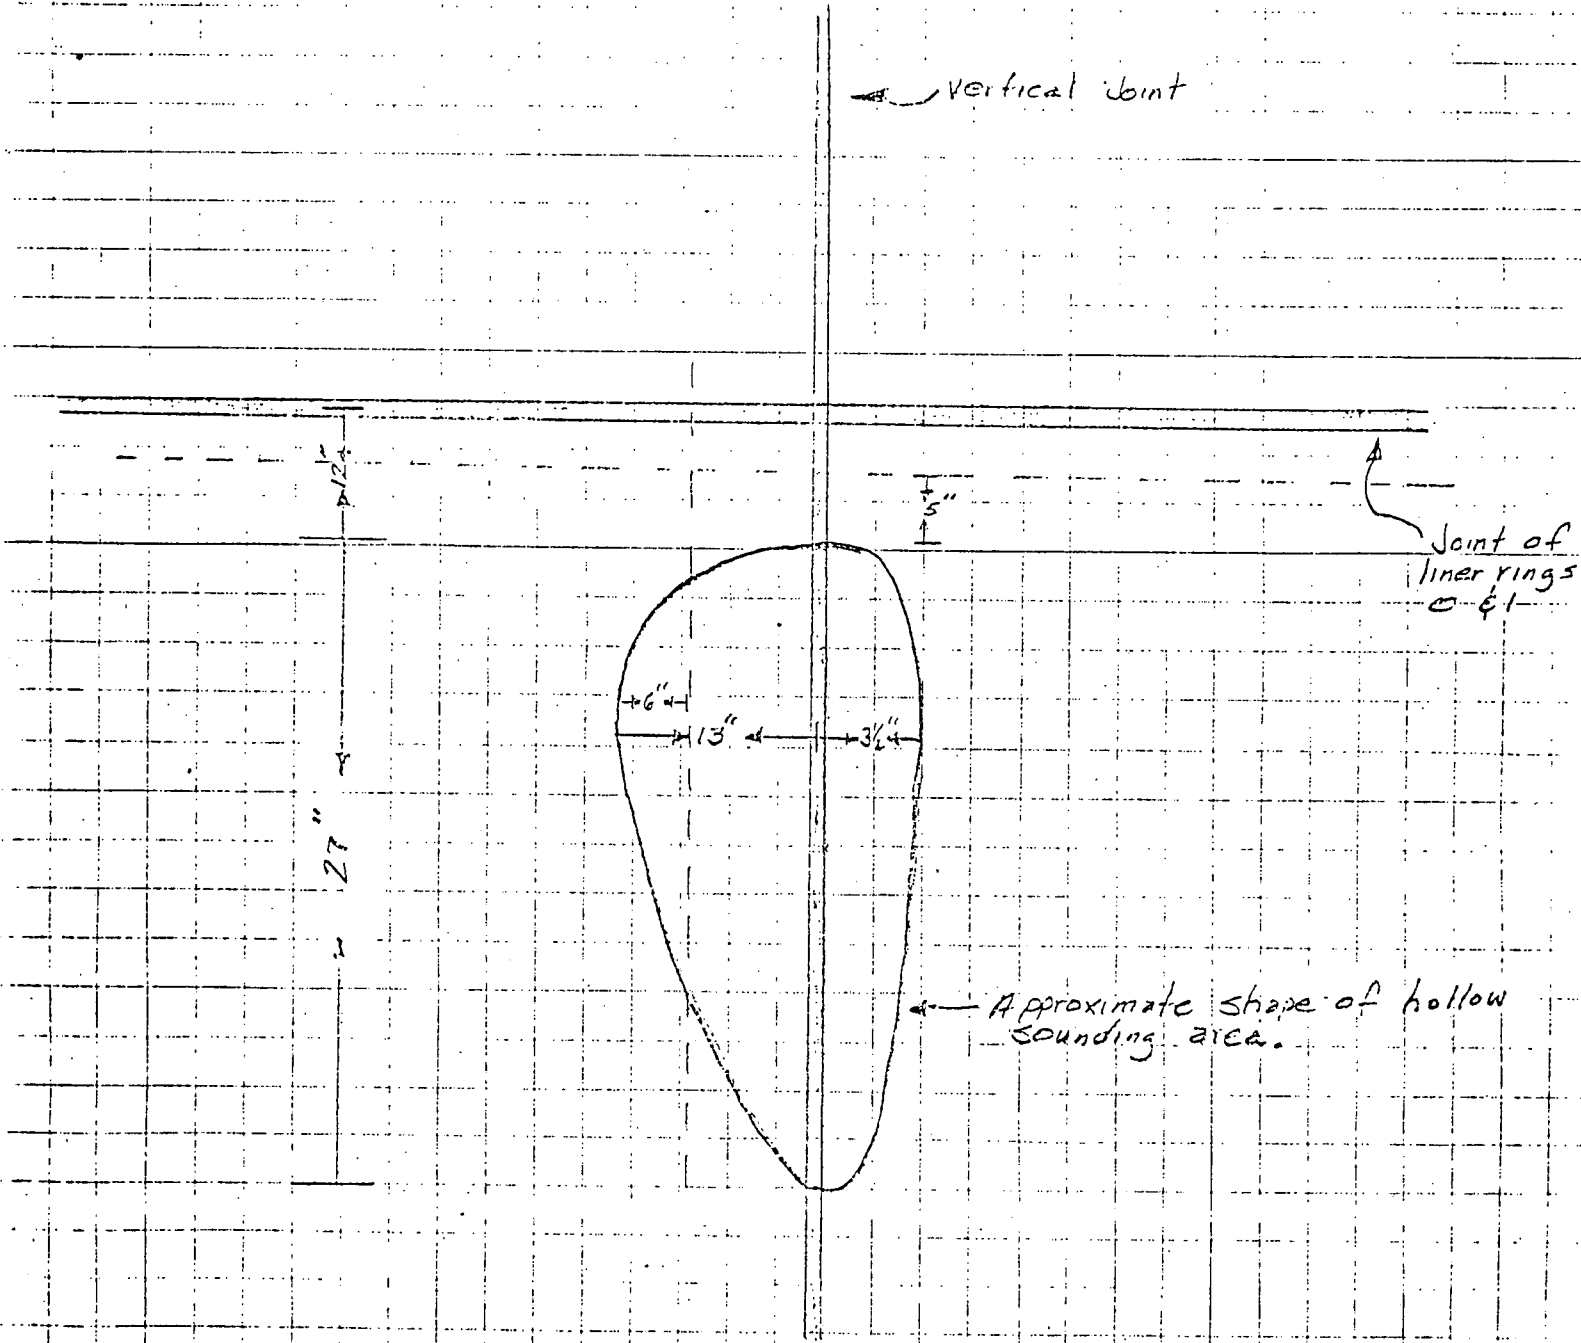
Attachment 2

A review of the concrete design in the area of the ring girder has shown that, assuming all four of the suspect areas are voids and are five inches deep, the concrete dome will not be overstressed by any load condition. With regard to the second concern, analysis has shown that suspect areas 1 and 2 will not result in liner strains exceeding allowable strains of ASME, Section III, Division 2. Suspect areas 3 and 4 would not cause tearing or failure of the liner, but the strains induced by containment test pressures would exceed allowables.

Area @ Azimuth $232\frac{1}{2}^{\circ}$
--- REPRESENT STIFFENERS

Void Condition 3.

The suspect areas of Nonconformance 1070 are located in the ring girder area where dome concrete is thickest. To excavate concrete to expose and repair any voids would result in damage to tendon sheathing and reinforcing steel. Several alternatives are being investigated and a final disposition has not been chosen. The most likely disposition is that suspect areas 3 and 4 will be repaired by grouting through holes drilled in the liner plate. Suspect areas 1 and 2 are acceptable without repair. Attachments 2 and 3 provide a general description of the size and shape of suspect areas 3 and 4, respectively.
