**SUBJECT:** Request for Use of Non-ASME Code Repair to Service Water  
Piping in Accordance with Generic Letter 90-05  
Relief Request ANO1-R&R-015  
Arkansas Nuclear One, Unit 1  
Docket No. 50-313  
License No. DPR-51

**ATTACHMENT 1 TO**  
**1CAN031103**  
**RELIEF REQUEST ANO1-R&R-015**

Component / Number: HBD-45-10" Piping

Description: Service Water (SW) supply line to the Reactor Building Cooling Coils VCC-2C/D

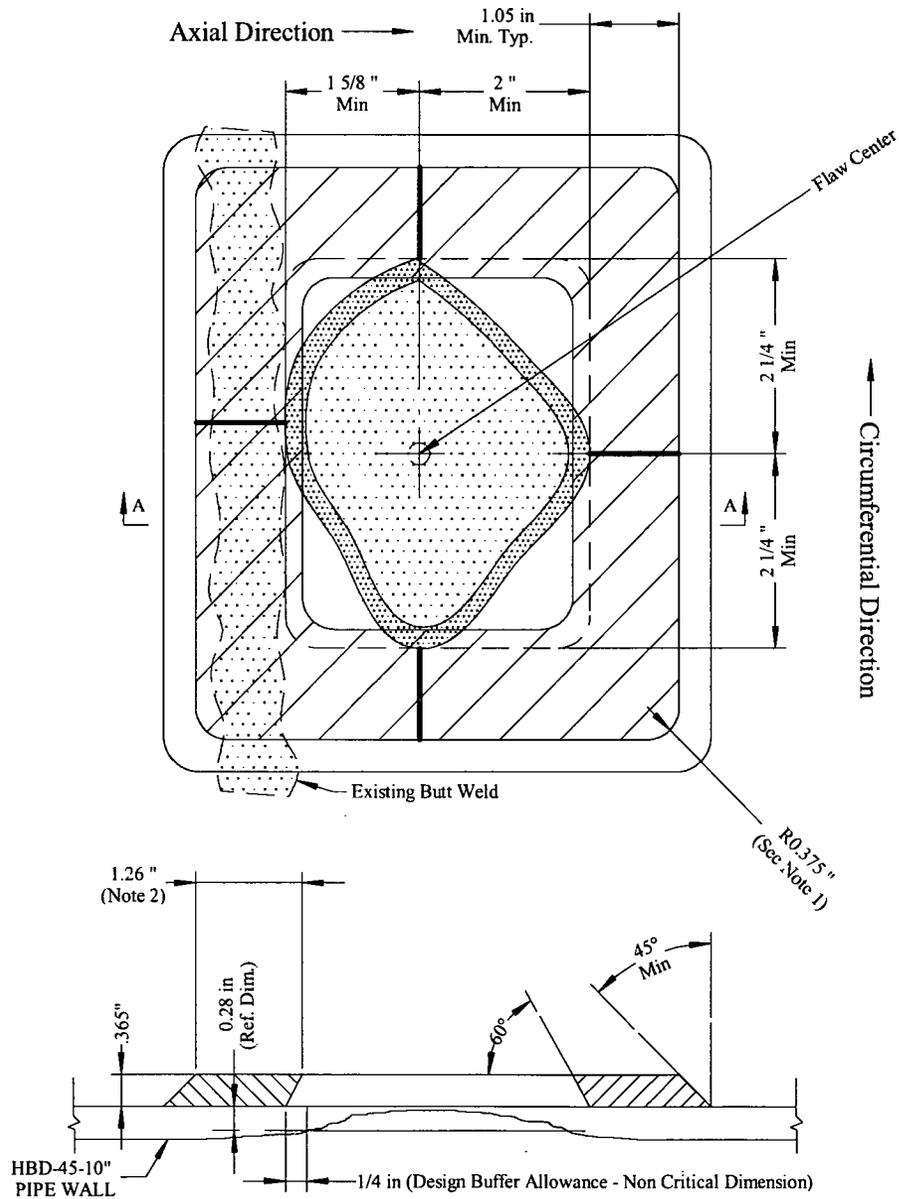
# HBD-45-10" Reinforcing Plate Sketch EC-28569 13-SW-119, Item 48

Attachment 2, "Minimum Weld Pad Thickness Calculation," has been prepared to determine the minimum allowed wall thickness, size and thickness of the repair plate, and determine required attachment weld thickness and width. The piping stress inputs were obtained from Pipe Stress Qualification CALC-91-E-0016-70, Revision 2. The pressure and temperature inputs were obtained from SW PT CALC-88-E-0100-23, Revision 2. The calculation included the effects on piping stresses due to a globally applied minimum pipe wall thickness. ANO historical data collected for MIC rates, in SW, indicates that the maximum corrosion pit rate is 0.012"/yr. Thus, the minimum required wall thickness conservatively included a corrosion allowance of 0.012" prior to replacement activities. Further, an additional stress intensification factor of 2.1 was applied to ratio up the stresses because the overlay is applied to straight pipe and adjacent welds as directed by Code Case N-661-1, Section 3.2(c). The required thickness was determined by iteratively selecting a required minimum wall thickness (0.280"), which satisfied ANSI B31.1-73 code of record equations 11, 12 and 13. Once the minimum wall thickness was determined, the plate was sized to cover the entire thinned area, which would be thinner than the required wall thickness. The plate size was then conservatively increased by 1/2" in length and width to provide a +1/4" tolerance in covering the affected area. Attachment 3 includes a depiction of the area which is less than 0.280" thick and shows the placement of the repair plate in relation to the thinned area.

Pursuant to 10CFR50.55a(g)(6)(i), Entergy proposes to install a welded reinforcing plate over the degraded area with an attachment weld or weld overlay located in an area where the minimum wall thickness is 0.280" or greater (refer to Attachment 3). The attachment weld will be installed using the methodology of Code Case N-661-1 as described herein. Minor surface conditioning will be required on an original construction code weld in order to obtain as near as practical metal to metal contact between the reinforcing plate and existing base material. To keep the weld area dry and moisture from encroaching near the reinforcing plate weld, sealant will be utilized around and/or over the leakage location to form a leakage barrier.
