INTERIM REPORT ON THERMOSTATIC VALVE FAILURE ON PALO VERDE EDG

Report No. 10CFR21-0098

**10CFR21 REPORTING OF DEFECTS
AND NON-COMPLIANCE**

COMPONENT: Amot thermostatic valve element
P/N: 9760X

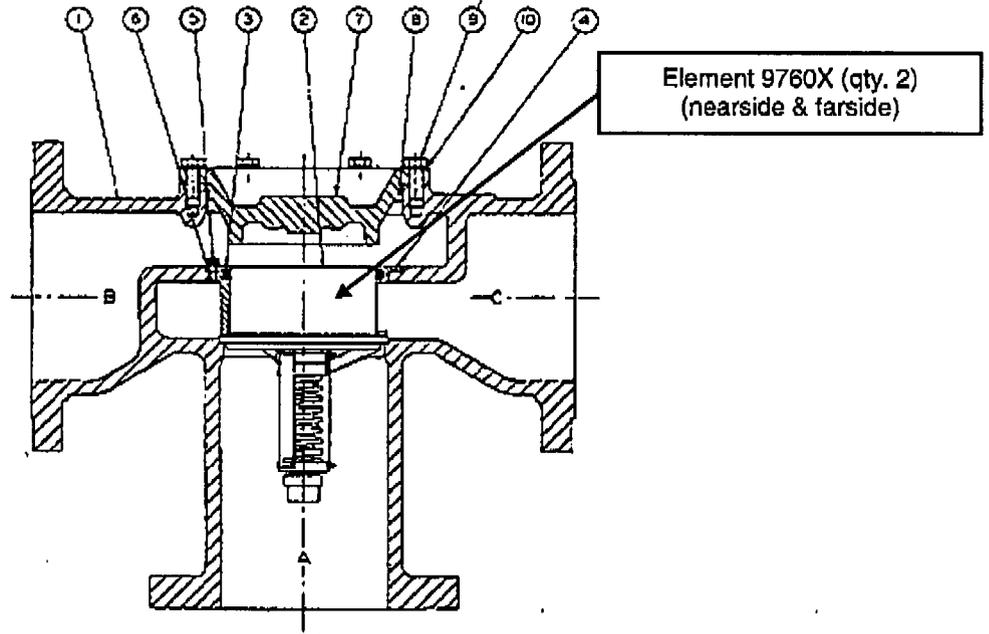
FIGURE 1: AMOT THERMOSTATIC VALVE

Each valve uses 2 thermostatic elements, Amot type 9760X (item 2 in Figure 1). The element being investigated for the Palo Verde application has a nominal temperature setting of 160°F and therefore the element part number is 9760X-160.

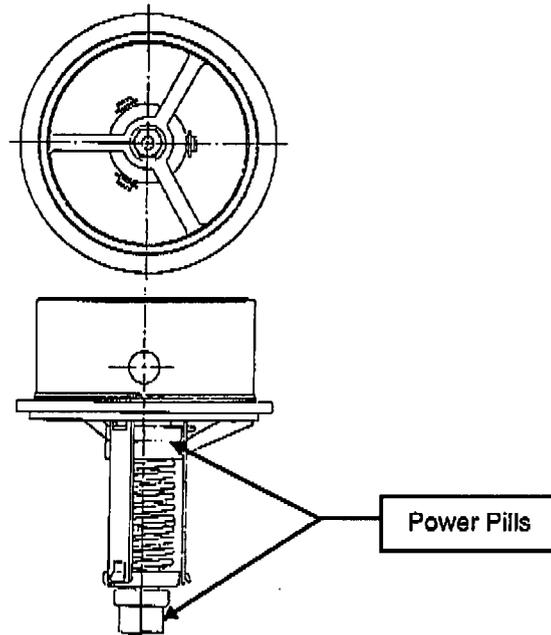
FIGURE 2: VALVE ELEMENT 9760X

The Palo Verde failure analysis determined that one of two elements within the valve was defective. The element failure was attributed to wax leakage past the diaphragm seal on one of two power pills within the element. Evidence of mechanical binding of the piston is believed to have caused the wax leakage. If the piston was jammed, the expanding wax could have over-pressurized the diaphragm seal leading to wax leakage. The failure analysis noted the following to support piston binding:

- The piston was initially difficult to remove from its guide tube.
- A gouge was observed on the piston surface.
- The rubber plug within the power pill exhibited brass machining chip debris.

- The primary cause of the failure is believed to be the gouge found in the pill stem. The gouge could have occurred during the conversion process as the stem is removed and handled at that time.

The 9760X element contains two power pills (Figure 2). The power pills contain a temperature sensitive wax that expands with increasing temperature and provides the motive force to lift the element off of its seat.

- As a precaution, Amot has made changes to their conversion process for this pill. The drilling fixture was modified to eliminate the possibility of chips entering the pill during the machining operation. This change was made effective 10/22/09.

The element failure at Palo Verde is considered to be an isolated incident related to a gouge in the pill stem. Thus, there is no recommended corrective action for users of the Amot 9760X element.

The evaluation also indicated a weakness in Amot's manufacturing process for the element pill which introduced machining debris. While not believed to be the cause of the Palo Verde element failure, machining debris within the element pill is undesirable and increases the potential for failure in the future. Users with thermostatic valves containing Amot P/N 9760X elements should be aware of this issue so that they can monitor their systems for any indications of thermostatic element problems.
