## EMD JACKET WATER PUMP WITH INCORRECT IMPELLER ORIENTATION

**Report No. 10CFR21-0100**

**10CFR21 REPORTING OF DEFECTS  
AND NON-COMPLIANCE**

COMPONENT: EMD water pumps

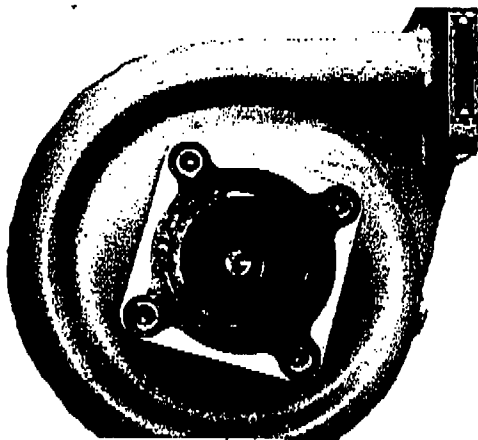
It was reported by Grand Gulf that "while troubleshooting low Div III DJ jacket water pressure it was discovered that the wrong impeller was supplied in the P81C007A pump. The supplied impeller was intended to rotate in the opposite direction as the pump rotation. This appears to be the cause of low jacket water pressure in the A engine."

Subsequently, the water pump was returned to ESI for further inspection. It was apparent from a visual inspection that the incorrect impeller was installed for this pump. P/N 8324589 corresponds to a right hand rotation, left bank water pump for use on a 12-cylinder EMD 645E4 or E4B engine. As shown in Photos 1 and 2 below, the housing corresponds to a right hand rotation pump, but the impeller is for left hand rotation. Figure 3 shows the correct impeller for a right hand rotation pump.

**Photo 1:** Water Pump Returned by Customer (note impeller fin orientation)

ESI recommends that as a precaution, all customers with an EMD water pump in stock which was supplied by ESI prior to April 2000 should perform a visual inspection to ensure the correct impeller is installed. A pump which has been installed on the diesel engine is considered acceptable based on successful operation of the diesel engine. The impeller inspection is easily performed, without disassembly, by looking into the inlet port of the pump to confirm the orientation of the impeller matches the pump housing. A listing of the various part numbers supplied prior to April 2000 is included in Table 1. Figures 4 and 5 contain visual guidance to ensure the impeller corresponds to the installed pump housing.

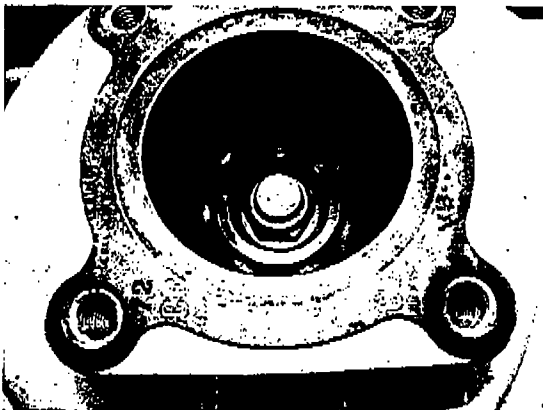
**Photo 2:** Close-up of Water Pump (note impeller fin orientation)
