SUBJECT: PUBLIC MEETING SUMMARY– REGULATORY CONFERENCE FOR
BROWNS FERRY NUCLEAR PLANT, DOCKET NO. 50-259

**TENNESSEE VALLEY AUTHORITY
BROWNS FERRY NUCLEAR PLANT, UNIT 1**

**Low Pressure Coolant Injection Valve
1-FCV-74-66**

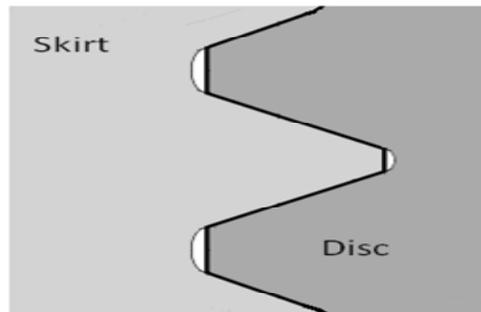
As-Designed Thread

- The valve was purchased as an assembly that would not be taken apart to perform receipt inspections
 - Undersized skirt thread diameter caused the threaded connection between disc and skirt to be 38 percent of design strength

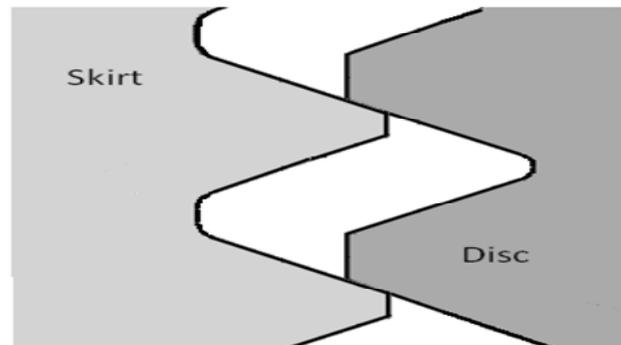
As-Found Thread

- Disassembly of the valve revealed the disc separated from the stem and lodged in the seat
- The disc separation from the stem resulted from an original manufacturing defect, undersized threads in the disc skirt/disc assembly

- Short-term corrective actions
 - Repaired valve 1-FCV-74-66
 - Verified discs attached in all like valves, with tack welds intact and in good condition
 - Implemented controls limiting back-pressure on valves
- Long-term corrective actions
 - Restore or repair valve skirts to address potential undersized thread issue

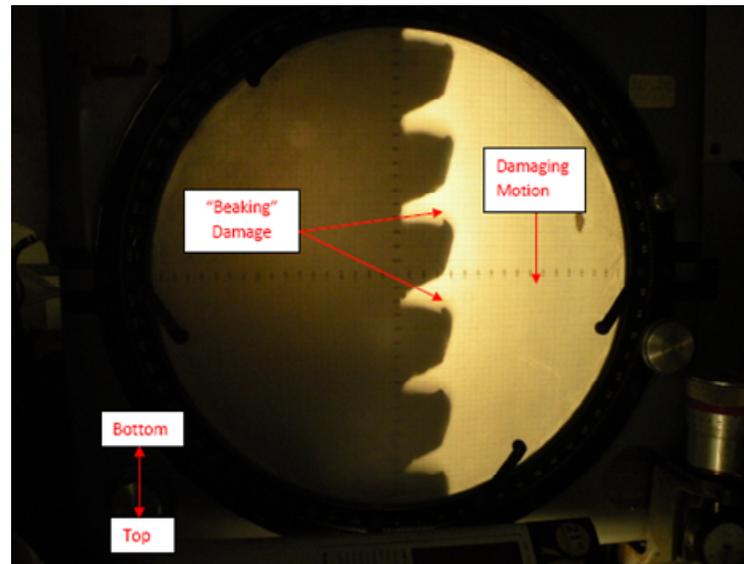
Optical Comparator Image of Damaged Threads

Forensic examination found axial damage on the threaded connection between disc and skirt

- Pressure on skirt/stem side of disc due to downstream check valve leakage and surveillance testing configuration
 - Tack welds designed to prevent rotational, not axial separation

- Stem and skirt pulled away from disc in open direction
- Disc was initially separated from stem/skirt before November 2008, based on Motor-Operated Valve Actuator Testing (MOVAT) data review and forensic examination

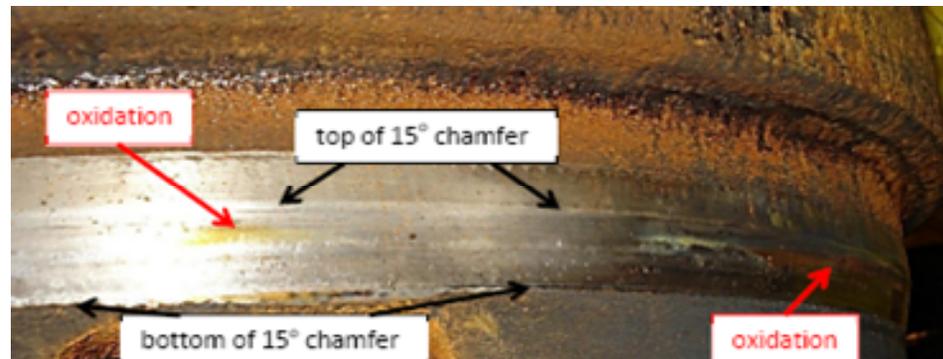
74-66 valve disc contacting surface immediately after removal (11/2/10)

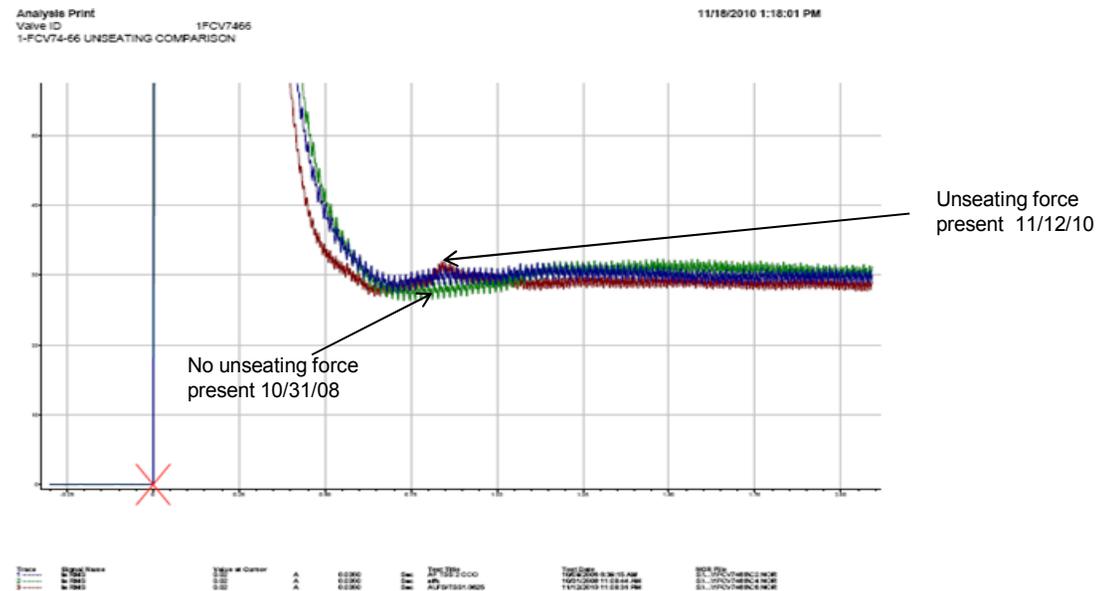
Review of MOVAT testing data, combined with stellite aging research, strongly indicates that the disc separated prior to November 2008

Note: Blue trace is 2006 data for newly lapped seating surfaces – no aged stellite.
