ENGINE SYSTEMS, INC.

Subject: 10CFR21 Reporting of Defects and Non-Compliance -
Engine Systems, Inc. Report No. 10CFR21-0098, Rev. 1

Amot Thermostatic Valve Element
P/N: 9760X

10CFR21 REPORTING OF DEFECTS AND NON-COMPLIANCE

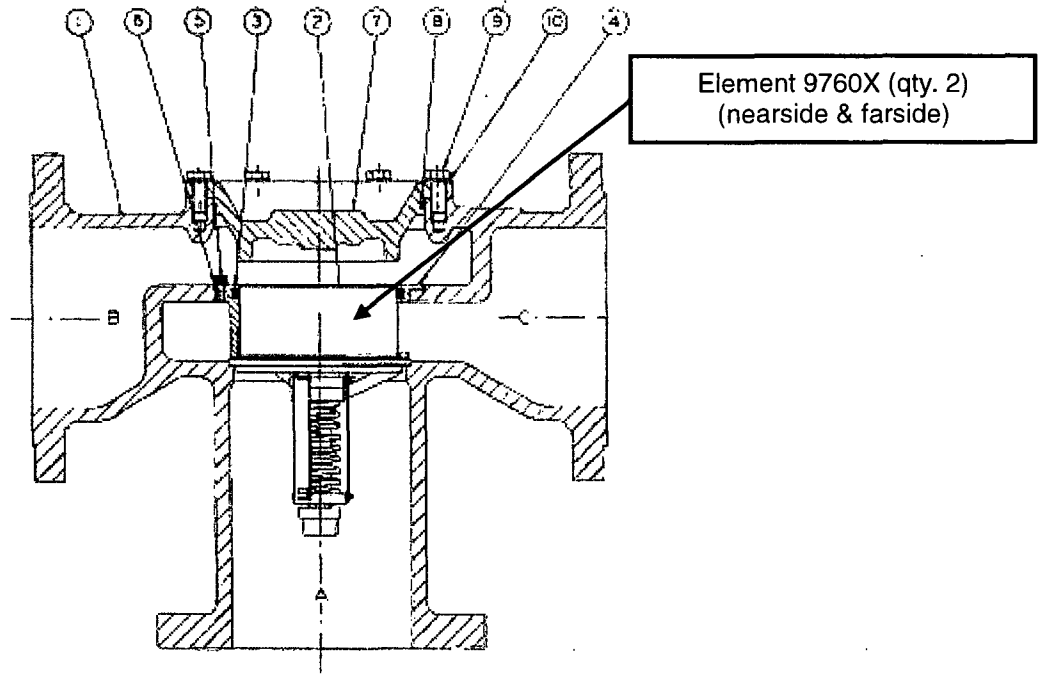
FIGURE 1: AMOT THERMOSTATIC VALVE

Each valve uses 2 thermostatic elements, Amot type 9760X (item 2 in Figure 1). The element being investigated for the Palo Verde application has a nominal temperature setting of 160°F and therefore the element part number is 9760X-160.

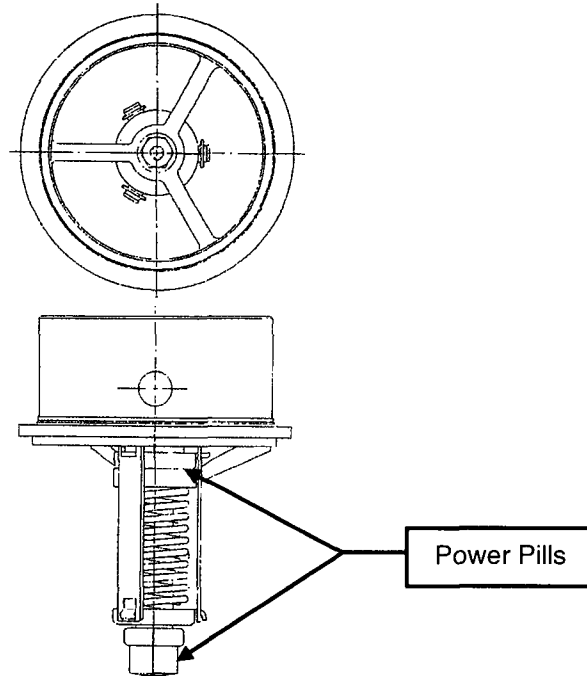
FIGURE 2: VALVE ELEMENT 9760X

The Palo Verde failure analysis determined that one of two elements within the valve was defective. The element failure was attributed to wax leakage past the diaphragm seal on one of two power pills within the element. Evidence of mechanical binding of the piston is believed to have caused the wax leakage. If the piston was jammed, the expanding wax could have over-pressurized the diaphragm seal leading to wax leakage. The failure analysis noted the following to support piston binding:

- The primary cause of the failure is believed to be the gouge found in the pill stem. The gouge could have occurred during the conversion process as the stem is removed and handled at that time.

The 9760X element contains two power pills (Figure 2). The power pills contain a temperature sensitive wax that expands with increasing temperature and provides the motive force to lift the element off of its seat.

- As a precaution, Amot has made changes to their conversion process for this pill. The drilling fixture was modified to eliminate the possibility of chips entering the pill during the machining operation. This change was made effective 10/22/09.

The element failure at Palo Verde is considered to be an isolated incident related to a gouge in the pill stem. Thus, there is no recommended corrective action for users of the Amot 9760X element.
