Subject: 10CFR21 Reporting of Defects and Non-Compliance -  
Engine Systems, Inc. Report No. 10CFR21-0100, Rev. 1

EMD Water Pump, P/N 8324589

**Report No. 10CFR21-0100**

COMPONENT: EMD water pumps

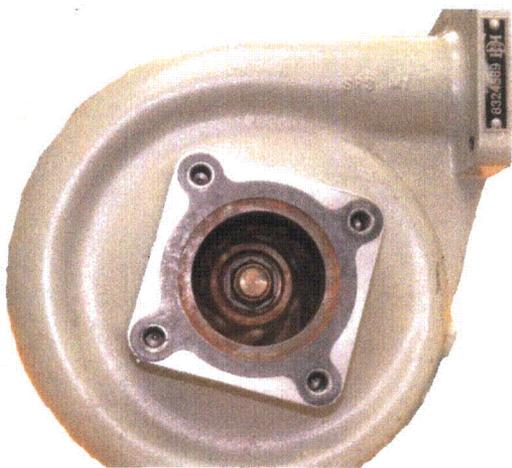
It was reported by Grand Gulf that “while troubleshooting low Div III DJ jacket water pressure it was discovered that the wrong impeller was supplied in the P81C007A pump. The supplied impeller was intended to rotate in the opposite direction as the pump rotation. This appears to be the cause of low jacket water pressure in the A engine.”

Subsequently, the water pump was returned to ESI for further inspection. It was apparent from a visual inspection that the incorrect impeller was installed for this pump. P/N 8324589 corresponds to a right hand rotation, left bank water pump for use on a 12-cylinder EMD 645E4 or E4B engine. As shown in Photos 1 and 2 below, the housing corresponds to a right hand rotation pump, but the impeller is for left hand rotation. Figure 3 shows the correct impeller for a right hand rotation pump.

**Photo 1:** Water Pump Returned by Customer (note impeller fin orientation)

ESI recommends that as a precaution, all customers with an EMD water pump in stock which was supplied by ESI prior to April 2000 should perform a visual inspection to ensure the correct impeller is installed. A pump which has been installed on the diesel engine is considered acceptable based on successful operation of the diesel engine. The impeller inspection is easily performed, without disassembly, by looking into the inlet port of the pump to confirm the orientation of the impeller matches the pump housing. A listing of the various part numbers supplied prior to April 2000 is included in Table 1. Figures 4 and 5 contain visual guidance to ensure the impeller corresponds to the installed pump housing.

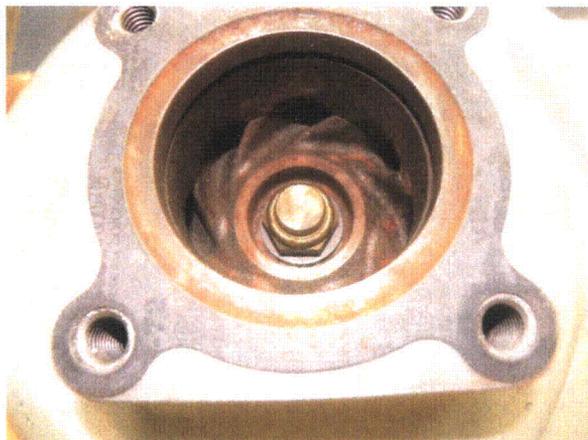
**Photo 2:** Close-up of Water Pump (note impeller fin orientation)

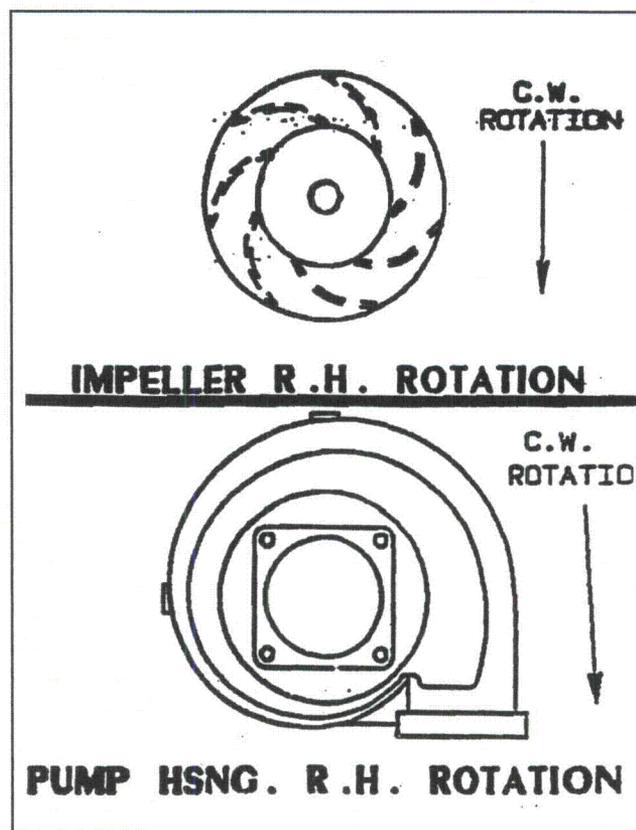
**Figure 3:** Correct Housing and Fin Orientation for RH Rotation

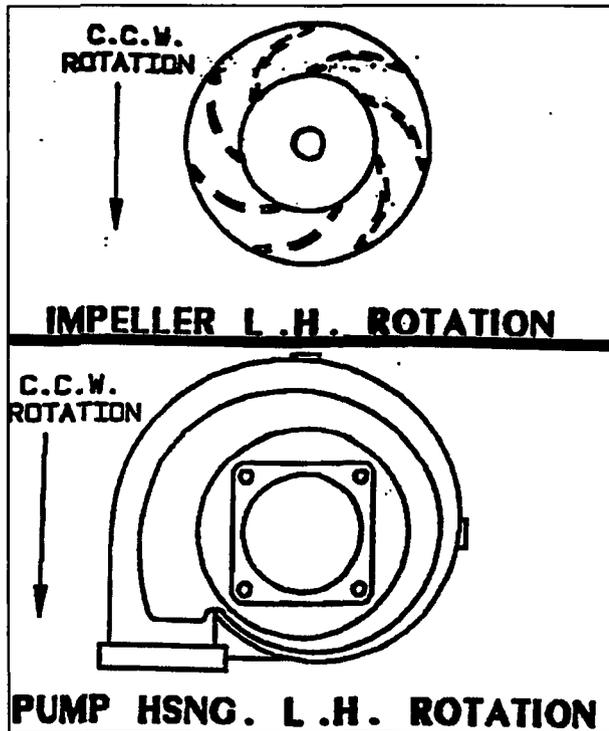
**Figure 4:** Correct Housing and Fin Orientation for LH Rotation

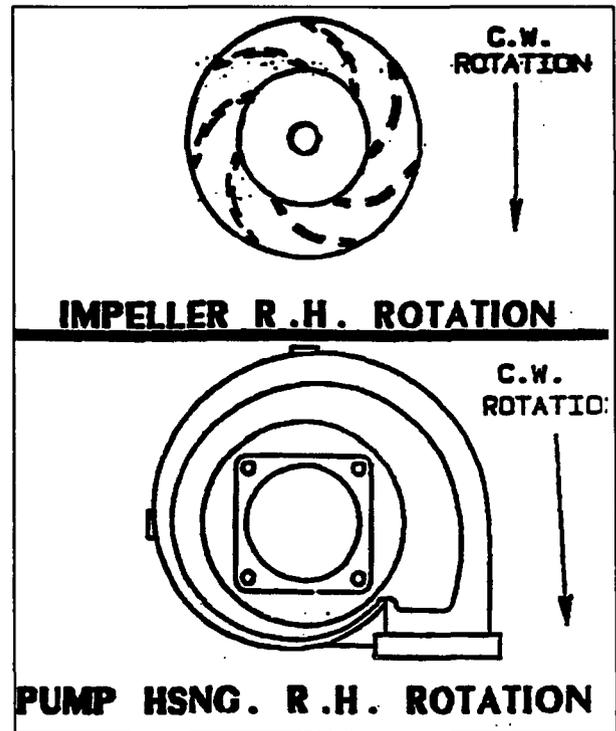
**Figure 5:** Correct Housing and Fin Orientation for RH Rotation
