RE: North Butte ISL Operation, Permit No. 632

ANNUAL INSPECTION REPORT

SUBJECT: Cameco Resources' North Butte Project

DATE OF INSPECTION: March 16, 2011

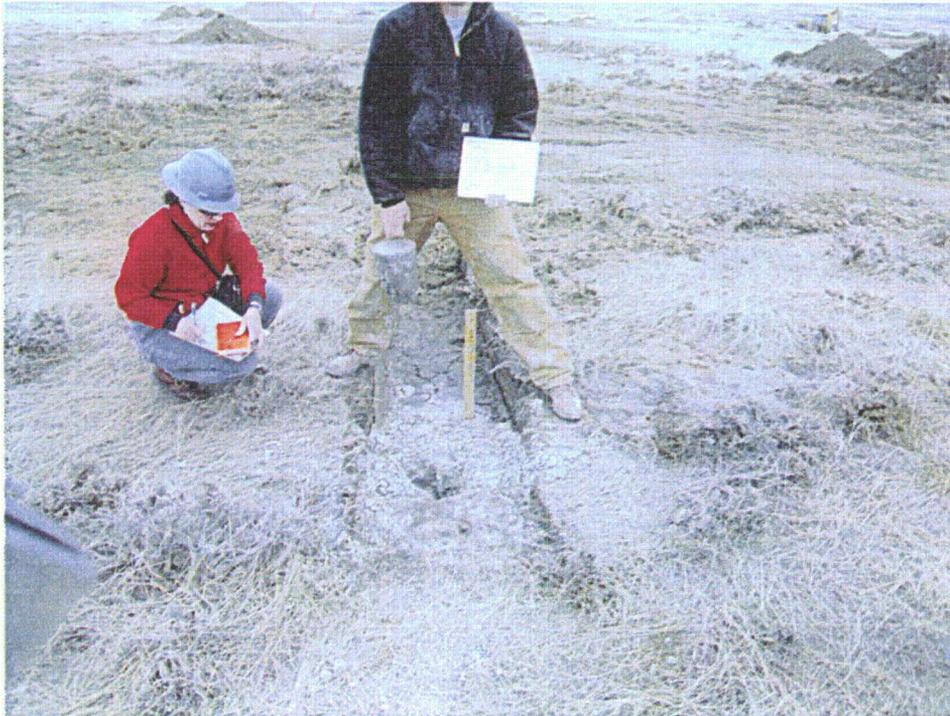
Photo No. 1

Looking southward at Drillhole No. 13-491 which has been filled with hydrated bentonite chips and covered with a temporary cap, concrete in this case. Later, additional chips will be added, the hole enlarged down to a depth of 2 feet, a permanent concrete cap installed and the area around the hole backfilled. The mudpit in the background has already been backfilled.

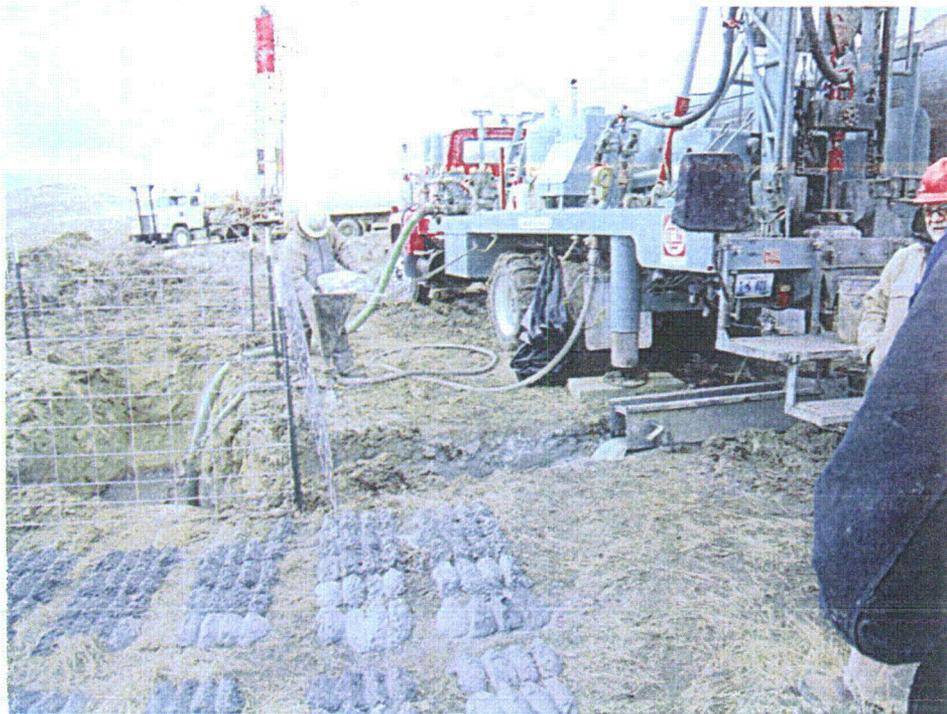
Photo No. 2

Currently, drilling is proceeding on 200 holes. Drilling is carried out using bentonite-based drilling mud. Then, once the hole has reached its planned depth, abandonment mud or plug gel is added to the mud in the mud pit and circulated through the total depth of the hole (Photo No. 2). The mud is added until the viscosity reaches the point where it takes sixty seconds to pass through a Marsh funnel. Following that, the hole is logged. A temporary metal cap is placed on the top of the hole and the mud column allowed to settle (Photo No. 1). Following settling, the metal cap is set aside and bentonite chips trickled down the hole. The cap is replaced and the chips allowed to hydrate. If it is found later that the mud and bentonite column has settled further, more chips are added. Then the top of the hole is enlarged down to a depth of two feet below the ground surface and a permanent concrete cap is inserted. Subsoil and topsoil are then spread over the hole area and on the nearby mudpit, if it has not already been backfilled and retopsoiled. The location is then drill-seeded (Photos Nos. 4, 5 and 6).

One of the drill rigs in action where abandonment mud is being added to the drilling mud to give it the desired consistency prior to the hole being logged. The gray cuttings piles indicate this hole has been drilled on the reduced side of the roll-front.

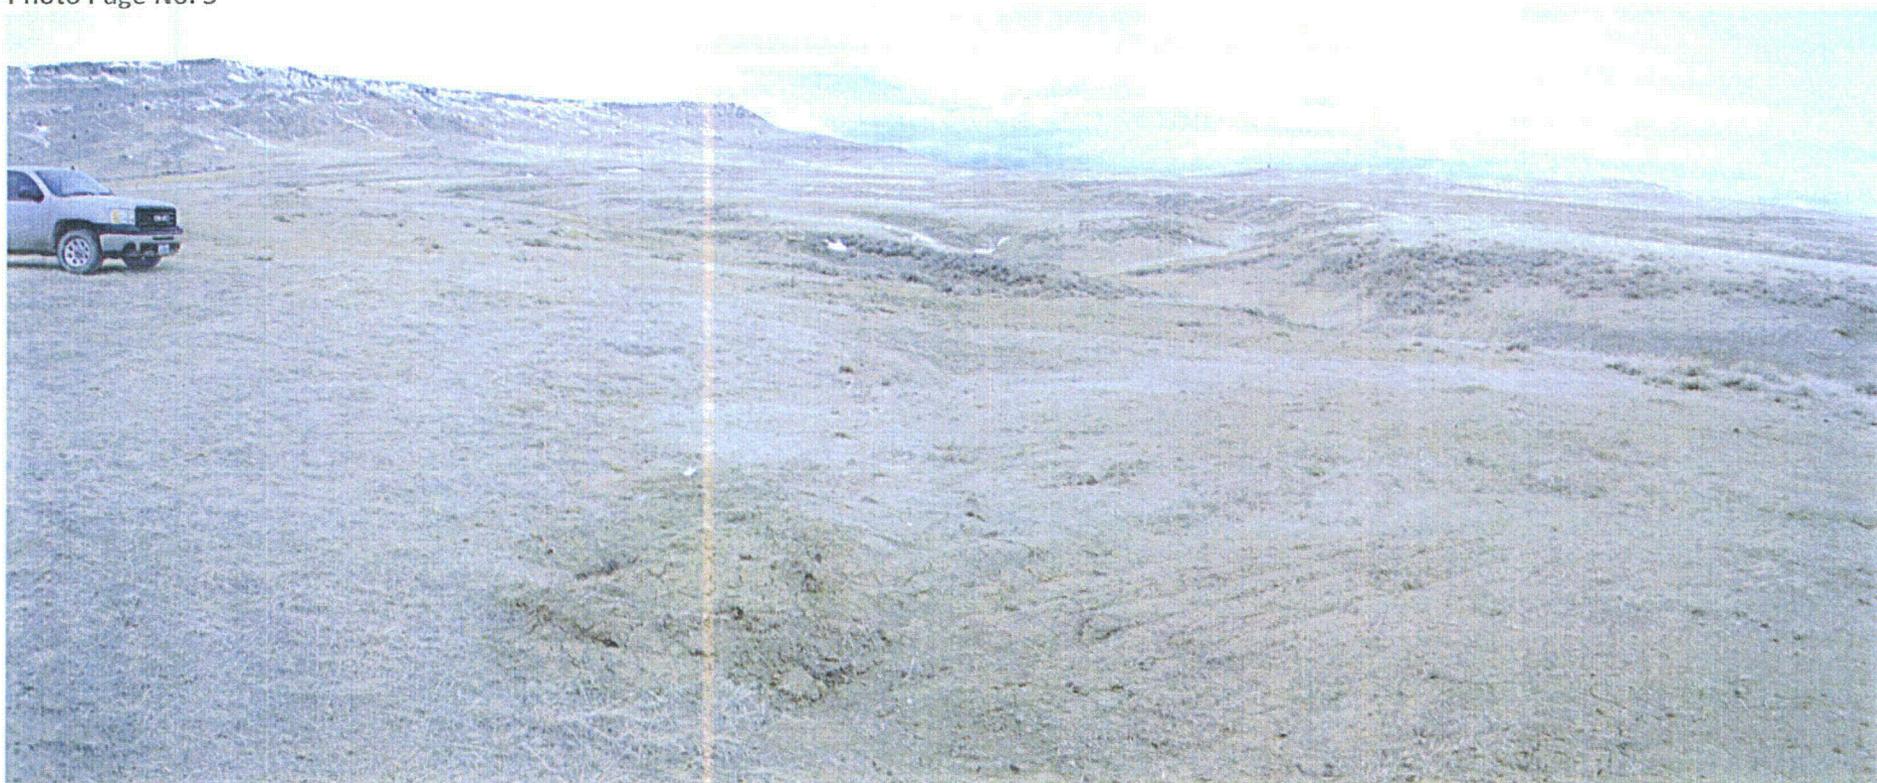
One potential problem noted was that a couple of locations were found where the drill seeding had not been seeded on the contour with the drill tracks running up and down the slope. Experience has found that the grass sprouting in tracks oriented this way is not nearly as effective at retarding erosion as that seeded on the contour.

Photo No. 4 Looking north at sealed drill hole and backfilled and seeded mudpit. In this case the area was not drill-seeded on the contour. Most all other seeding was done on the contour, the preferred method. North Pumpkin Butte is visible in the left distance.

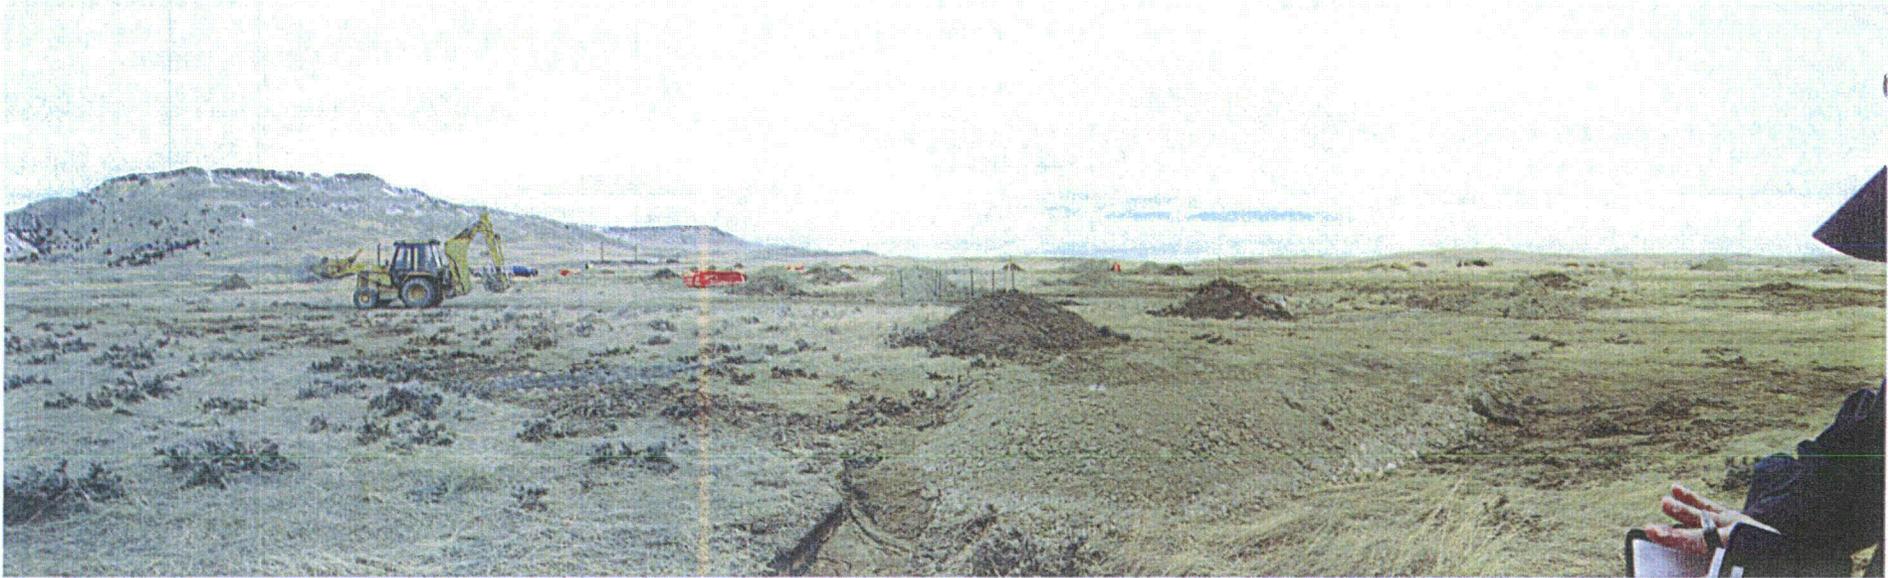
Historically, the property was drilled in lines of 50 holes on fences (rows) 200 feet apart (Photo No. 3). Now the well field areas are being drilled on a 100'X100' pattern. With four drill rigs running, they expect to complete drilling in Mine Unit 2 by July or August of this year.

Photo No. 3 Looking north to east across future Mine Unit No. 1 where delineation or infill drilling has been completed and drill holes and mud pits are in different stages of sealing and reclamation.

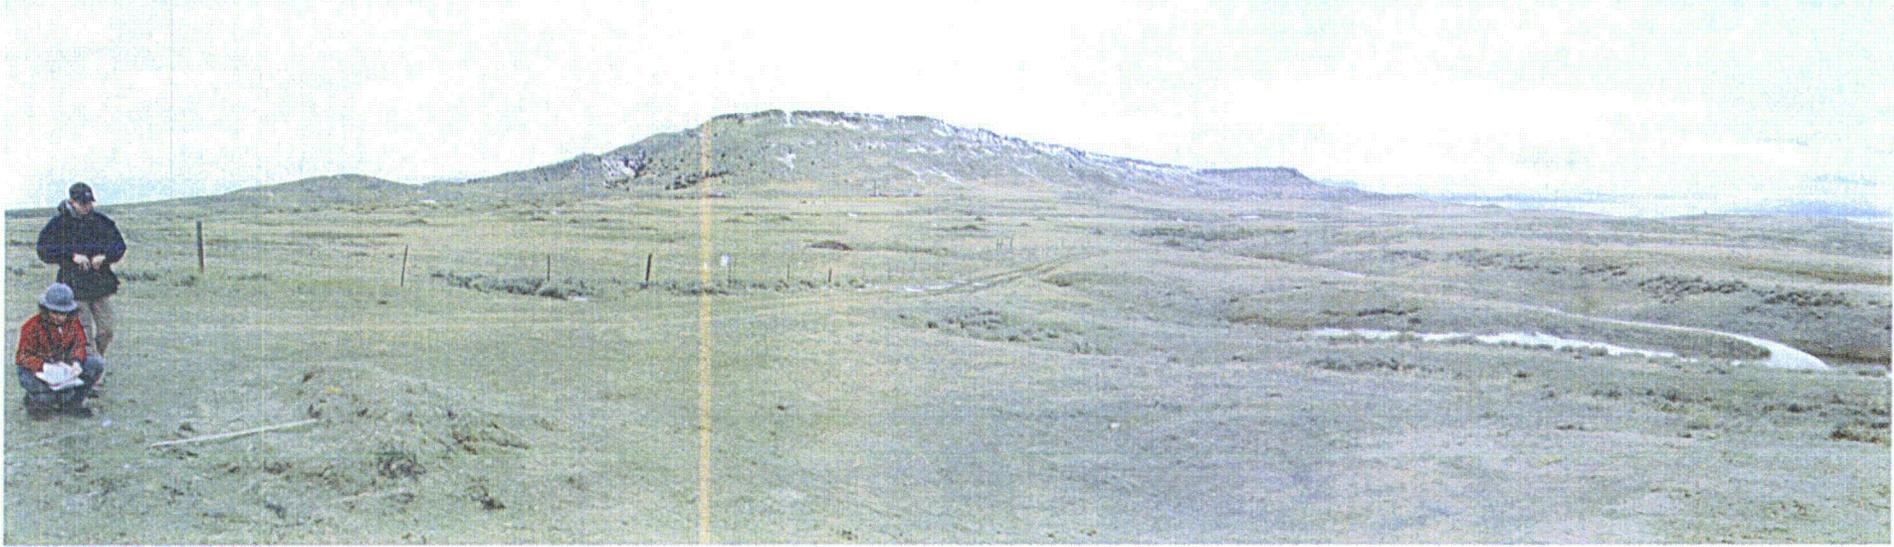
Photo No. 5 Looking north-northwest at reclaimed drill hole in south end of Mine Unit 1.

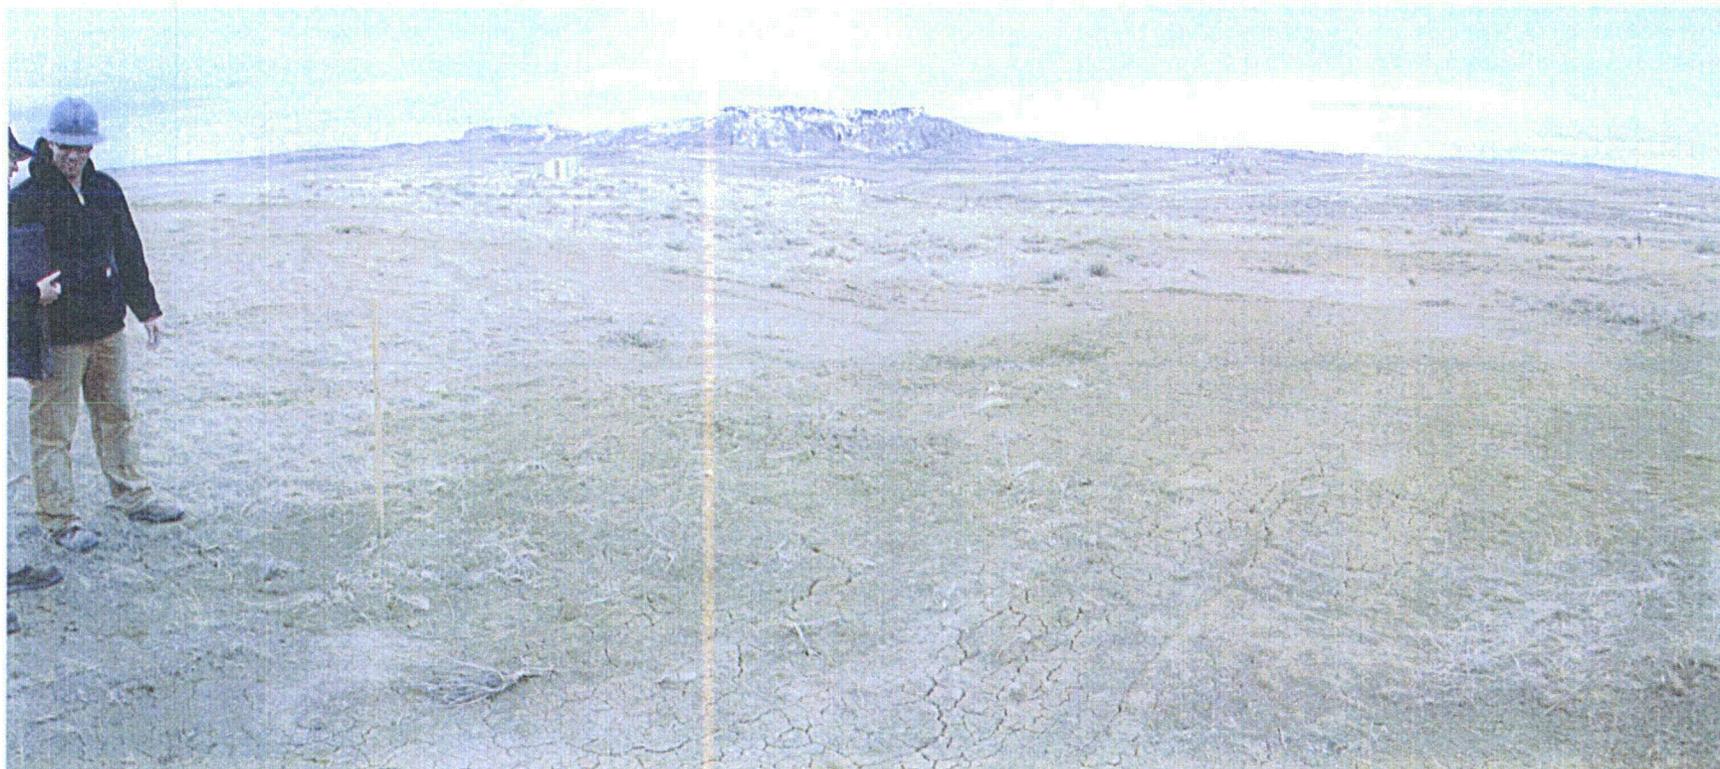
Photo No. 6 Looking south at reclaimed drill hole 19-336 in Mine Unit 1.
