Communication Plan  
Waterford 3 Steam Generator Inspection  
Scheduled for Refueling Outage 17  
(April 6, 2011 through May 5, 2011)

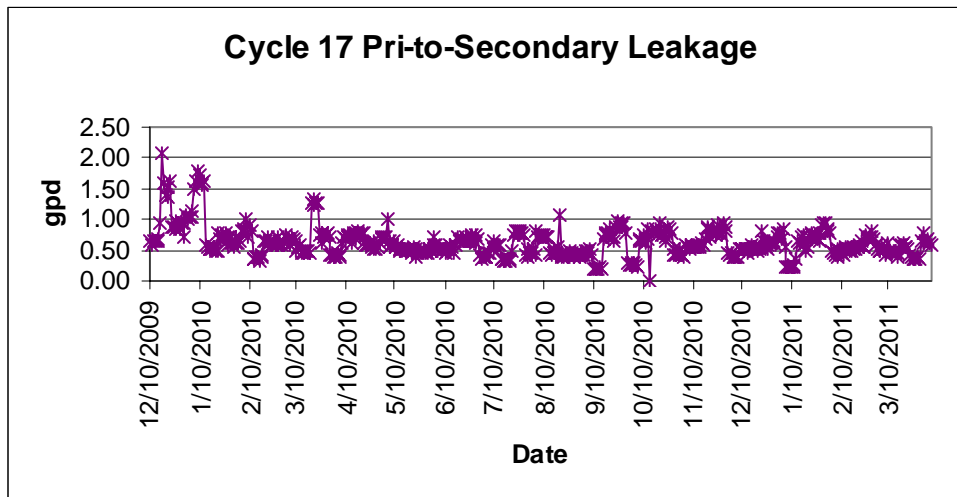
A graph of the primary-to-secondary leakage for Cycle 17 is shown below:

Primary to secondary Leakage has remained below 2 gpd for the entire cycle. Primary to secondary leakage has remained less than 1 gpd for the last 12 months.
