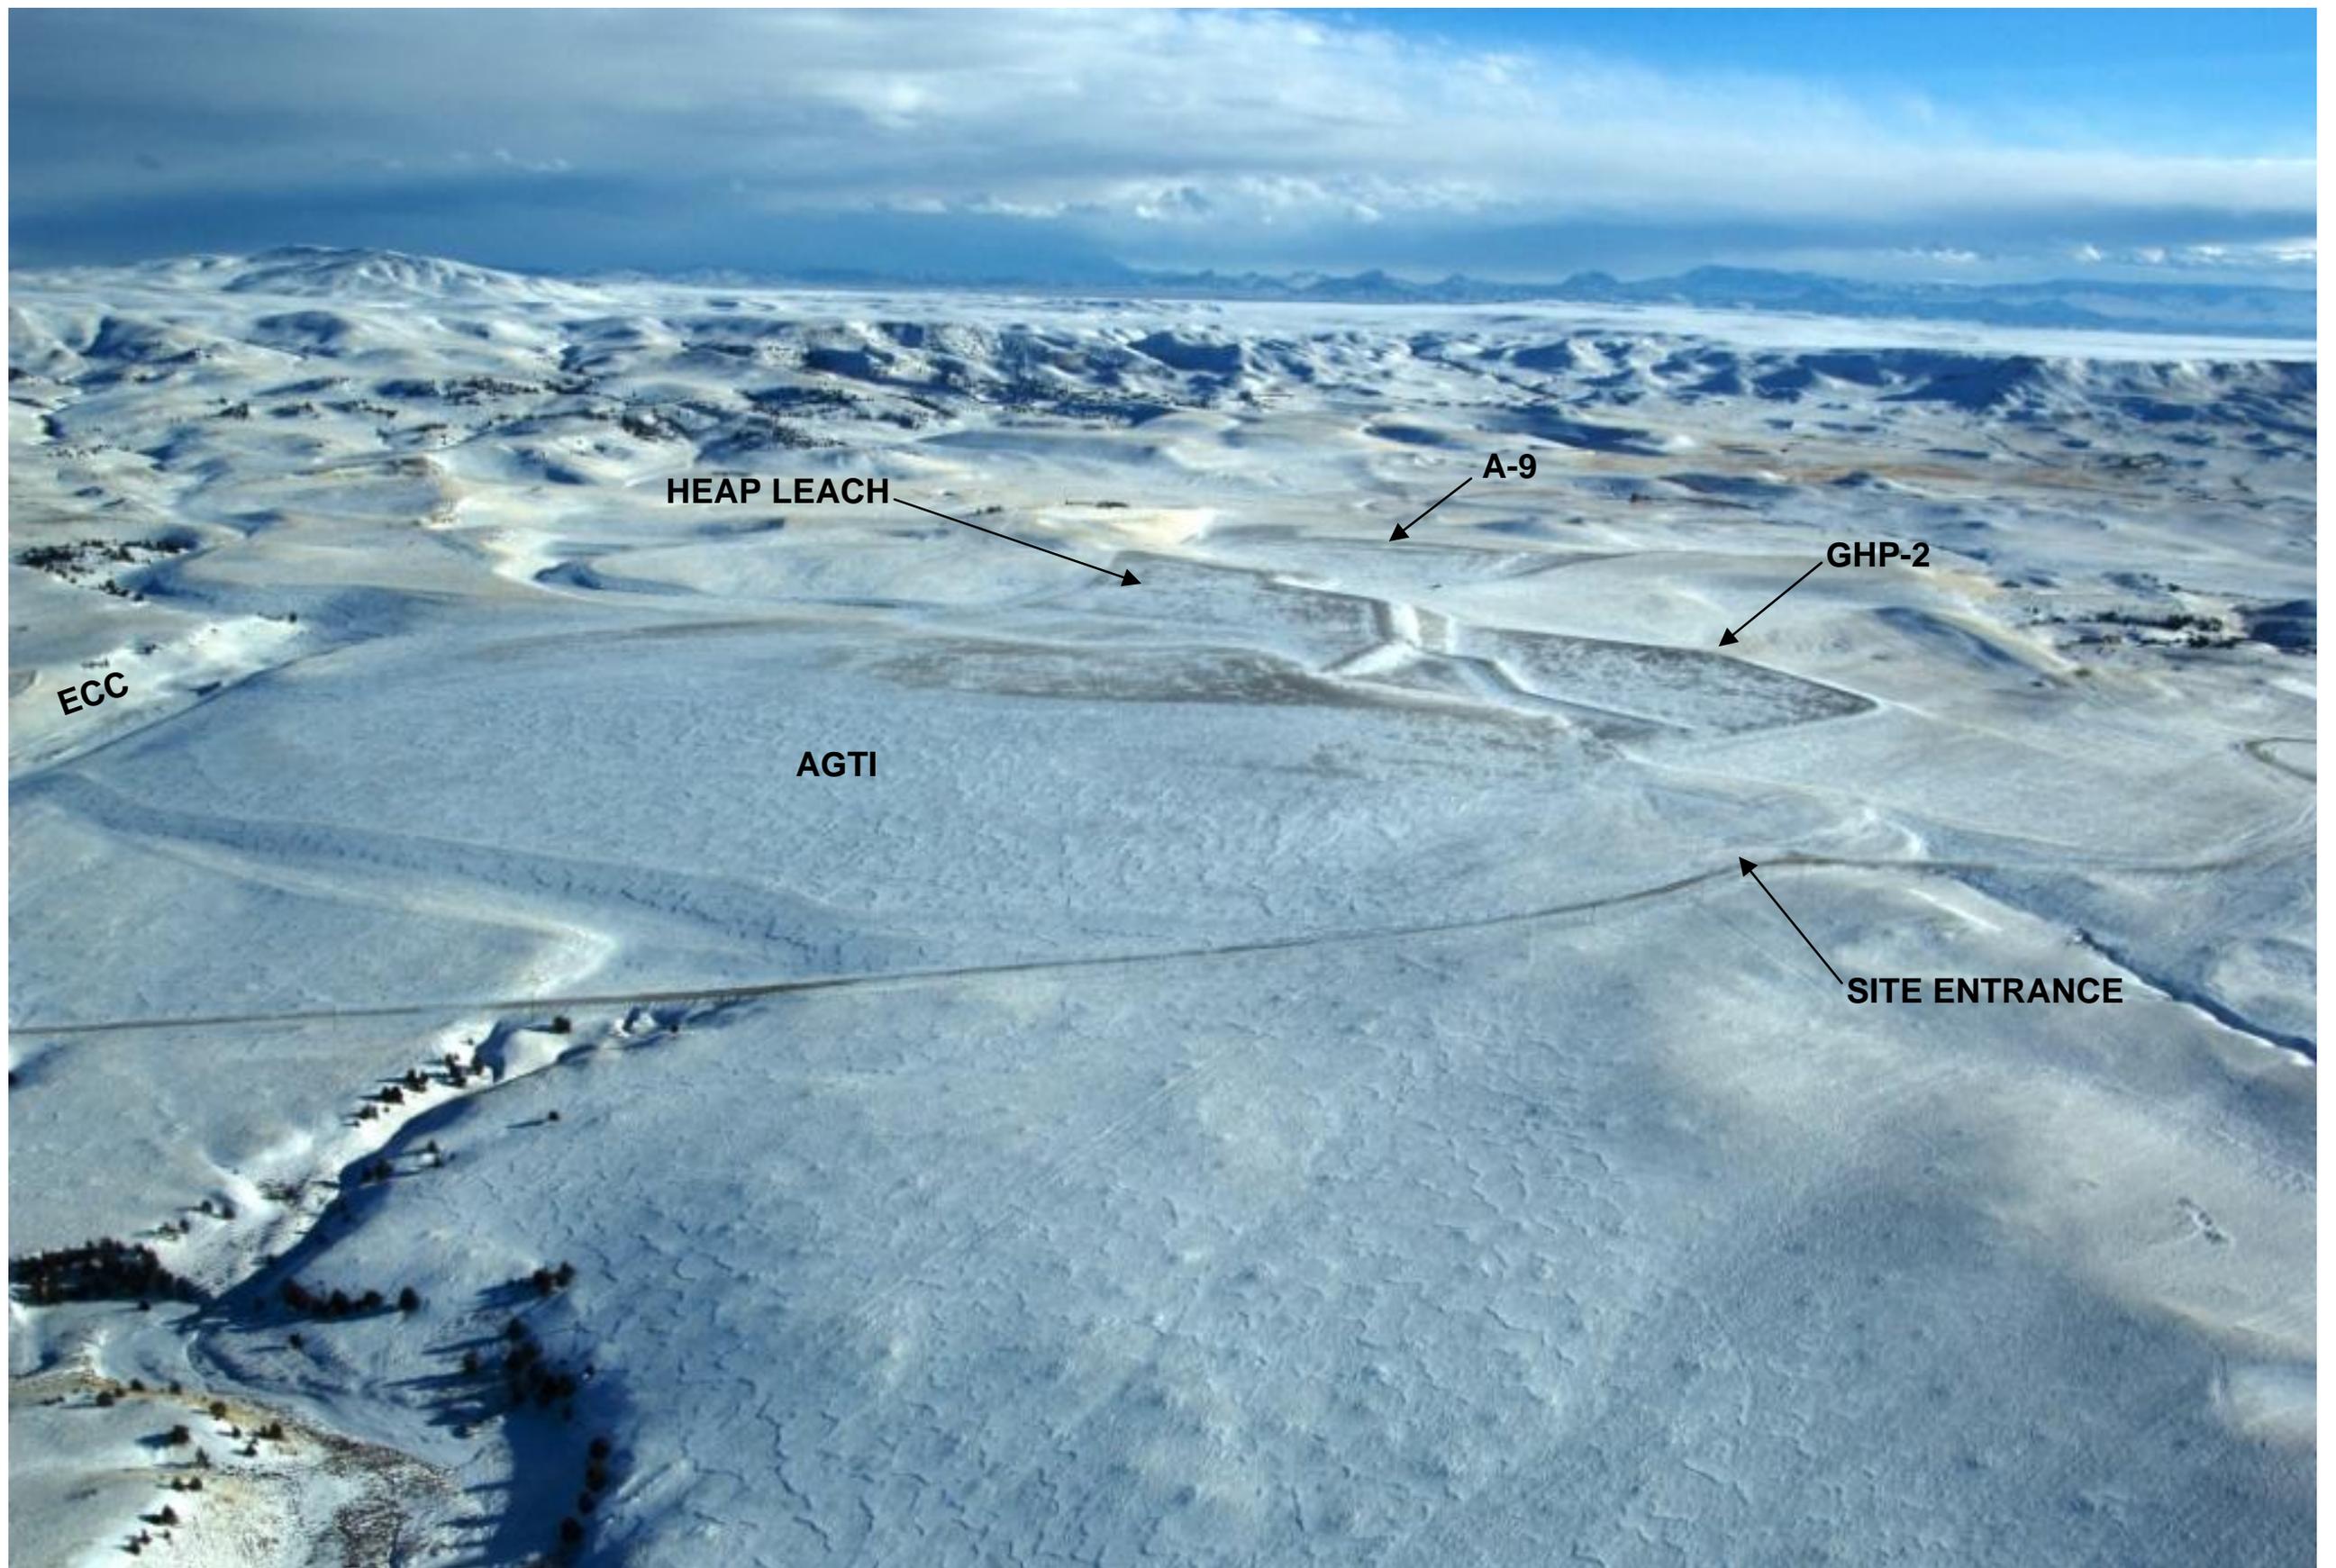
Overall view looking southwest of the Gas Hills Site. Note the Above Grade Tailings Impoundment (AGTI) in the center, East Canyon Creek (ECC) left side and the A-9 Repository center background. It appears snow begins to accumulate at the transition between Type A and Type B riprap on the top of the AGTI. 2/22/2011

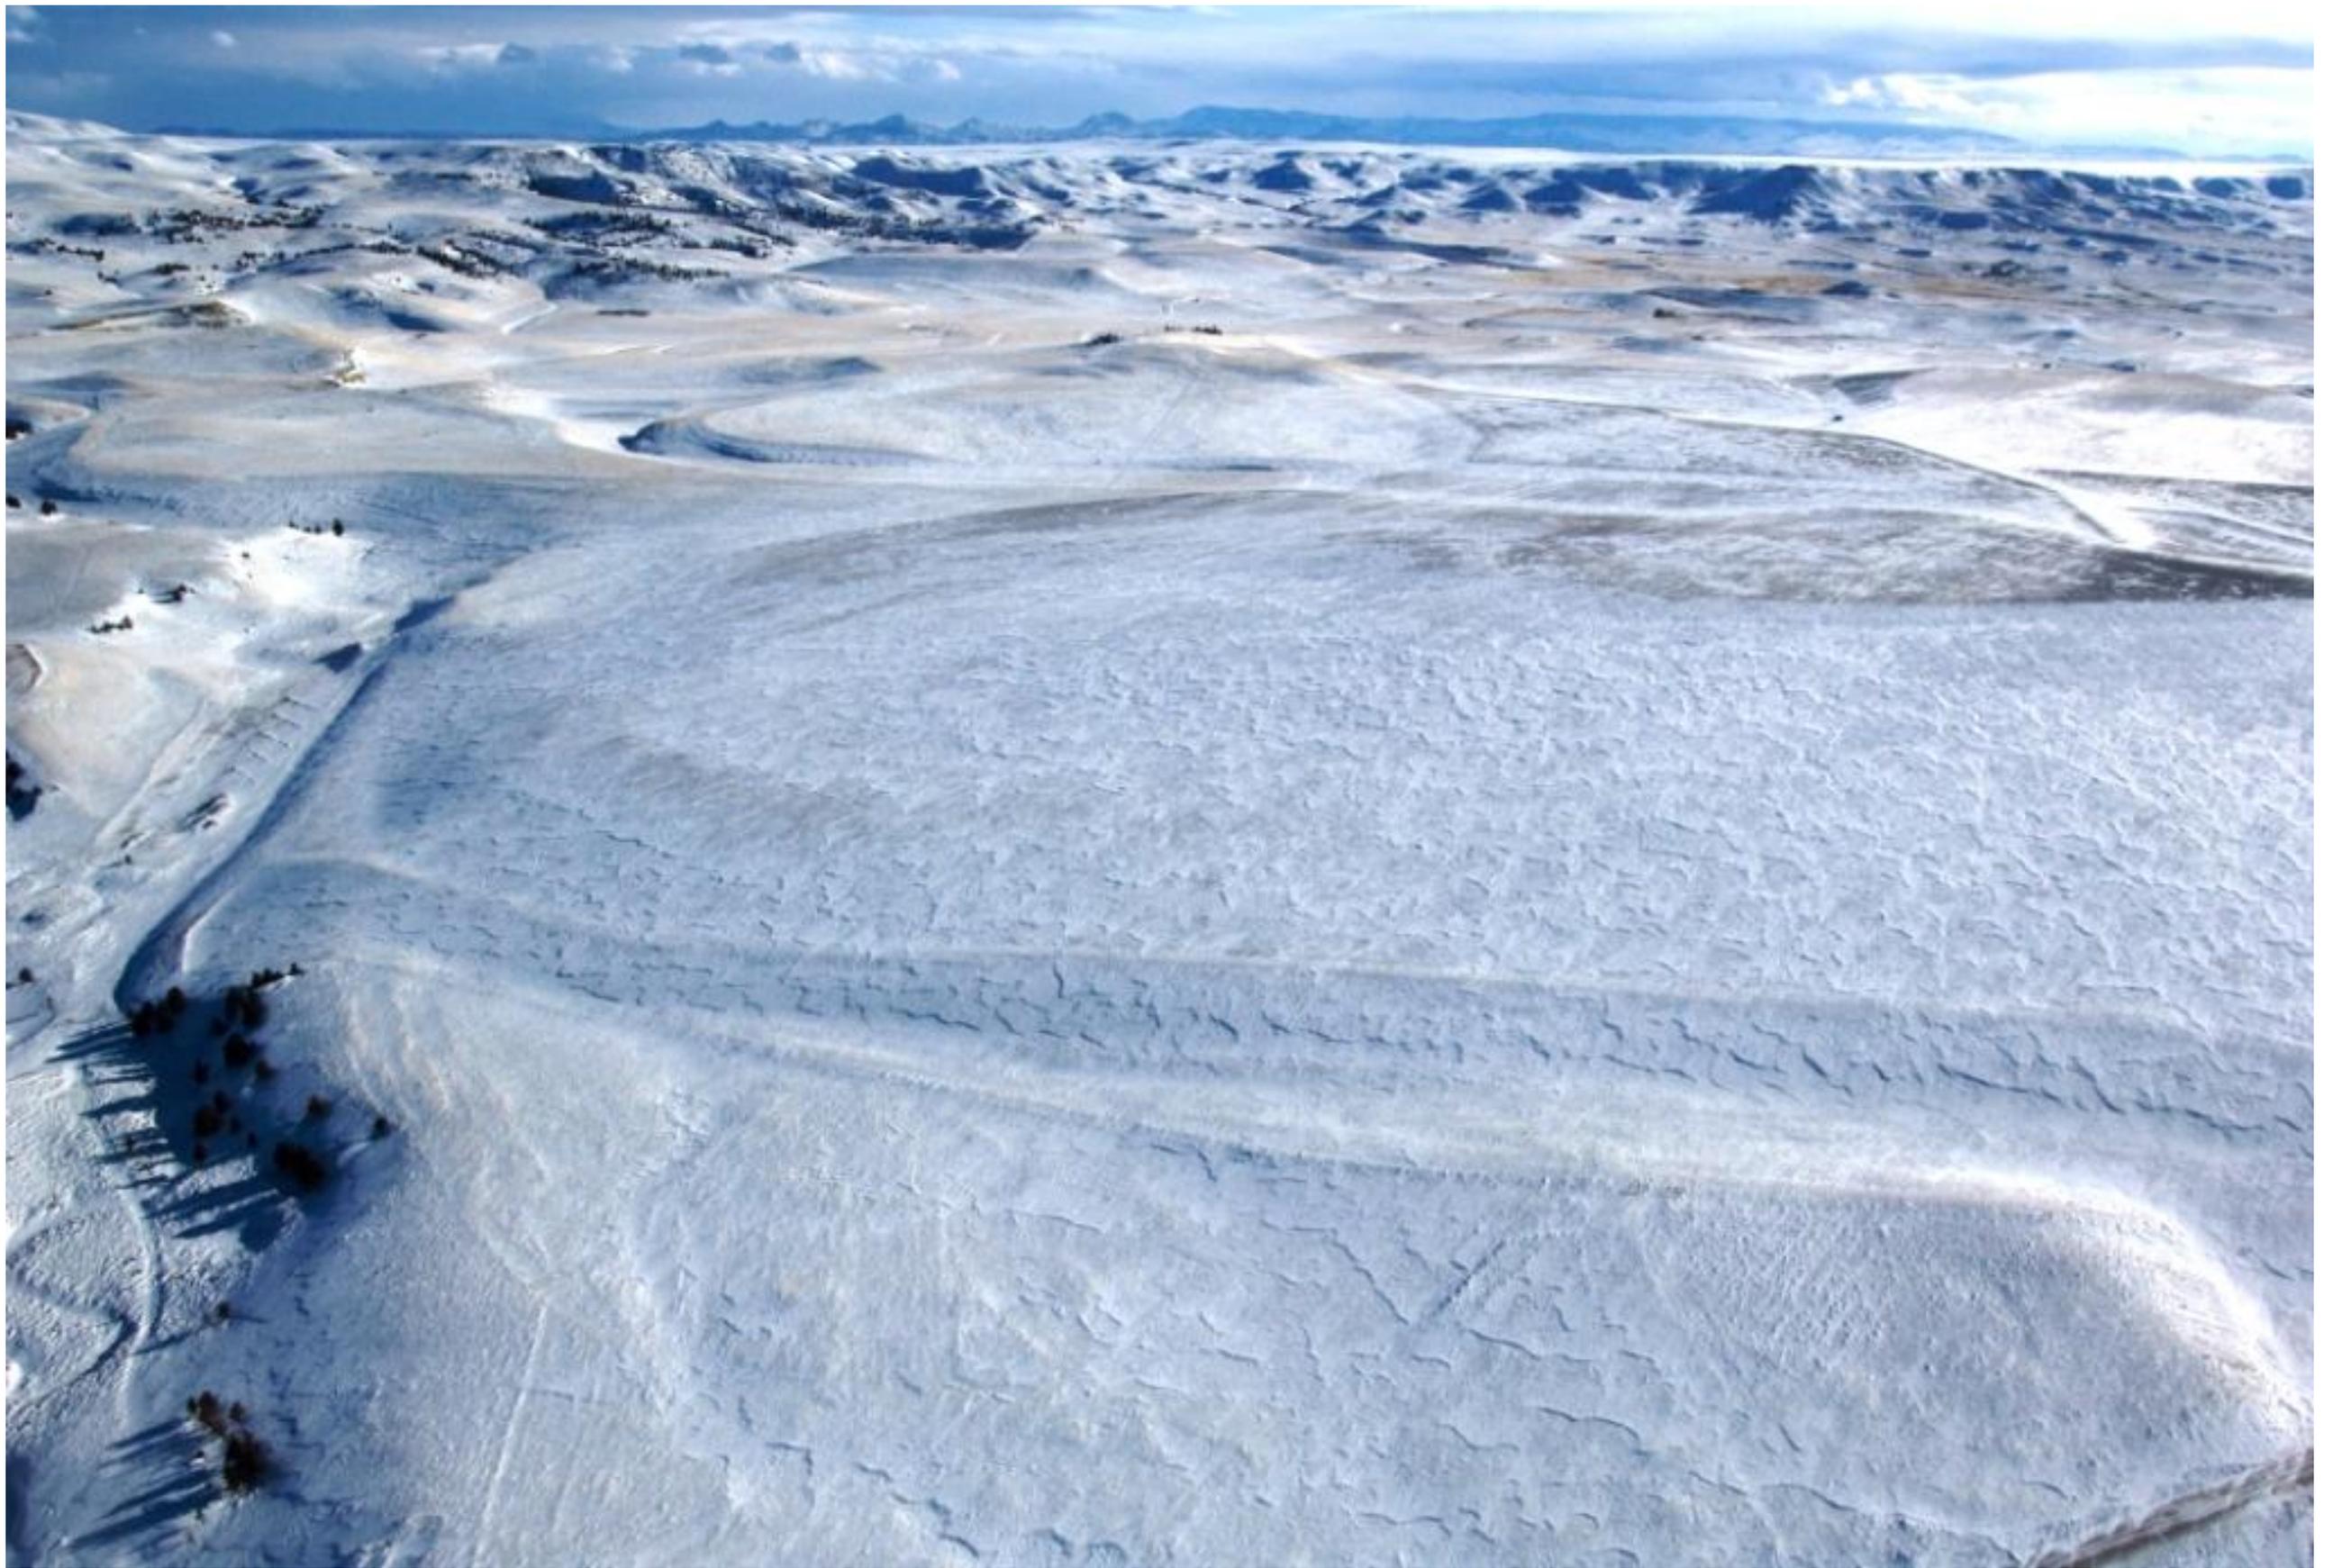
View of the AGTI looking south of the north facing slope. Note East Canyon Creek / Launch Rock on left side of the photo. The linear slope change running along the bottom of the slope depicts the end of the Type C riprap and transition to natural ground. 2/22/2011

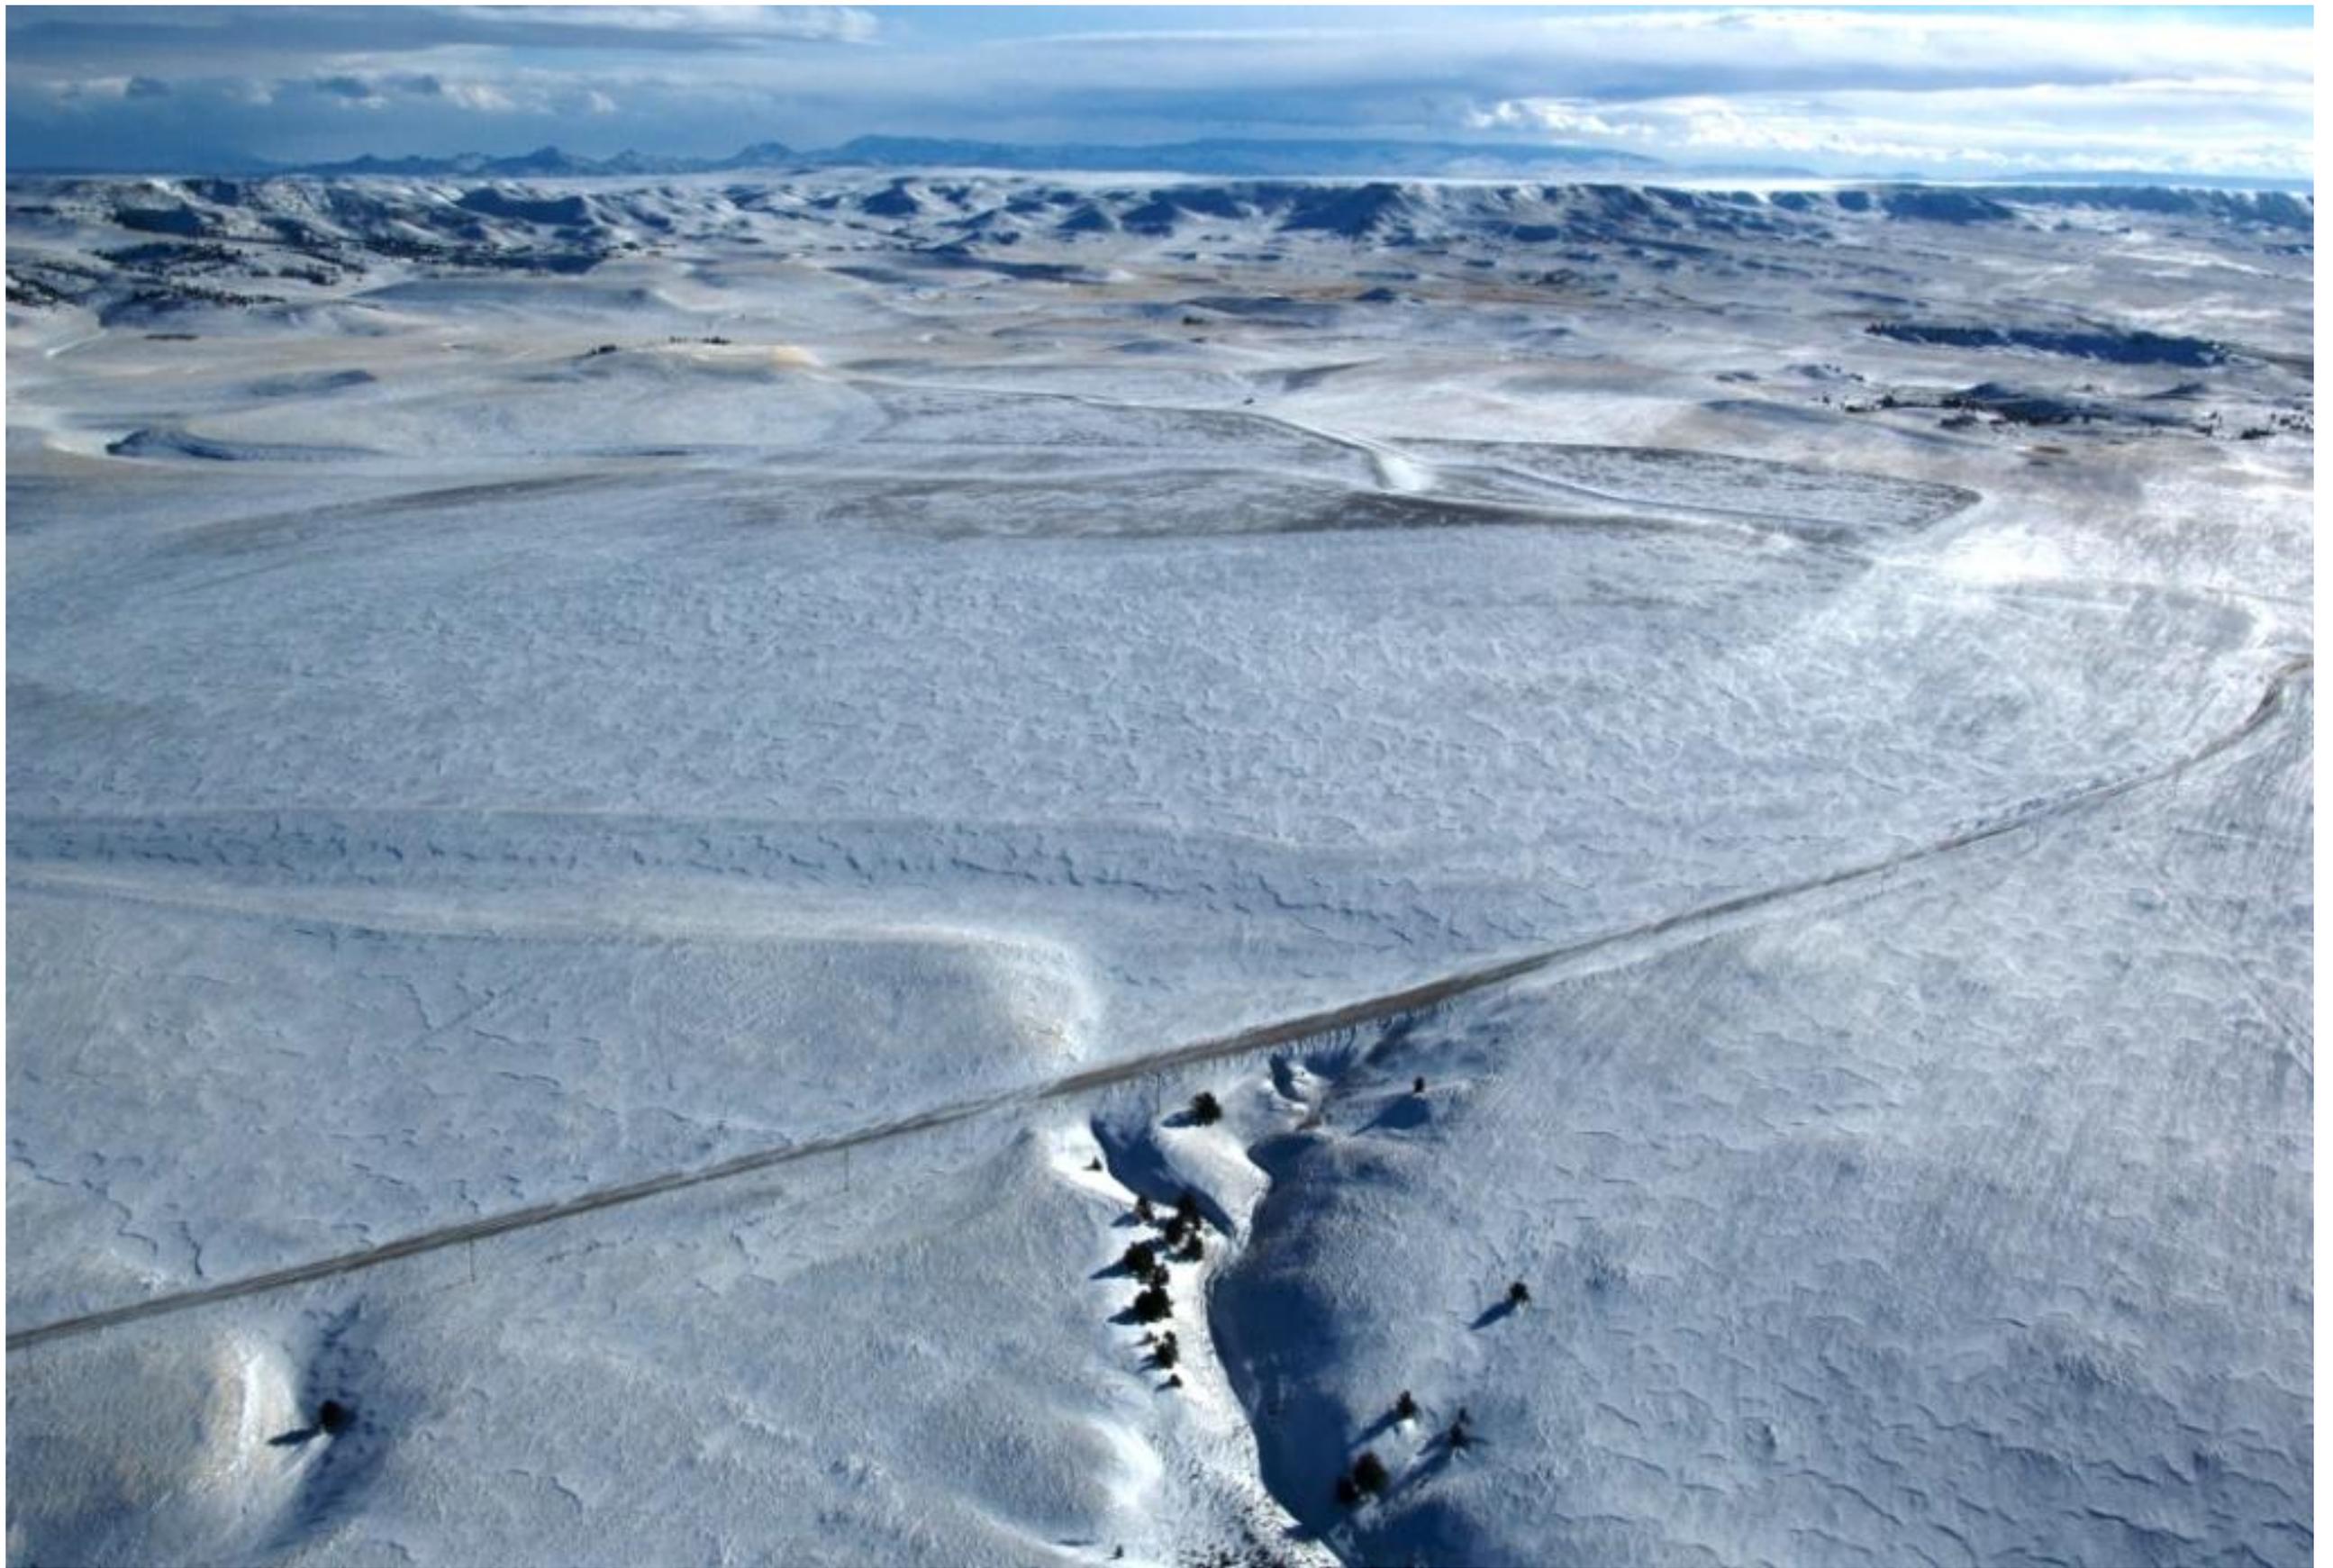
View of the AGTI looking south / southwest of the north and west slopes. The access gate is located on the right side of the photo (near the road). Again, it appears snow accumulates at the transition between the Types A and B riprap on the AGTI structure. 2/22/2011

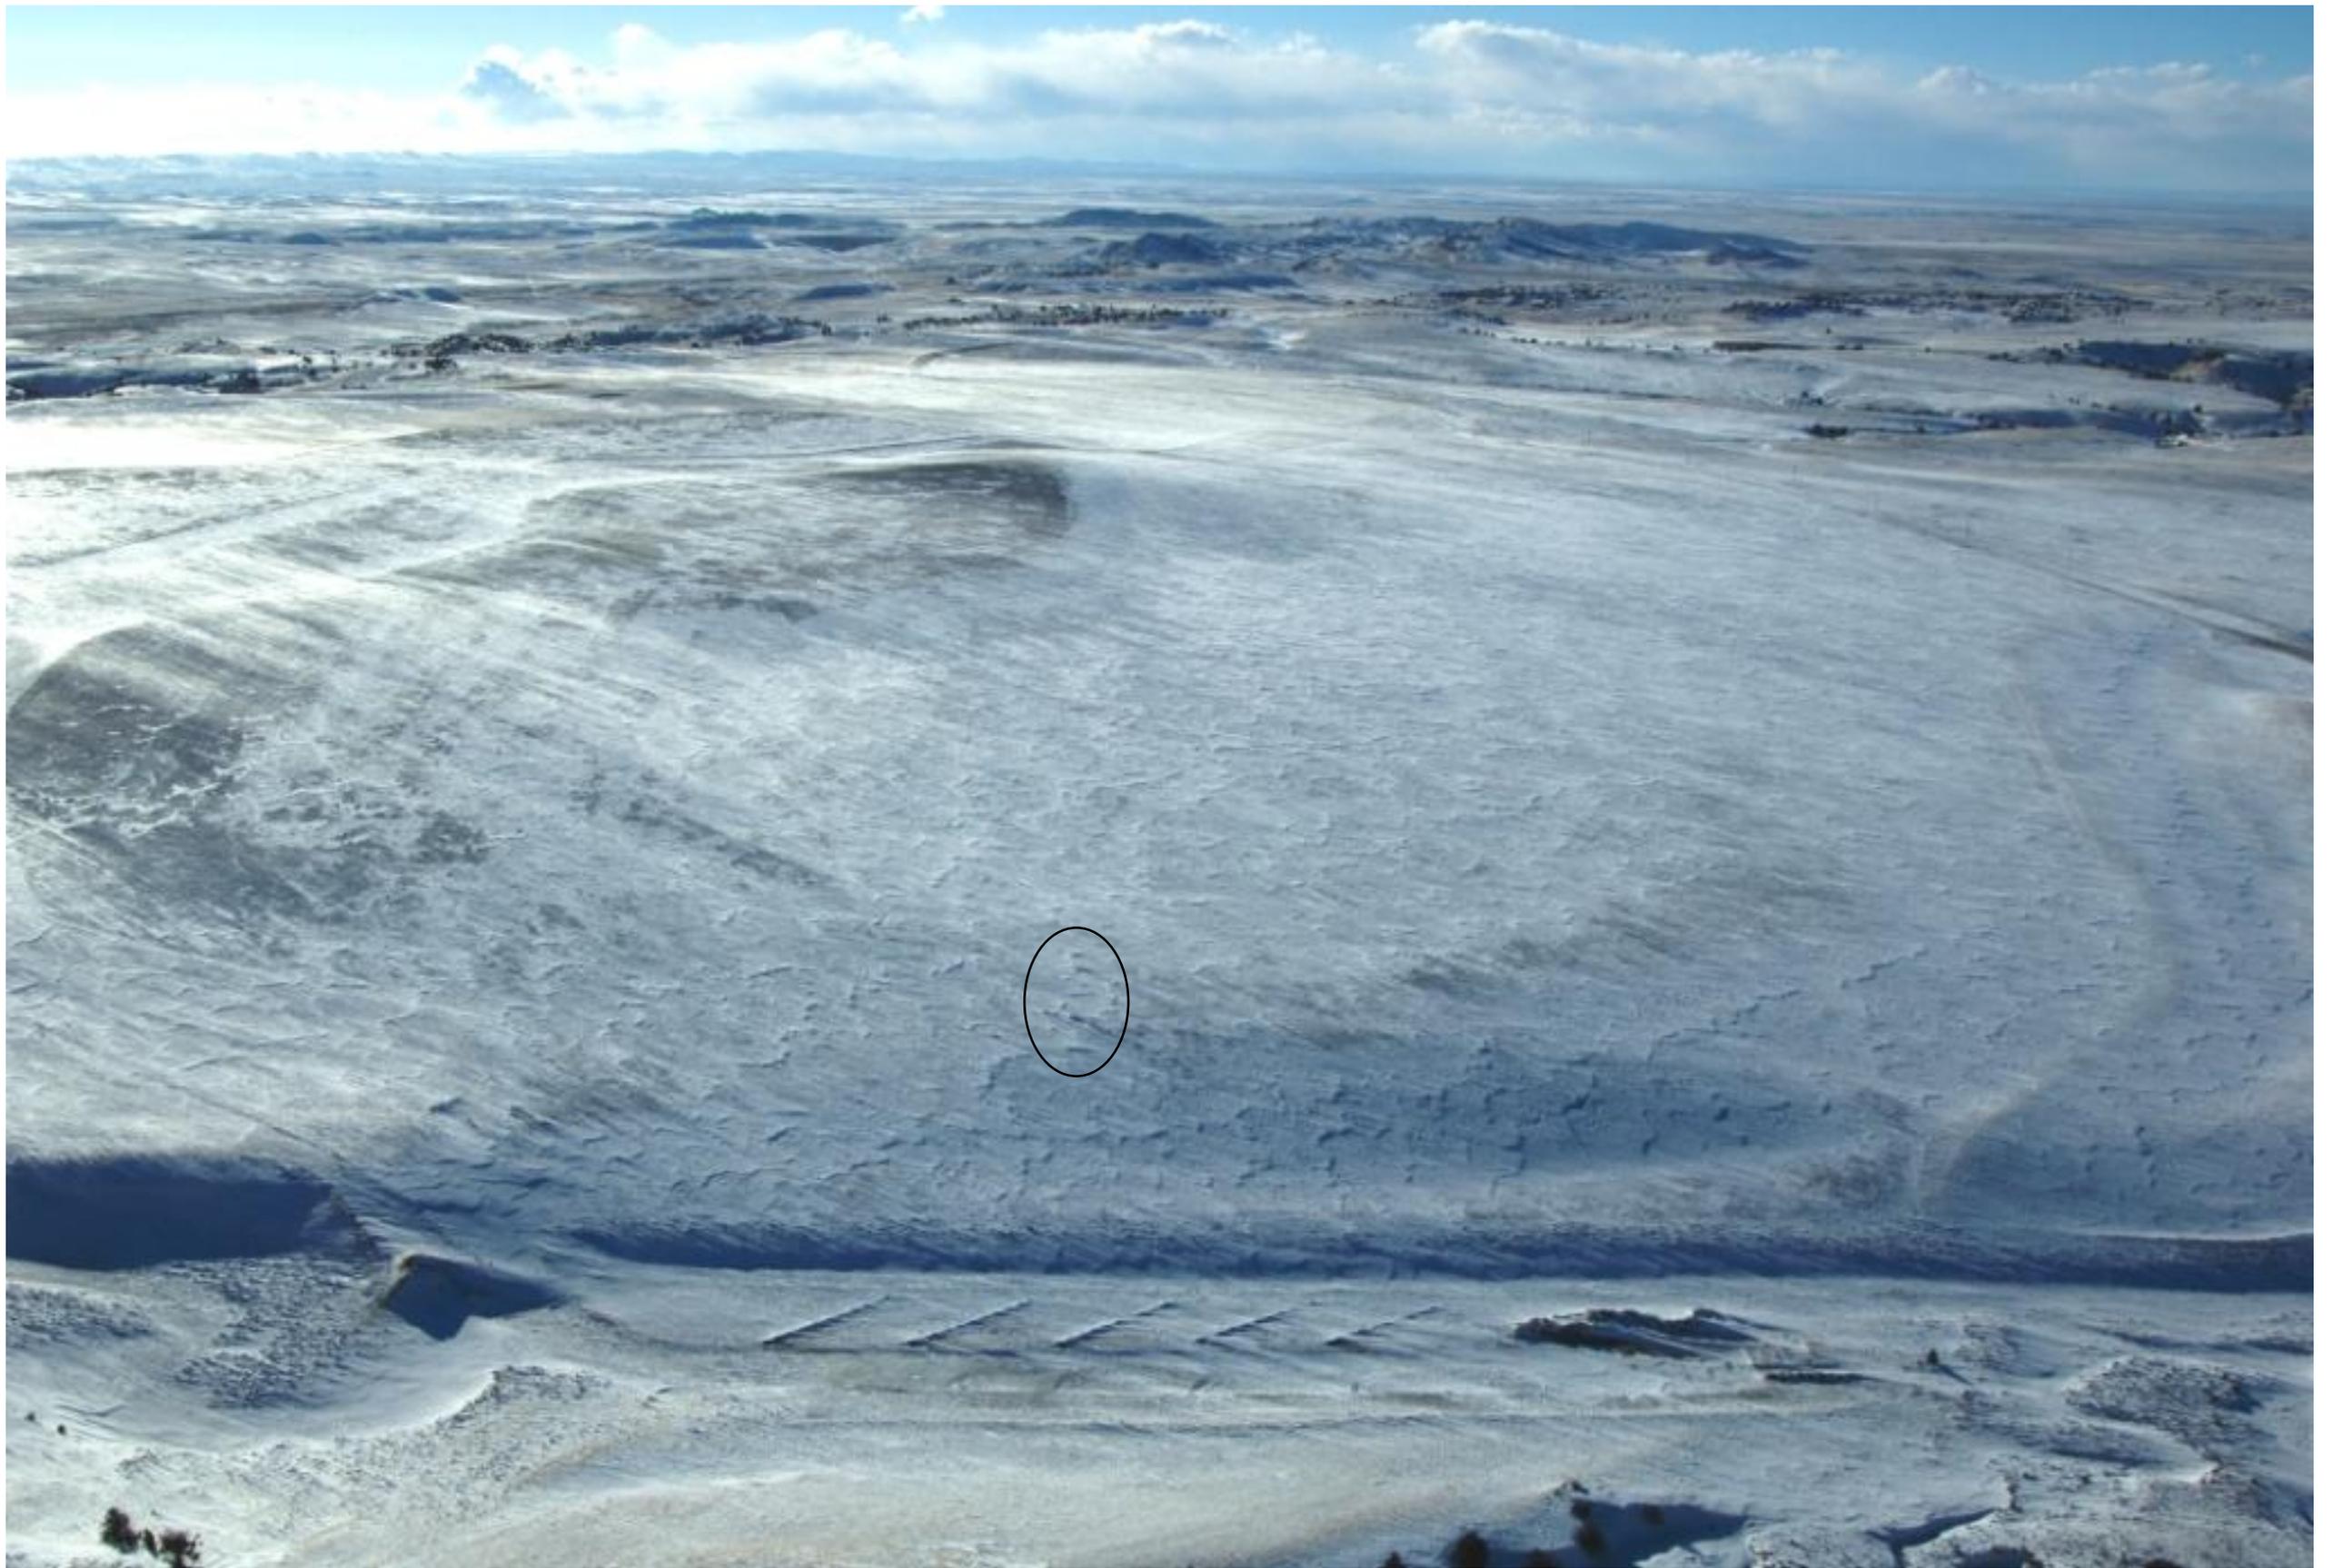
View of the AGTI looking west of the eastern slopes. The apron channel area (left side of the photo) appears to be completely drifted over. The Launch Rock structure is located along the lower portion of the photo (left to right). The test pits excavated last summer are barely discernable in the lower center of the photo. 2/22/2011

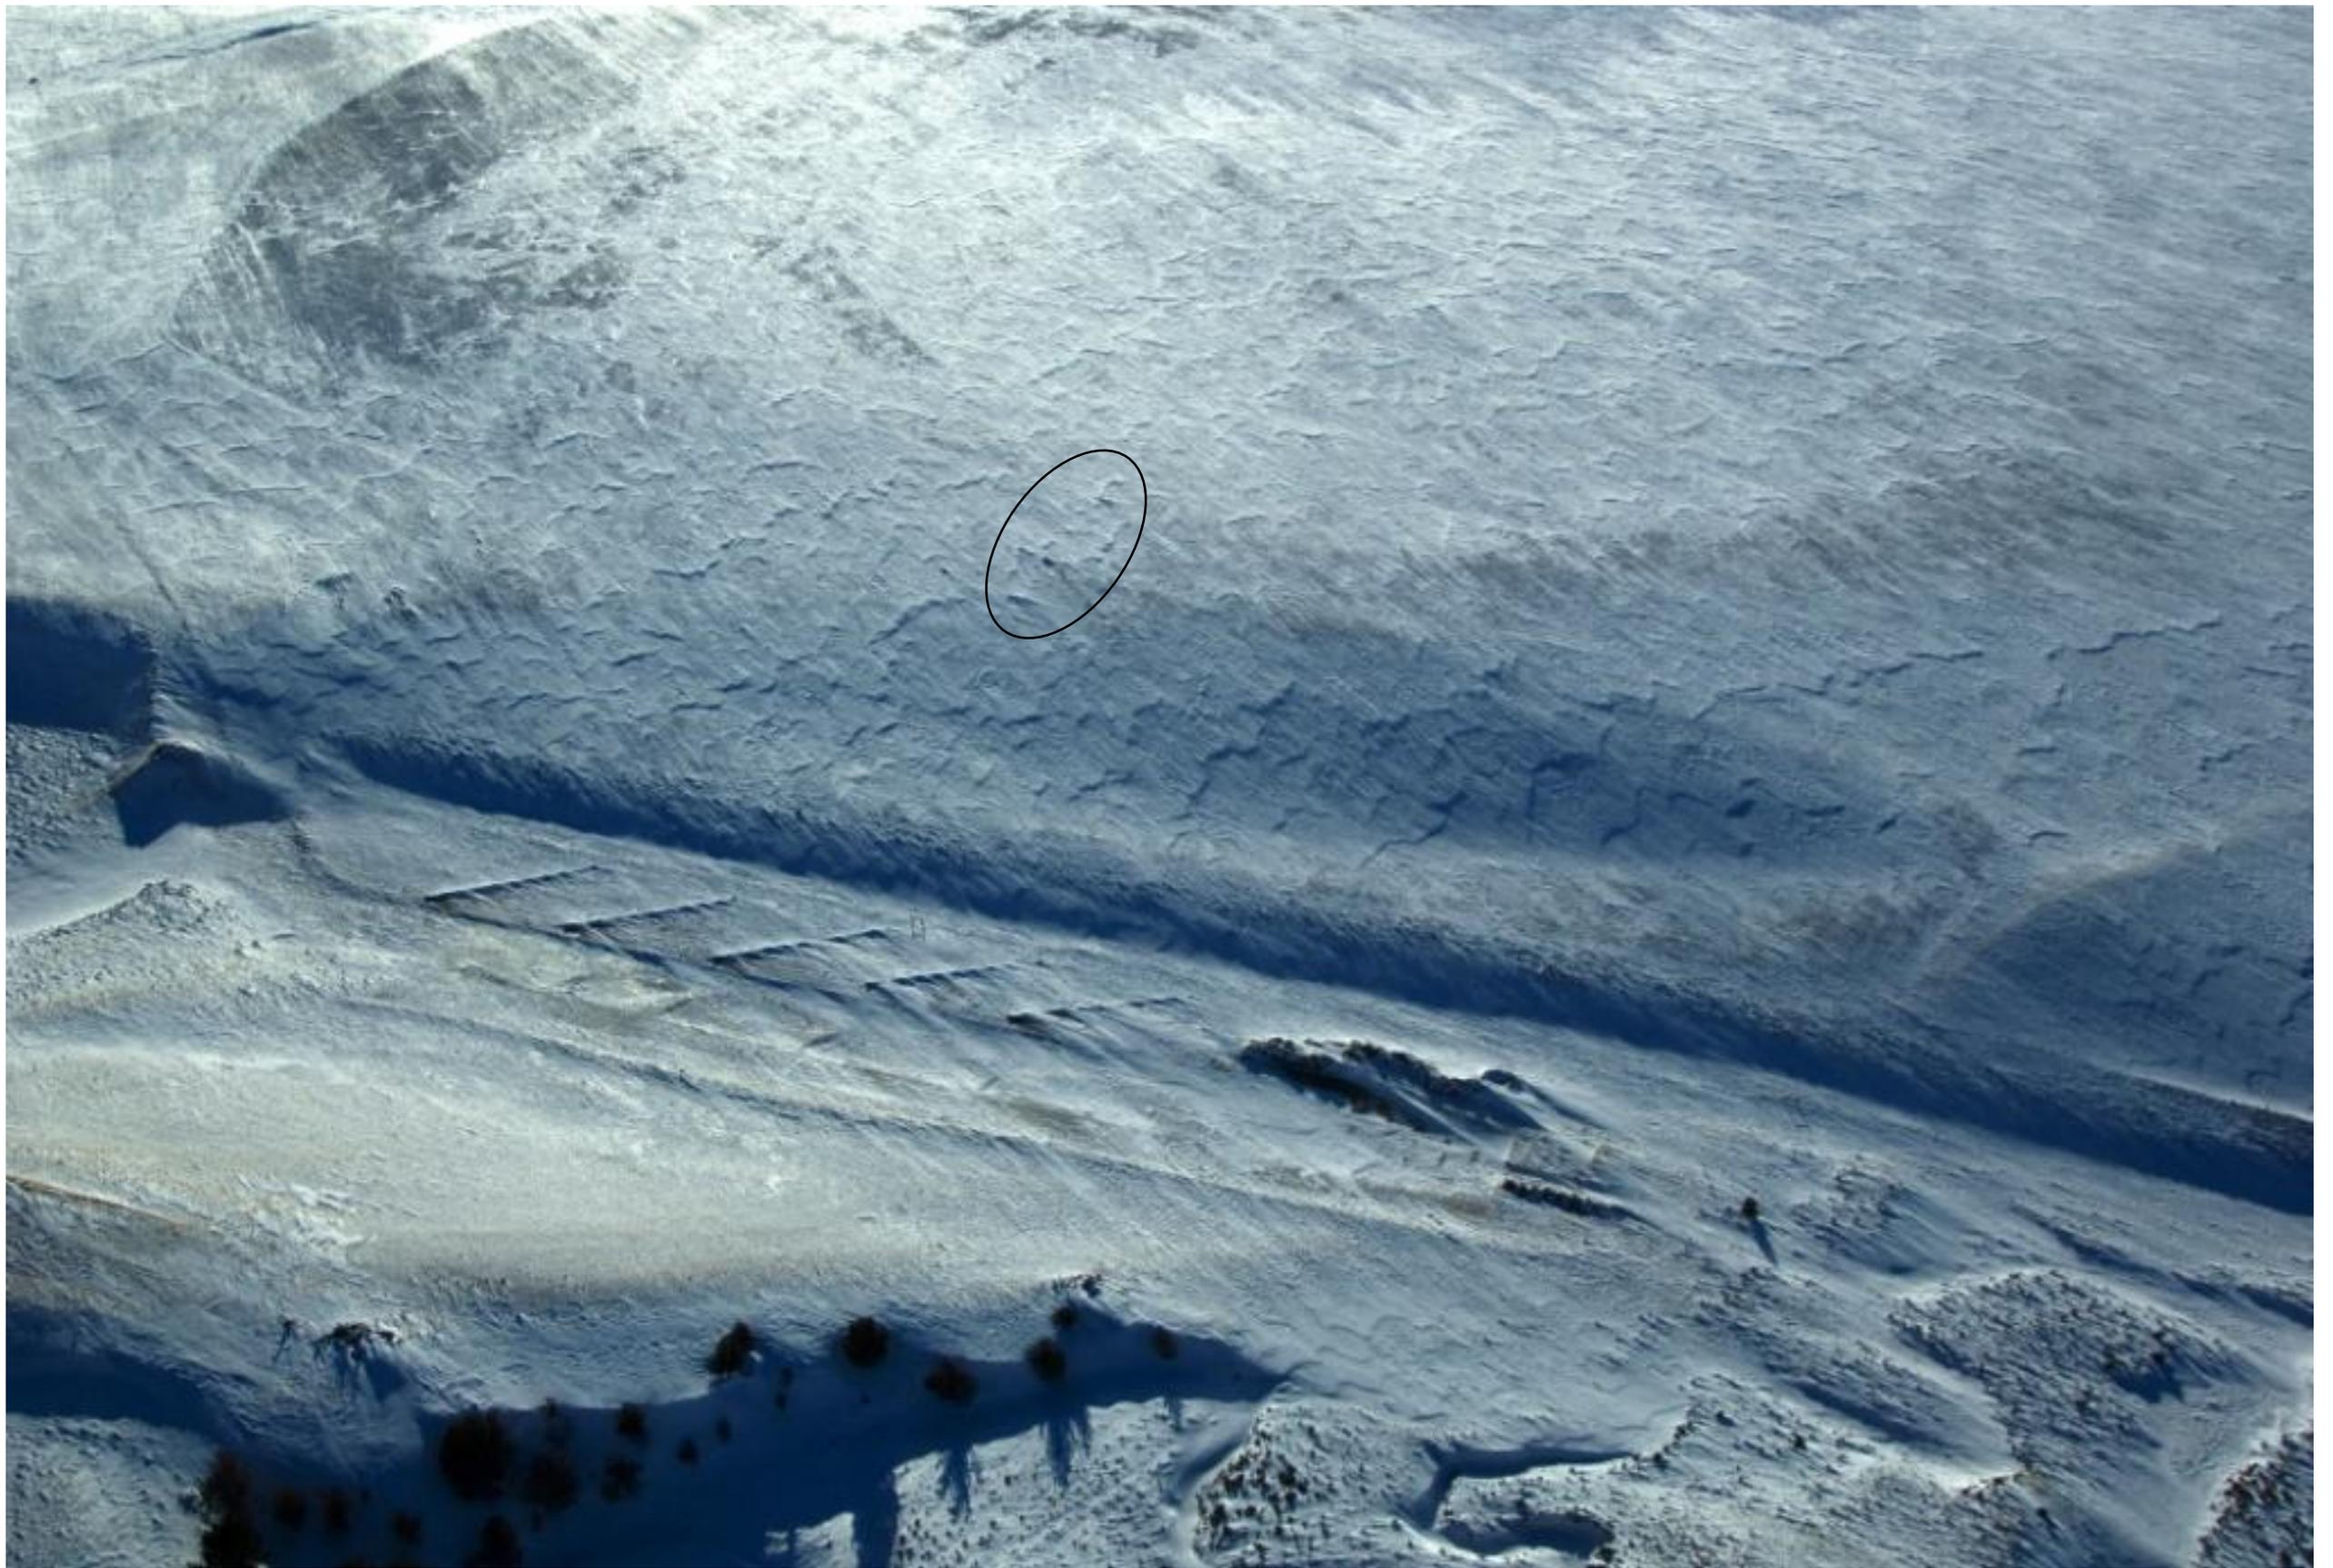
View of the AGTI looking down and west of the east Slope. Again, the test pit spoil piles are discernable in the center of the photo. 2/22/2011

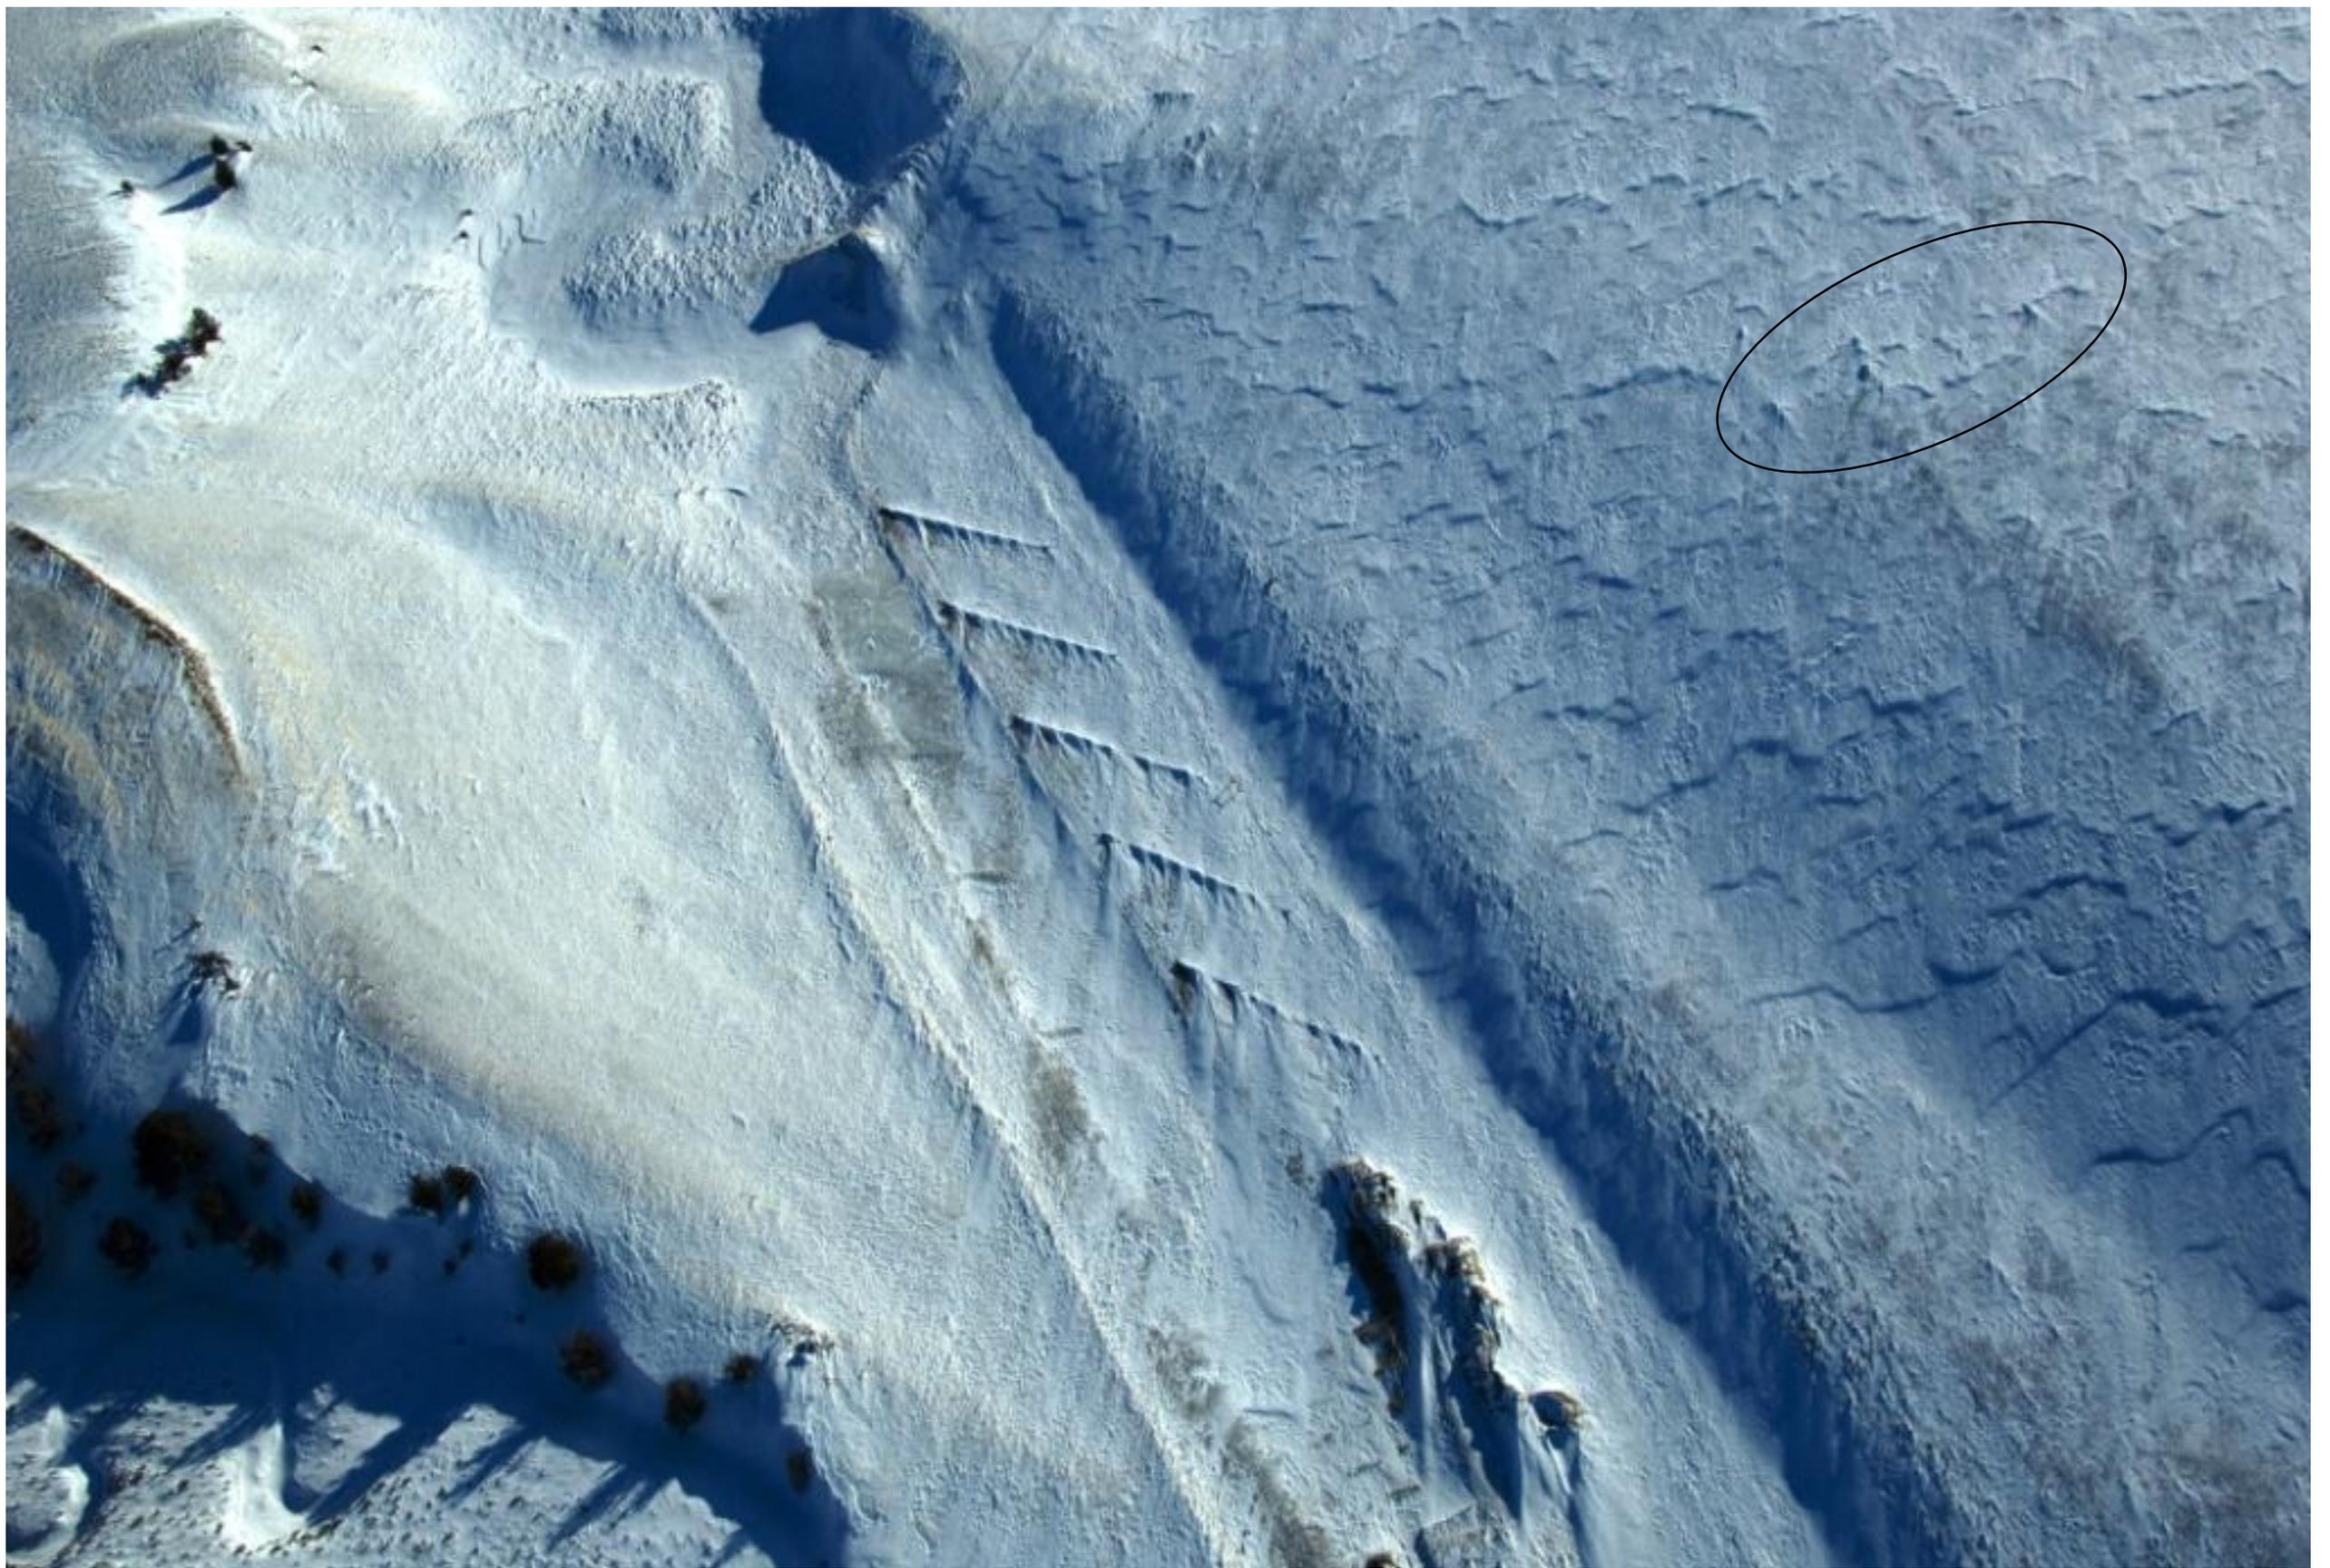
View looking down of the east slope of the AGTI. Test pits can be seen in the center of the upper right quarter of the photo. 2/22/2011
