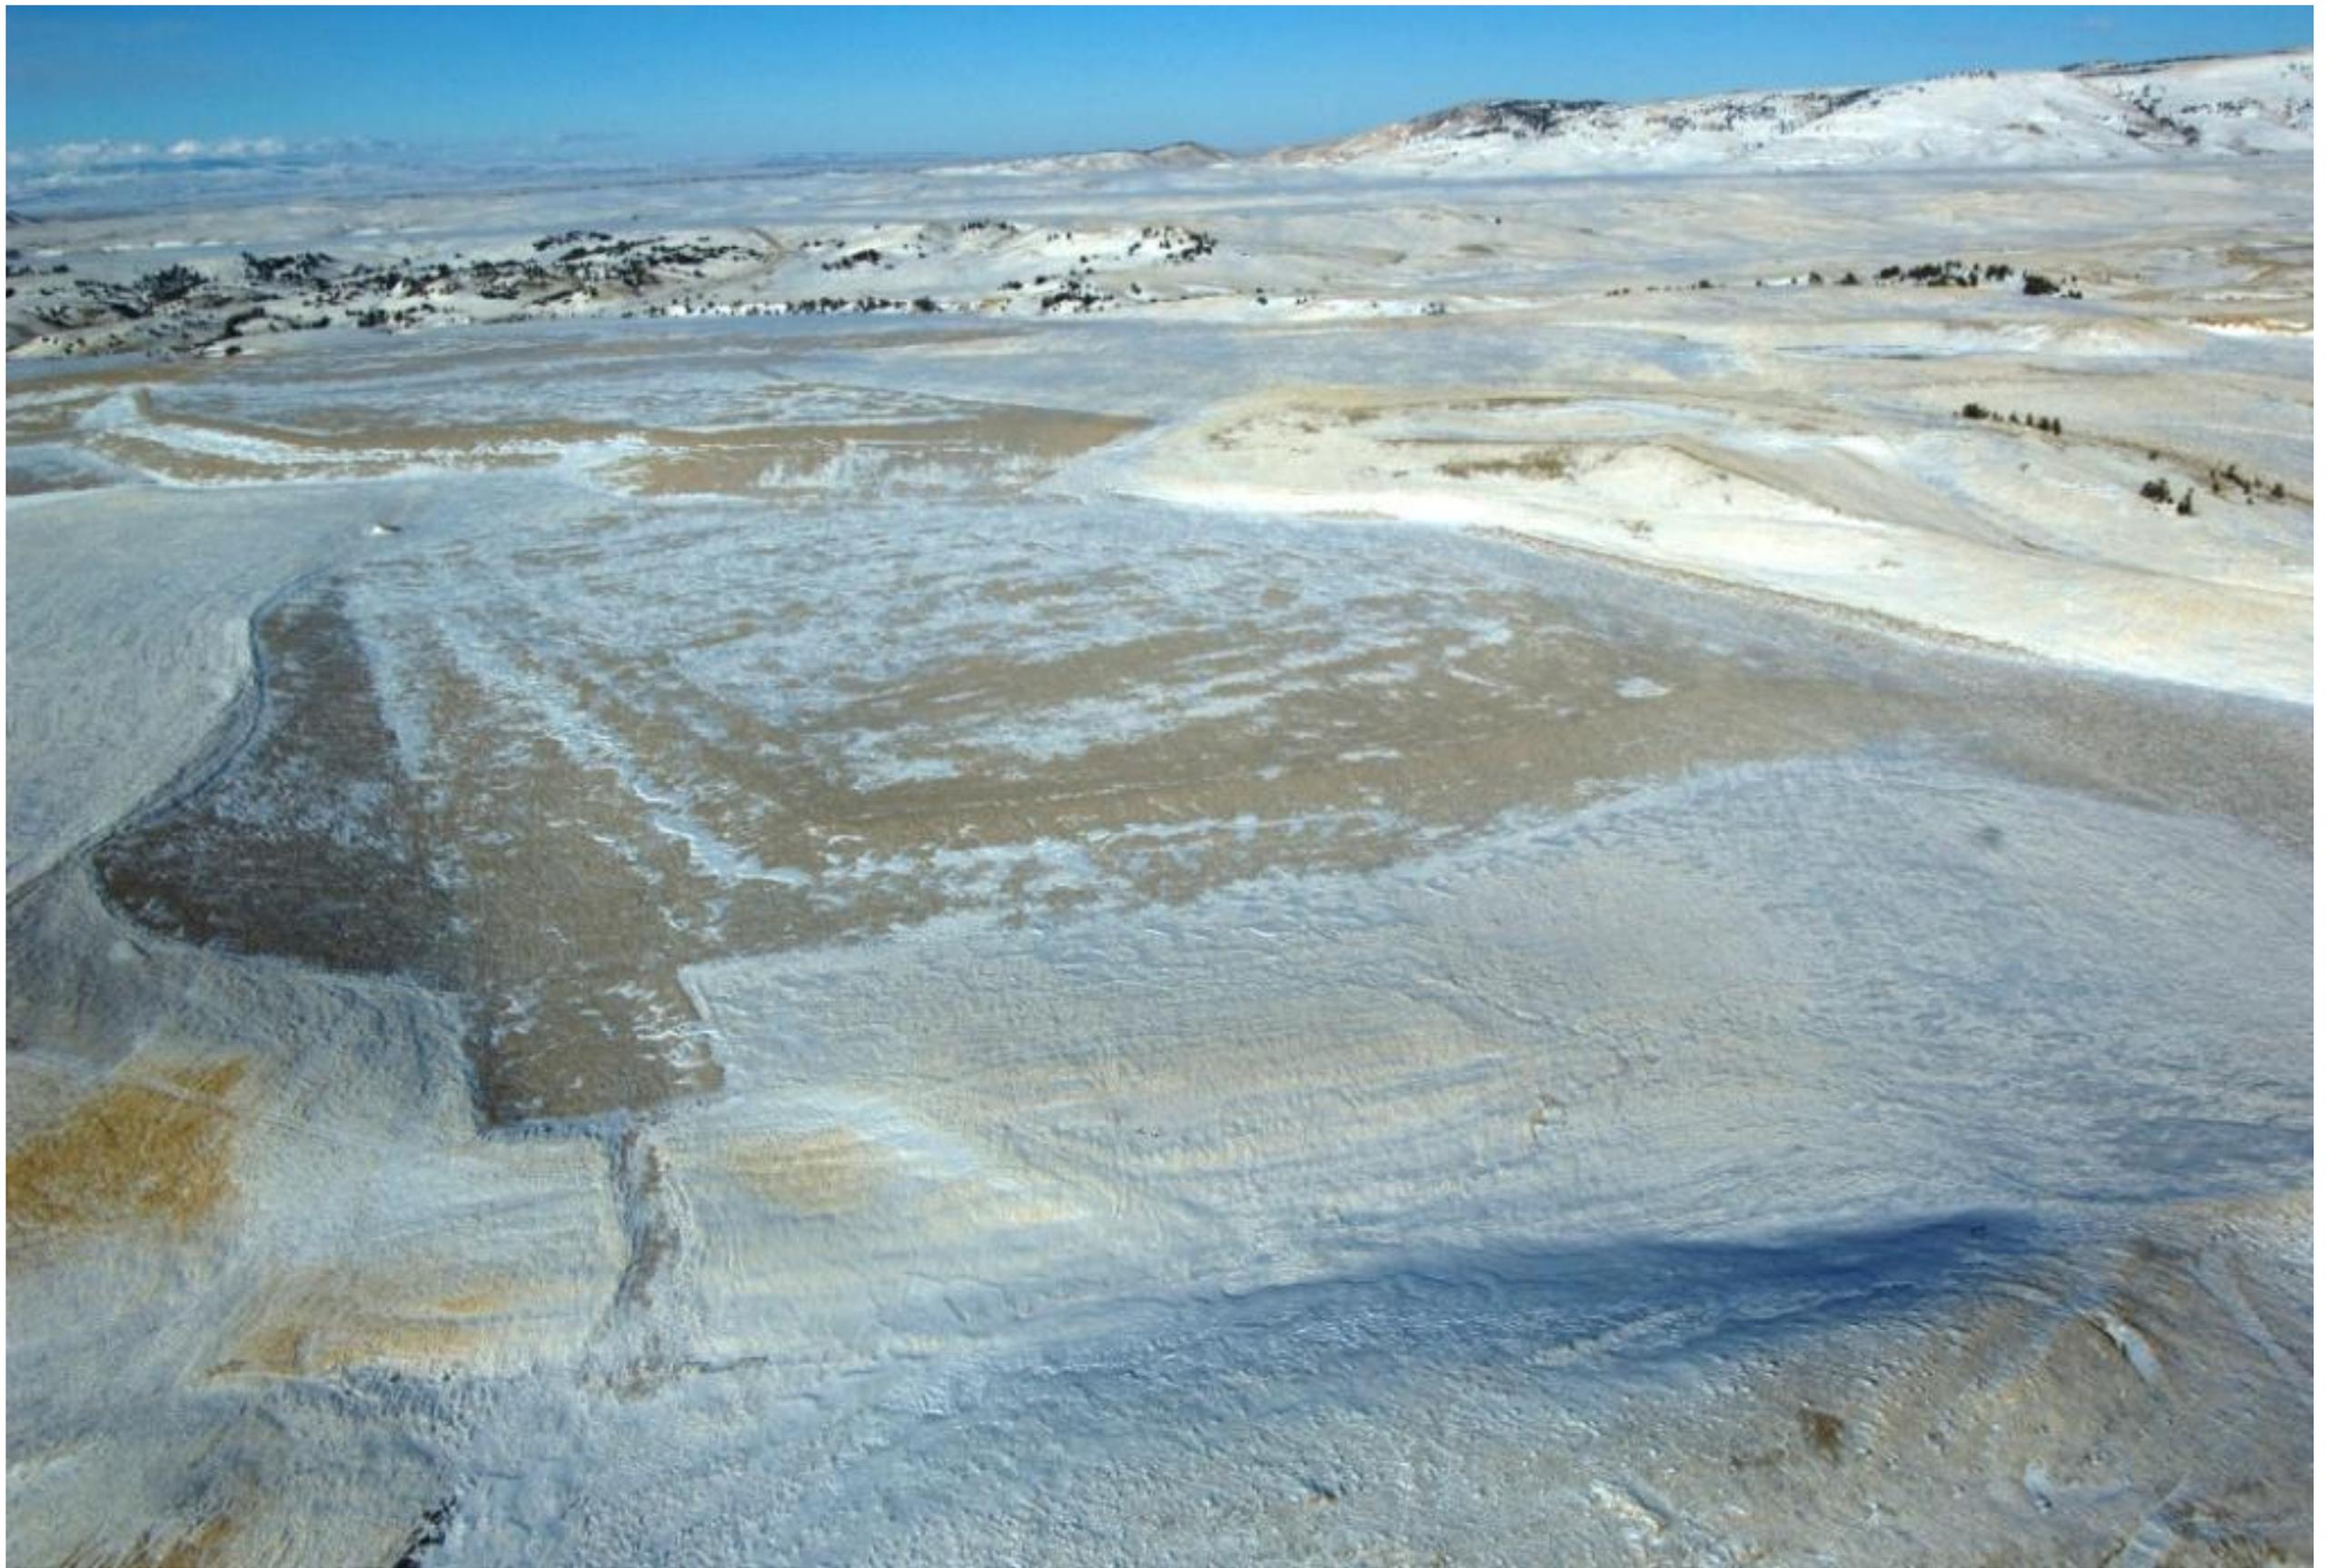
View of the A-9 Repository looking northeast. The prevailing wind comes out of the southwest and appears to remove snow from the A-9 structure and attendant drainage basin. The Type C riprap slope can be seen in the center of the photo. 2/22/2011

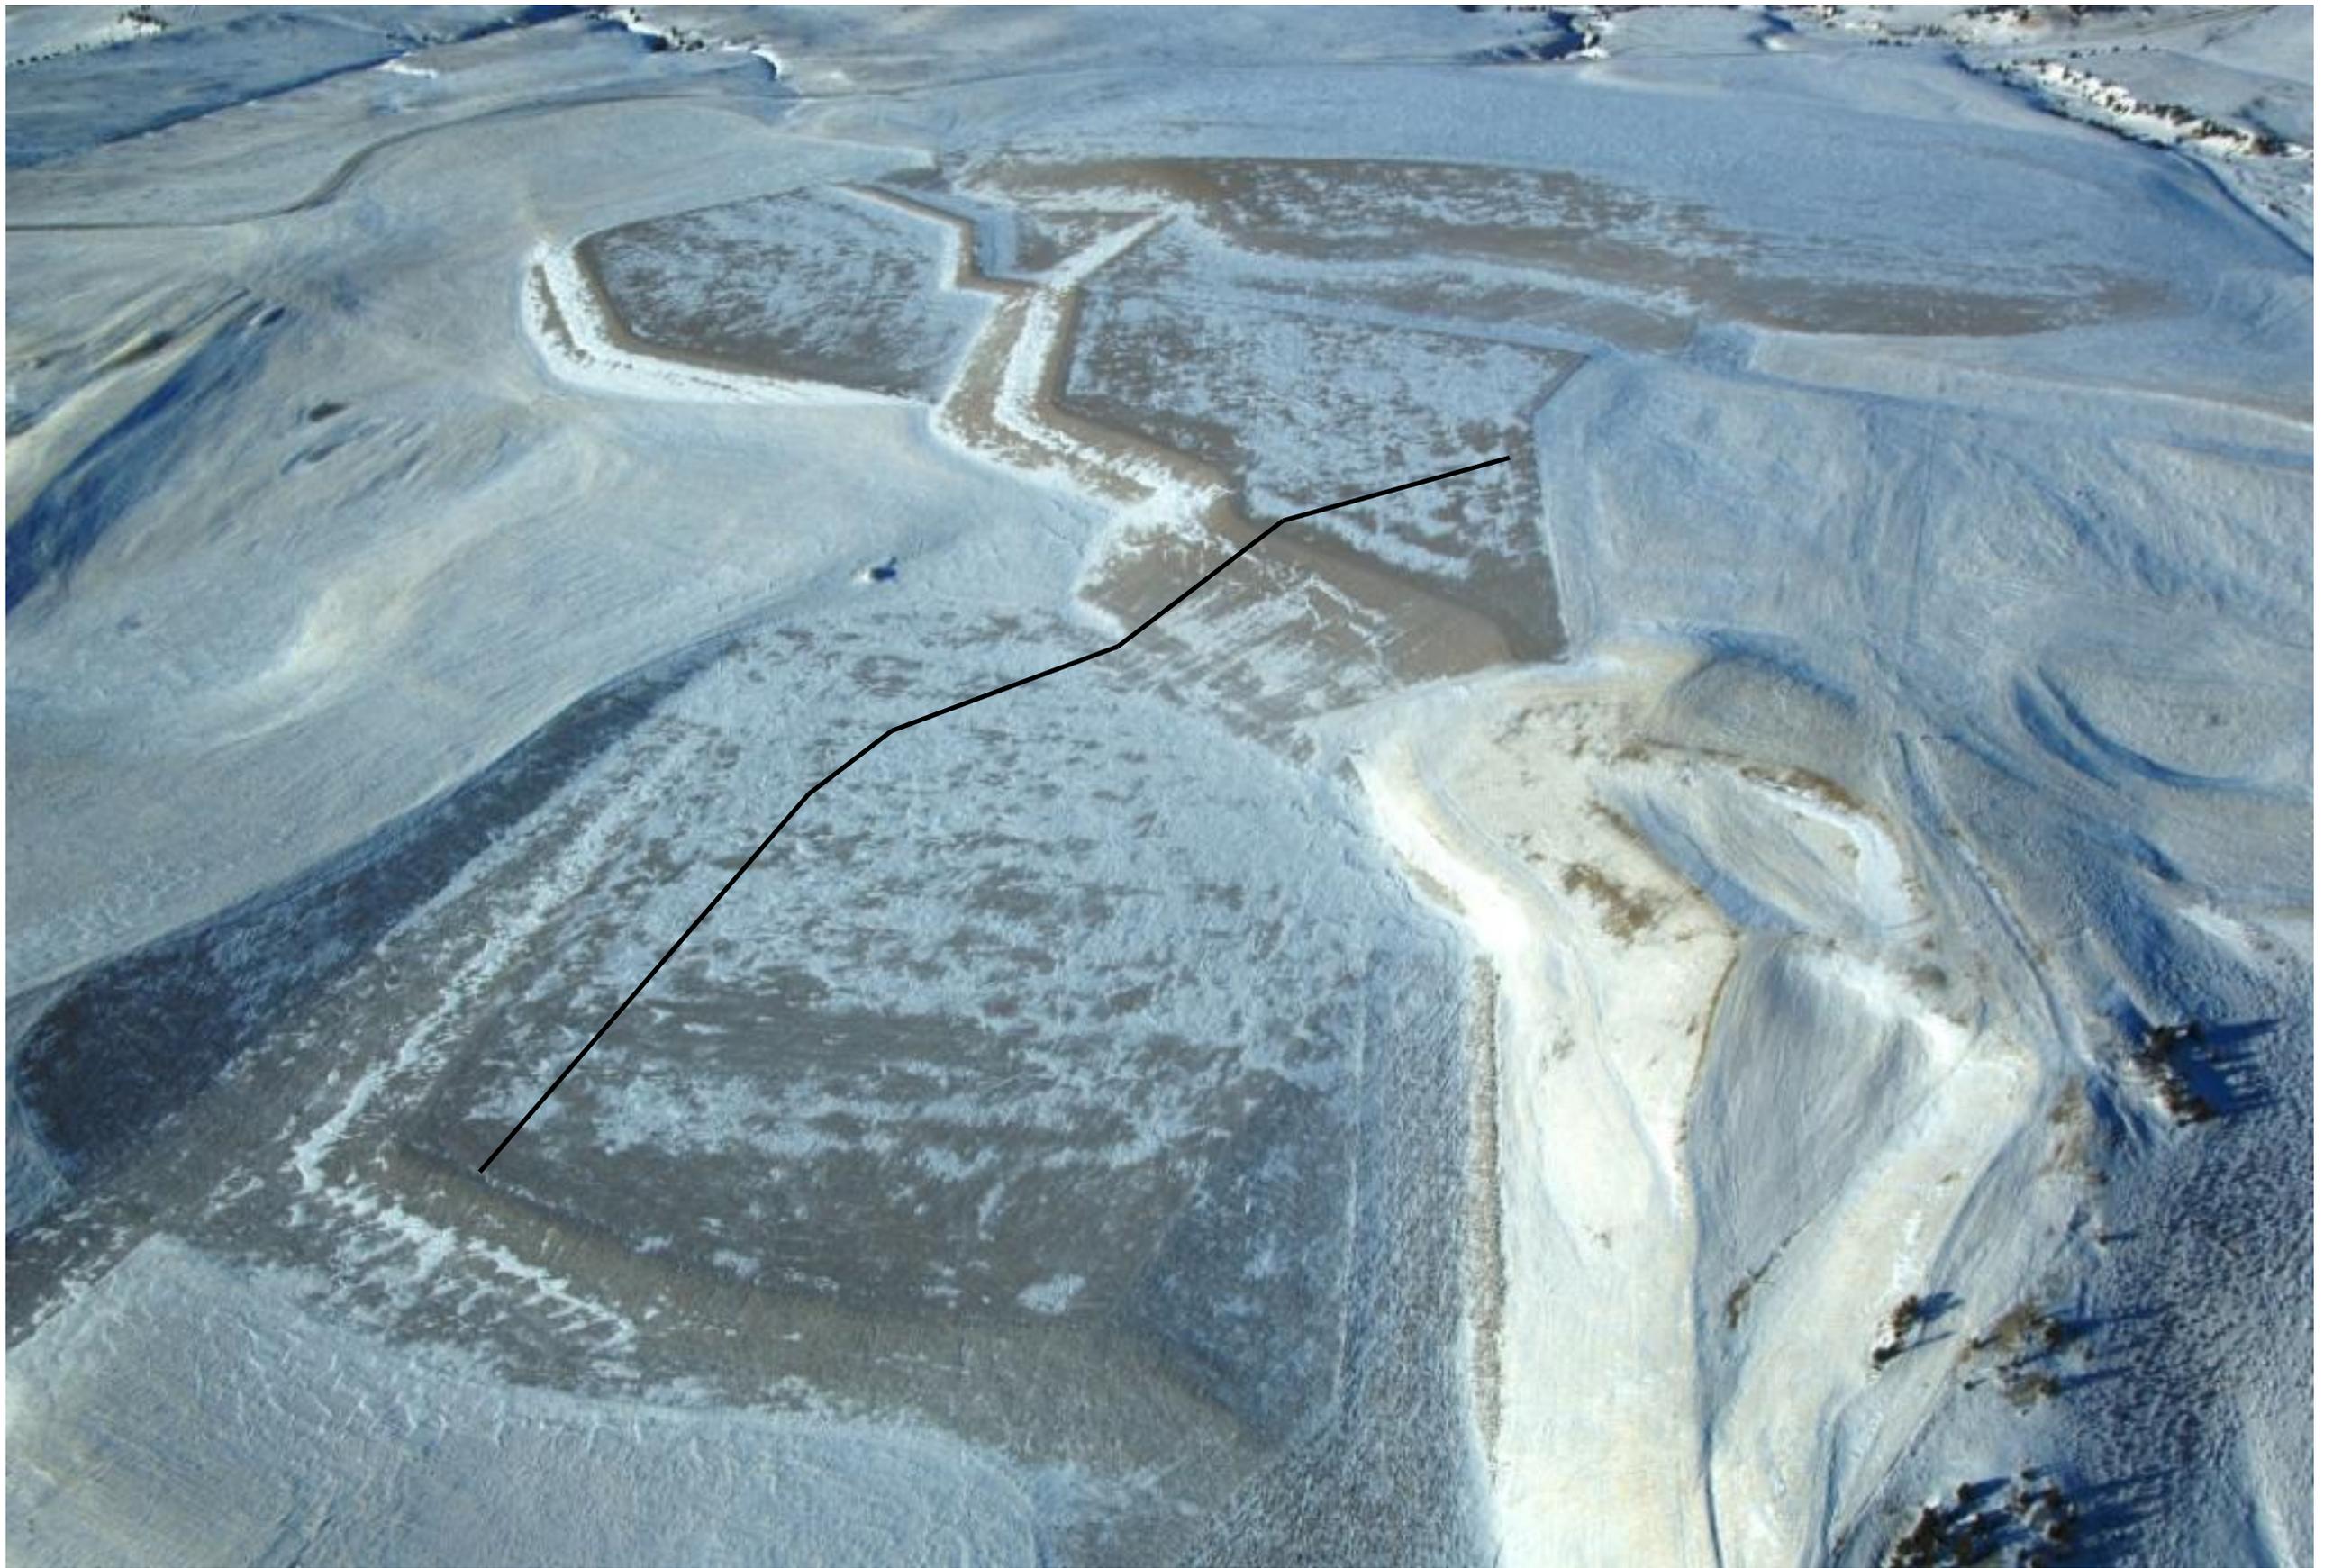
View of the A-9 Repository looking down and north. Note longest drainage flow path, Type C riprap crest and AGTI in top right background. 2/22/2011
