UNITED STATES
NUCLEAR REGULATORY COMMISSION
OFFICE OF INSPECTION AND ENFORCEMENT
WASHINGTON, D.C. 20555

IE Bulletin No. 79-13
Revision 2

CRACKING IN FEEDWATER SYSTEM PIPING

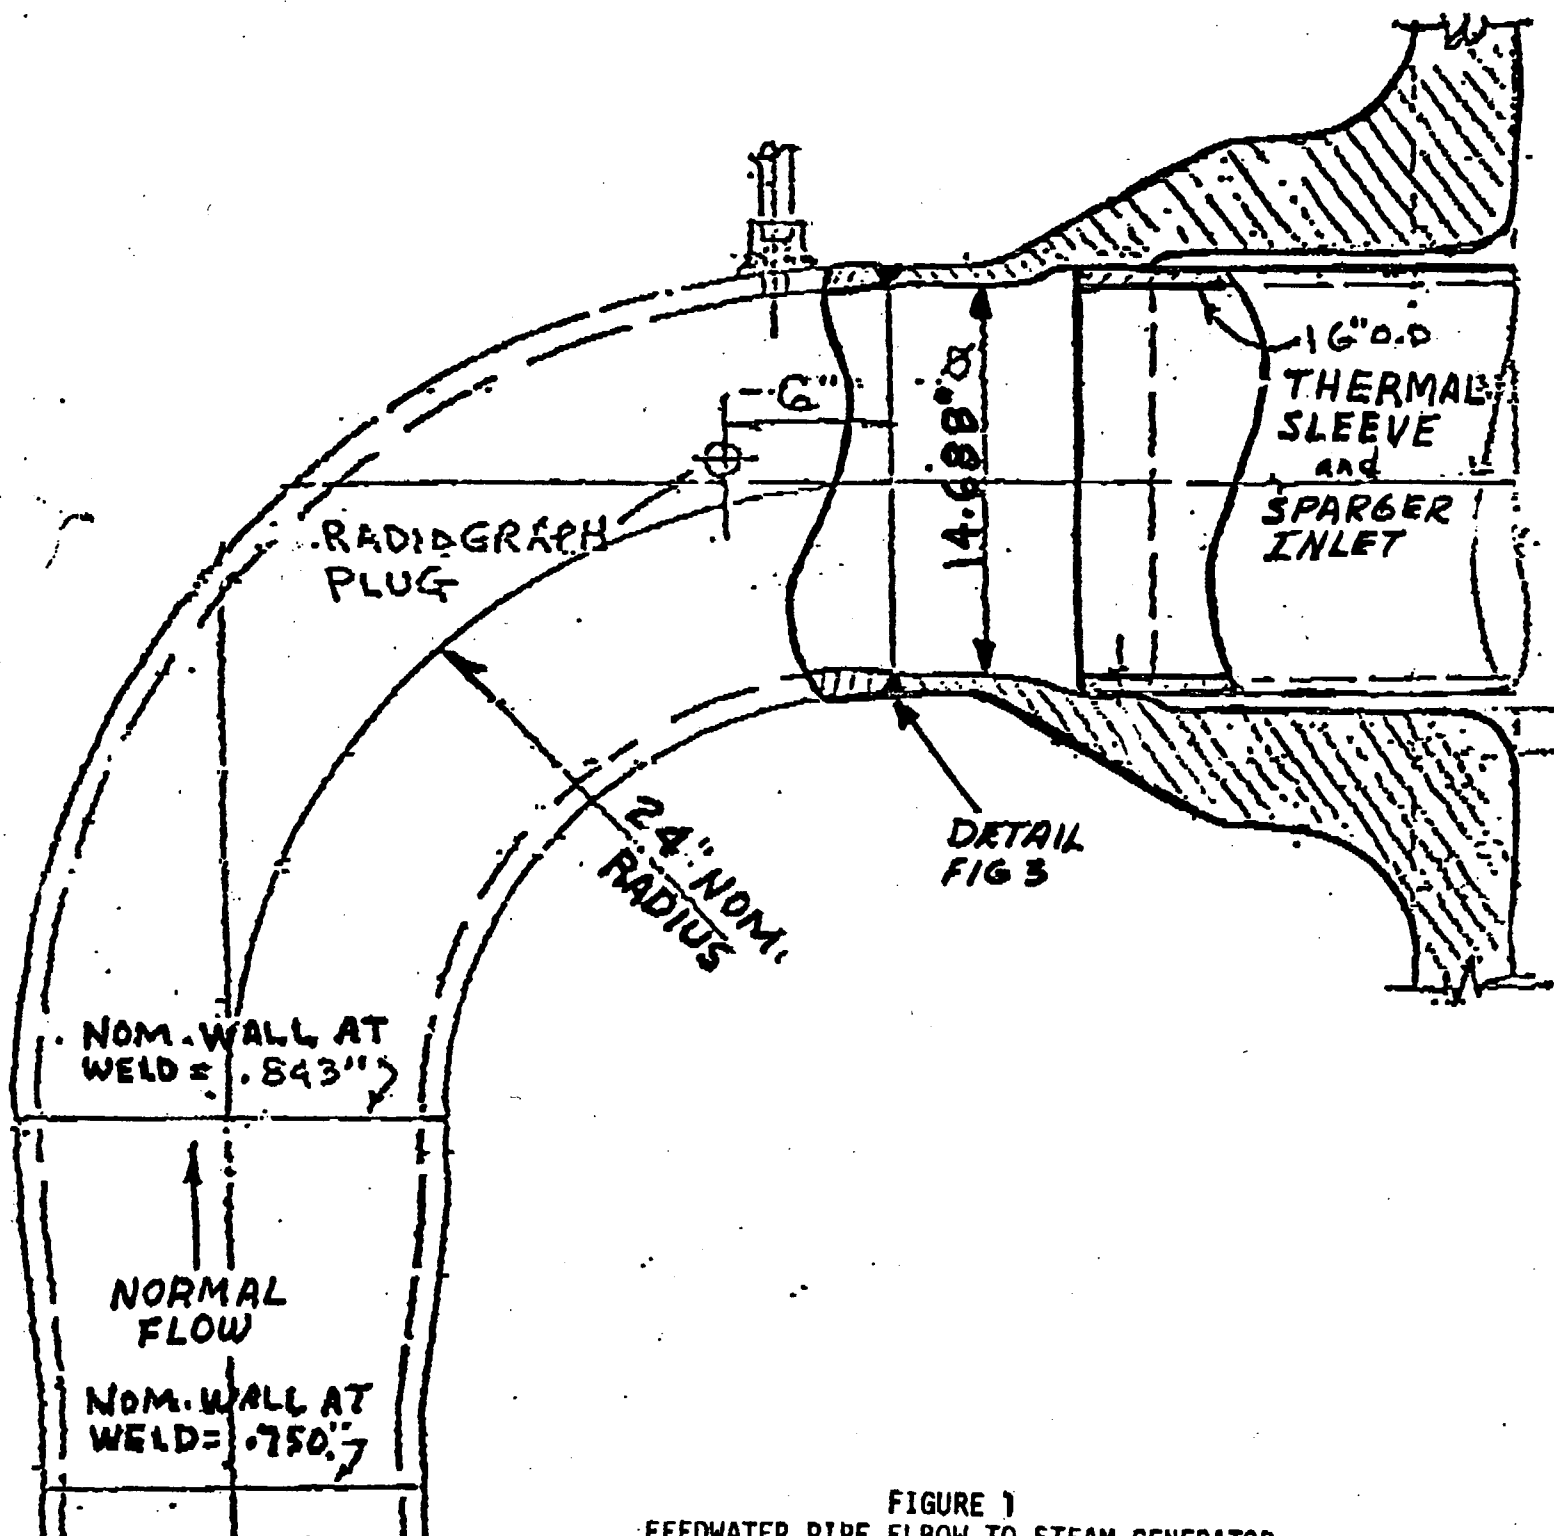
FIGURE 1
FEEDWATER PIPE ELBOW TO STEAM GENERATOR
NOZZLE INSTALLATION (DC COOK)

On May 20, 1979, Indiana and Michigan Power Company notified the NRC of cracking in two feedwater lines at their D. C. Cook Unit 2 facility. The cracking was discovered following a shutdown on May 19 to investigate leakage inside containment. Leaking circumferential cracks were identified in the 16-inch feedwater elbows adjacent to two steam generator nozzle elbow welds. Subsequent radiographic examination revealed crack indications in all eight steam generator feedwater lines at this location on both Units 1 and 2.

The feedwater nozzle-to-pipe configurations for D. C. Cook and for San Onofre are shown on the attached figures 1 and 2. A typical feedwater nozzle-to-pipe weld joint detail showing the principal crack locations for D. C. Cook and San Onofre are shown on the attached figure 3.

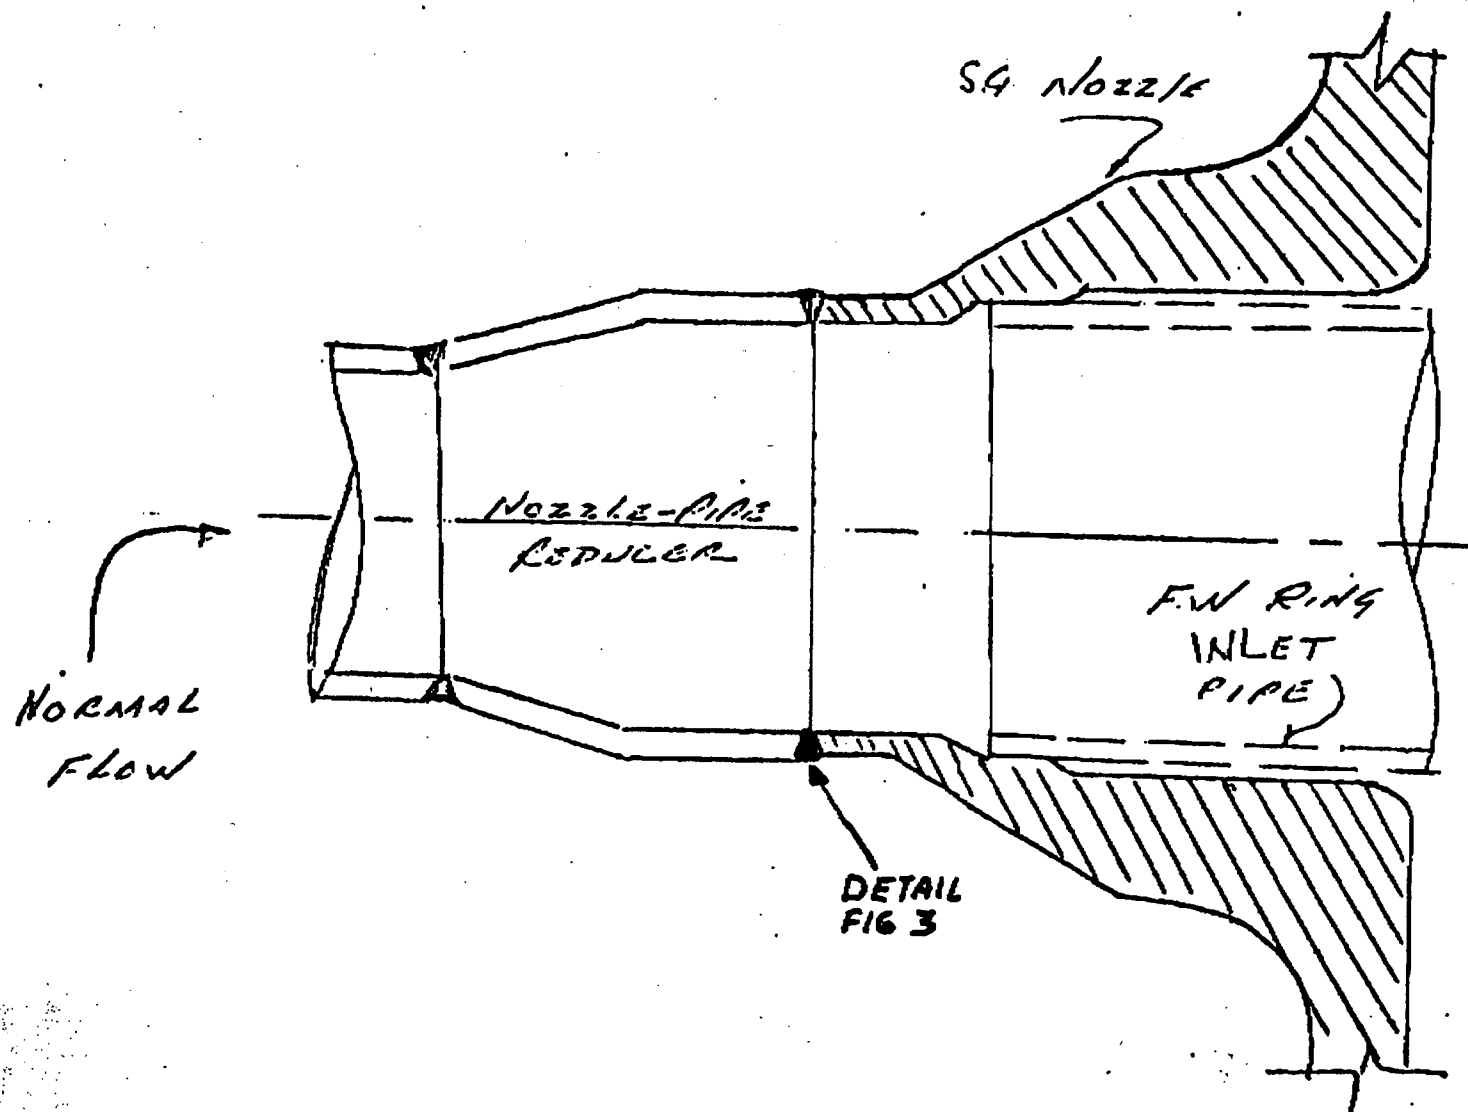
FIGURE 2
FEEDWATER PIPE REDUCER TO STEAM GENERATOR
NOZZLE INSTALLATION (SAN ONOFRE)

As a result of these actions, several other licensees with Westinghouse steam generators reported crack indications. Southern California Edison reported on June 5, 1979, that radiographic examination revealed indications of cracking in feedwater nozzle-to-pipe welds on two of three steam generators of San Onofre Unit 1. On June 15, 1979, Carolina Power and Light reported that radiography showed crack indications in similar locations at their H. B. Robinson Unit 2. Duquesne Power and Light confirmed on June 18, 1979, that radiography has shown cracking in their Beaver Valley Unit 1 feedwater piping-to-vessel nozzle weld. Public Service Electric and Gas Company reported on June 20, 1979 that Salem Unit 1 also has crack indications. Wisconsin Public Service company decided on June 20, 1979 to cut out a feedwater nozzle-to-pipe weld which contained questionable indication, for metallurgical examination. As of June 22, 1979 and since May 25, 1979 seven other PWR facilities have inspected the feedwater nozzle-to-pipe welds without finding cracking indications.

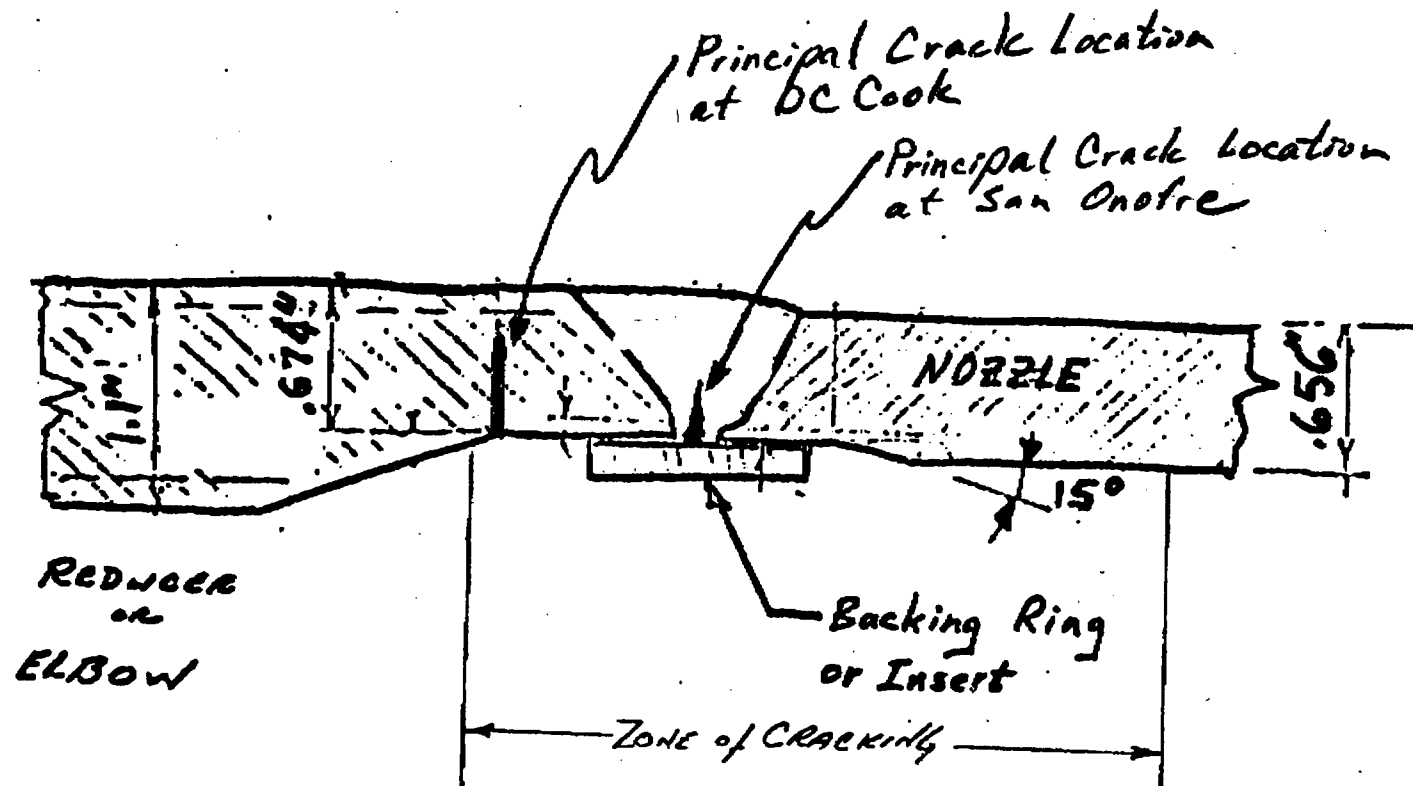
FIGURE 3
TYPICAL FEEDWATER PIPE TO NOZZLE
WELD JOINT DETAIL
(W , CE)

An extensive metallurgical investigation has been conducted by Westinghouse on a substantial number of cracked weldments removed from the above plants. Results of the metallurgical analysis lead to the conclusion that a corrosion fatigue phenomenon is the probable failure mechanism, except for the San Onofre piping which has been characterized as stress assisted corrosion.

- a. Perform radiographic examination, supplemented by ultrasonic examination as necessary to evaluate indications, of all feedwater nozzle-to-pipe welds and of adjacent pipe and nozzle areas (a distance equal to at least two wall thicknesses). Evaluation shall be in accordance with ASME Section III, Subsection NC, Article NC-5000. Radiography shall be performed to the 2T penetrameter sensitivity level, in lieu of Table NC-5111-1, with systems void of water.
