TE Connectivity
Energy Division
8000 Purfoy Road
Fuquay-Varina, North Carolina 27526-9349

NOTICE OF DEVIATION PURSUANT TO 10 CFR 21

Subject: NPKC-7-21A(N) Splice kit with possible compromised jacket seal

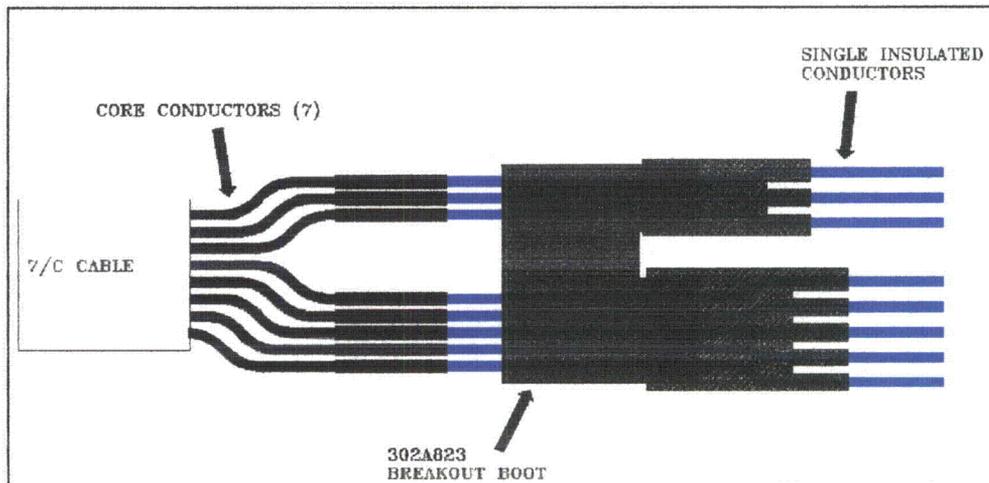
2. USING THIS ILLUSTRATION:

TE Connectivity Energy division has determined that when the Raychem brand splice kit NPKC-7-21A(N) was created, an incorrect breakout boot was selected as part of the kit. As a result, the jacket sealing properties of the splice kit may be compromised when the kit is installed on single insulated conductors that have an outside diameter less than 0.18 inches.

Determine if any splices were installed on single insulated conductors that have an outside diameter less than 0.18 inches.

2.1. If NOT, then the installed splices are still insulated, sealed and protected and therefore no corrective action or replacement is required.

2.2. If YES, Determine whether or not the cable jacket or the cable jacket seal is required for Environmental Qualification.

2.2.1. If YES, the splices should be removed and replaced. Notify TE Connectivity for replacement. (Telephone 800-327-6996)

2.2.2 If NOT, then verify the diameter of the seven core conductors to be greater than 0.11 inch. If they are equal to or greater than 0.11 inches, then the seven individual conductor splices are still insulated, sealed and protected and therefore not part of this notification. If they are less than 0.11 inches, the splices should be removed and replaced. Notify TE Connectivity for replacement. (Telephone 800-327-6996)
