Re: Varian Medical Systems, Inc. NRC
License No. 45-30957-01, Docket No. 03036666
30-day report – Events 46695 and 46758

Written notification in accordance with 10 CFR 21.21 (d)(3)(ii) and § 21.21 (d)(4)
Events 46695 and 46758

VariSource HDR Afterloader – Model VariSource iX

X-rays and photographs of wedge block

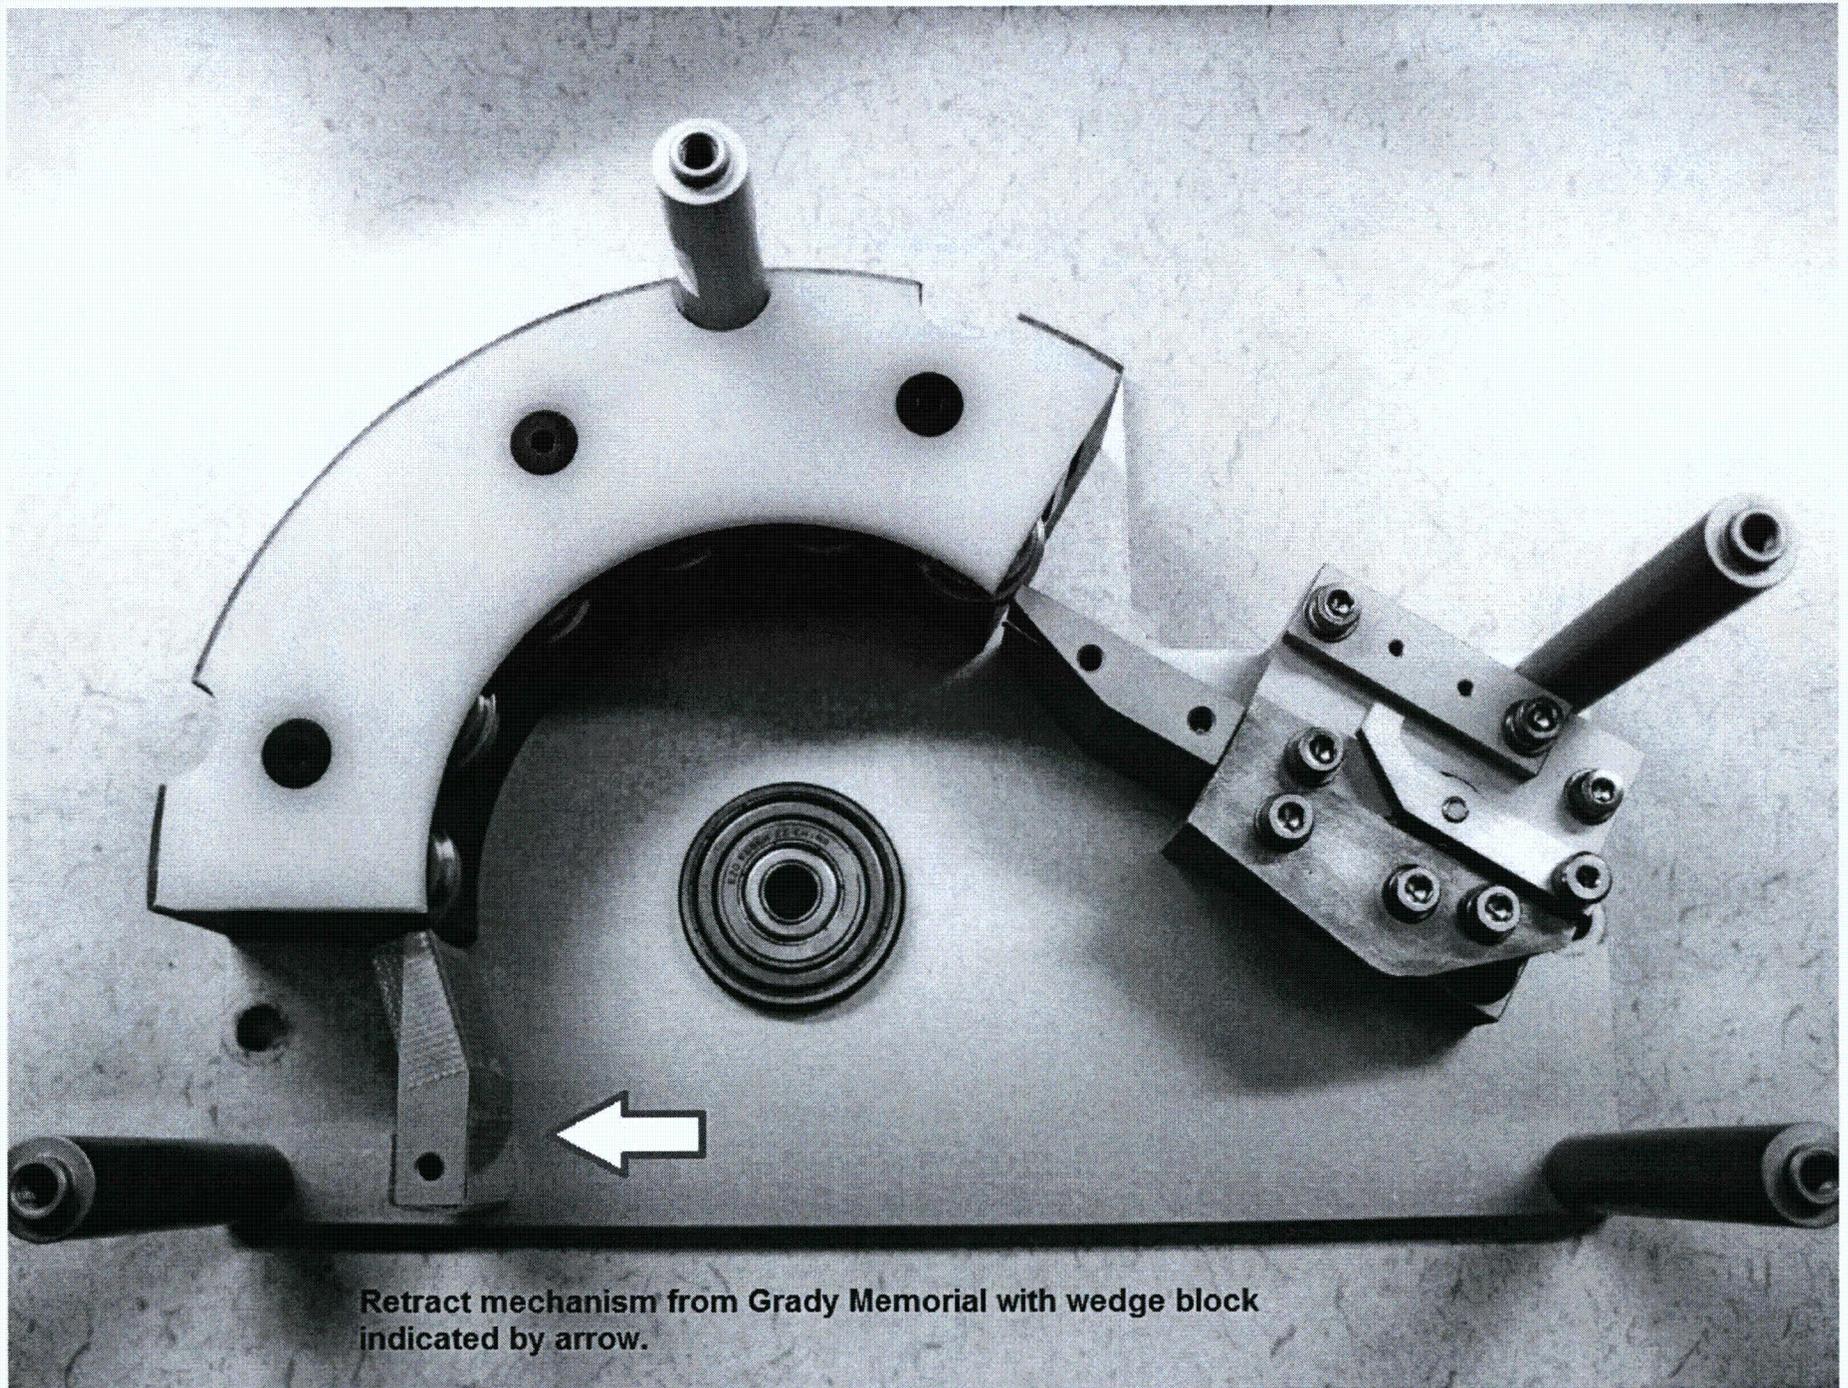
1. **Retract mechanism from Grady Memorial – wedge block on lower left.** This is the component involved in the event at Grady. The wedge block in its proper orientation is identified by the arrow.

Retract mechanism from Grady Memorial with wedge block indicated by arrow.

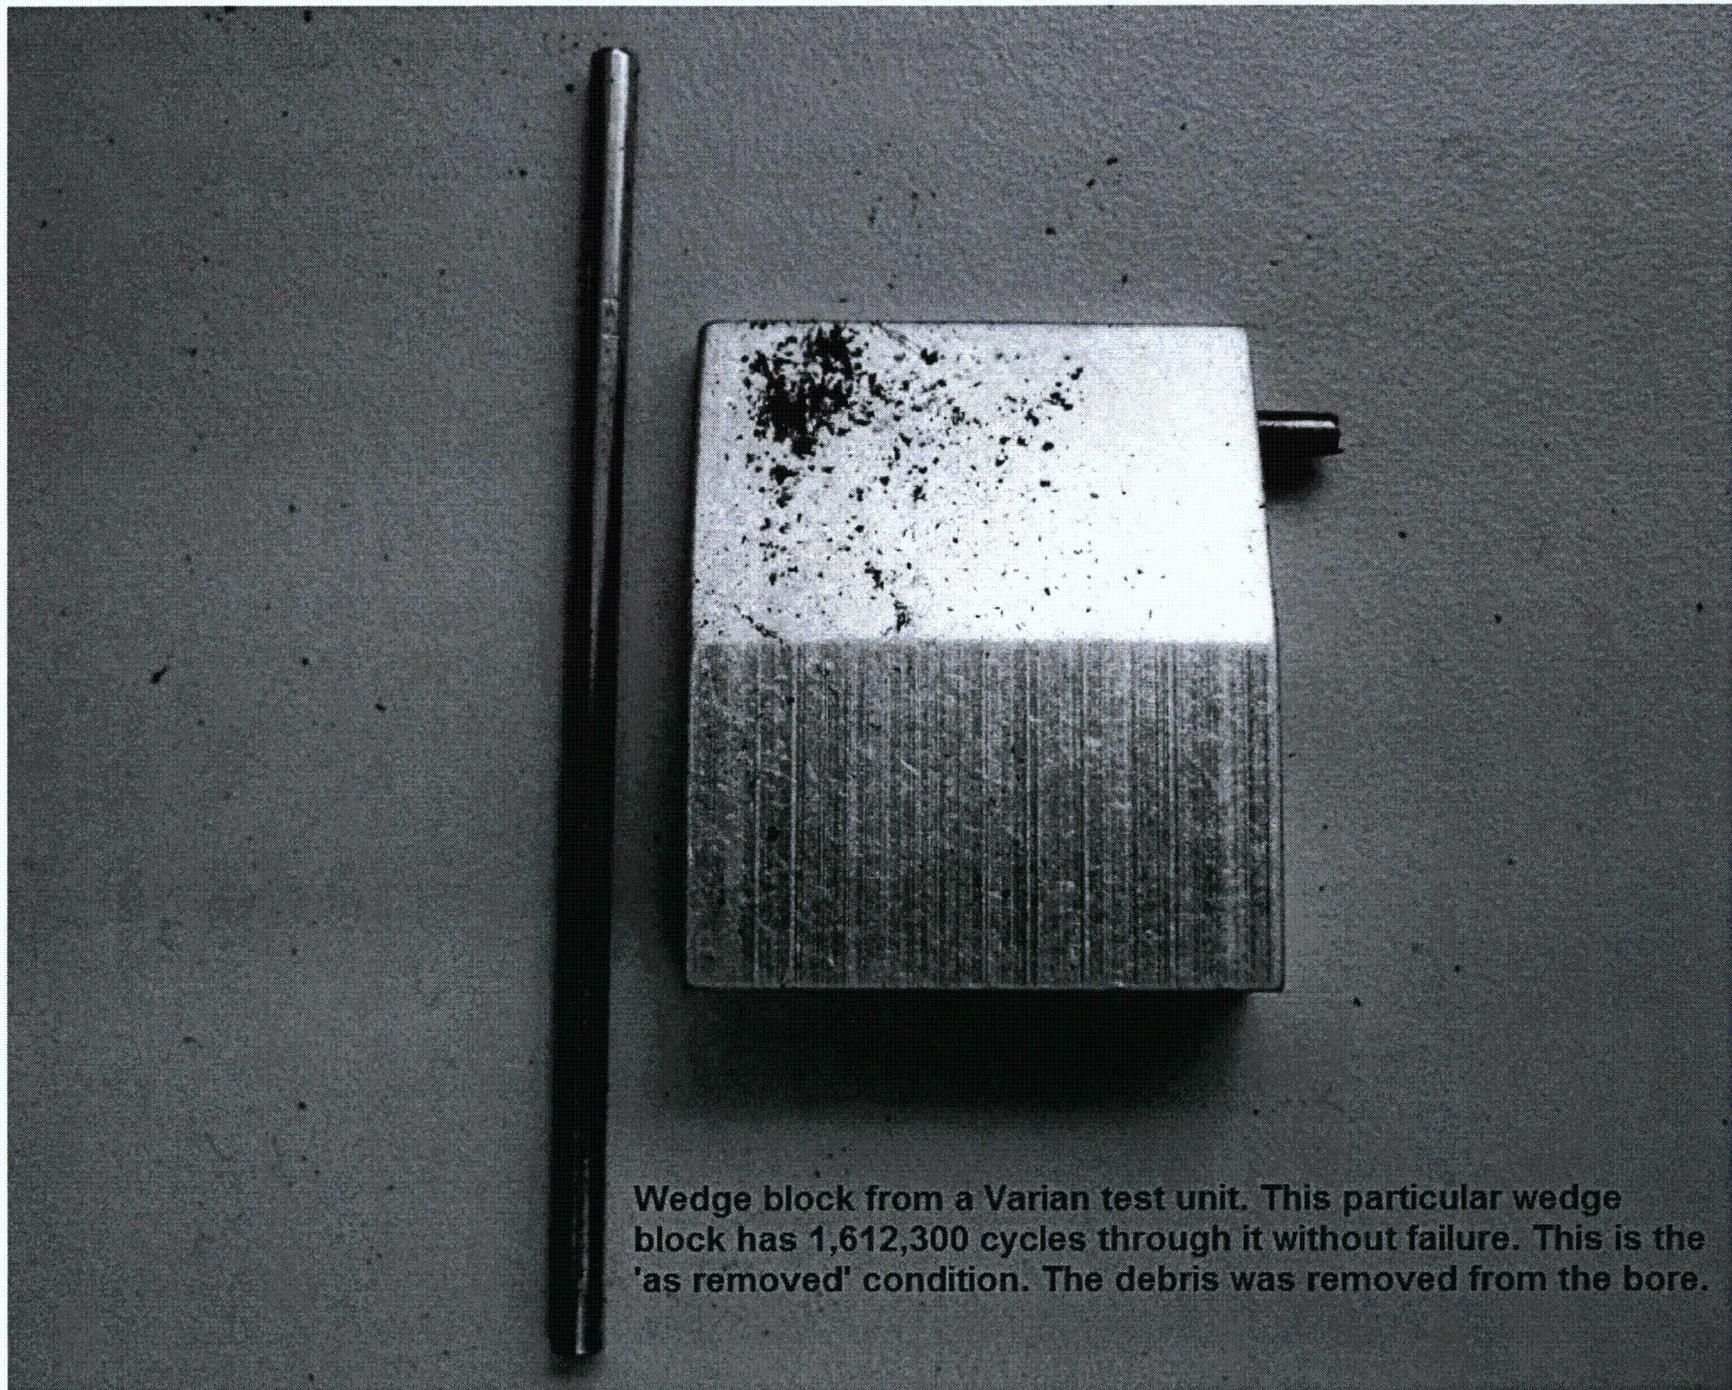
2. **Wedge block from a Varian test unit...** This is from a test unit at Varian Charlottesville that has 1,612,300 cycles on the wedge block. The debris is the material of interest in Event 44774.

Wedge block from a Varian test unit. This particular wedge block has 1,612,300 cycles through it without failure. This is the 'as removed' condition. The debris was removed from the bore.

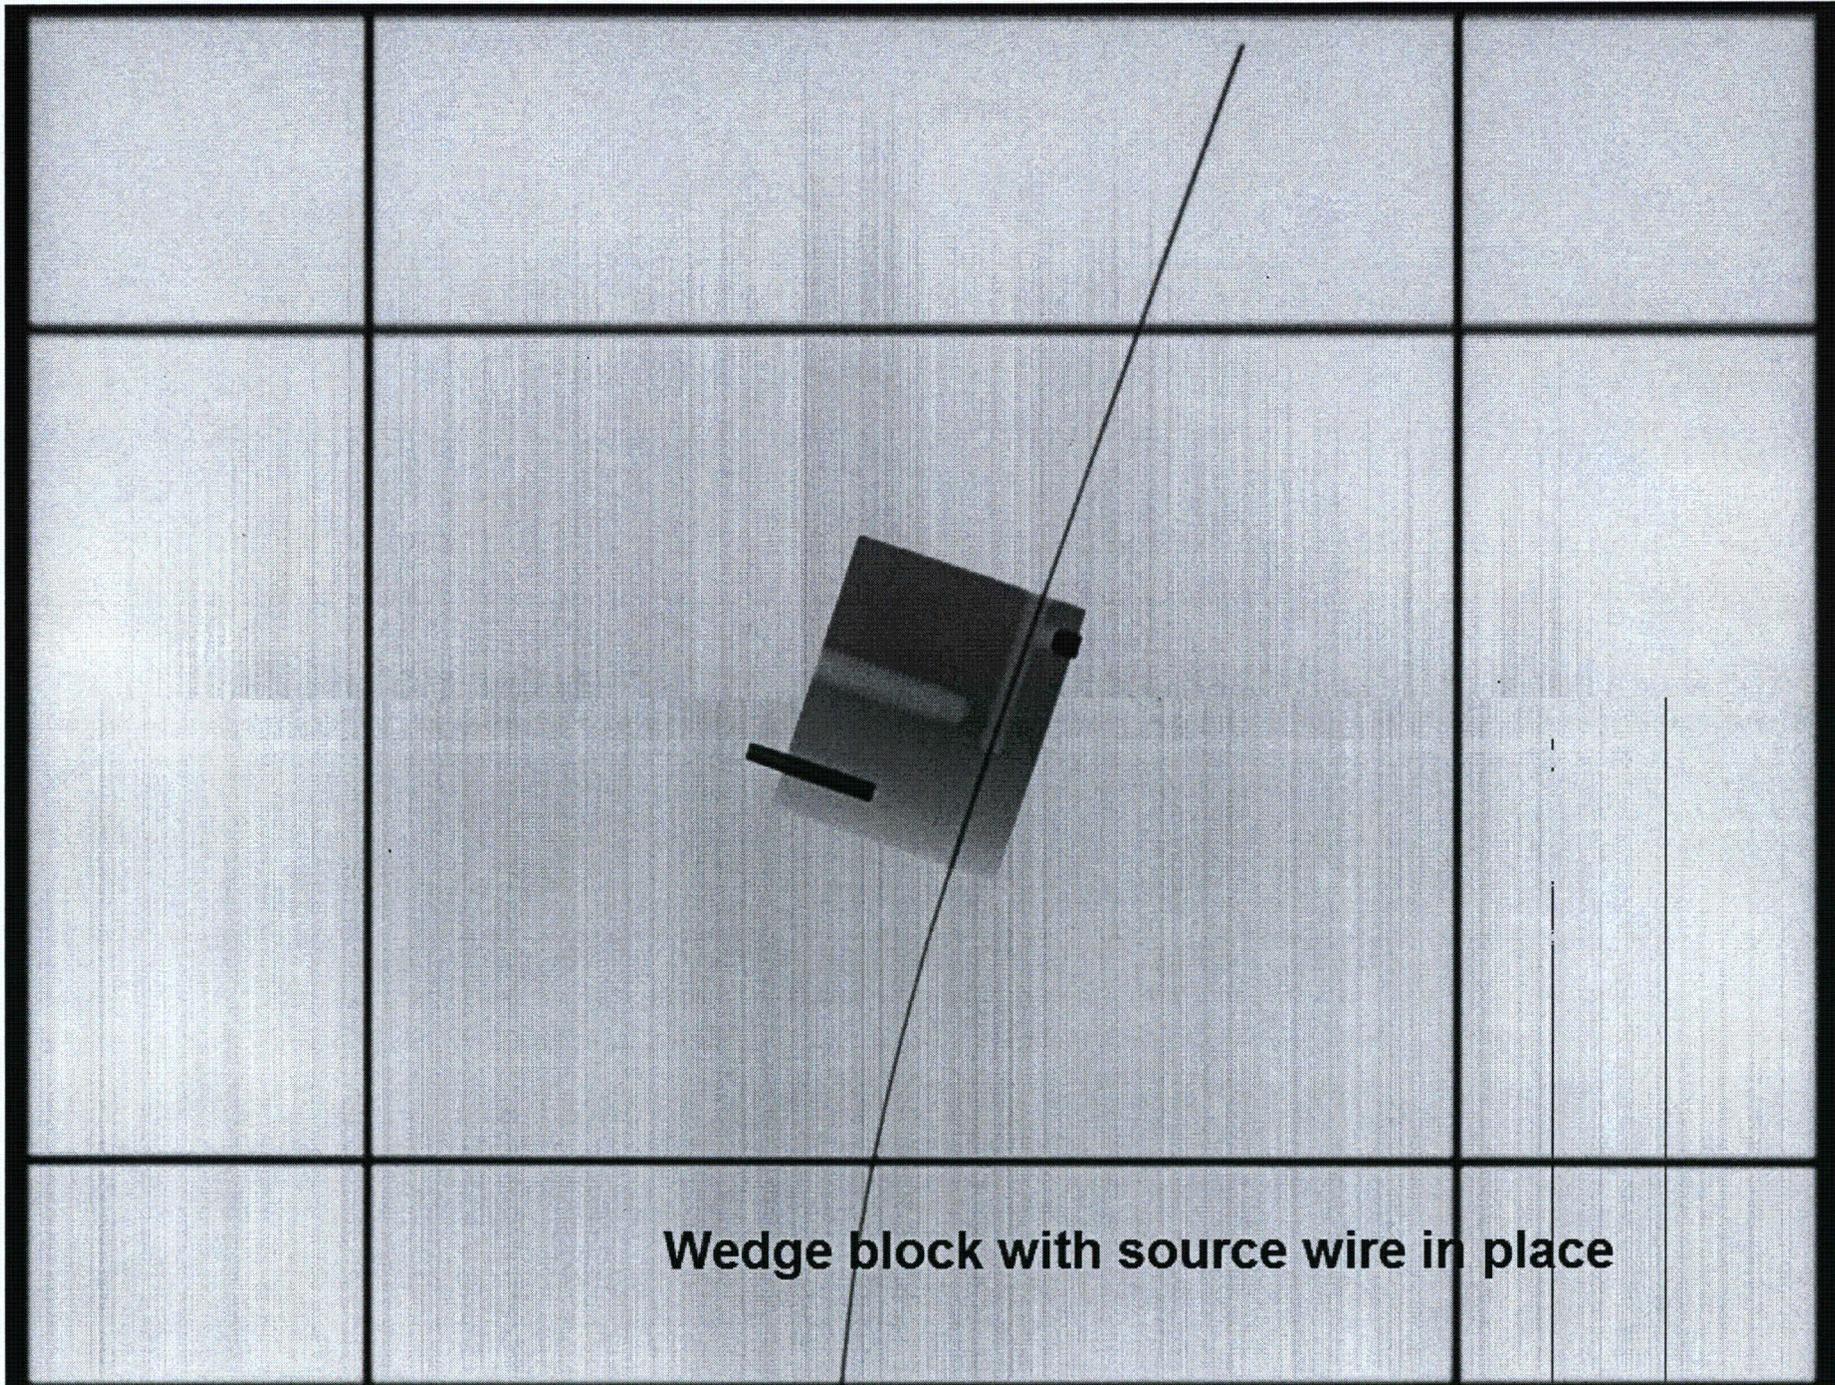
3. **Wedge block with source wire in place.** This shows the source wire as it fits through the bore of the wedge block.
4. **Wedge block.** X-ray at oblique view of the wedge block. When installed on the HDR unit the right side of the wedge block is at the top and the wire travels through the length of the wedge block. The source wire is only out of the wedge block when a source exchange takes place. Otherwise, the lumen of the bore is always occupied as the wire moves forward and back with each extension and retraction

Wedge block with source wire in place

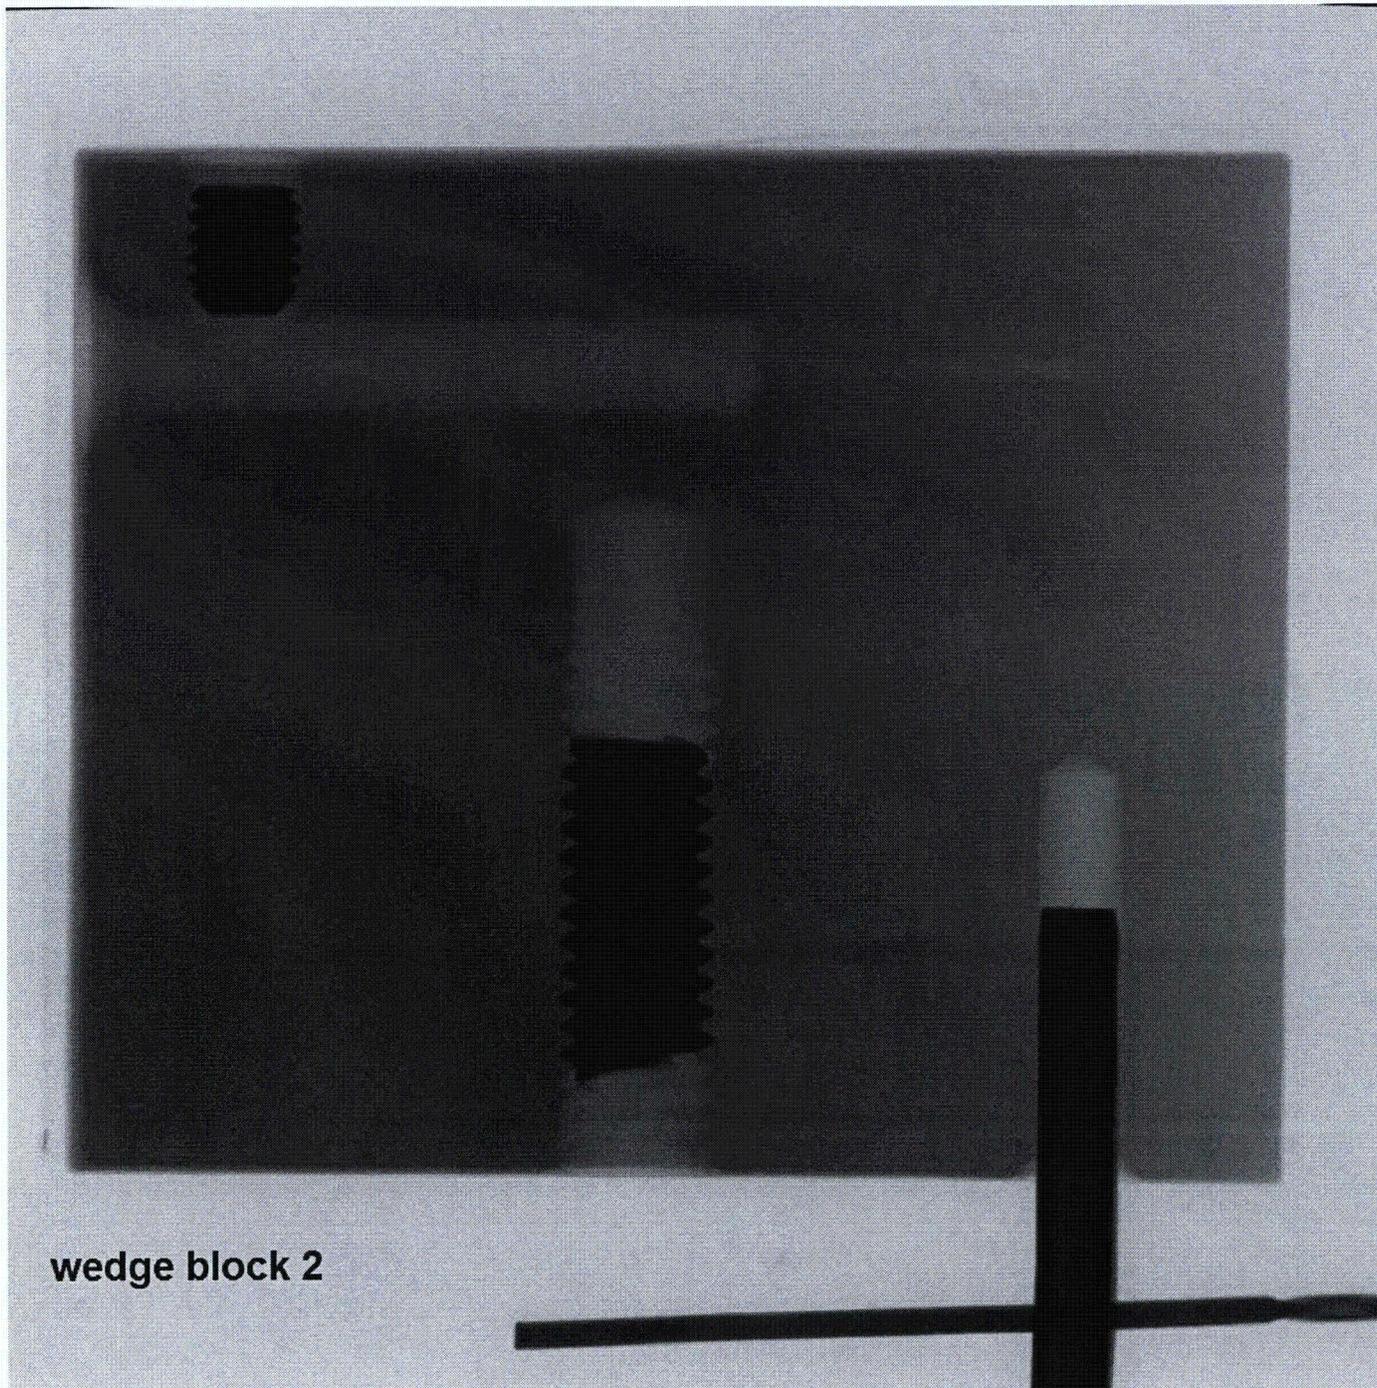
wedge block 2

5. **Wedge block 2 .** X-ray view, showing the exit of the bore to the right. The bore exits on the angled face of the wedge, therefore, it does not extend to the far edge of the image.

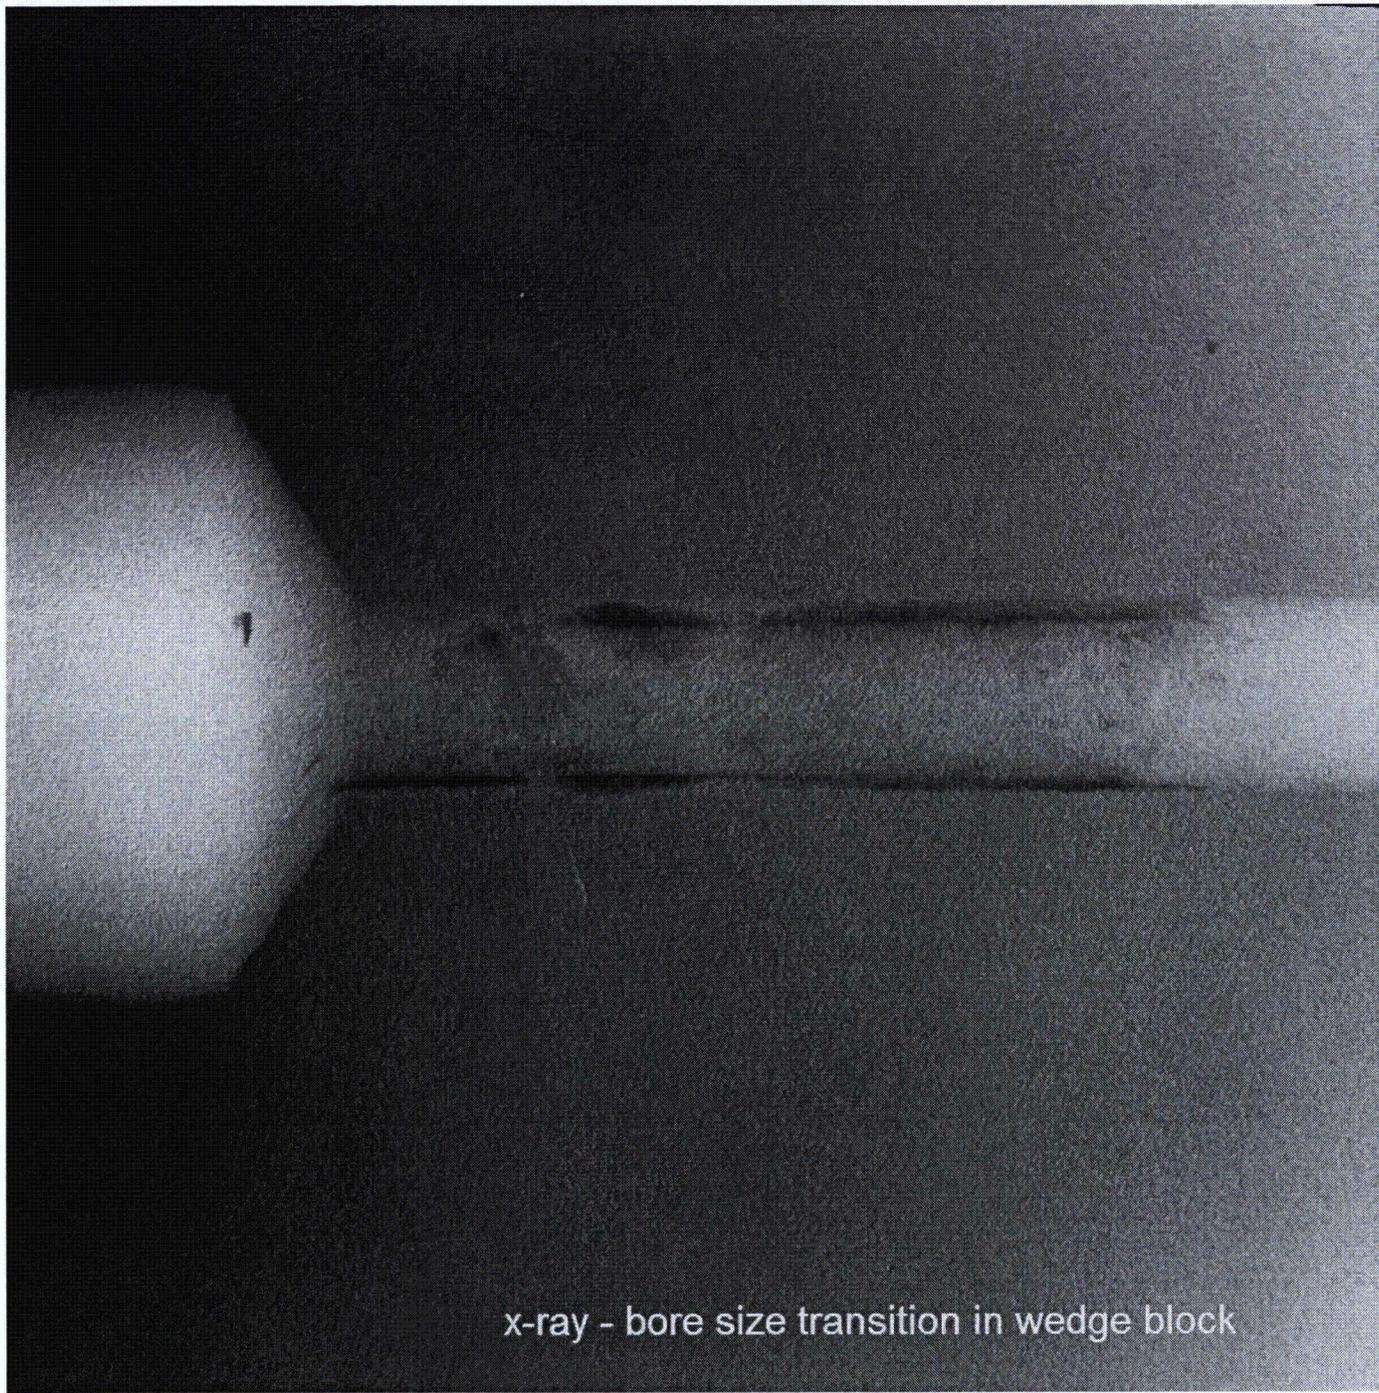
x-ray - bore size transition in wedge block

6. **X-ray – bore size transition in wedge block.** Close up view of the transition of the bore size. Slight deposition of material is seen, though it cannot be quantified. The bore diameter is nominally 0.7mm.

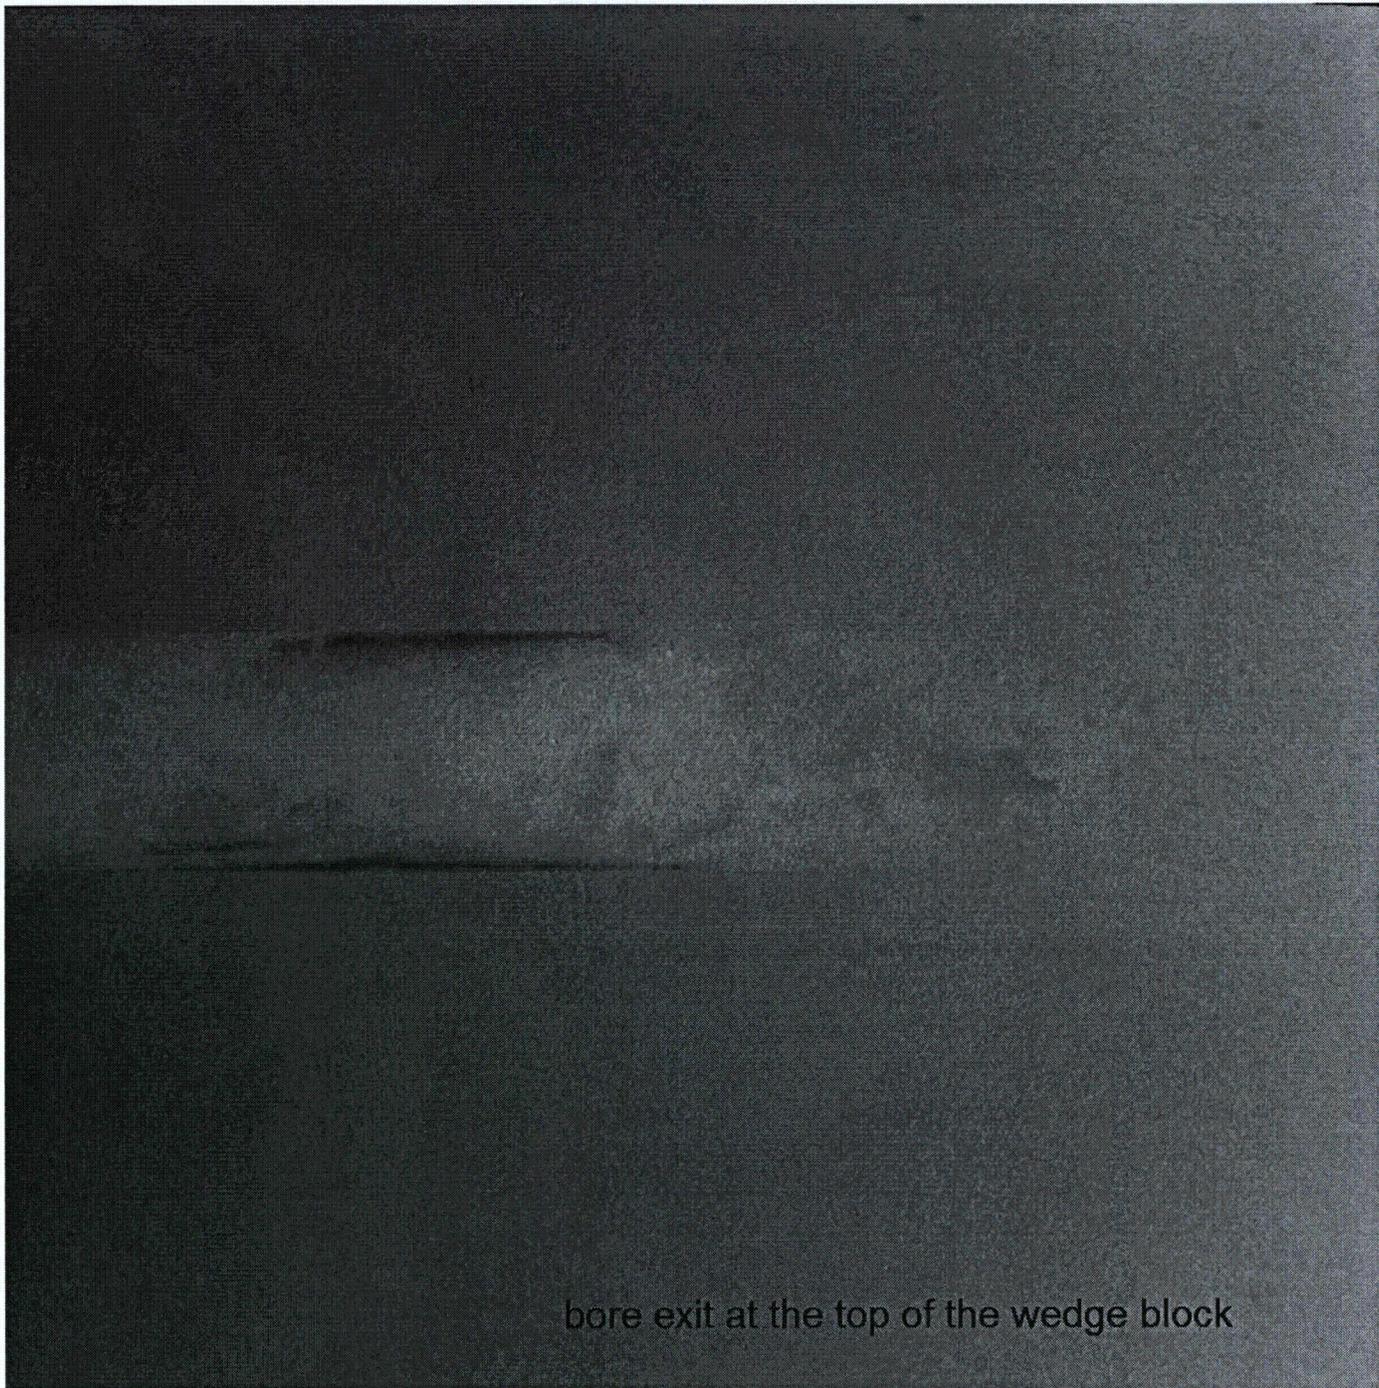
bore exit at the top of the wedge block

7. **Bore exit at the top of the wedge block.** Close up view of the exit of the bore on the angled face of the wedge block. In real life it looks like the end of a hypodermic needle, as if one were to cut through a hollow needle at an angle.

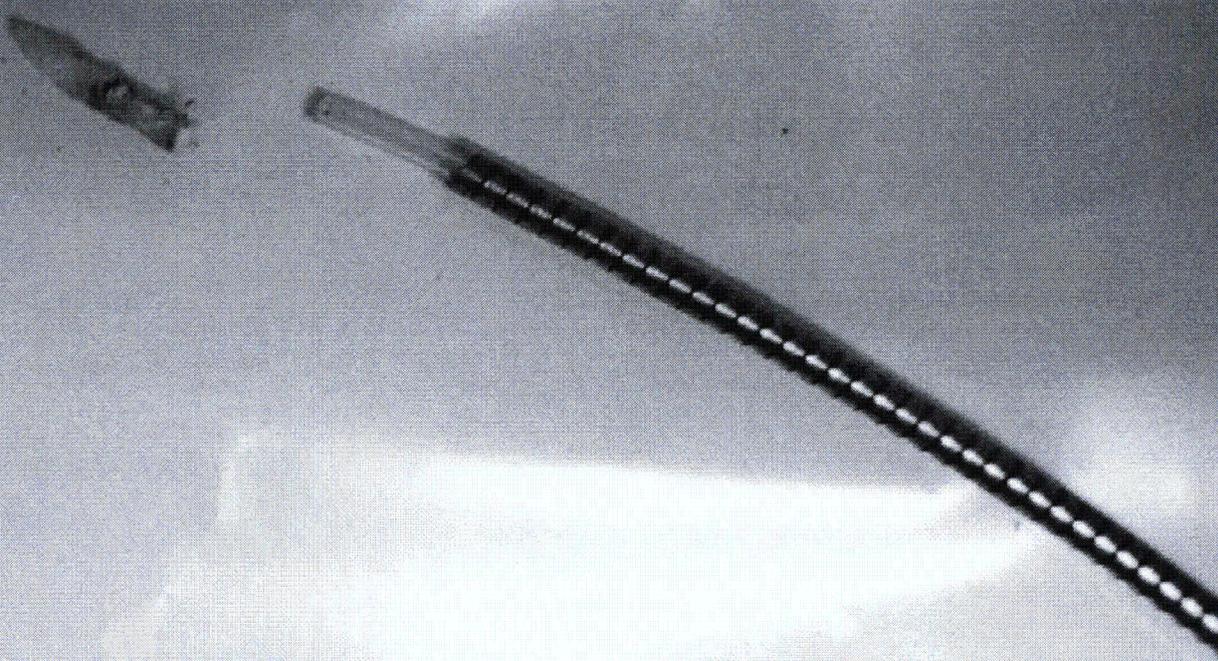
monocoil swab 1

8. **Monocoil swab 1.** View of the monocoil sheath that is used to cover, protect and secure the tail end of the source wire while it is installed in the shipping container. Some debris is seen on the swab. Source wires are cleaned as part of the installation procedure.

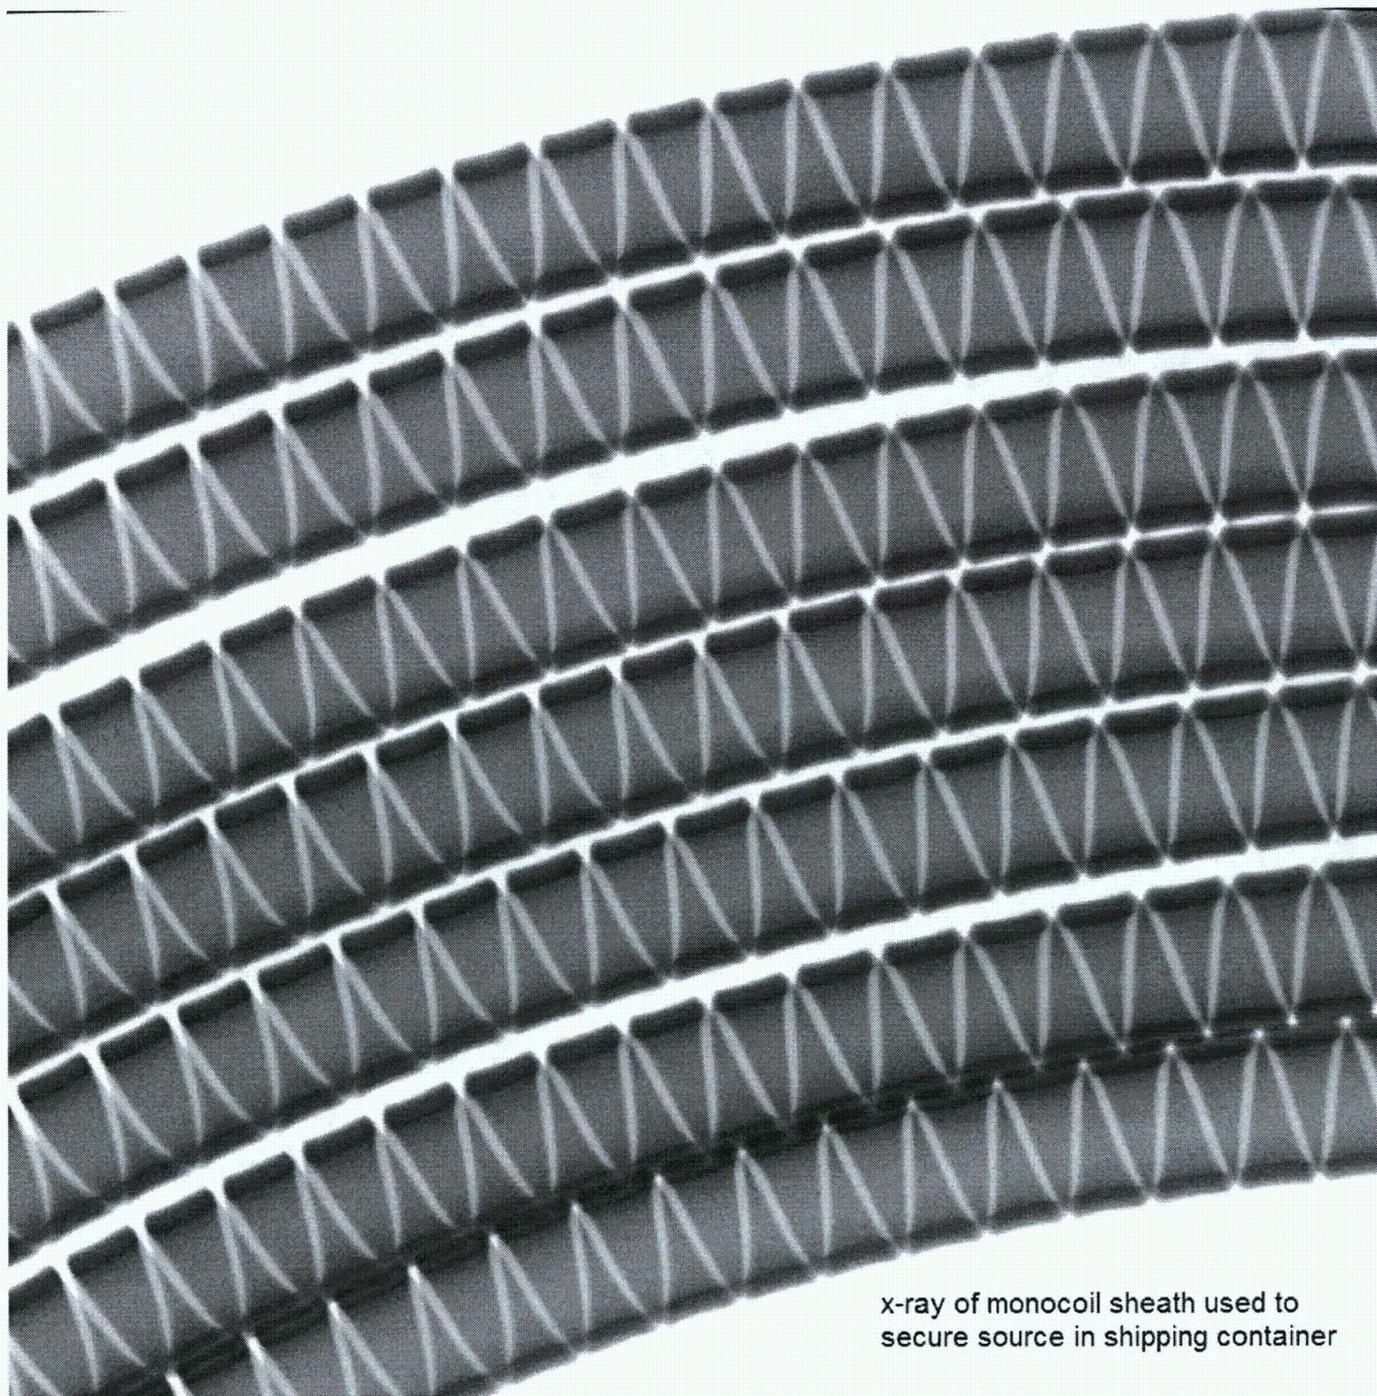
9. **Monocoil swab 2.** Close up view of the swab taken of the interior of the monocoil sheath.
10. **X-ray of monocoil sheath used to secure source in shipping container.** X-ray through several coils of the monocoil sheath while investigating if there was anything on the internals of the sheath that might contribute to the event.

x-ray of monocoil sheath used to
secure source in shipping container

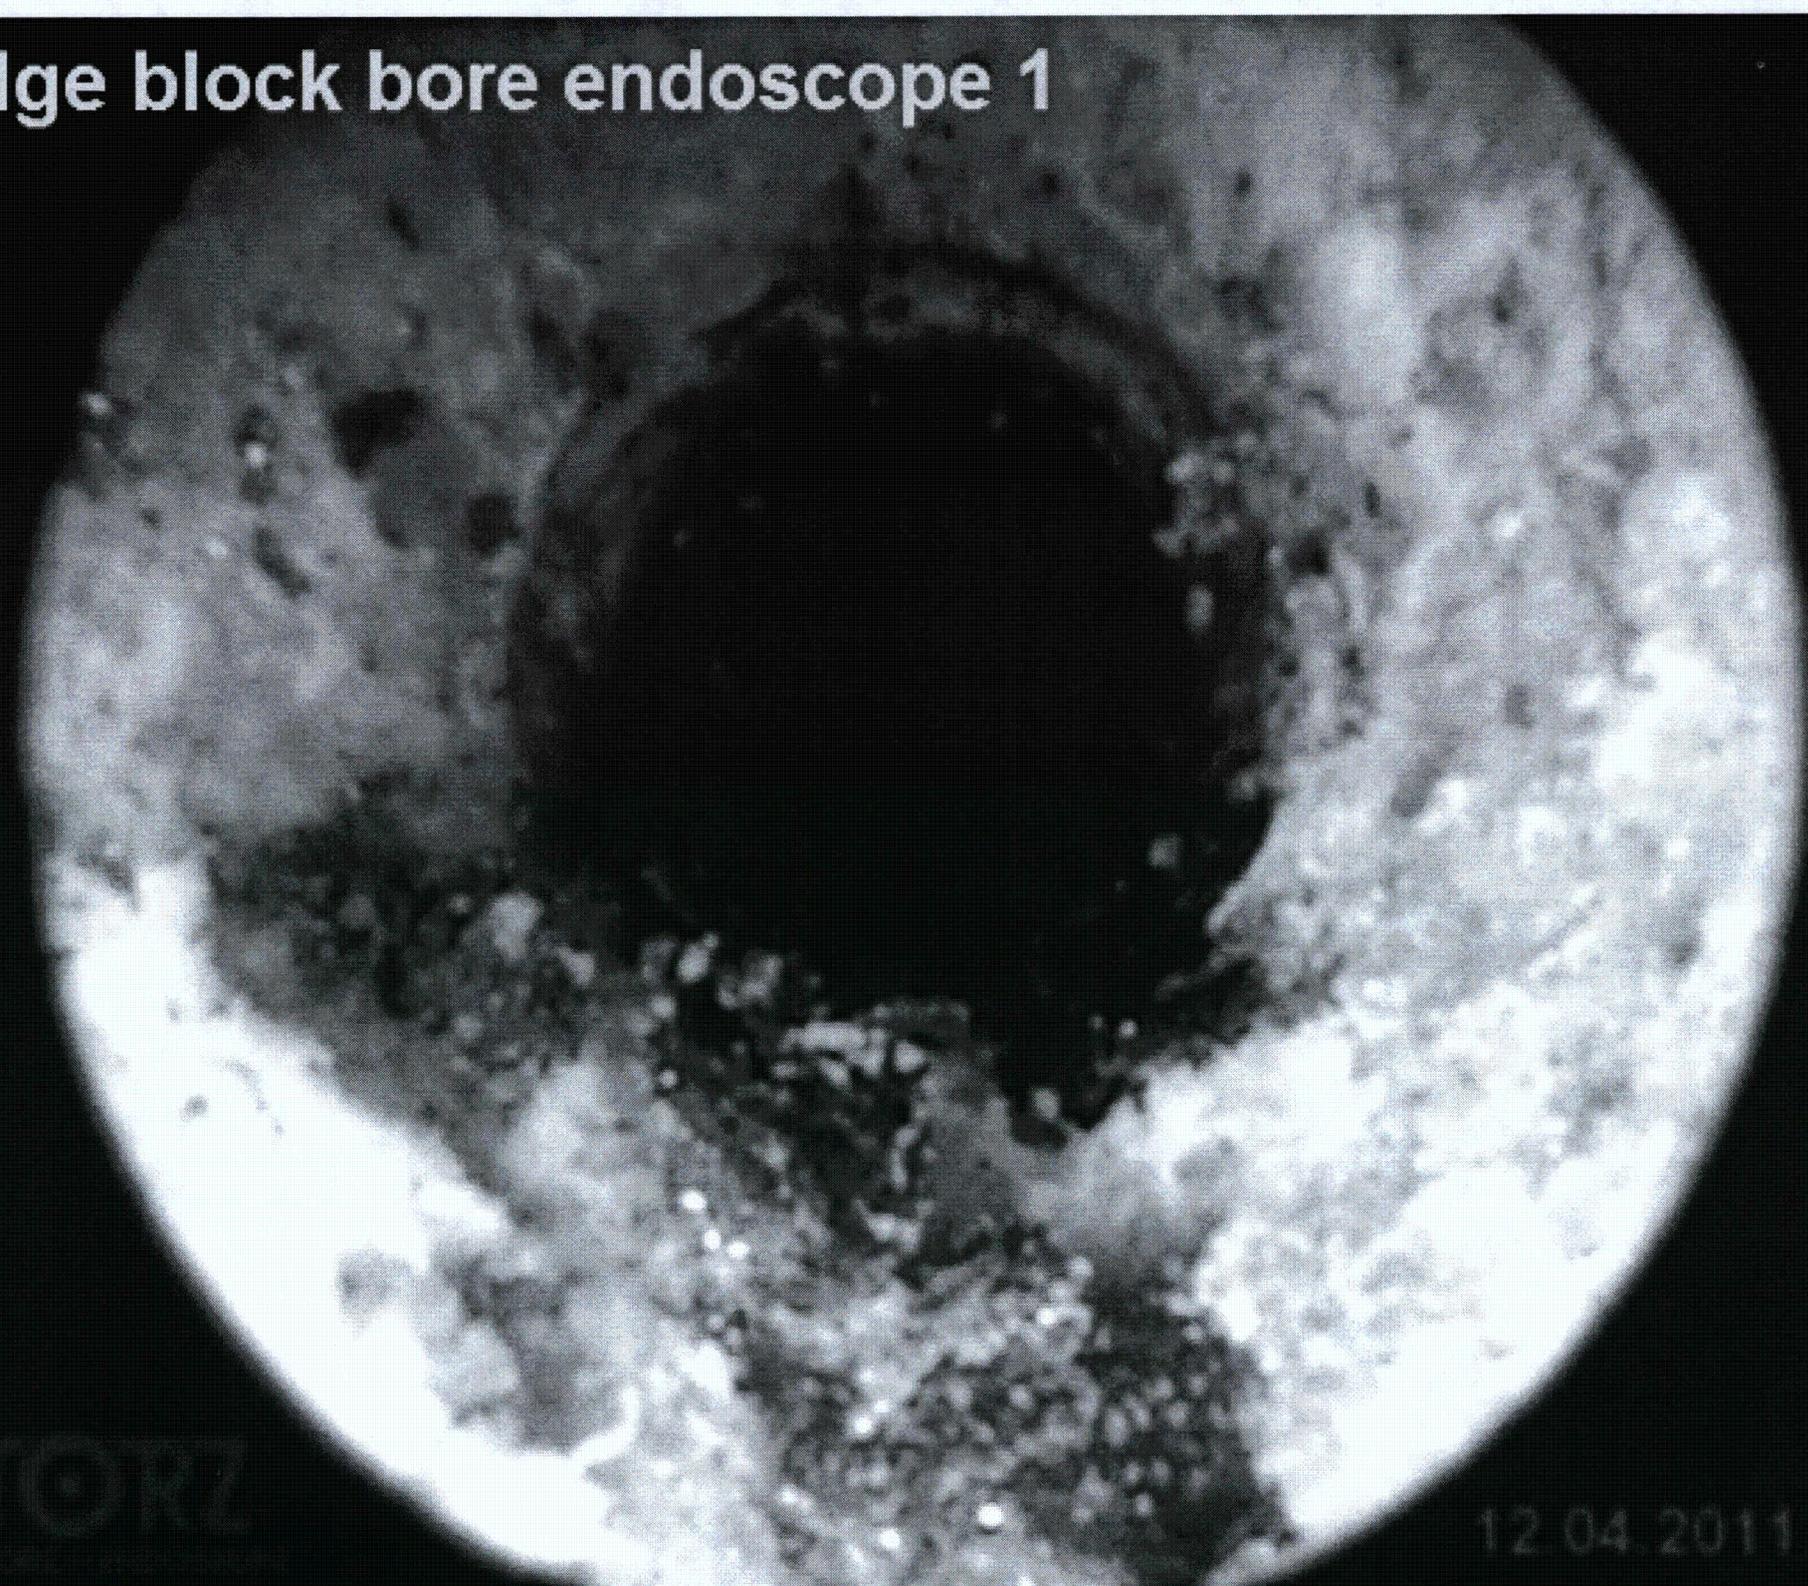
wedge block bore endoscope 1

13. **Wedge block bore endoscope 1.** Close up endoscopic photo into the bore of the wedge block involved in the event.
14. **Wedge block bore endoscope 2.** Wider angle endoscopic view into the bore of the wedge block with an area of interest highlighted. There was no clear decision if the area of interest was anything more than random manufacturing markings.

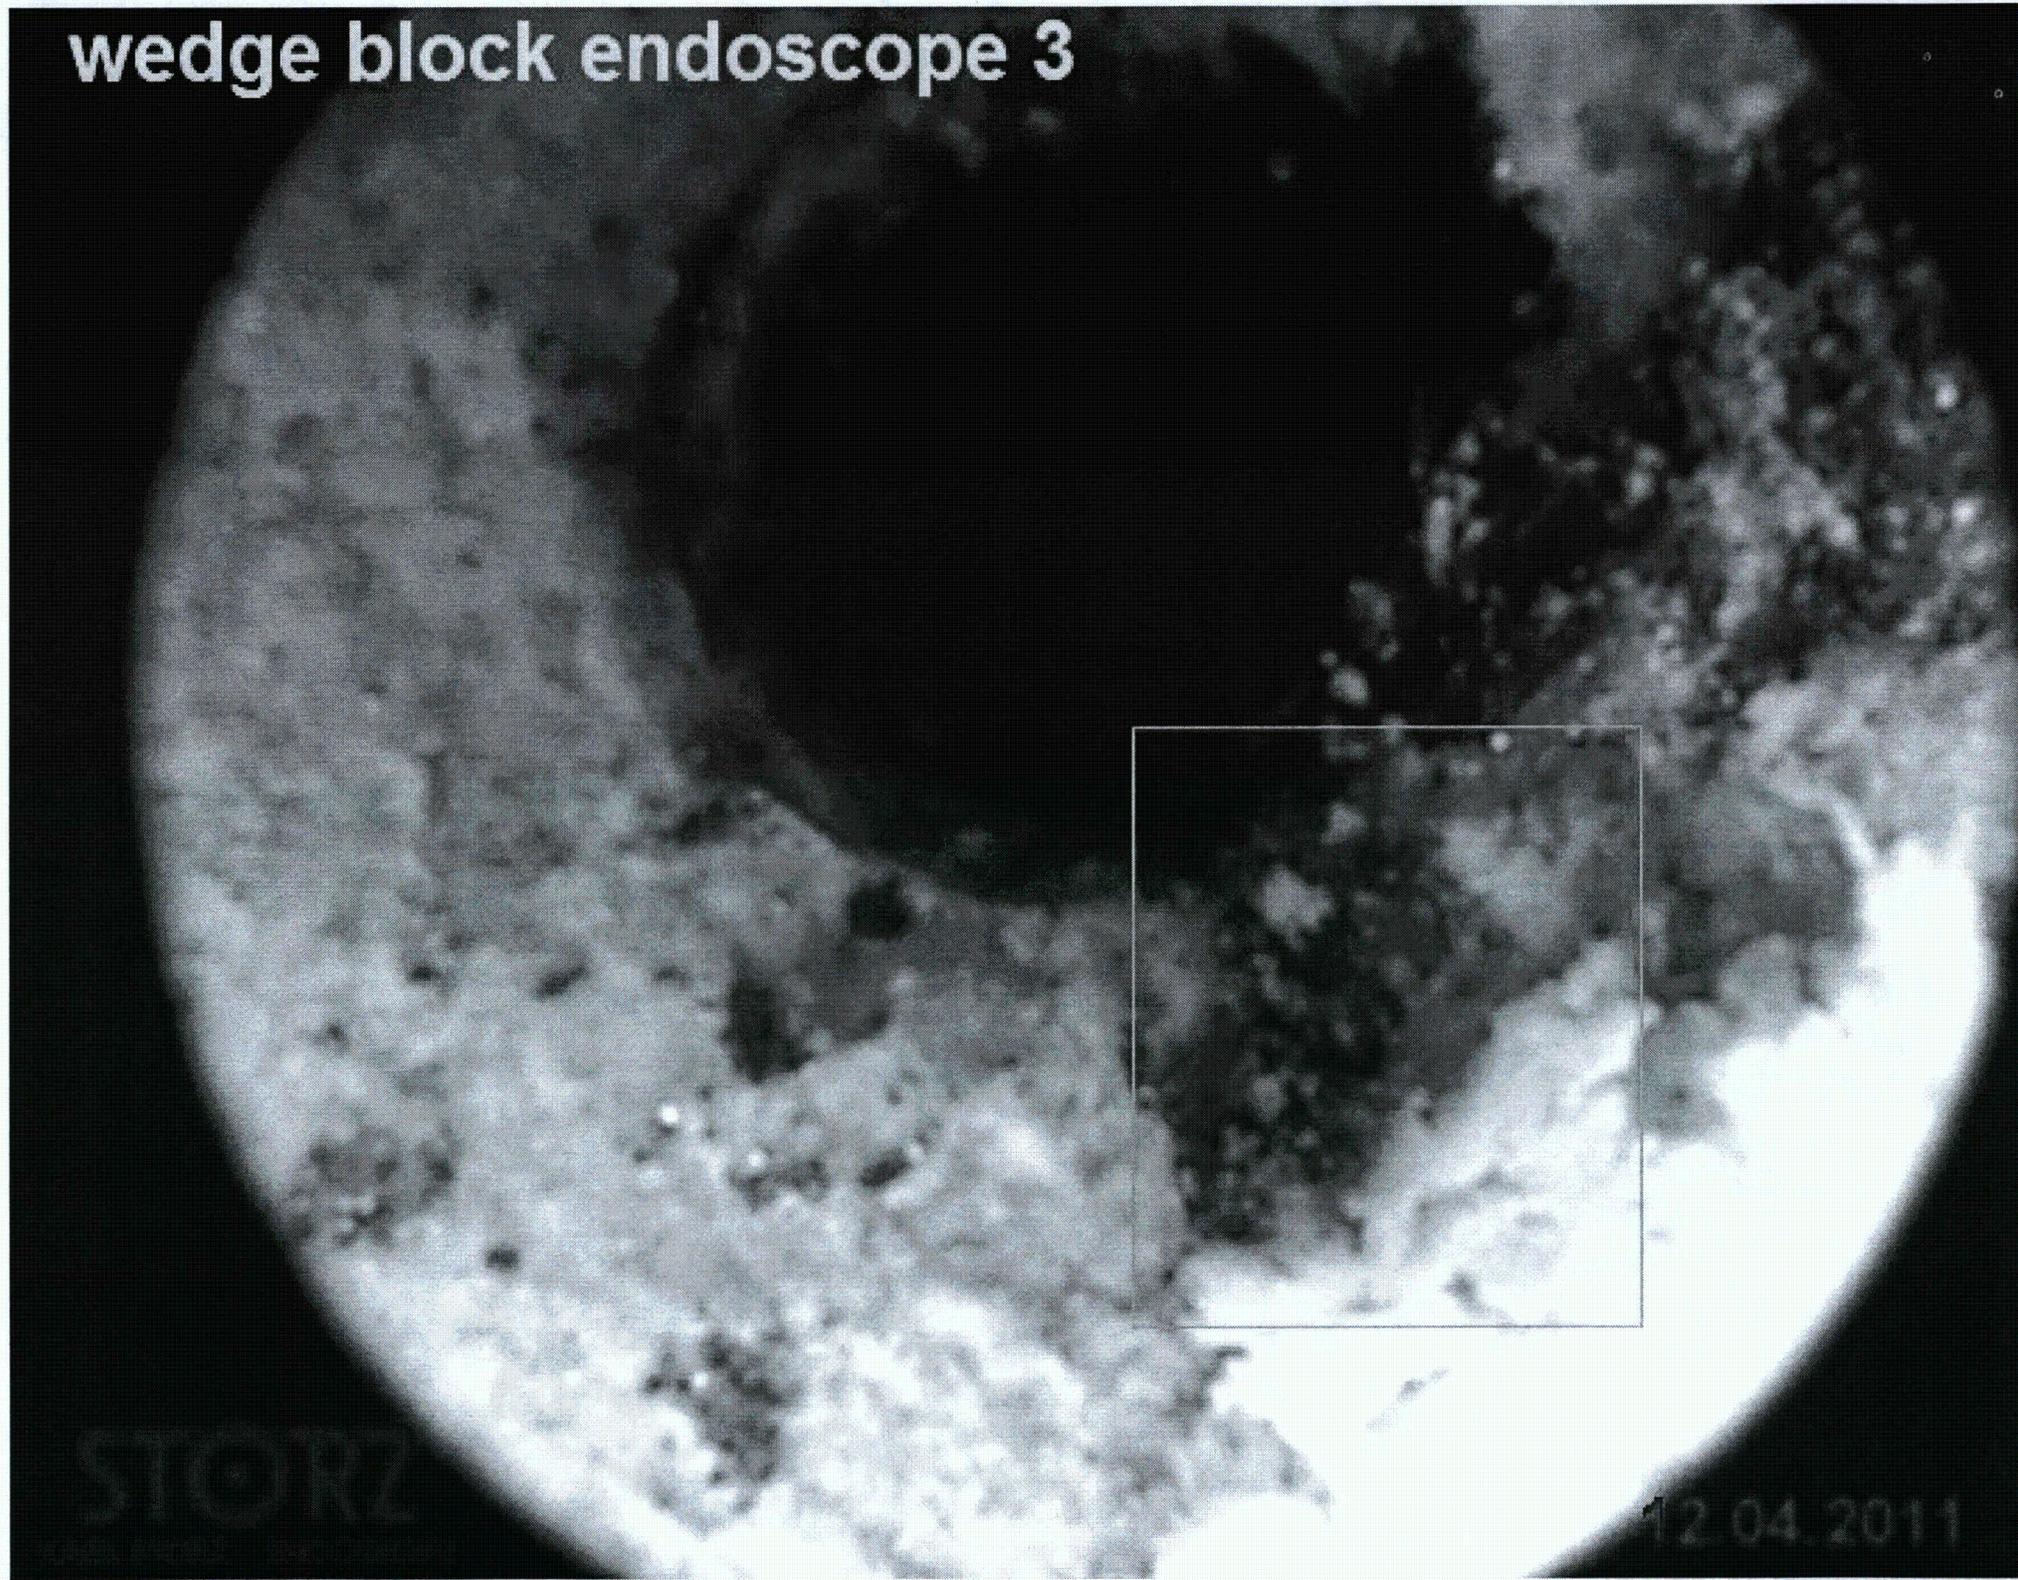
wedge block endoscope 3

15. **Wedge block bore endoscope 3.** Close up view of the area of interest. Nothing definitive was identified.
