Subject: Oconee Nuclear Station  
Docket Nos. 50-269, -270, -287  
LER 287/90-01

LICENSEE EVENT REPORT (LER)

TITLE (4)  
**Control Rod Group Drop During Testing Due to Unknown Reasons Causes Automatic Reactor Trip**

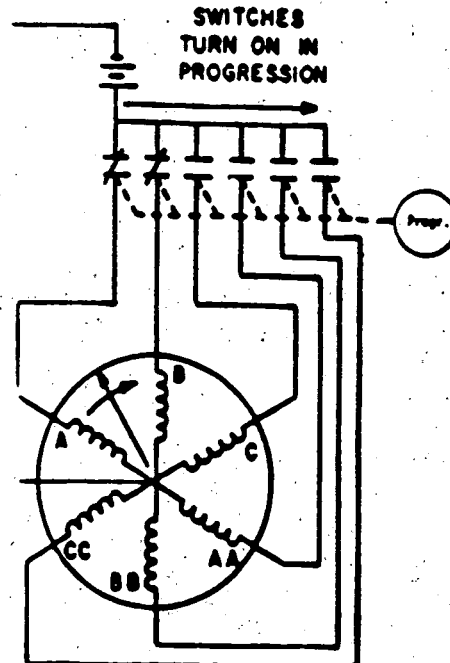
ATTACHMENT # 2

SUMMARY DESCRIPTION AND ILLUSTRATION OF TEST SEQUENCE CAUSING ROD GROUP 6 TO DROP INTO THE CORE

During testing of the Group 6 control rod power supply, transfer of power to the auxiliary power supply was initiated. The normal power supply apparently failed to disengage properly. As a result of this failure, when the normal power supply was cycled to the various phases of the rod contactors (as illustrated below), four phases were energized instead of the normal two phases. Normal operation is that the next phase in sequence is energized and therefore three phases are energized for a brief time until the first phase in the sequence drops out due to the three-two hold feature. At the beginning of the test phases, AA and BB were energized. After cycling once, phases AA, BB, and CC were energized. After cycling again, phases AA, BB, CC, and A were energized (phase AA would have de-energized if the normal power supply had been disconnected). Cycling one more time, phases AA, BB, A, and B were energized. When this occurred, the magnetic fields were 180 degrees out of phase effectively cancelling each other, and the lead screw roller nuts disengaged resulting in the rods in group 6 falling into the core.

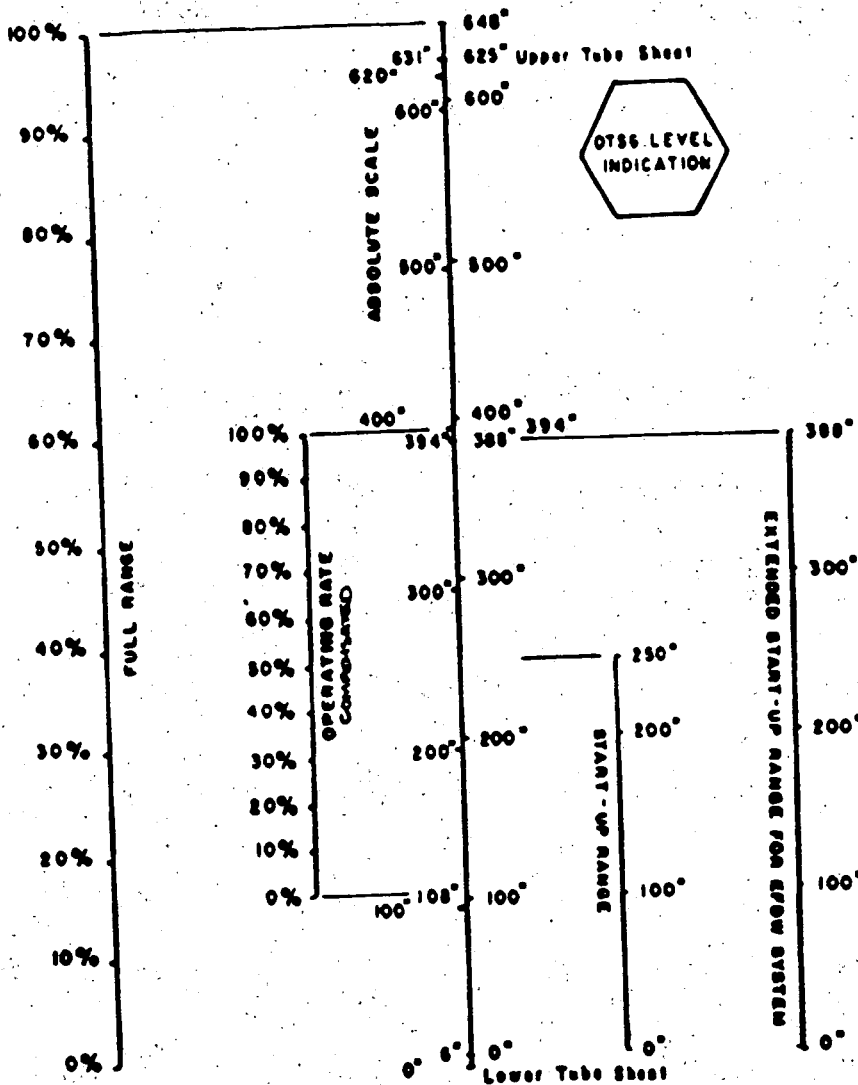
ATTACHMENT # 3

A failure in the "B" Feedwater Controller (FDW-41) resulted in an overfeed of the "B" Steam Generator to about 75% on the operating range (see attachment # 3). This failure was attributed to the integral module controlling FDW-41, which was found set at 0.3 repeats/minute. The expected setting is 4.5 repeats/minute. The automatic demand signal sent to FDW-41 initially closed the valve. However, the large error across the integral (due to the incorrect setting) caused the valve to re-open. Then, upon operator input to close the valve, a much slower than normal response resulted. The valve response was verified to be consistent with the integral's as-found rate setting subsequent to this event.
