**Subject: Palo Verde Nuclear Generating Station (PVNGS) Unit 1
Docket No. STN 50-528
License No. NPF-41
Response to NRC Draft Request for Additional Information 2010
Steam Generator Tube Inspections**

**Response to Draft Request for Additional Information
Unit 1 2010 Steam Generator Tube Inspections**

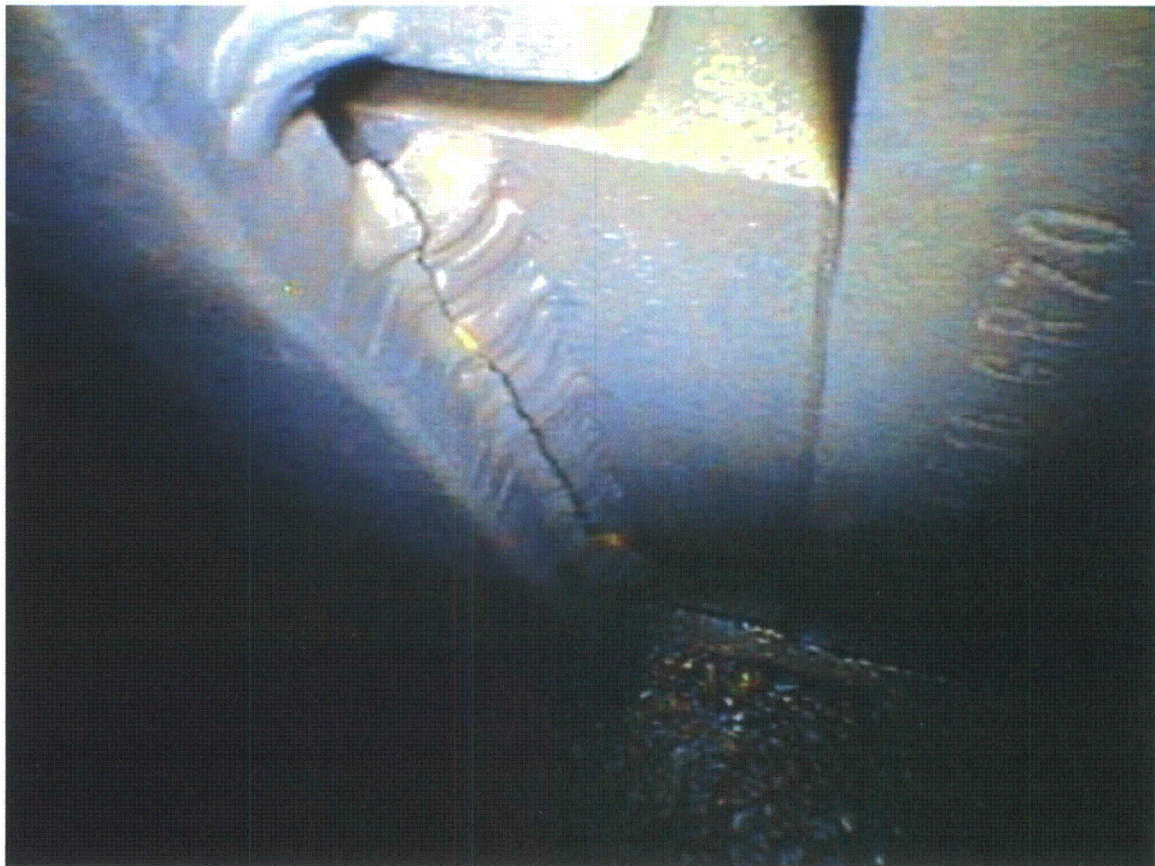
During Foreign Object Search and Retrieval (FOSAR) on the secondary side of the PVNGS Unit 2 replacement steam generators (RSGs) during the 15th refueling outage in Unit 2 (U2R15), cracked welds were observed on the (blowdown duct) patch plates, which are located on the secondary divider plate assembly near the 90-degree and 270-degree handholes (See Figures 1 and 2). Similar cracks were confirmed to exist on the twelve blowdown duct patch plates in each of the six RSGs. This condition is documented in the PVNGS corrective action program (Condition Report / Disposition Request (CRDR) 3395100).

Figure 1
View of Patch Plate to Lug Weld Crack in RSG 21 at 90° Handhole Hot Leg Side

Figure 4 shows the lower shell divider plate lugs. Both the upper lug and lower lug are full penetration welded to the steam generator shell. The divider plate, which is full-penetration welded to the central stay cylinder, has only a tongue-and-groove attachment to the upper and lower divider plate lugs. Since the divider plate can move relative to the lugs, the design should not have specified the patch plate to be rigidly connected to the lower divider plate lug. However, Figures 1 and 2 show that the patch plate was welded to both the divider plate and the lower lug. Movement of the divider plate relative to the lower lug is the likely cause of the cracked weld.

A review of Figures 1 and 2 shows the cracked weld metal remains attached to either the patch plate or the lug at every location except at the bottom. At this location there is a small section of the weld that is attached only to the patch plate. A close review of

where the cracked weld remains attached to the lug and patch plate does not show any indication of cracking or any other indication that it would become loose. This has been verified on all 12 patch plates at PVNGS. Since the crack has relieved any significant loadings on the weld, the likelihood that a piece would fall off is remote. As a result, there is a minimal risk that the cracked weld could cause a loose part that could affect the structural or leakage integrity of the tubes.

To confirm these conclusions, APS will inspect the patch plates whenever a top of tubesheet FOSAR is performed. These inspections will examine the remaining welds and verify they are intact and that the cracked welds are not disintegrating (chipping away) or forming a loose parts concern.

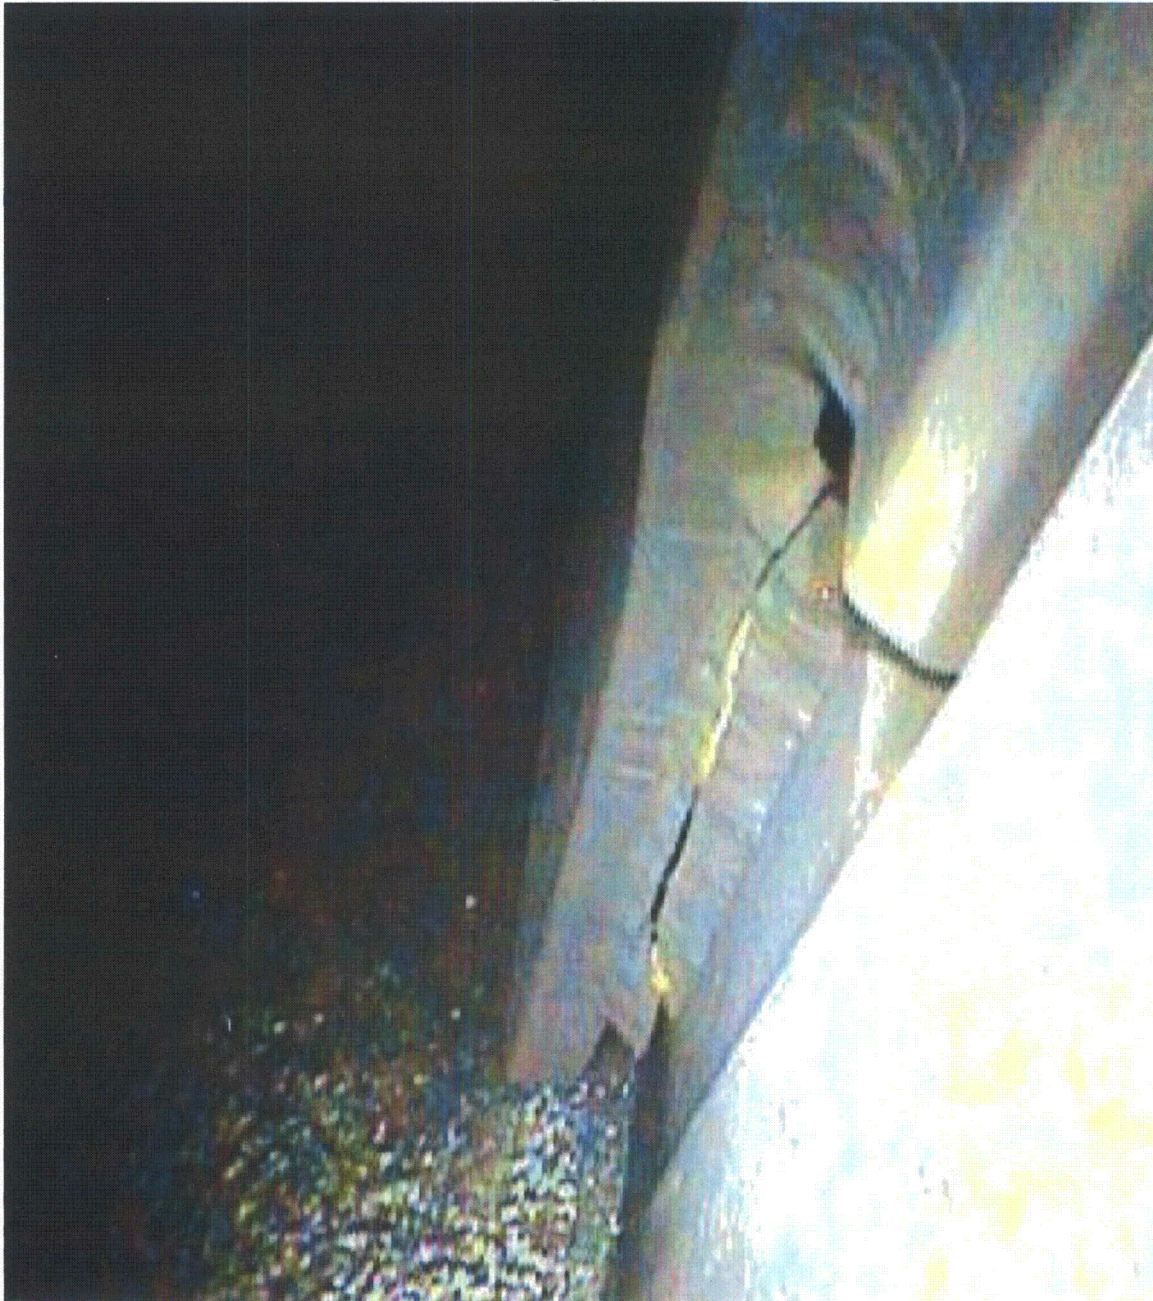
Figure 2

Alternate View of Patch Plate to Lug Weld Crack in RSG 21 at 90° Handhole Hot Leg Side

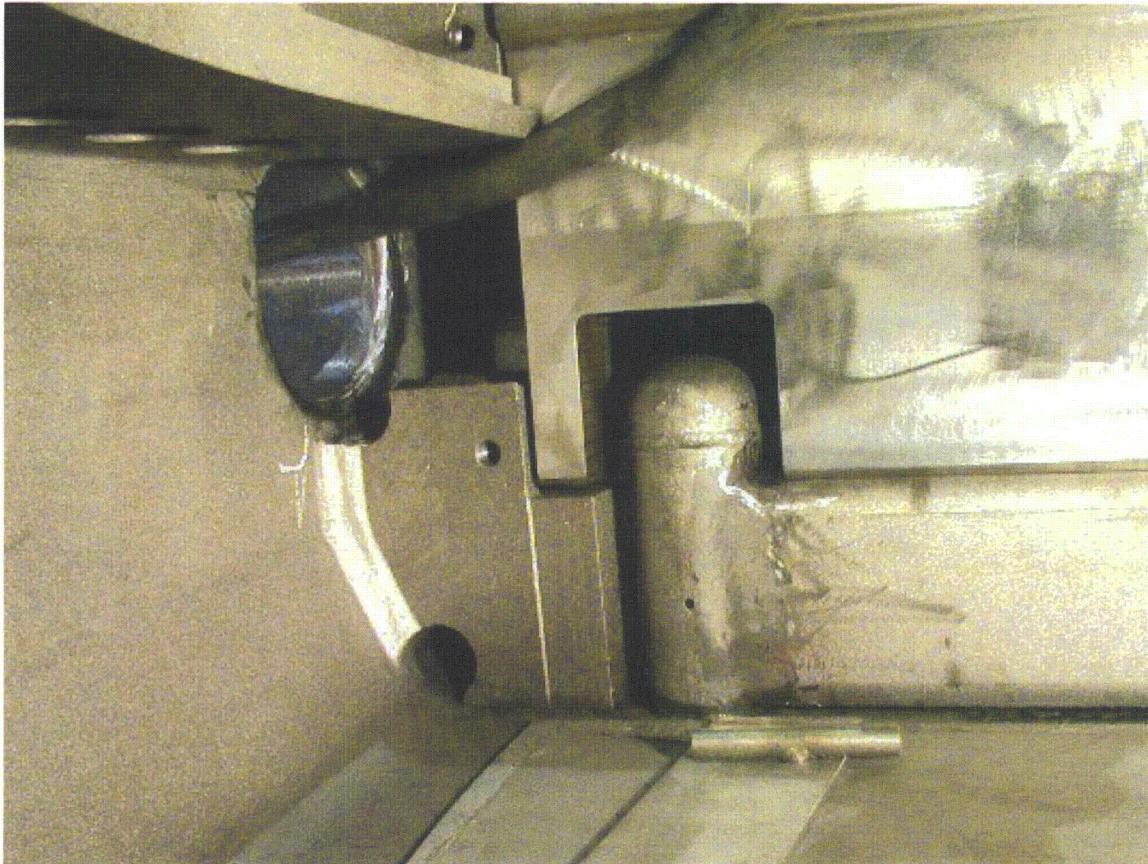
The design basis for the blowdown duct patch plate is to minimize the amount of feedwater flow that can escape from the economizer (preheater) and enter the hot leg side of the steam generator. As shown in Figure 3, the divider plate has a cutout for a capped cylinder that connects to the interior blowdown piping. The cylinder is inserted into the tubesheet and allows the blowdown flow to exit the steam generator through the

tubesheet and out the blowdown nozzle exterior to the steam generator. The cutout contains several square inches of uncovered opening, which is covered by the patch plate.

Figure 3
View of Secondary Divider Plate Cutout before Patch Plate Installation

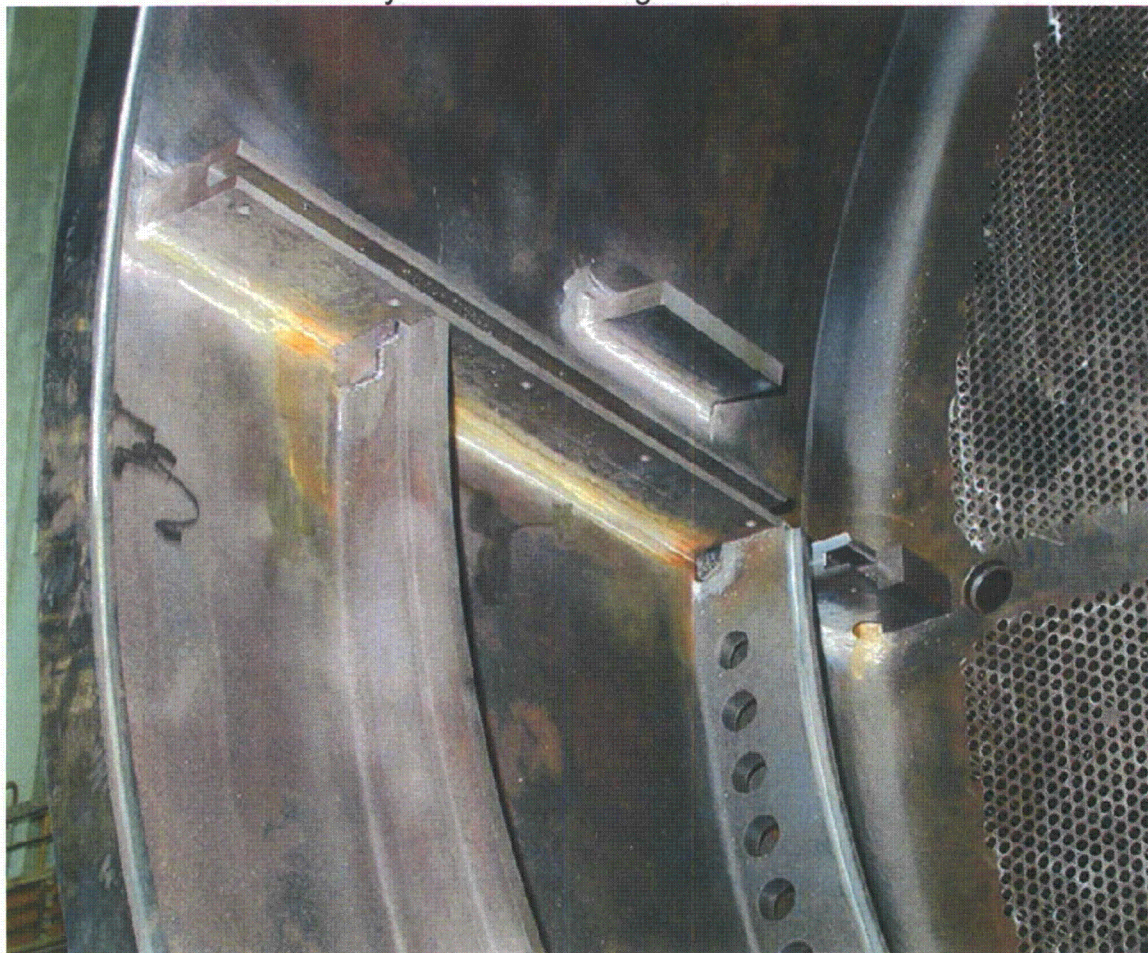
Figure 4
View of Secondary Divider Plate Lugs before Divider Plate Installation
