PVP2011-58001

Road Tunnels and Fires: Implications for the Transport of Used Nuclear Fuel

E. Easton,¹ C. Bajwa,¹ T. Mintz,² J. Huczek,³ K. Das,² K. Axler²

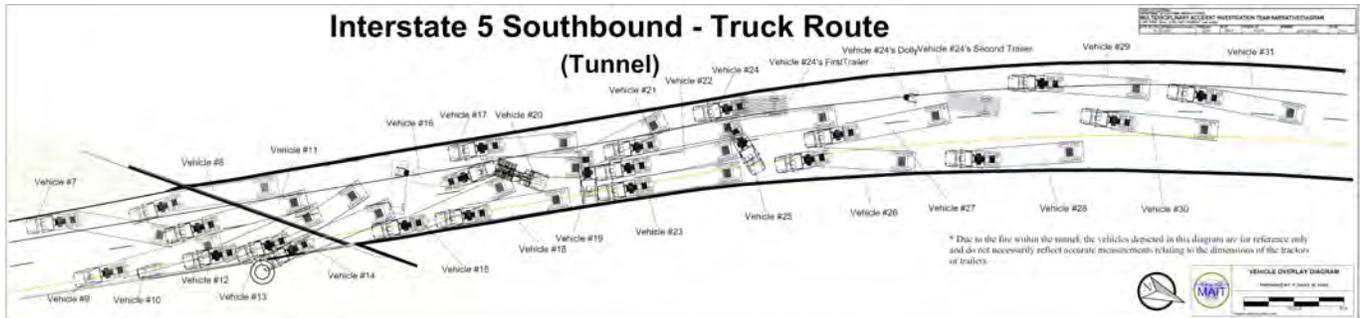
The tunnel fire was the result of a truck exiting the tunnel, losing control, and hitting a concrete median barrier. This led to a chain reaction, and 33 commercial vehicles and 1 passenger vehicle were involved in a multivehicle pileup, which spanned the full 167 m (550 ft) length of the tunnel [See Figure 3(a)]. Twenty-five of the 34 vehicles, including the passenger vehicle, were involved in the fire. The other nine vehicles were only involved in collisions that occurred outside the tunnel. There were three fatalities as a result of the fire.

Figure 3. Newhall pass tunnel geometry (a) provided by multidisciplinary accident investigation team (courtesy of CHP) and (b) fire dynamics simulator (FDS) model approximation

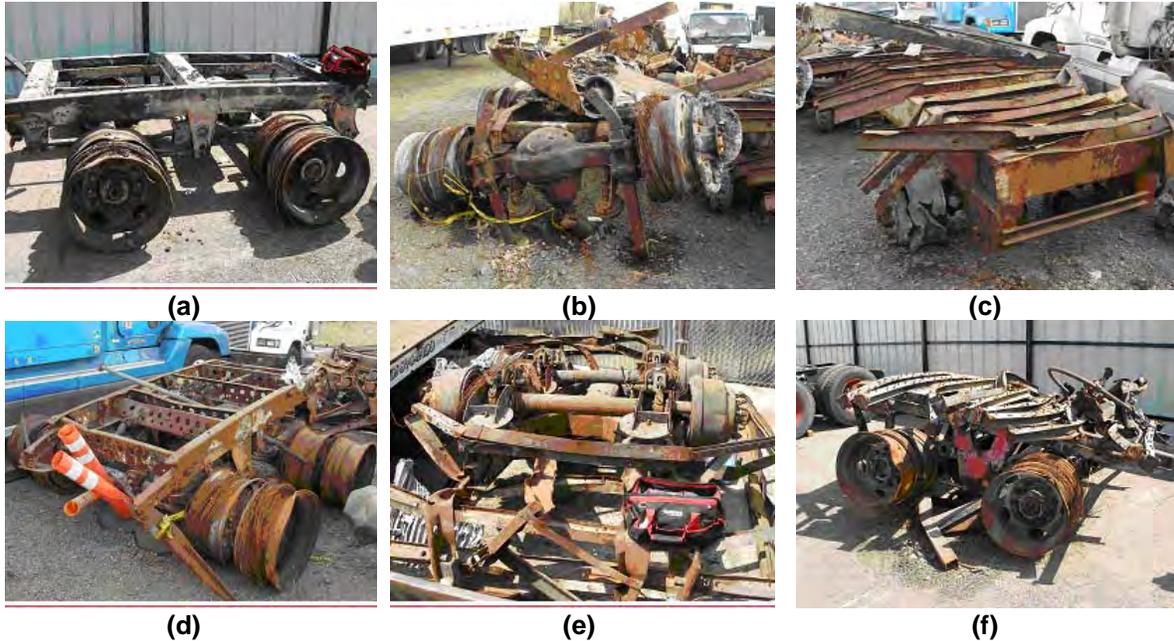
In cooperation with CHP, staff from SwRI[®] accessed the vestiges of five vehicles incinerated in the Newhall Pass tunnel fire which were held in vehicle impound lots. (Figure 4) During the onsite examination of the

Figure 4. Overall View of the Incinerated Vehicles Where Material Samples Were Collected. The Vehicles Examined Included (a) Truck 9 Trailer, (b) Truck 14 Trailer, (c) Truck 14 Trailer, (d) Truck 17 Trailer, (e) Truck 18 Trailer, and (f) Truck 27 Trailer.

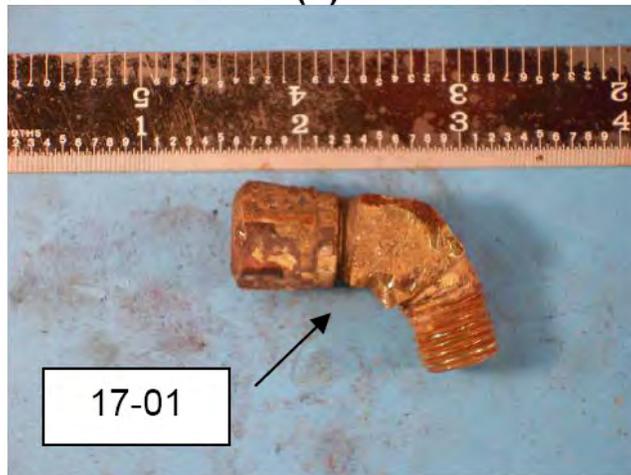
Copper (wire) is typically present in automotive electrical systems[4], and was collected from the battery cable wiring and brake light fixtures. The smaller gauge brake light wiring was expected to provide an excellent indication of the surrounding ambient temperature because the low thermal mass wire responds rapidly to changes in ambient temperature. In addition to copper, brass is in many automotive components and represents a range of copper and zinc alloy compositions. For brass, there is a wide range of compositions with corresponding variations in solidus temperatures. The brass samples collected, with one exception, showed no signs of incipient melting, which indicates that none of their respective solidus temperatures were achieved in the fire. The single exception was Truck 17 Sample #1, where one inside ferrule of a fitting was observed to have partially melted (Figure 5). The opposite side of the fitting had the same internal ferrule, but did not have any indications of incipient melting. DSC measurements indicated that these components had similar incipient melting temperatures, and therefore the difference in melting behavior was likely due to a thermal gradient. The results of these and other DSC measurements for copper-based alloys are shown in Table 2.

Figure 5. Incipient Melting of Brass Compression Fitting Ferrule From Truck 17

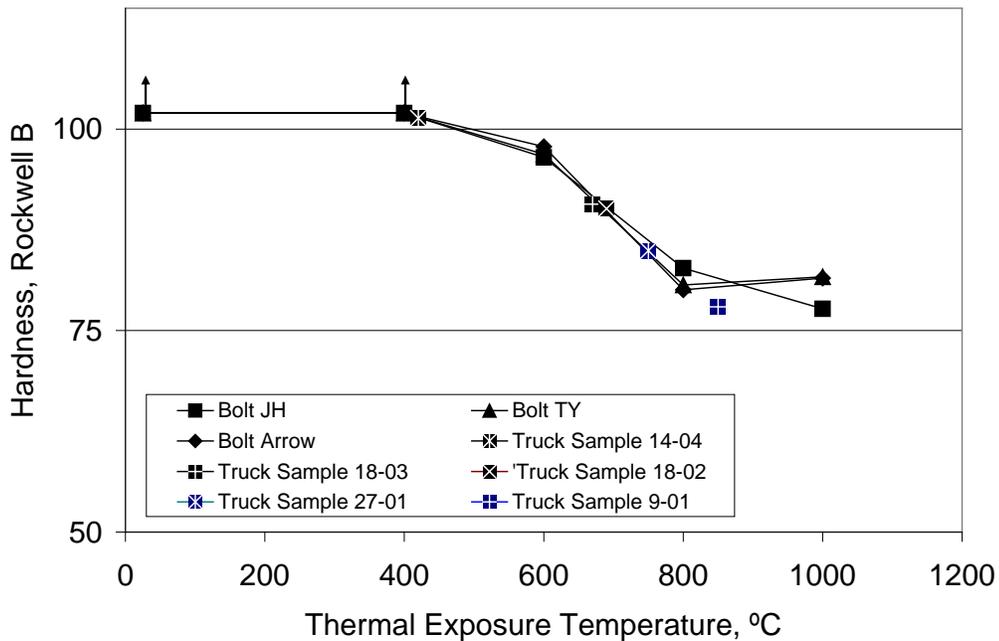
minimum tempering temperature, thereby reducing strength and hardness. The results suggest that an exposure to a temperature between 800 and 1,000 °C (1,472 and 1,832 °F) for 2 hours would result in a reduction of hardness similar to that observed for the as-collected condition of Truck Sample 9-01. The results also suggest that an exposure to temperatures of roughly 420, 670, 690, and 750 °C (788, 1,238, 1,274, and 1,382 °F, respectively) would similarly reduce hardness that was observed for the as-collected condition of Truck Samples 14-04, 18-03, 18-02, and 27-01, respectively.

The effect of temperature on hardness is shown in Figure 6 as a decreasing slope in this figure. Although there were some slight differences in the chemical composition of the three reference samples, the hardness curves as a function of temperature are very similar. Hardness values of the graded bolts taken from the vehicles are also shown.

Figure 6. Effect of exposure temperature on the hardness of truck samples and commercially available Grade 5 bolts
