MARCH 2011 INSPECTION REPORT
To protect, conserve and enhance the quality of Wyoming's
environment for the benefit of current and future generations.

Subject: March 2011 Inspection Report, Cameco Resources, Permits 603 & 633

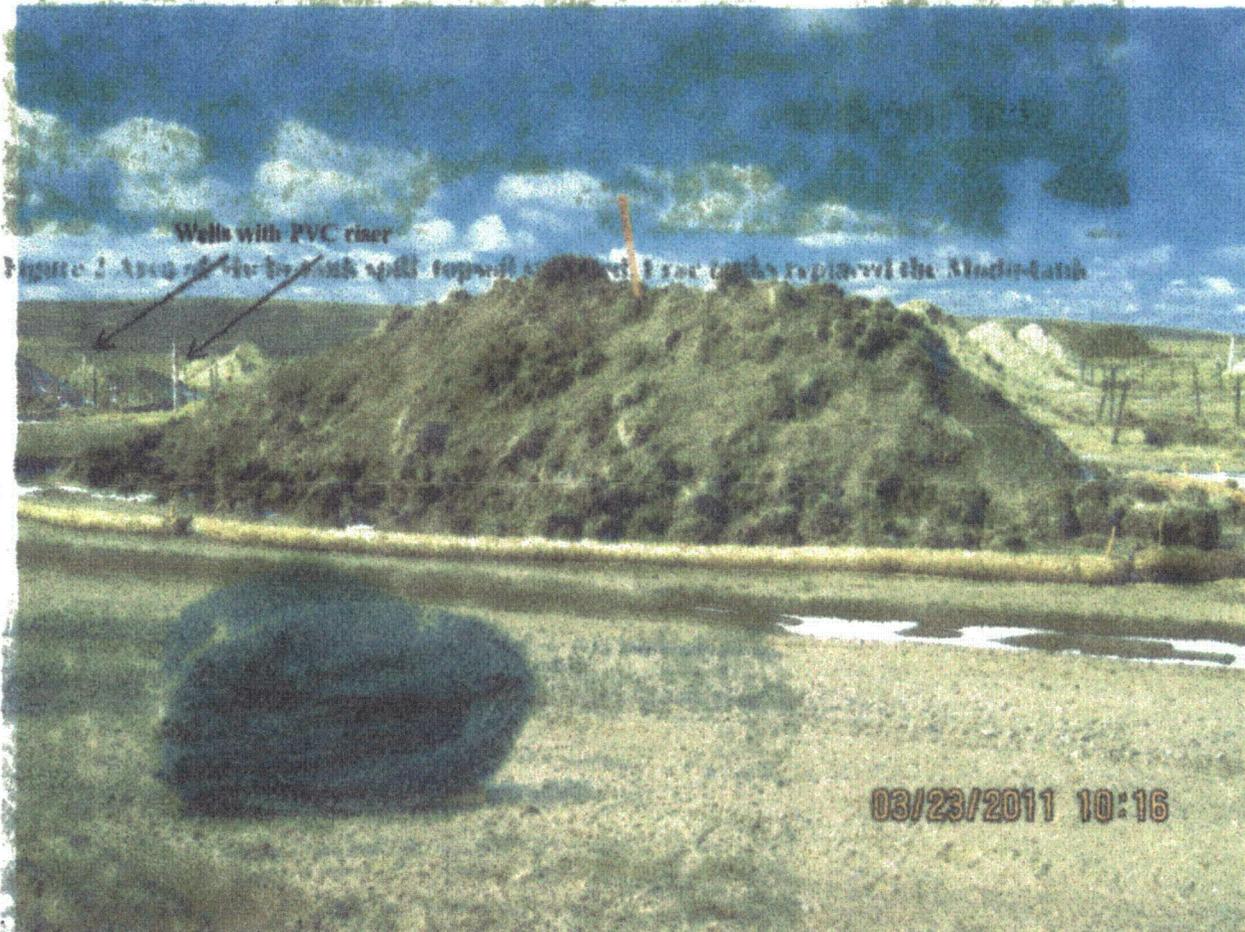
- straw waddles around topsoil stockpile, needs more stakes (Figure 1); located
- topsoil protection is inconsistent; inspector does not understand the use of waddles/toe ditches and when they are used; permit revision remains incomplete;
- development wells have PVC pipe risers (approximately 3-4 feet above ground) to assist in locating wells and better define visibility and avoid accidental damage to the wells (Figure 1);
- inspection of the modu-tank and spill area; no evidence of erosion resulting from the spill however, the CR staff on the inspection did not know the direction of the spill; during the close-out meeting it was stated that the spill was toward the Frac tanks which is away from the drainage; soil has been removed in the area of the spill (Figure 2);
- the liner from the modu tank was wrapped into a package for transport from the site (Figure 3);

Figure 1 MU-K-North topsoil protection with straw waddles

9. CR is installing sediment control around randomly selected topsoil stockpiles using straw waddles and/or ditch/berms. The methodology is not strictly regulated however,

the effectiveness of the chosen method is important. If waddles are used they should be staked approximately every 2-3 feet. On flat areas, it may be sufficient to stake the waddles every 4-6 feet. CR should error on the conservative side to ensure maximum protection.

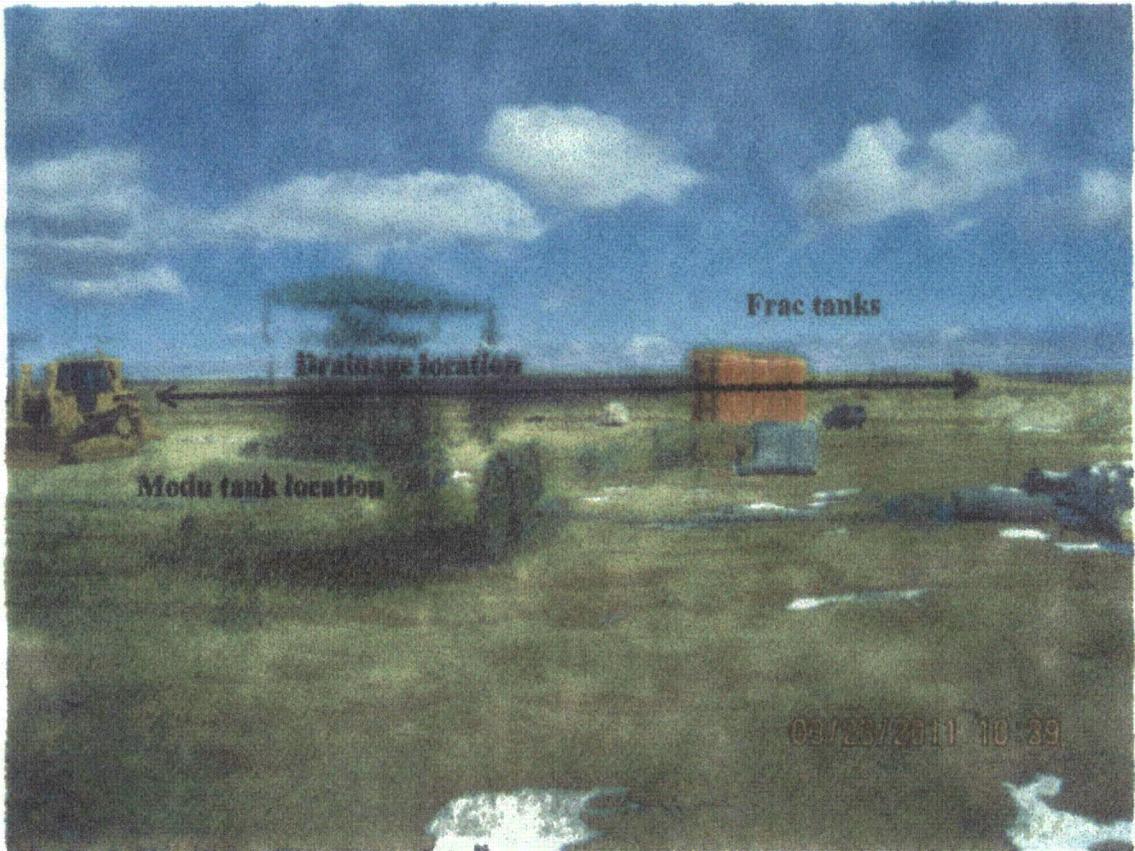
- MUs H, I, J, K, 2, 3, 9, 15 in production
- K-North – continuing with wellfield development; high winds blew liner from modu-tank, replaced with frac-tanks

Figure 2 Area of Modu-tank spill, topsoil stripped, Frac tanks replaced the Modu-tank

6. The surface spill at MU-K-North which resulted from the accident of the modu-tank during the wellfield pump test is considered a reportable spill and should be reported (WDEQ/WQD Chapter 4, Section 3 and 4). Please provide the spill report to the appropriate agencies including LQD.

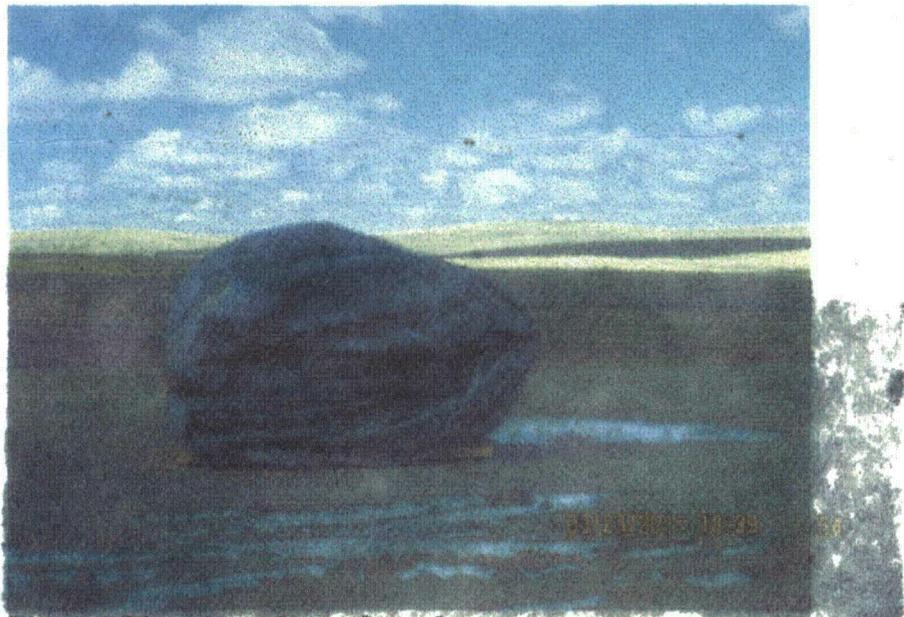
Figure 3 L-jack from the modu tank

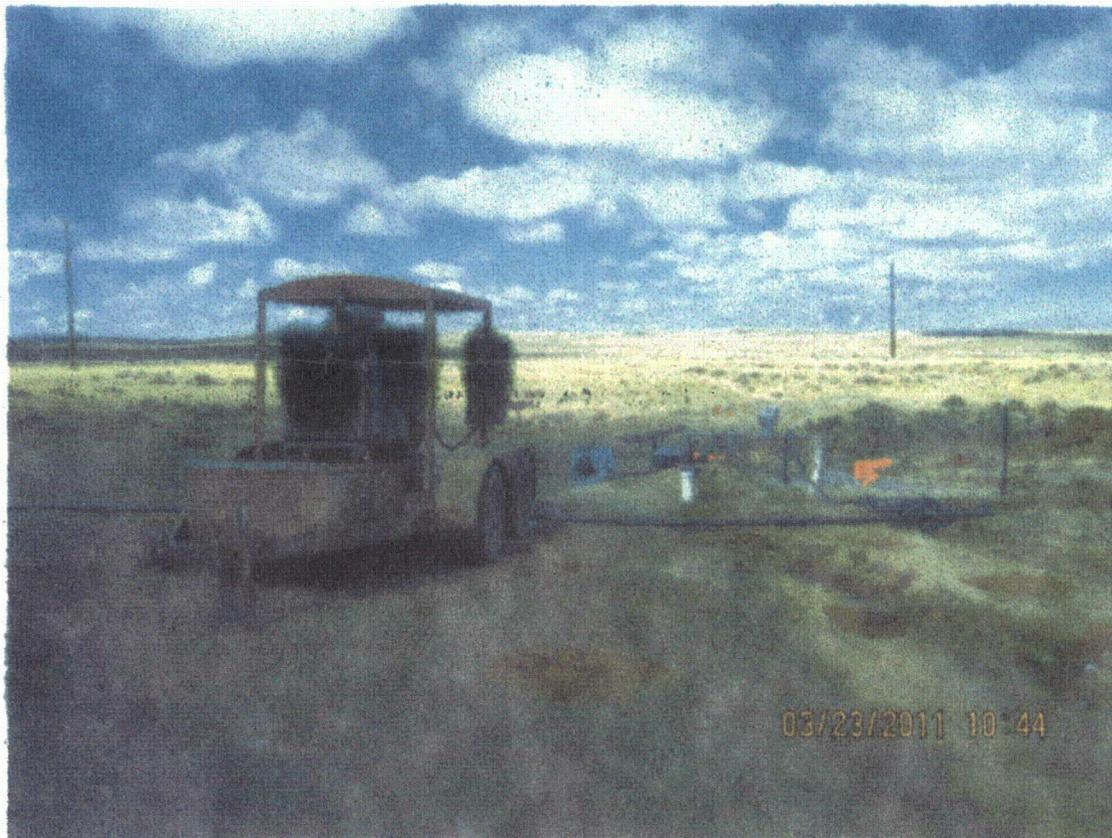
- pump test was in progress; waiting for recharge of the aquifer (Figure 4);
- MU-F
- Four drill rigs in MU-F delineating the ore body;
- MU-E
- Inspection of SRHUP #9 well and pump house, confirmed the well is in operation with approximately 40GPM; Topsoil stockpile (TSP) #94 was inspected and found stable, seeded and mulched; sign was on northeast side opposite the area of activity;
 - Inspection of Topsoil Stockpiles;

Figure 4 MU-K-North pump test well

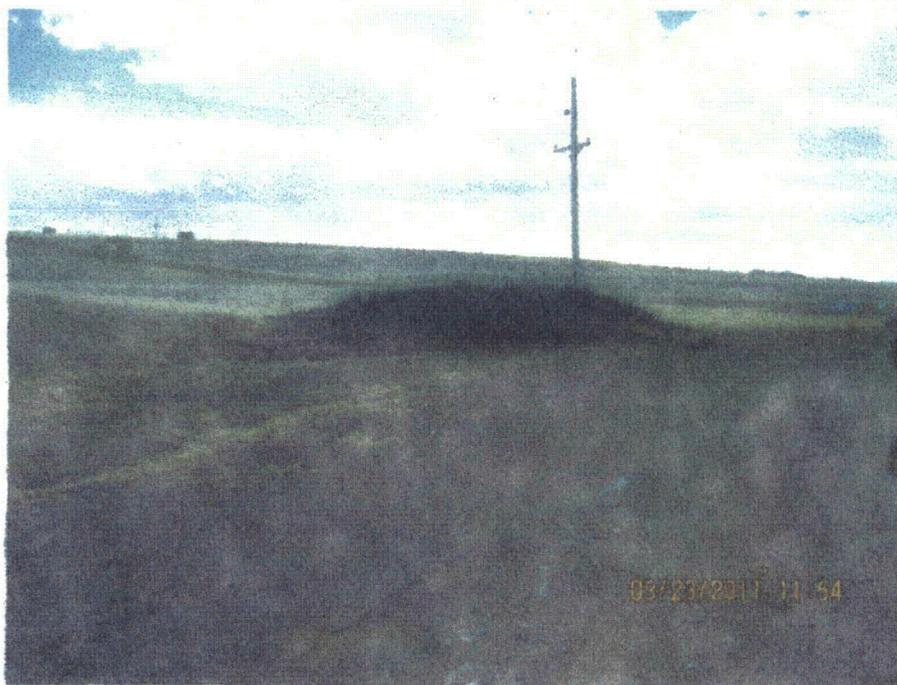
Figure 5 Topsoil addition to TSP 30
