WOLF CREEK

Subject: Docket No. 50-482: Licensee Event Report 2011-003-00, "Diesel Generator Declared Inoperable Due to Inadequate Reinstallation of Pipe Connection Resulting in Excessive Governor Oil Coolant Leak"

4. TITLE
Diesel Generator Declared Inoperable Due to Inadequate Reinstallation of Pipe Connection Resulting in Excessive Governor Oil Coolant Leak

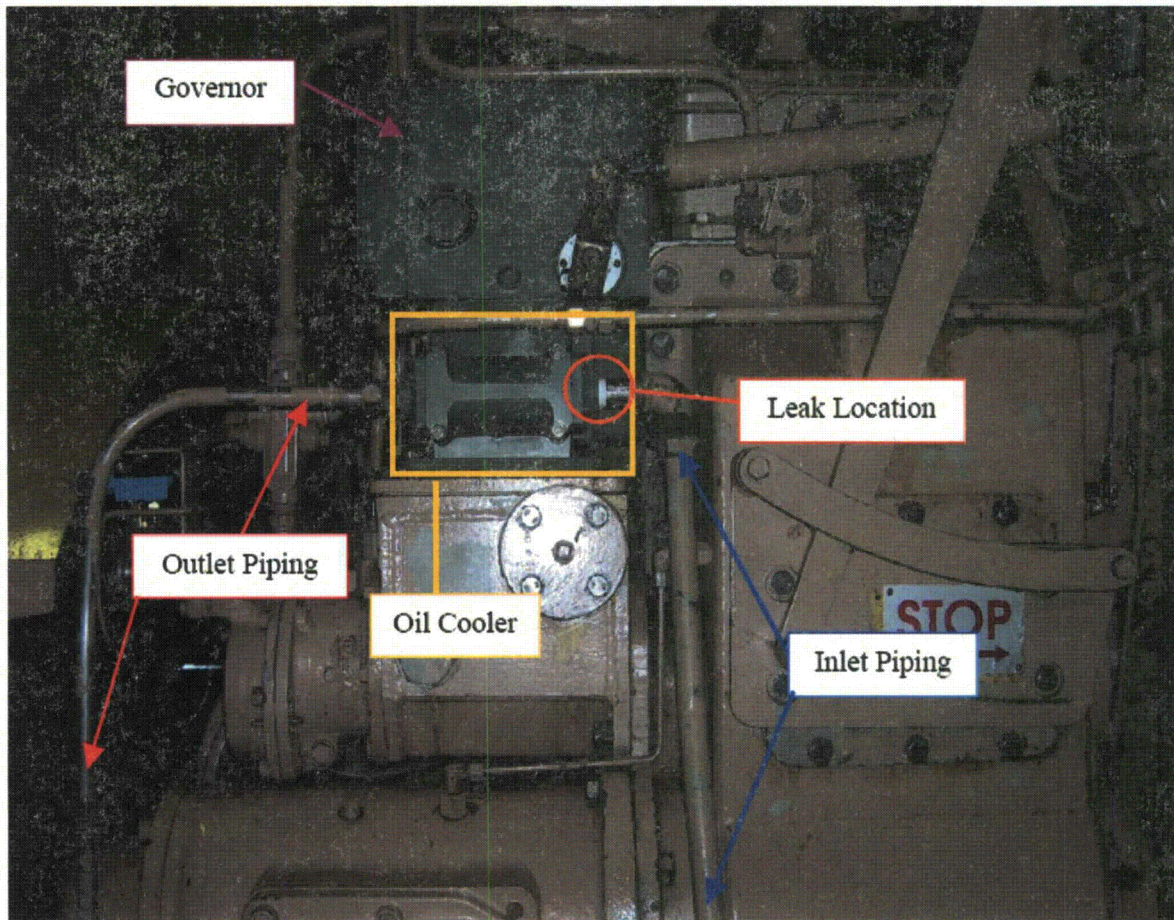
Figure 1

Work Order 11-338729-000 was generated to correct the leak. Upon disassembly, it was noted by the Wolf Creek Nuclear Operating Corporation (WCNOC) mechanic and documented in the work order, the pipe nipple at the inlet of the governor oil cooler was hand tight. As is common on National Pipe Threads (NPT), Neolube 100, a sealing paste, had been used on the pipe threads. Upon visual inspection, the threads of both the oil cooler inlet flange and the pipe were in good condition. There was no physical damage that would prevent the connection from sealing properly. The components were reassembled and the connection remained leak free during the subsequent reperformance of the 24 hour run (STS KJ-011A) on March 12-13, 2011.

While the pipe was found hand tight, the threads were fully engaged such that a rigid connection was established. This was confirmed prior to disassembly, noting no pipe movement occurred with the application of external force. This indicates, while the threads were not tight and sealed against leakage, the piping was restrained from movement. The pipe was restrained such that no further tightening or loosening could occur without disassembling other components (See Figure 1).

Work Order 11-338729-000 was generated to correct the leak. The components were reassembled on March 12, 2011 and the "A" DG was restored to operable status at 1815 CDT on March 12, 2011 following completion of post maintenance testing. The connection remained leak free during the subsequent reperformance of the 24 hour run (STS KJ-011A) on March 12-13, 2011.
