SUBJECT: COMANCHE PEAK NUCLEAR POWER PLANT, UNIT 2 - SUMMARY OF
CONFERENCE CALL REGARDING THE SPRING 2011 STEAM GENERATOR
TUBE INSPECTIONS (TAC NO. ME5826)

SUMMARY OF APRIL 14, 2011, CONFERENCE CALL
WITH LUMINANT GENERATION COMPANY LLC
REGARDING THE SPRING 2011 STEAM GENERATOR
TUBE INSPECTION RESULTS
AT COMANCHE PEAK NUCLEAR POWER PLANT, UNIT 2
DOCKET NO. 50-446

Steam Generator Tube Inspections

Comanche Peak Nuclear Power Plant, Unit 2

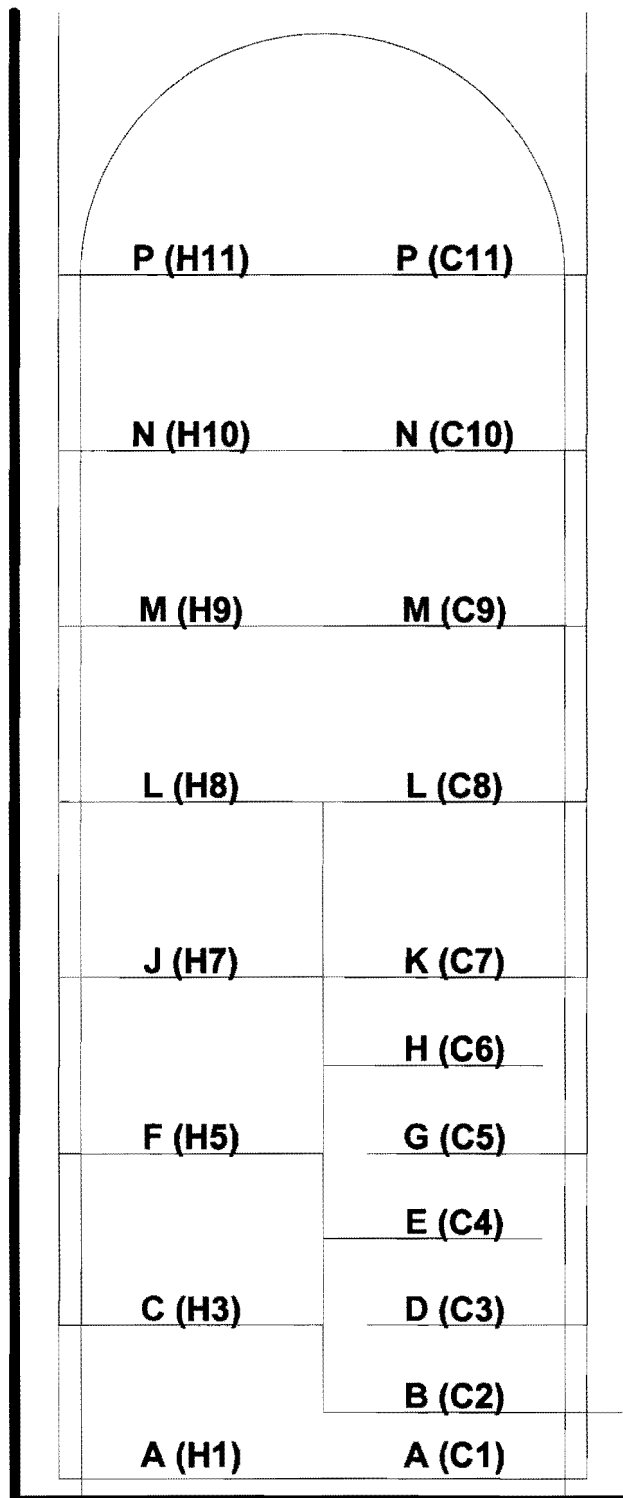
Figure 1. General Location and Designation of Tube Support/Baffle Plates (designations in parentheses show eddy current test terminology)

During normal operation feedwater is discharged into a “water box” in the SG from which it flows into the preheater above the baffle plate B (see Figure 1) in the cold leg. As a result, loose parts enter the SG over baffle plate B. Therefore close attention is paid to this region. Video inspection is performed over baffle plate B in all SGs. In particular, the periphery and the T-slot are inspected. These are the areas of highest potential for loose parts accumulation and tube damage. If video inspection detects the presence of a loose part (either over the tubesheet or over baffle plate B), the adjacent tubes are inspected by +Point to detect and quantify any tube degradation.
