UNITED STATES
NUCLEAR REGULATORY COMMISSION
OFFICE OF NUCLEAR REACTOR REGULATION
WASHINGTON, DC 20555-0001

August 1, 2011

NRC INFORMATION NOTICE 2011-15: STEEL CONTAINMENT DEGRADATION AND
ASSOCIATED LICENSE RENEWAL AGING
MANAGEMENT ISSUES

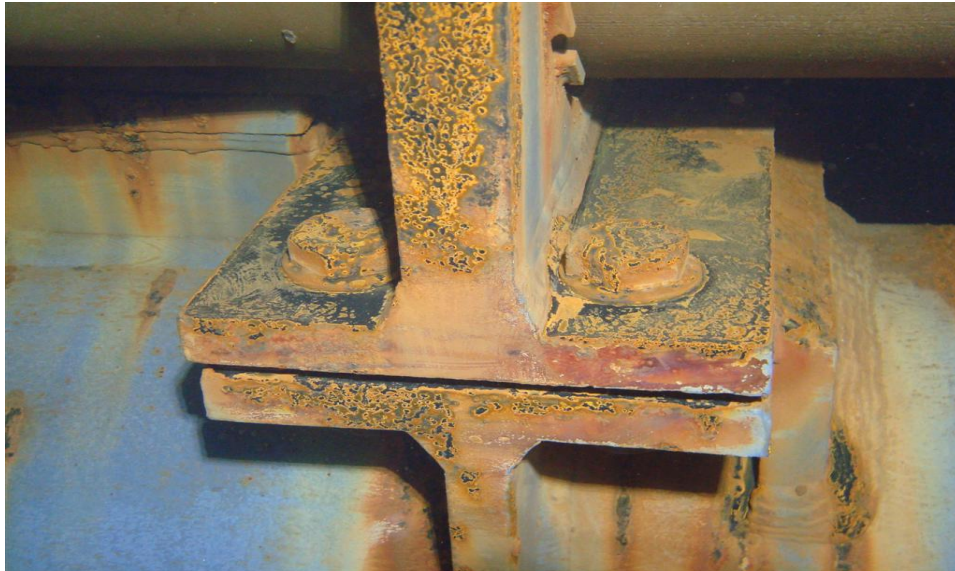
During its review of the Duane Arnold Energy Center license renewal application (LRA), the NRC staff noted that since 1977, when the applicant performed the first inspection of the torus after the initial coating application, the applicant has found numerous instances of localized corrosion and depletion of the coating of the torus shell (see Enclosure Figures 1 and 2) of its boiling-water reactor (BWR) Mark I containment. The applicant performed repairs in 1980 and 1983 prior to a full recoat of the suppression chamber in 1985. Since 1988, the applicant has been repairing degraded coatings and managing and tracking the effects of aging of the torus in accordance with the American Society of Mechanical Engineers (ASME) Boiler and Pressure Vessel Code Section XI, "Rules for Inservice Inspection of Nuclear Power Plant Components," Subsection IWE, "Requirements for Class MC and Metallic Liners of Class CC Components of Light-Water Cooled Power Plants." Since 1995, the torus coating has been repaired at more than 15,000 locations, all below the water line, which is equivalent to approximately 5 percent of the underwater coating surface inside the torus. The torus steel behind the degraded coating has corroded locally at some of these locations. The applicant evaluated this degradation of

coating of the torus and determined that the degradation has not affected the structural integrity of the torus. In addition, the applicant performed detailed analysis and determined that localized corrosion of the torus shell was acceptable without repair. The NRC staff requested that the applicant address the possibility of localized galvanic corrosion (pitting) due to degraded coatings during the period of extended operation since the normal life of the underwater zinc coating is approximately 15 to 20 years and aging management of the torus steel minimizes the potential for pitting corrosion to extend through-wall. In response to NRC requests for additional information during the license renewal review, the applicant committed to recoating the suppression pool interior surfaces below the water line prior to startup from the first refueling outage during the period of extended operation (applicant letter, dated March 9, 2010, Agencywide Documents Access and Management System (ADAMS) Accession No. [ML100700248](#)). The applicant subsequently stated that the current project plan ensures that recoating will extend well above any fluctuations in water level, including the 2-foot wide splash band at the water level (applicant letter, dated April 2, 2010, ADAMS Accession No. [ML100960277](#)).

Figure 1 Duane Arnold Energy Center—Depletion of Zinc Coating on Torus Shell and Supporting Steel

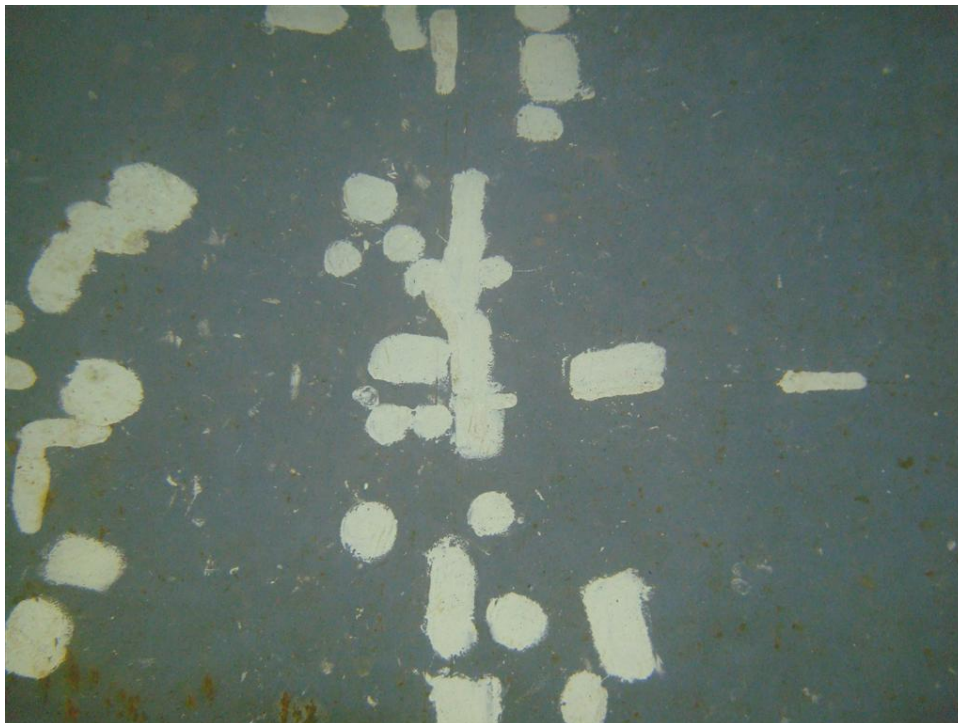
Figure 2 Duane Arnold Energy Center—Torus Coating Repairs

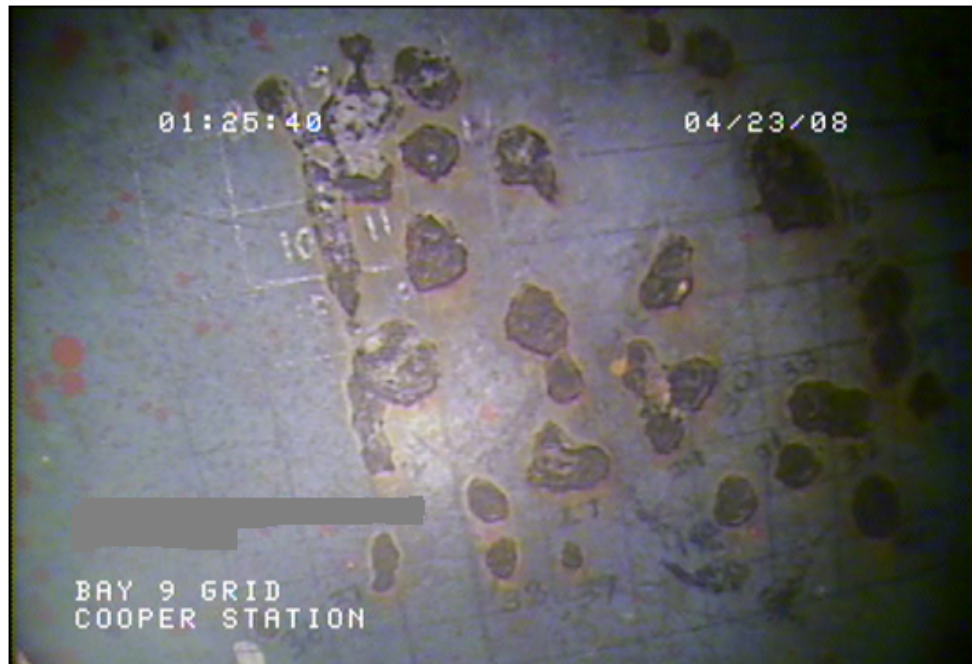
During its review of the Cooper Nuclear Station LRA, the NRC staff noted that the applicant had identified pitting corrosion in its BWR Mark I containment throughout the wetted area of the torus as a result of degradation of the zinc coating (see Enclosure Figure 3). The applicant documented approximately 3,800 locations of torus degradation since 1991, covering approximately 1.1 percent of the surface area below the water line. The applicant has been tracking the effects of aging of the torus by performing augmented inspections in accordance with the ASME Subsection IWE requirements and performing coating repairs to manage torus degradation. Upon review of plant operating experience, the NRC staff requested that the applicant address the cumulative effects of pitting corrosion in its aging management program to ensure that torus degradation would be adequately managed during the period of extended operation and to minimize the potential for through-wall pits. In response, the applicant committed to inspect the wetted portion of the torus during every refueling outage from now until the wetted portion of the torus is recoated by the committed date of January 18, 2017 (applicant letter, dated May 4, 2010, ADAMS Accession No. [ML101310605](#)).

Figure 3 Cooper Nuclear Station—Pitting Corrosion of Torus Steel

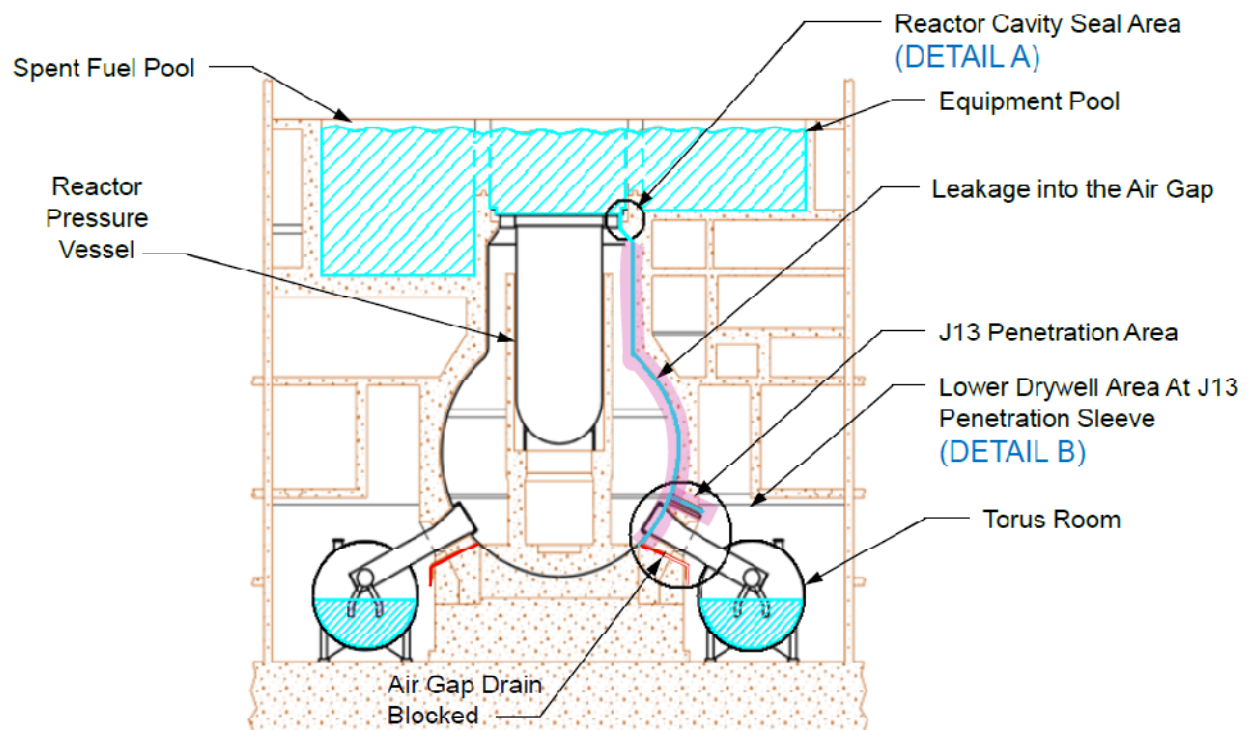
During its review of the Hope Creek Generating Station LRA, the NRC staff noted that during the 2009 refueling outage, the applicant observed in its BWR Mark I containment a small water leak from a drywell shield wall penetration sleeve J13 located in the drywell air gap region. The applicant did not observe any leakage from the drywell lower air gap drains that are located approximately 8-feet below the penetration. In its review, NRC staff identified the possibility that water might be trapped between the concrete and drywell steel below the penetration and that trapped water could lead to thinning of the drywell steel. During the subsequent 2010 refueling outage, the applicant observed leakage from the same penetration, but again no leakage was noted from the air gap drains located below the penetration. The applicant investigated and found that all four drywell air gap drains were blocked (see Enclosure Figures 4–7). The applicant subsequently performed ultrasonic testing (UT) to measure drywell thickness. The

Figure 4 Hope Creek Mark I Containment During Refueling Operation

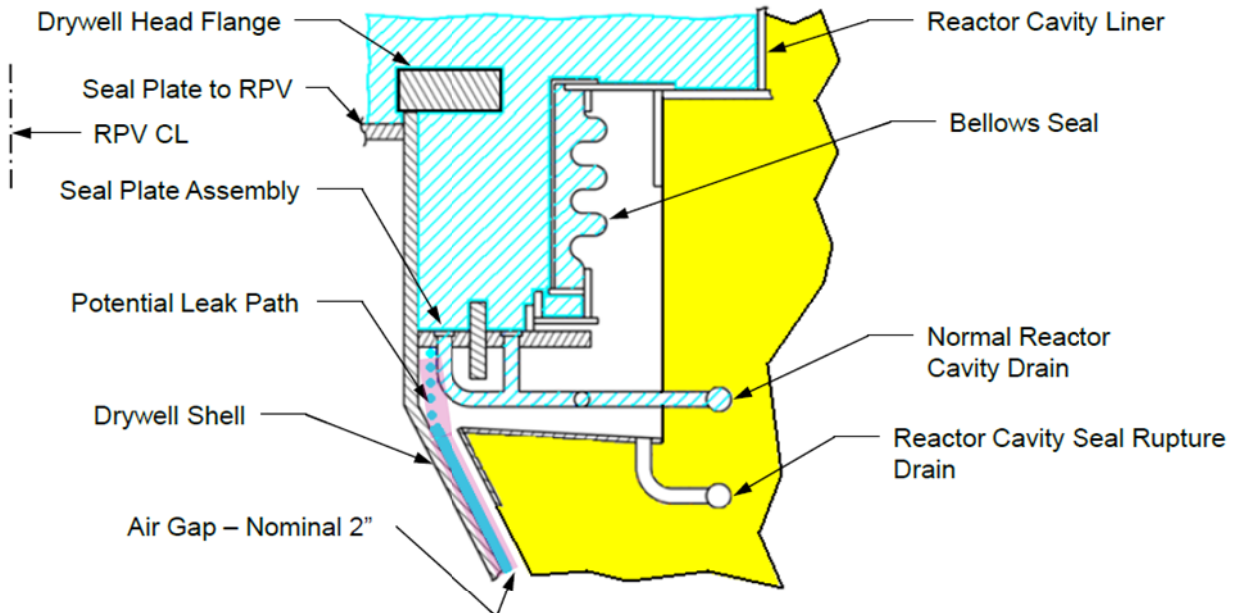
Figure 5 Detail A: Configuration of Hope Creek Reactor Cavity Seal Area During Refueling Operation

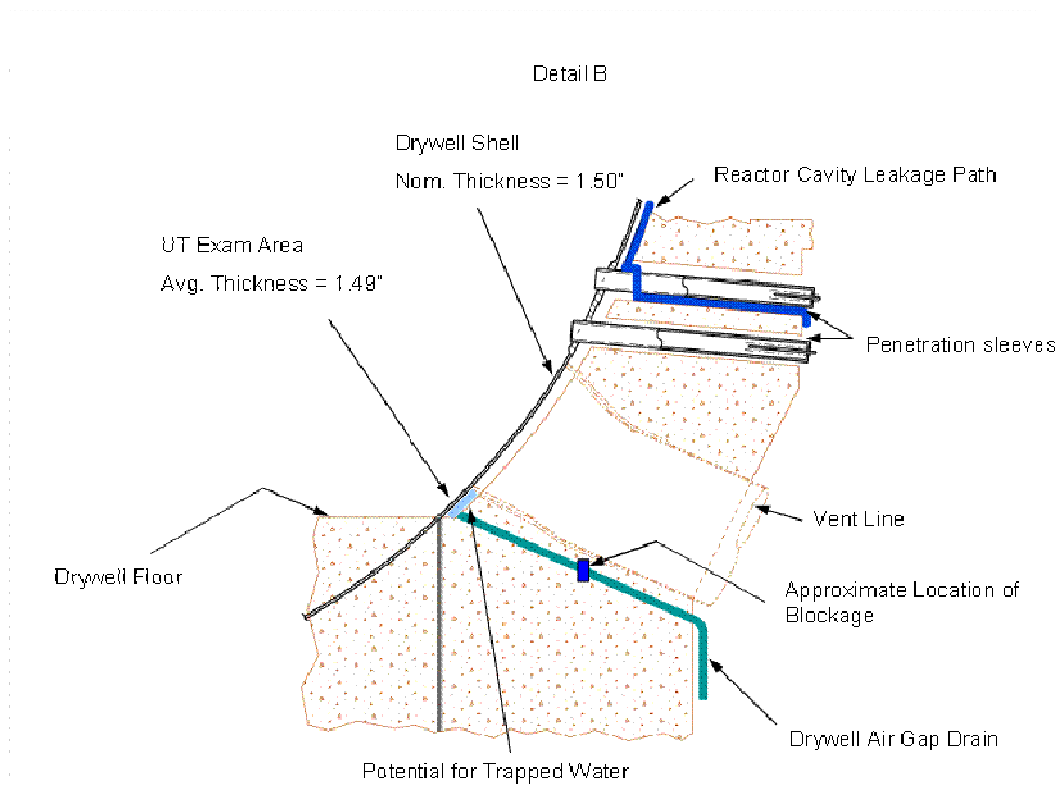
measurements indicated greater than nominal plate thickness in all areas of drywell steel except the lower portion of the plate below the penetration. In that area, the reduced plate thickness was still greater than design requirements and was able to perform its intended function. Notwithstanding, the NRC staff requested the applicant to address the possibility that this reduced plate thickness could be the result of corrosion of the steel plate due to the presence of trapped water. The NRC staff requested that the applicant provide information on establishing a corrosion rate of the steel and projected loss of drywell thickness. In response, in its letter of January 19, 2011 (ADAMS Accession No. [ML110210677](#)), the applicant updated its commitments to perform UT thickness measurements over the next three refueling outages in the area of the drywell shell in the air gap below the penetration sleeve area and inform the NRC of its findings. The applicant will use the measurements to establish a corrosion rate and demonstrate that the effects of aging will be adequately managed such that the drywell will continue to perform its intended function for the period of extended operation.

Figure 6 Detail B: Hope Creek Lower Drywell Area

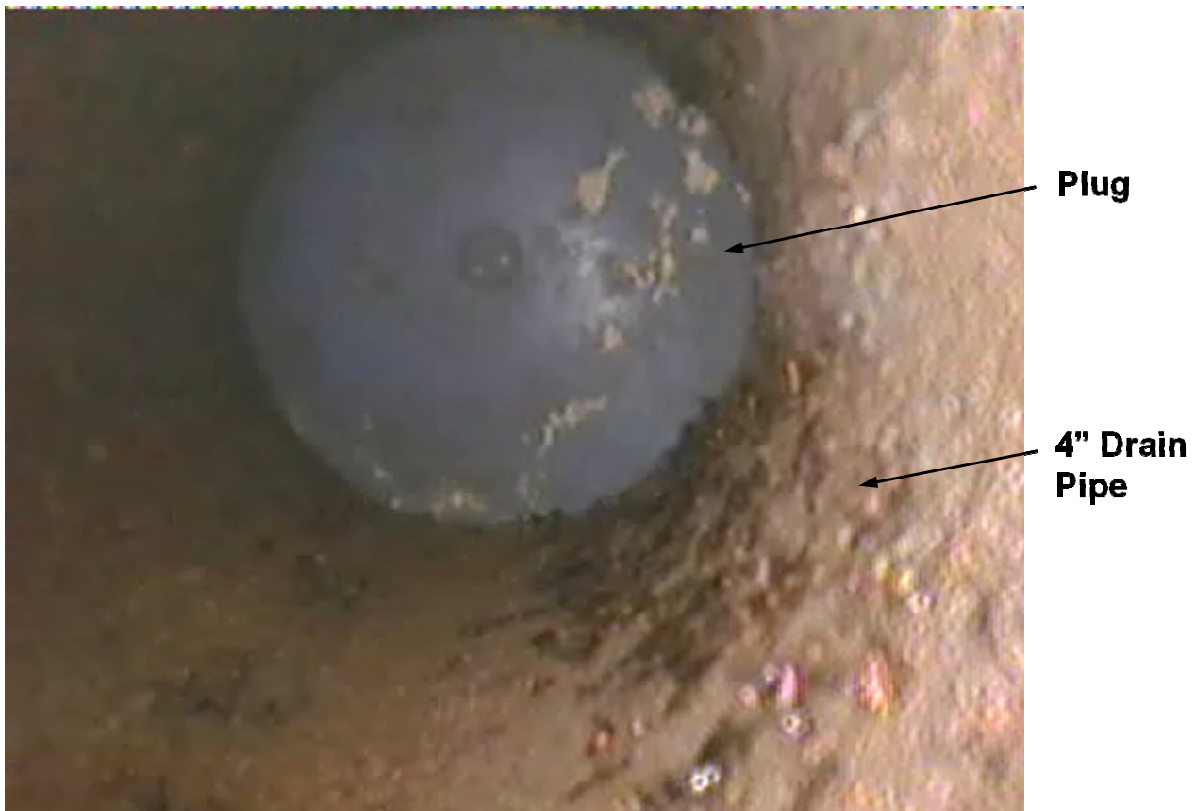
Upon recent further investigation of the blockage in one of the drywell air gap drains, the applicant's boroscopic inspections were unable to confirm the existence of any air gap drain opening, contrary to the existing design configuration. The applicant was not able to determine the as-built configuration of the air gap drains but confirmed that there were no indications of water accumulation inside the drywell air gap space and no indications of corrosion of the containment steel shell exterior surface. In response to NRC staff questions, in its letter dated May 19, 2011 (ADAMS Accession No. [ML11144A016](#)), the applicant committed to perform UT thickness measurements during each refueling outage in the area of the drywell shell below the penetration sleeve area until drainage is established from all four drains. The licensee will ensure that the corrosion rate is such that the drywell can continue to perform its intended function for the period of extended operation. The applicant committed to document and address evidence of drywell shell degradation in the corrective action program. In addition, in response to NRC staff questions regarding the current configuration of the drywell air gap drains, the applicant revised its aging management program to establish drainage capability from the bottom of the drywell air gap through four air gap drains on or before June 30, 2015 (applicant letter, dated May 19, 2011, ADAMS Accession No. [ML11144A016](#)). The NRC included a license condition for this issue in the renewed license.

Figure 7 Hope Creek Plugged Drywell Air Gap Drain
