Davis-Besse Nuclear Power Station, Unit No. 1  
Docket No. 50-346, License No. NPF-3  
Response to Request for Additional Information – 2010 Steam Generator Tube  
Inspection Report (ME5261)

Response to April 19, 2011 NRC Request for Additional Information

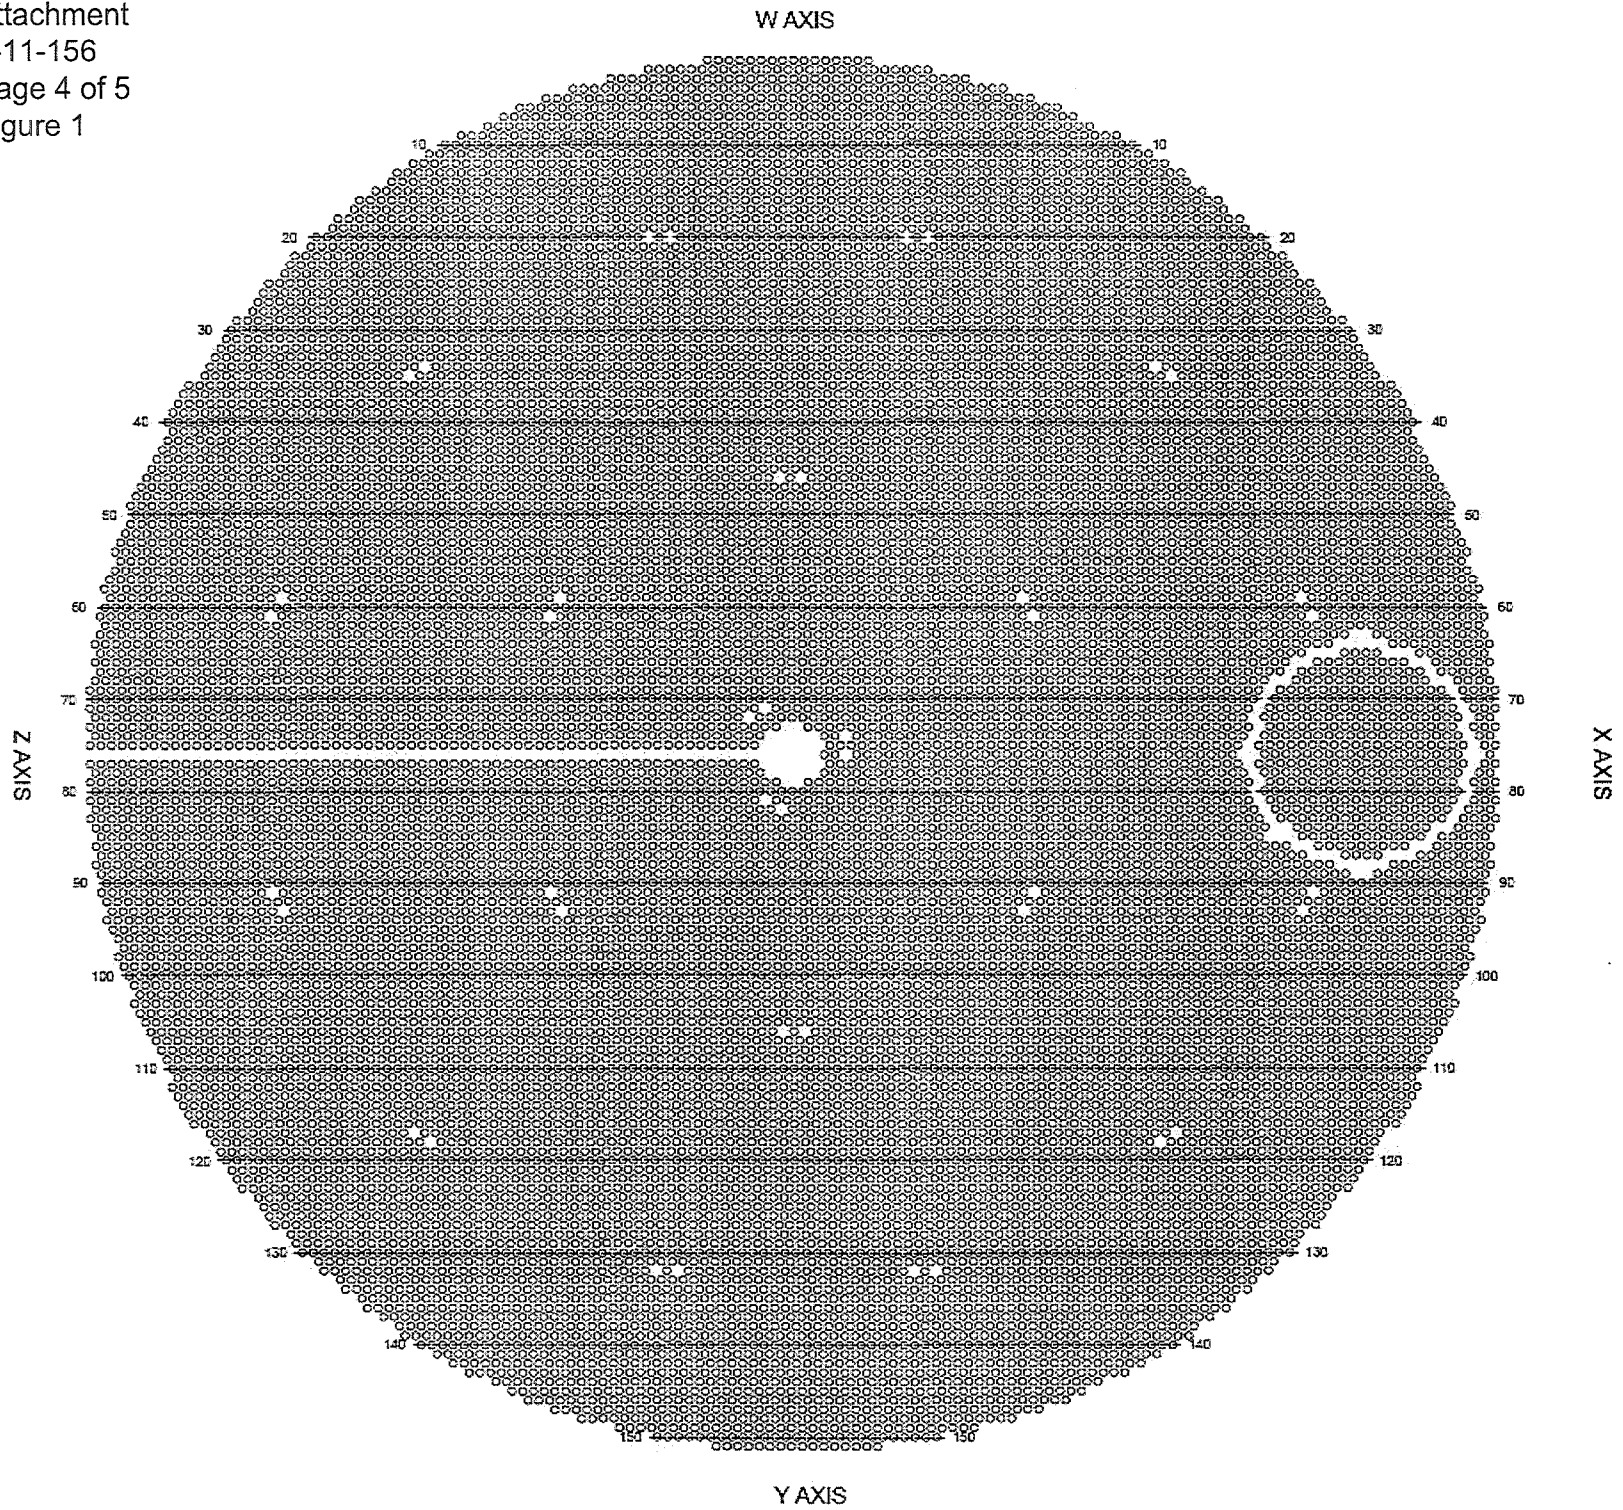
Copies of tubesheet maps are provided below. Figure 1 depicts the tubesheet map for the inlet of both SGs with row 1 at the top and 151 at the bottom. Figure 2 depicts the tubesheet map for the outlet of both SGs with row 151 at the top and row 1 at the bottom. In both figures, the tubes are numbered sequentially without skipping values for tube support plate tie rod locations or other no-tube locations. The only exception is row 76; the first tube in this row, near the center of the SG, is numbered as 64.
