SUBJECT: BEAVER VALLEY POWER STATION, UNIT NO. 2 - SUMMARY OF  
CONFERENCE CALL REGARDING THE SPRING 2011 STEAM GENERATOR  
TUBE INSPECTION RESULTS (TAC NO. ME5882)

SUMMARY OF CONFERENCE CALL

REGARDING THE SPRING 2011 STEAM GENERATOR TUBE INSPECTION RESULTS

BEAVER VALLEY POWER STATION, UNIT NO. 2

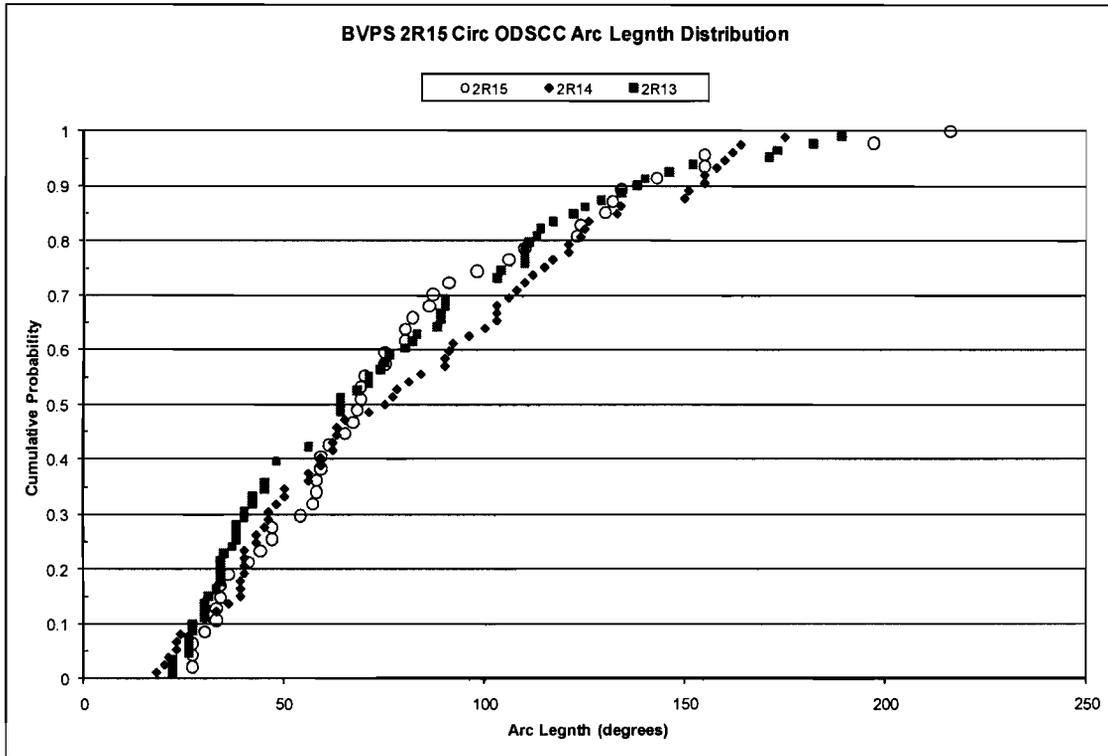
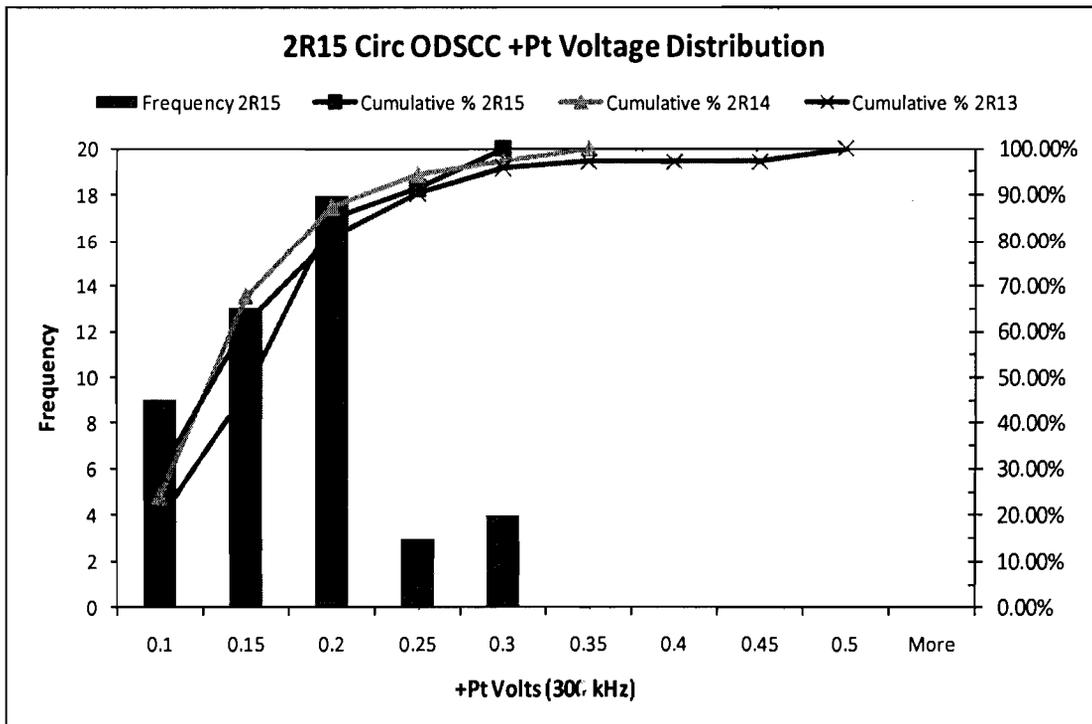
Circ ODSCC:

Length: 20 to 267 degrees arc, average of 84 degrees arc (first pass). The 267 degree arc indication was found to be comprised of two shorter cracks with non-degraded ligaments between the cracks from profiling.

Voltage: 0.06 to 0.29 volt, average of 0.15 volt, in 300 kHz

Based on a correlation of PDA vs +Pt amplitude from pulled tube data, the largest PDA at 95% probability of 60% has a lower 95/50 burst pressure of 5530 psi.

Long term trending of circumferential ODSCC at TTS flaw parameters shows little change. The following plots present the circ ODSCC arc length and +Pt voltage distributions for the last three outages.
