Event # 46923

POTENTIAL DEFECT IN CERTAIN VELAN SUPPLIED GLOBE VALVES

Subject: Globe Valve Notification, sizes 0.5, 0.75 and 1 NPS, Class 800, Carbon Steel

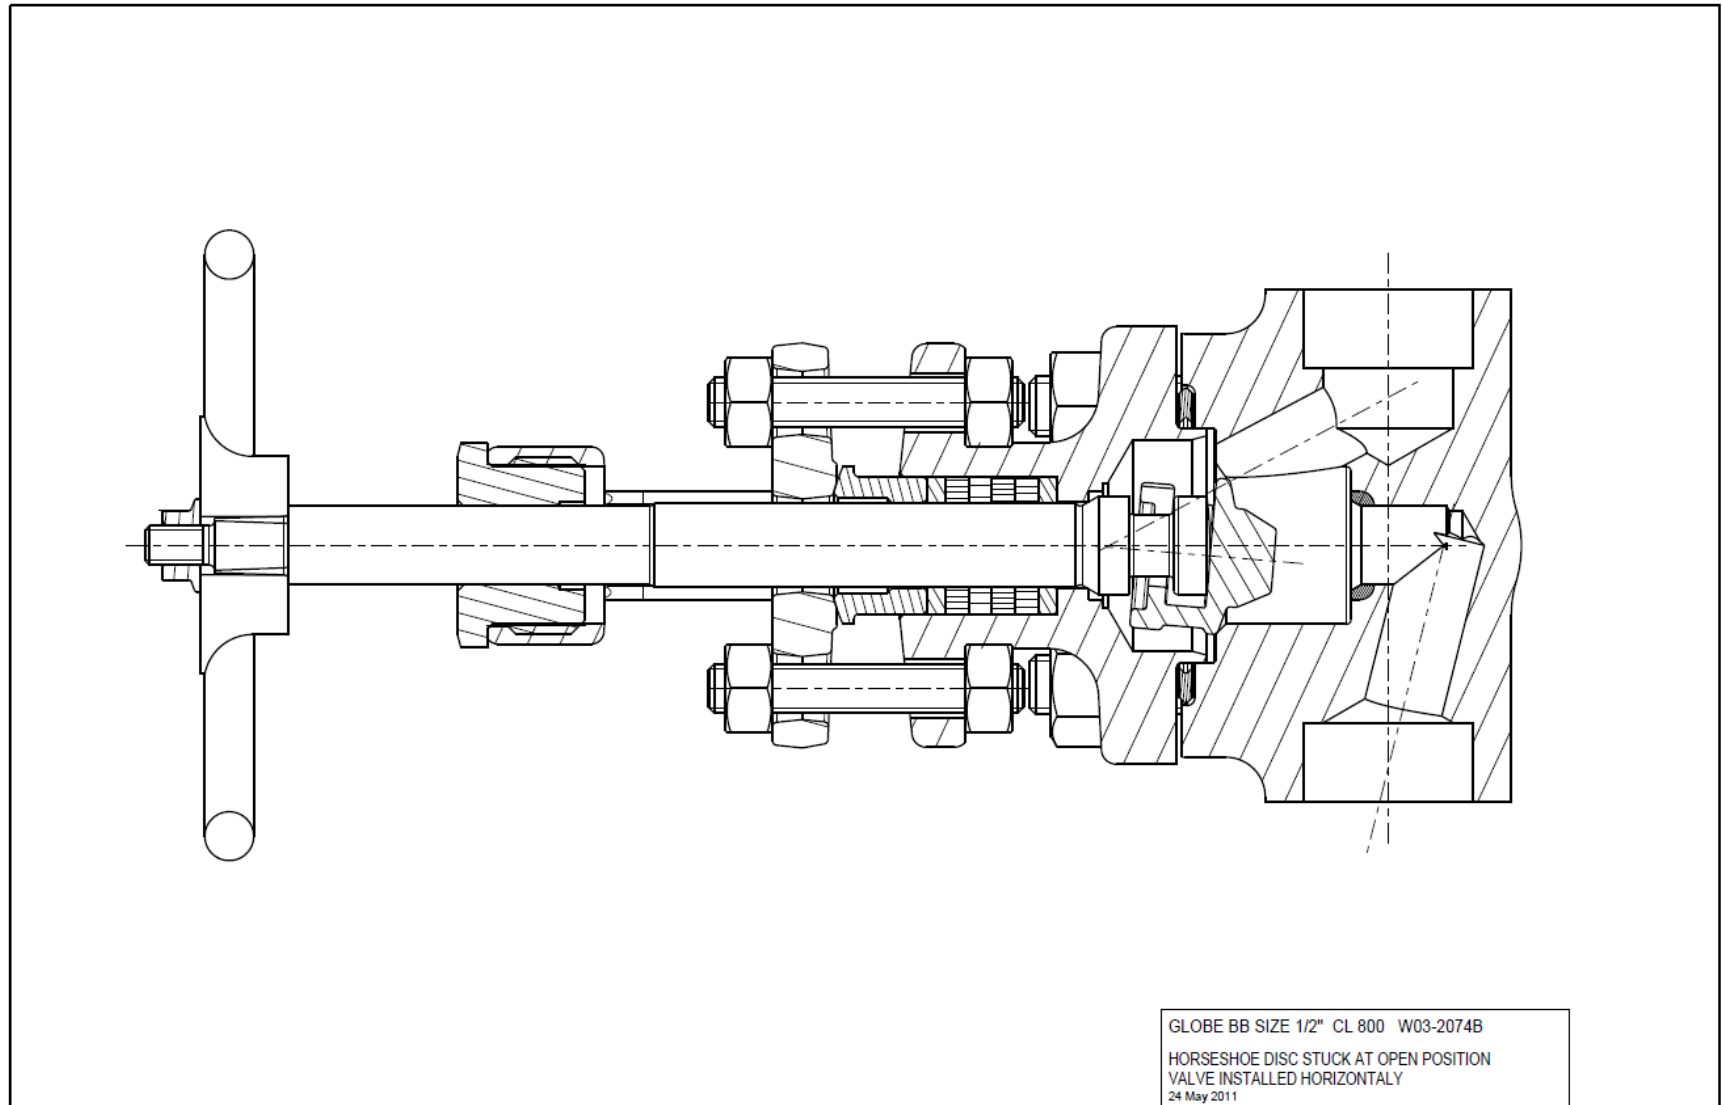
The valve was installed with the stem in a horizontal orientation; during the installation and commissioning procedure the valve was fully open (on the back seat position). The disc travelled into the bonnet cavity and became jammed between body and bonnet; the sketch in Exhibit # 1 shows the failure mode.

The analysis revealed that the failure was caused by the wrong bonnet being installed on the valve which ultimately allowed the disc to travel too far into the bonnet cavity and consequently the disc dropped into the body-bonnet gap. This prevented the valve from being closed during manual operation. The event is covered by Millstone 2 OE 33277.
