Docket No. 50-305

SUMMARY REPORT
FEEDWATER LINE CRACKING
KEWAUNEE NUCLEAR POWER PLANT

July 13, 1979

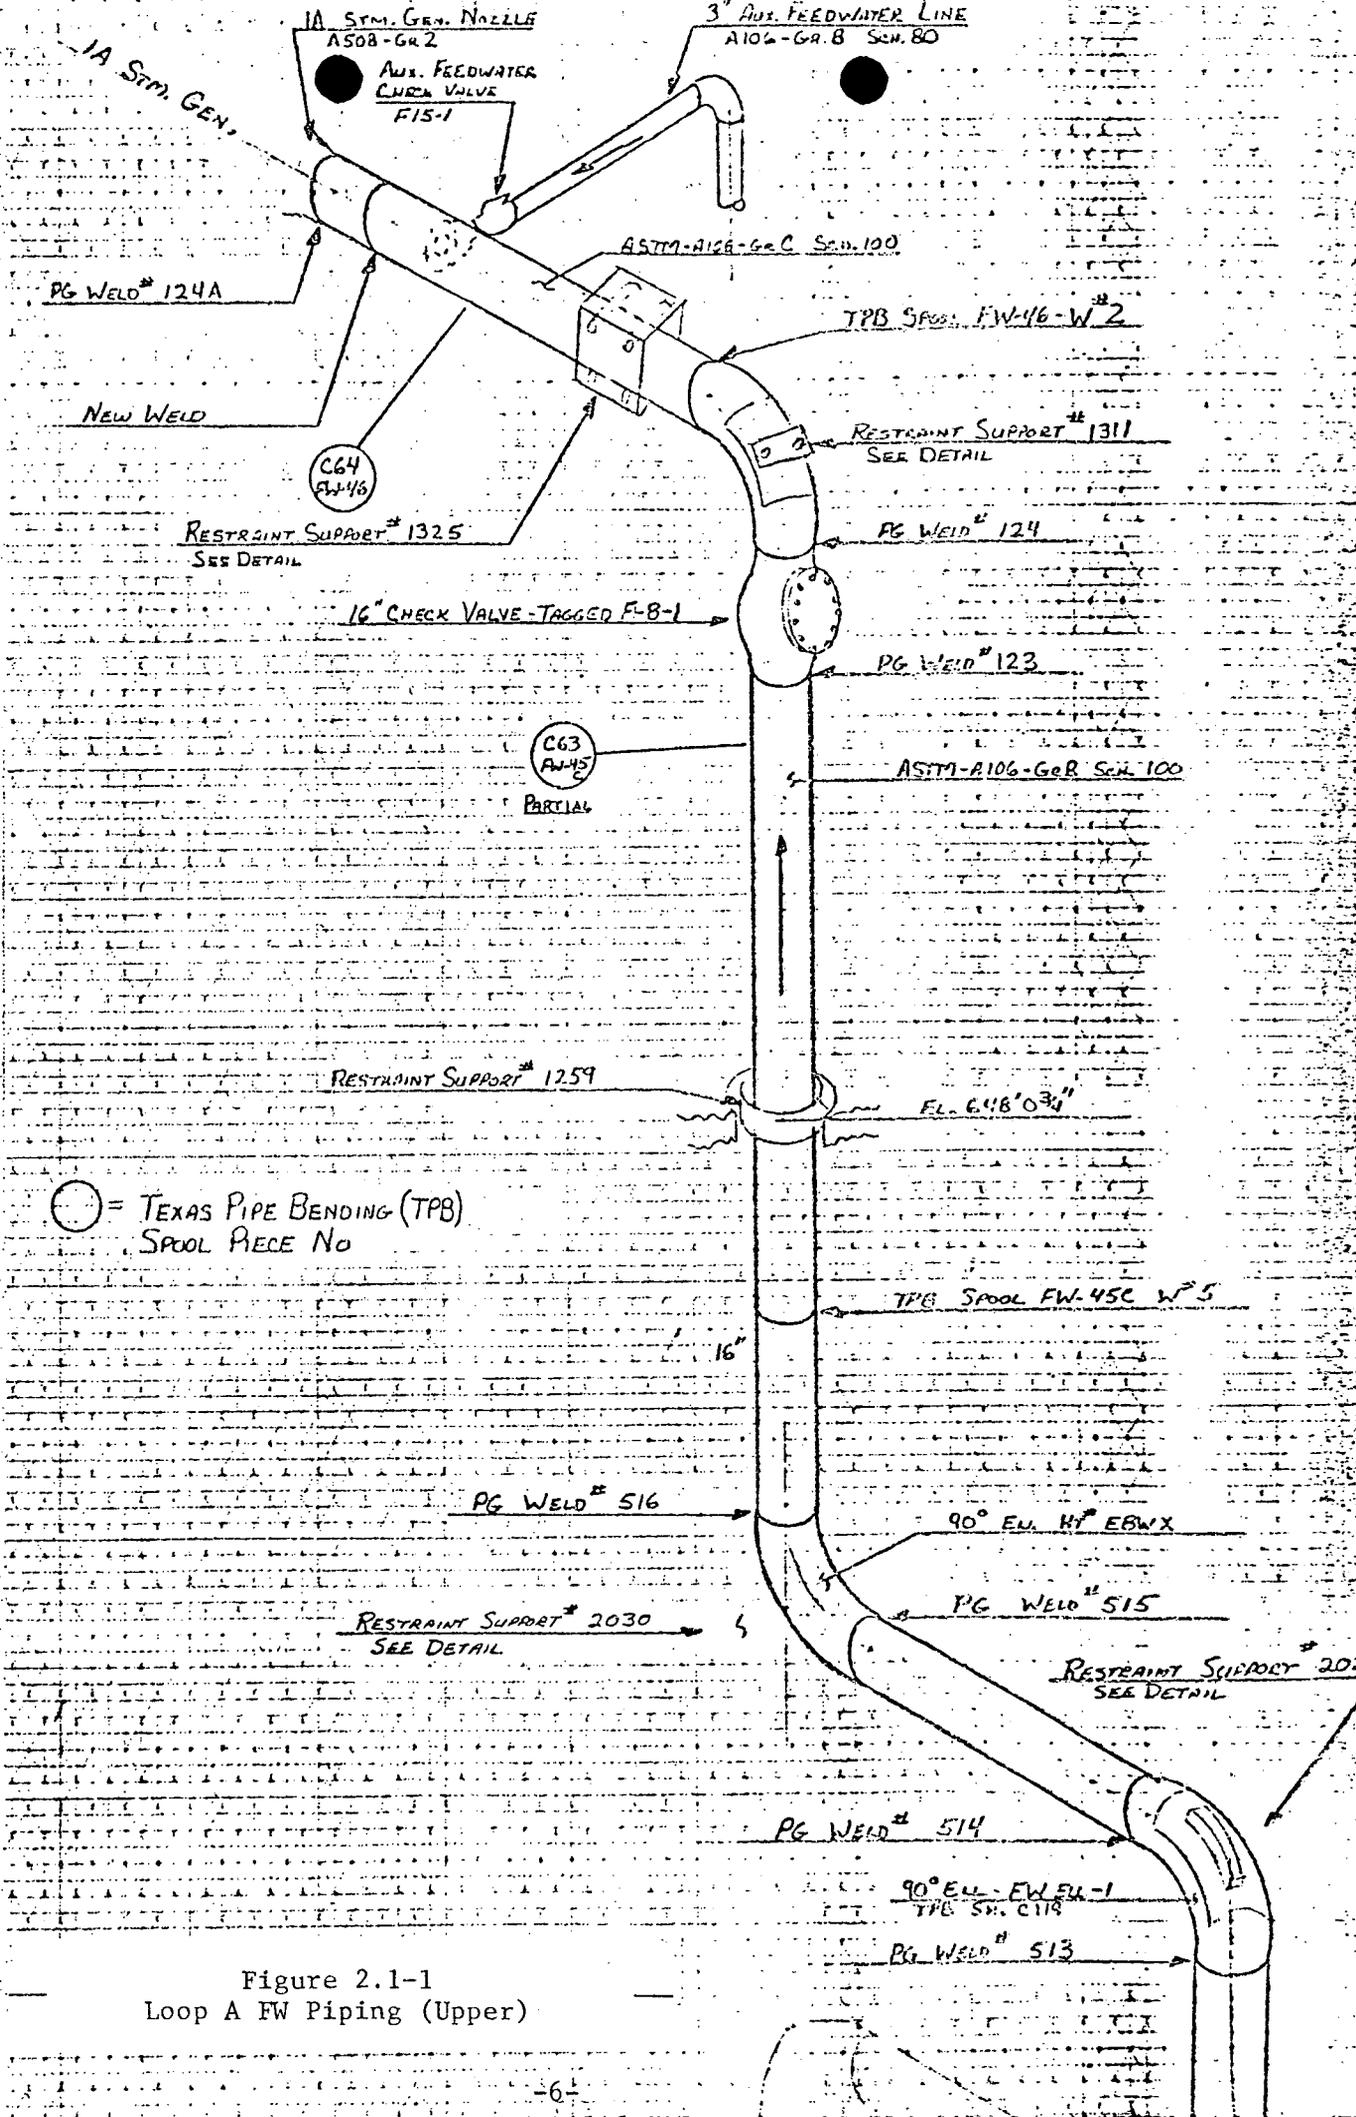
Figure 2.1-1
Loop A FW Piping (Upper)

When the sections of pipe were removed, about an 8 inch section on loop B and a 12 inch section on loop A, see figures 2.1-1 and 2.1-3, circumferential cracks were identified on the inside surface of pipe in the weld area and in pipe base metal near the weld. Several shallow surface cracks were also noticed on the nozzle side of the weld remaining attached to the S/G. These shallow cracks were removed by cutting away an additional 1/8 to 1/4 inch section of the nozzle on S/G A and by grinding and polishing loop B. The pipe sections were then flown to Westinghouse's metallurgical laboratory for detailed examination.

The two sections of pipe that were cut out for metallurgical analysis were replaced with sections of pipe having a 5° chamfer rather than the original 15°. This essentially eliminated the discontinuity at each end of the chamber. All new welds were then stress relieved.

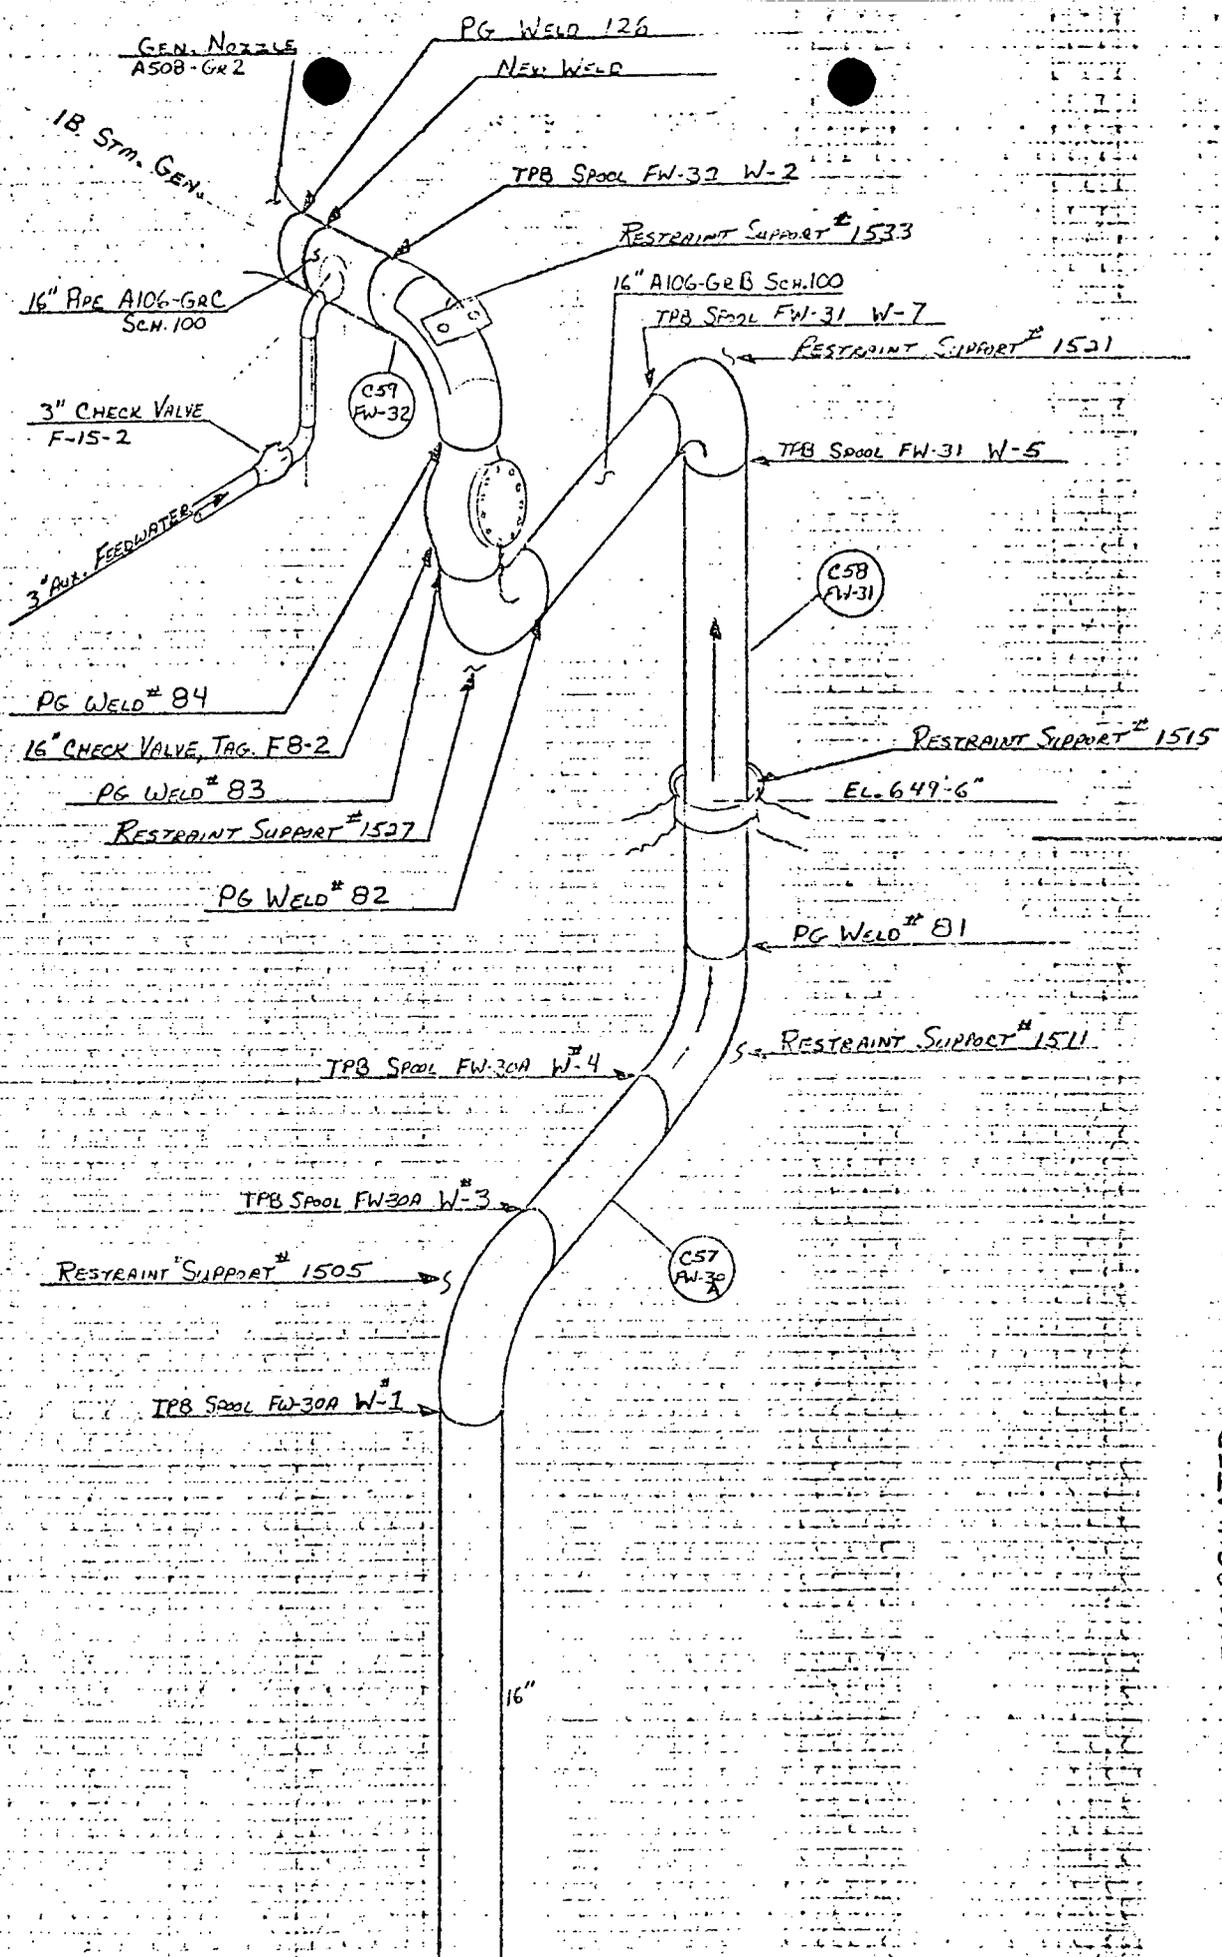
Figure 2.1-3
Loop B FW Piping (Upper)

A further problem exists at Kewaunee in that loop B FW line is partially encapsulated. Therefore, five welds upstream of the FW check valve, but before the first rigid support, could not be examined. Our intention was to perform all the examinations required within the current refueling outage, so no further shutdowns would be necessary to complete the required exams within the time allowed in the bulletin. Therefore, recognizing the increased protection afforded by the encapsulation, we sought a waiver of the bulletin's requirements for the encapsulated welds.

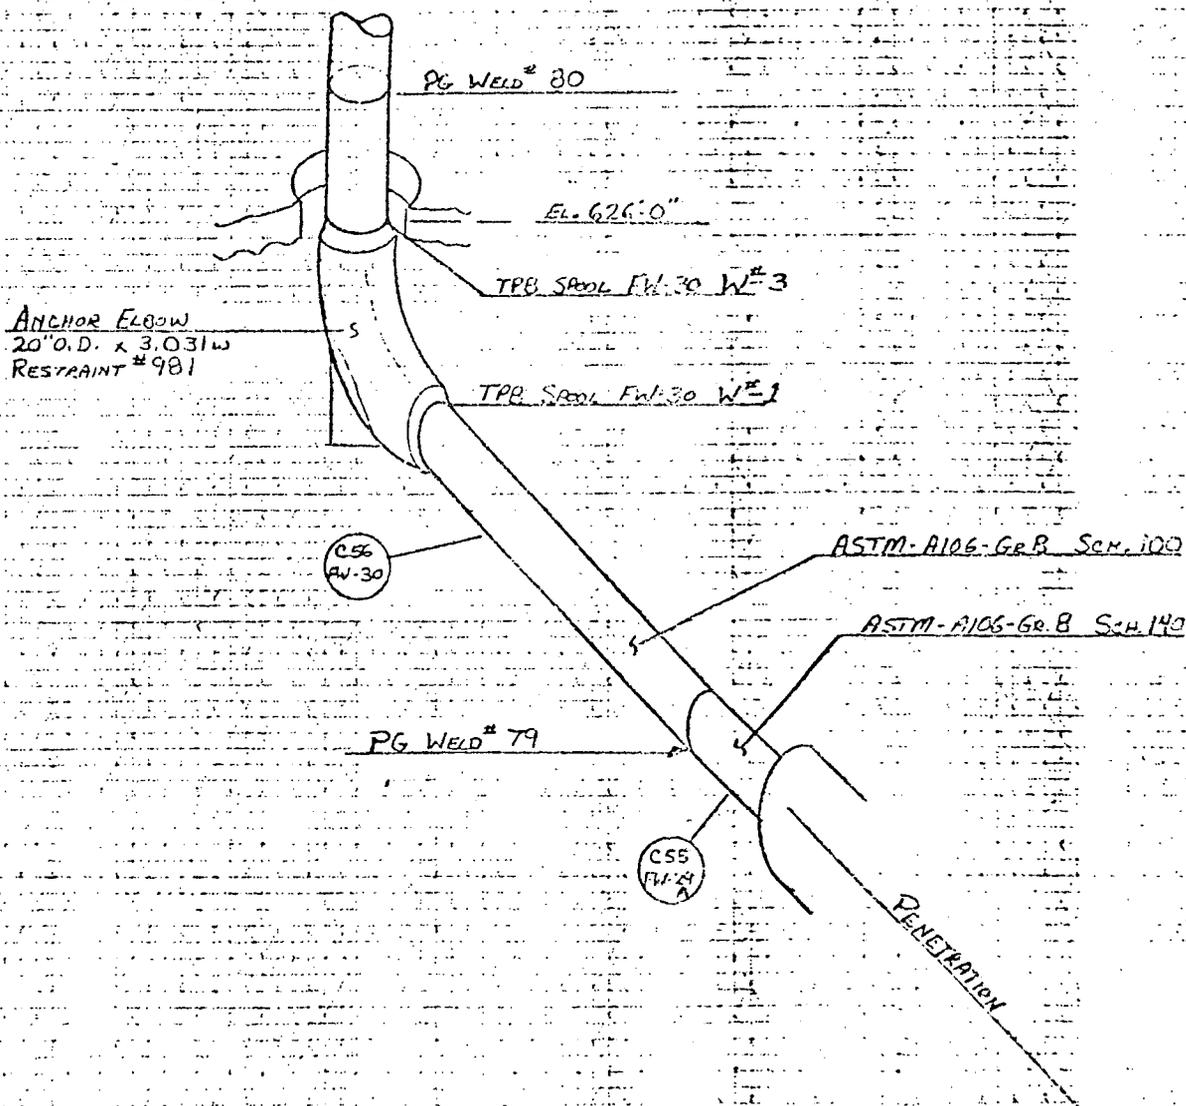
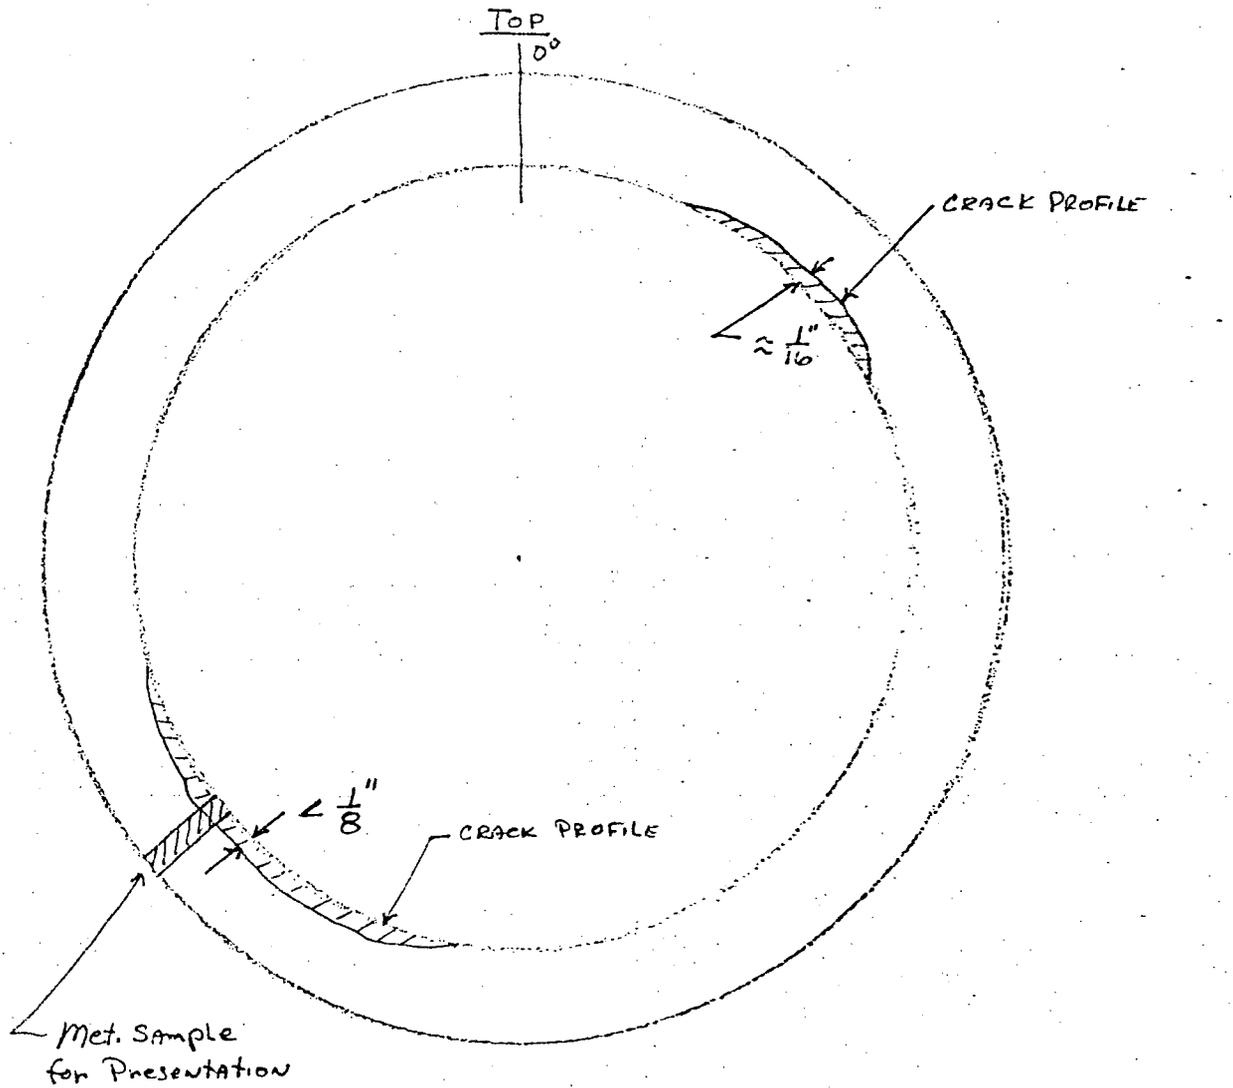
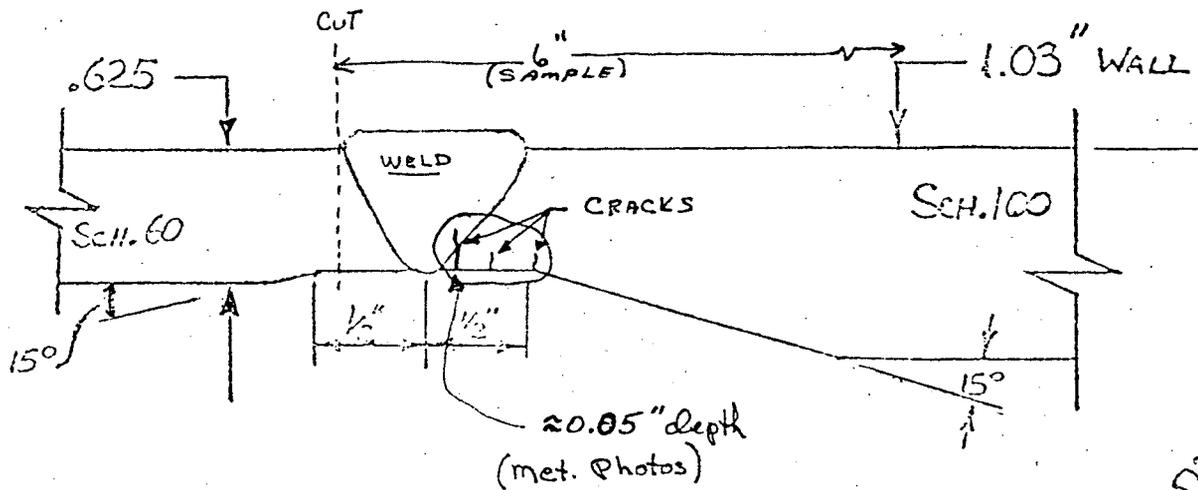
Figure 2.2-1
FW Nozzle to Pipe Loop A

Visual examination showed distinct areas (lines) of corrosion in the cracked regions on the inside surface of the pipe. Radiography and ultrasonic examinations were conducted to determine areas of maximum crack depth for metallurgical specimen selection. Crack profiles of extent and depth are shown in Figures 2.2-1 and 2.2-2 for loops A and B, respectively.

Loop A had lesser cracking with less depth than Loop B. Loop B's cracking extended almost 360° around the I.D. circumference. Metallurgical microstructure was typical ferrite/pearlite and the chemical composition checked out correct. Metallurgical properties, charpy and tensile tests, are still being checked and will be included in the full metallurgical report.

For both loops most of the cracking occurred at the geometric discontinuity area. Cracking was observed originating from the I.D. surface in the heat affected zone and propagating into weld metal. Some cracking occurred in the land region. Oxide was observed in the cracks.
