SUBJECT: Provides status of actions re IE Bulletin 88-002, "Rapidly Propagating Fatigue Cracks in Steam Generator Tubes."

Docket 50-305
Operating License DPR-43
Kewaunee Nuclear Power Plant
Response to NRC Bulletin No. 88-02: Rapidly Propagating Fatigue Cracks in
Steam Generator Tubes

Kewaunee : S/G - B
AVB Positions

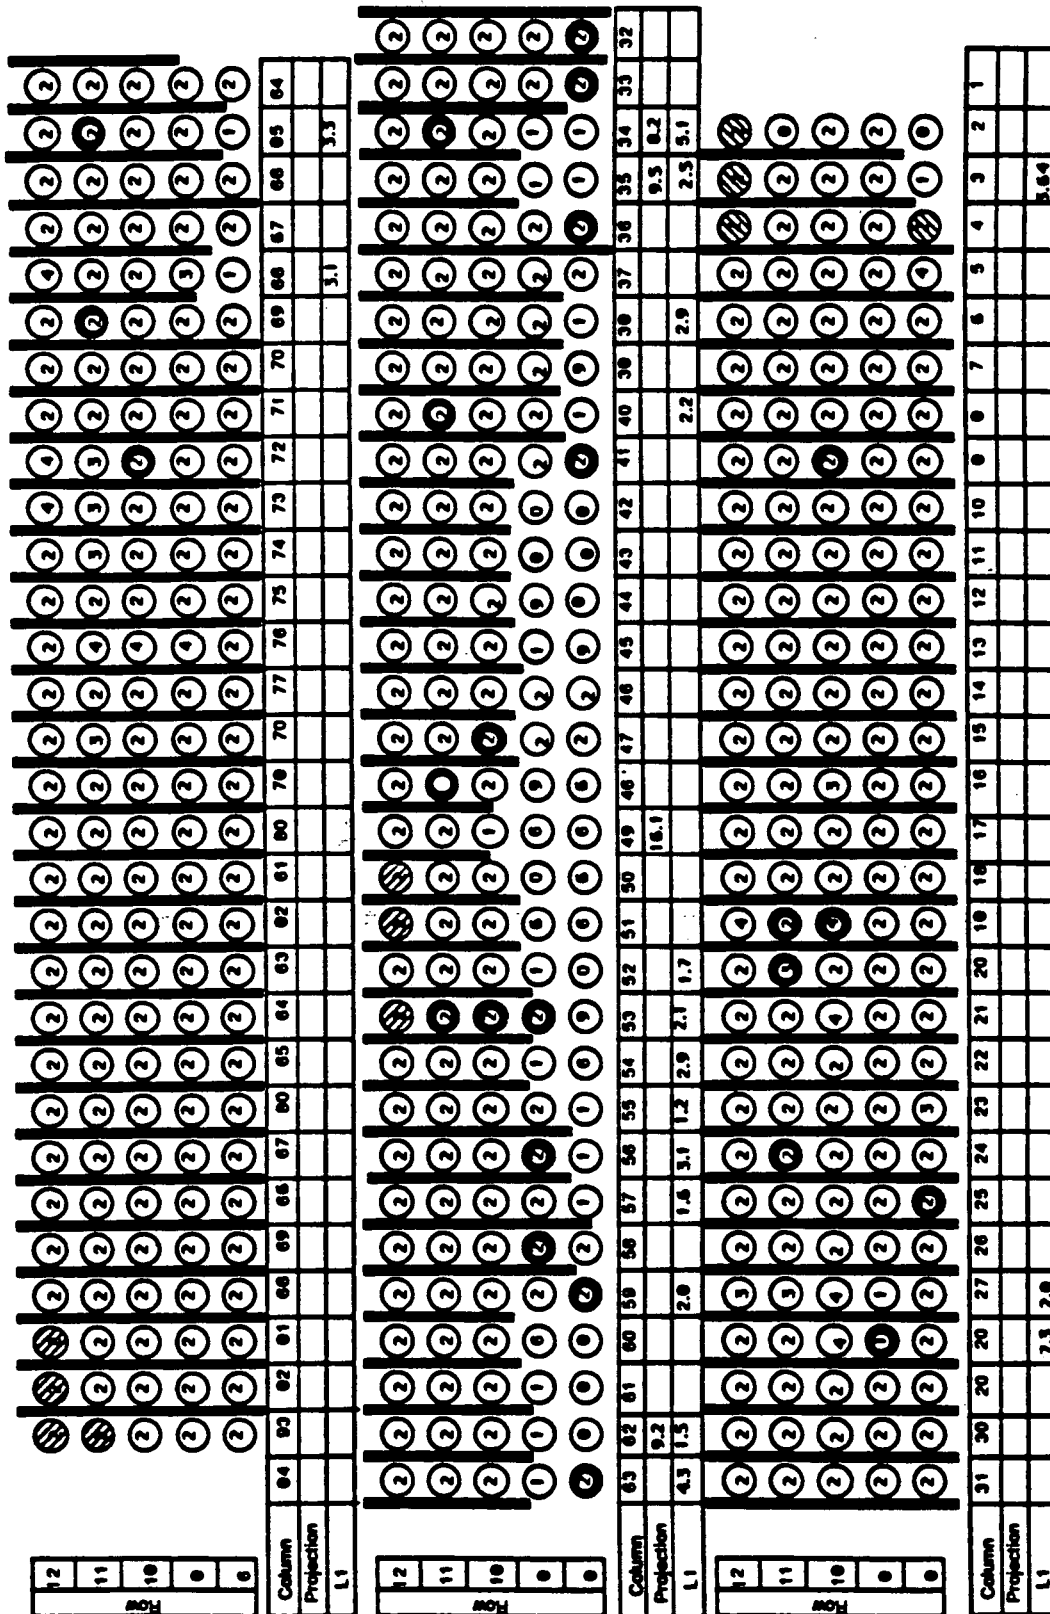
The results of the AVB insertion depth determinations for the Kewaunee steam generators are shown on the AVB maps attached as Figures 1 and 2. For Steam Generator 1A, AVB positions were established from direct observation of visible AVB/tube intersection signals for all columns except 6, 35, 39, 63, and 79. For these columns, the projection method was used to determine AVB insertion depths. For Steam Generator 1B, the projection method was required for columns 34, 35, 49, and 62. 1986 eddy current data was available for all of the tubes indicated on the maps as plugged except for Steam Generator 1B, row 11 column 48. All of the other tubes indicated as plugged were removed from service after the 1986 inspection.

For those tubes where the projection method was used, the projected insertion depth is shown on the AVB maps. The reference features for the projection value are the centerlines of the tube and the AVB. For a tube in a given row (N) to be considered supported, the AVB projection value must be equal to or less than N.1. The decimal portion of this value indicates the fraction of the tube pitch above the tube centerline to which the AVB is inserted. For example, a projection value of 9.1 indicates that the centerline of the apex of the AVB penetrates to 0.1 x the tube pitch above the centerline of the row 9 tube. In this example, the row 9 tube in this column would be at the limit of what is considered to be supported.

unsupported were in the outside column, column 93. These three (3) tubes were identified as requiring further analysis. In Steam Generator 1B, the row 9 tubes in columns 35, 42 through 54, and 60 through 63 were found to be unsupported. Westinghouse stated that based on their prior experience with model 51 steam generators, row 9 tubes are susceptible to this failure mechanism only under extreme flow peaking conditions. Based on this experience, the row 9 tubes in columns 42 through 54 and 60 through 63 were found not to require further flow and fatigue analysis. The row 9 column 35 tube, however, was found to be located in an AVB pattern which could result in elevated flow peaking factors. This tube was identified for further detailed evaluations of flow peaking and fatigue usage factors. All row 10 tubes in this steam generator were found to be supported, but the row 10 column 49 tube marginally satisfied the support criteria of the projection method. This tube also lies in an AVB pattern which generally leads to high flow peaking factors. For these reasons, this tube was identified for further evaluation despite the marginally acceptable support conditions. All row 11 tubes in Steam Generator 1B and all row 12 tubes in both steam generators were found to be supported.

WPSC is contracting Westinghouse to perform the necessary analysis of these five (5) tubes in accordance with the Westinghouse recommended approach. This approach includes the determination of critical velocities for fluidelastic instability from wind tunnel tests using our AVB configurations. Flow peaking factors will then be determined as a ratio of critical velocities between our AVB configurations and other configurations including that for the North Anna row 9 column 51 tube. In addition, flow calculations will be done to determine Kewaunee specific full load flow conditions. These calculations will be used to determine the fluidelastic stability ratios. Based on the results of the above analysis for the Kewaunee tubes and results of detailed analysis done for other plants, an engineering assessment will be made regarding the susceptibility of the five (5) tubes to the tube fatigue failure mechanism.

Following the completion of this analysis, WPSC will determine the need for further action. If one or more of the tubes is found to be susceptible, we will evaluate the possible actions which would include more detailed analysis or removal of the affected tube(s) from service.
