SUBJECT: LER 89-008-00: on 890328, procedural error results in isolation actuation.

LICENSEE EVENT REPORT (LER)

FACILITY NAME (1) Kewaunee Nuclear Power Plant										DOCKET NUMBER (2) 0 5 0 0 0 3 0 5										PAGE (3) 1 OF 07																																			
TITLE (4) Procedural Error Results in Containment Ventilation Isolation Actuation																																																							
EVENT DATE (5)									LER NUMBER (6)									REPORT DATE (7)									OTHER FACILITIES INVOLVED (8)																												
MONTH			DAY			YEAR			YEAR			SEQUENTIAL NUMBER			REVISION NUMBER			MONTH			DAY			YEAR			FACILITY NAMES													DOCKET NUMBER(S)															
																											NA													0 5 0 0 0															
0 3			2 8			8 9			8 9			0 0			8			0 0			0 4			2 7			8 9																0 5 0 0 0												
OPERATING MODE (9) N									THIS REPORT IS SUBMITTED PURSUANT TO THE REQUIREMENTS OF 10 CFR § (Check one or more of the following) (11)																																														
POWER LEVEL (10) 0 0 1 0									20.402(b)									20.406(c)									X 50.73(a)(2)(iv)									73.71(b)

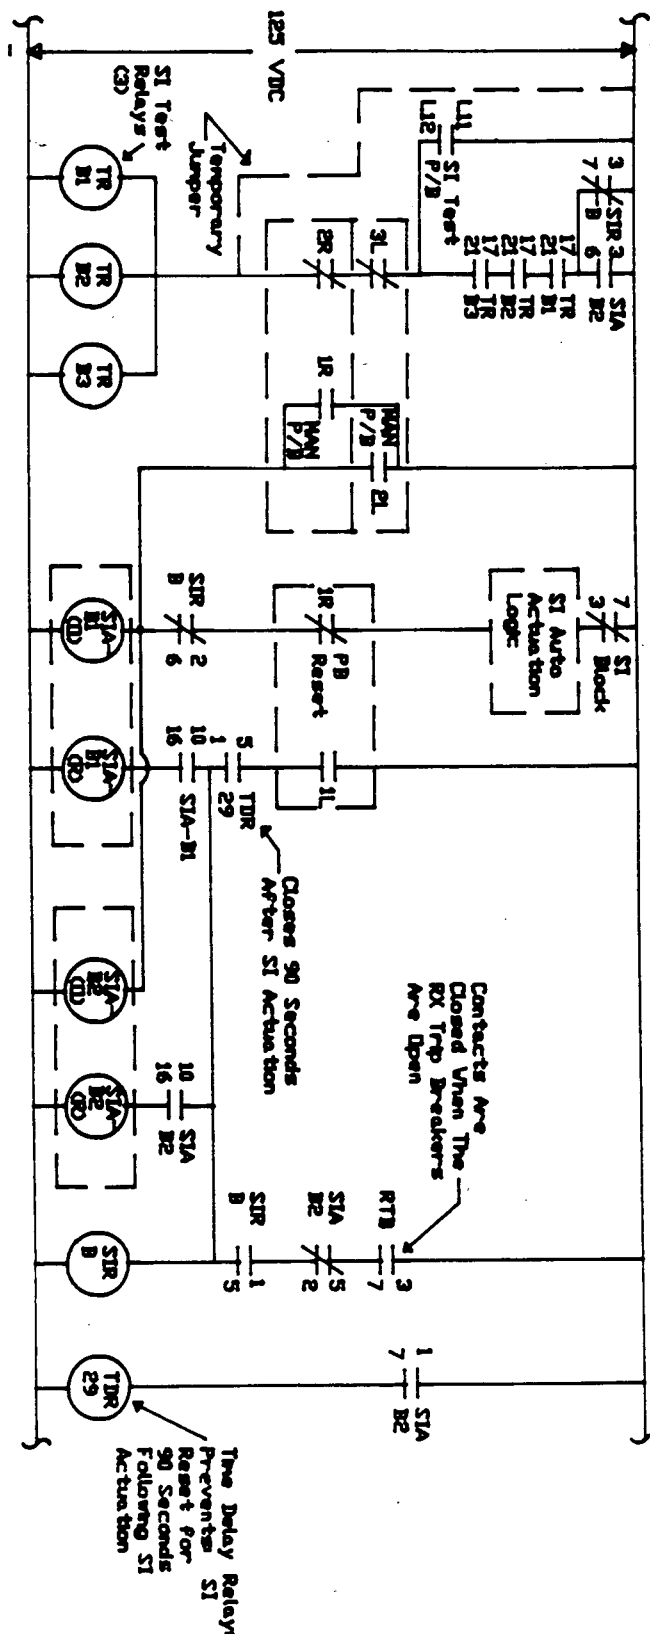
SI Actuation Logic
Figure 1

Procedure 55-44252 was performed to retest and troubleshoot the reset function of relay SIA-B2. Relays SIA-B2 and SIA-B1, refer to Figure 1, are the master relays for train B of the safety injection (SI) [BQ] actuation logic. These relays energize when an SI automatic setpoint is reached (pressurizer [PZR] pressure \leq 1815 psig, steam line pressure \leq 500 psig, or containment pressure \geq 4 psig) or when the manual SI initiation push buttons are depressed. Relay SIA-B2 was being retested because it failed to reset the first time the reset push buttons were depressed during the performance of surveillance procedure 33-110 (SP33-110) on March 26, 1989.

1. Energizing relay SIA-B1 (refer to figure 1).

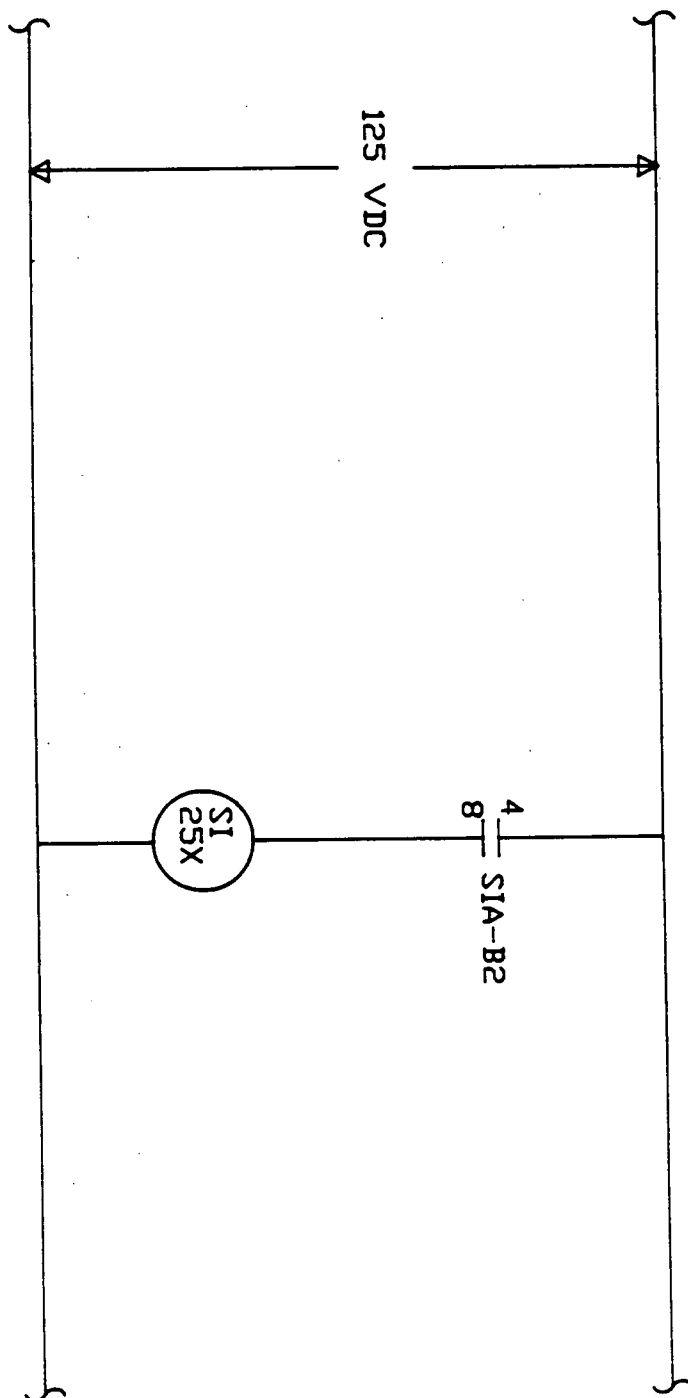
SI Slave Relay
Figure 2

2. This in turn, closes contact 4/8 which energizes relay SI-25X (refer to figure 2).
3. When relay SI-25X is energized, contact 20/24 closes and energizes relay VB (refer to figure 3).
4. When relay VB energizes, contact 4/8 closes and under normal, i.e., non test conditions, relay V20X would energize and initiate a containment ventilation isolation signal.

During the performance of procedure 55-44252 contact 8/4 of relay TRB-2 was maintained open by the jumper preventing the initiation of a containment ventilation isolation signal. When the SI signal was reset, contact 20/24 to relay SI-25X opened and removed power from relay VB. However, relay VB is a self latching relay and remained latched as designed leaving contact 4/8 in the closed position. Therefore when the jumper was removed, contact 8/4 to relay TRB-2 closed and relay V20X energized and initiated a containment ventilation isolation signal. The operators identified the actuation immediately and took steps to re-open the valves and re-establish containment vent.

This event occurred because procedure WR 55-44252 did not direct the operators to reset containment ventilation isolation prior to removing the jumper. Had the reset push buttons been depressed, relay VB would have de-energized and contact 4/8 of relay would have opened. This would have prevented relay V20X from energizing when relay TRB-2 was de-energized.
