SUBJECT: LER 89-016-00:on 891227,closure of turbine stop valves
 causes turbine/reactor trip.

Docket 50-305
Operating License DPR-43
Kewaunee Nuclear Power Plant
Reportable Occurrence 89-016-00

TITLE (4) Closure of the Turbine Stop Valves Causes a Turbine/Reactor Trip													
---	--	--	--	--	--	--	--	--	--	--	--	--	--

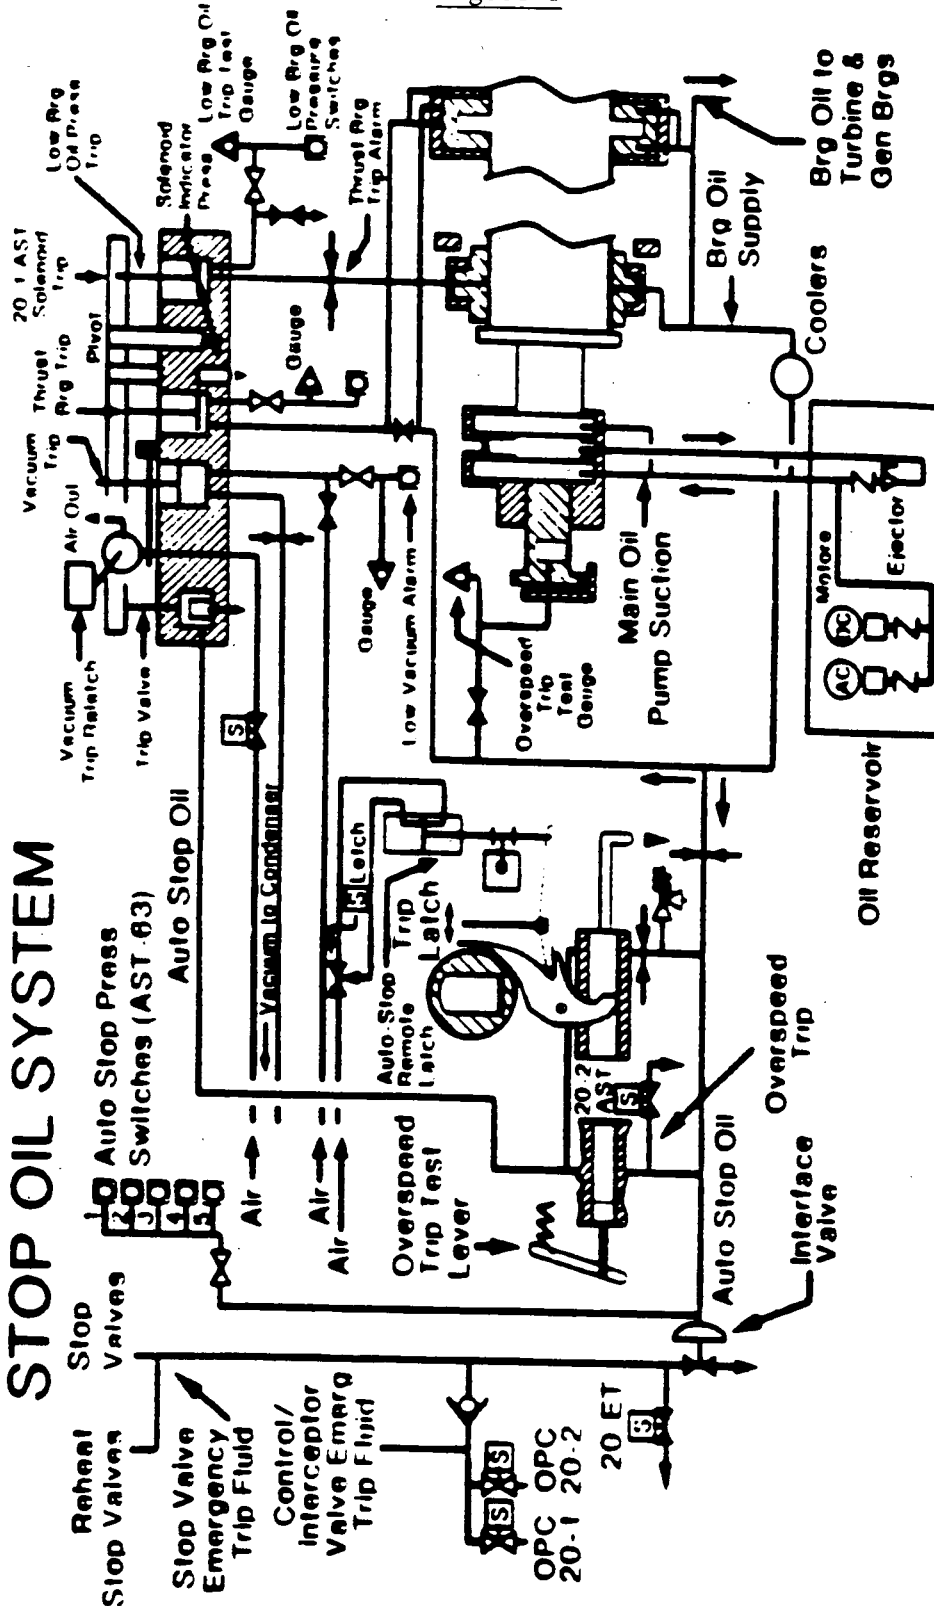
Figure 1

During normal operation the turbine stop valves, which are swing disc type valves, are kept 100% open toward steam flow by pressurized electro-hydraulic (EH) fluid. The EH fluid system supplies high pressure hydraulic fluid to position the turbine control valves, and initiates an abrupt closure of the control and stop valves upon receiving a trip signal. A decrease in EH trip fluid pressure below a nominal value of 1000 psig will cause the stop valves to close. The stop valves will close rapidly due to assistance from both steam flow and an internal closing spring. This decrease in EH pressure could be caused by the opening of either the interface valve or the emergency trip solenoid valve (20/ET) (Reference Figure 1).

The interface valve has a spring-loaded diaphragm which is held closed against spring force by the auto stop oil. The auto stop oil system allows turbine latching. In addition, the auto stop oil system dumps oil pressure to provide turbine and reactor protection by quickly tripping the turbine and closing the turbine stop valves, thus stopping steam flow to the turbine. With the interface valve closed, the EH fluid system can be pressurized to hold the stop valves open. The interface valve opens when auto stop oil pressure is insufficient to overcome the spring tension. The opening of the interface valve results in the dumping of EH fluid to drain, which causes the stop valves to close.

The emergency trip solenoid valve (20/ET) is connected directly to the EH fluid system. It opens in response to various plant inputs (for example - steam generator hi-hi level). The opening of 20/ET causes a dumping of EH fluid to drain, which closes the stop valves.
