SUBJECT: LER 91-004-00: on 910415, inadvertent closure of two containment isolation valves & actuation of several dampers in auxiliary bldg ventilation occurred. Caused by error in communication. Individuals counseled. W/910515 ltr.

Docket 50-305
Operating License DPR-43
Kewaunee Nuclear Power Plant
Reportable Occurrence 91-004-00

LICENSEE EVENT REPORT (LER)

TITLE (4)
 Communication Error Results in Actuation of Engineered Safety Features

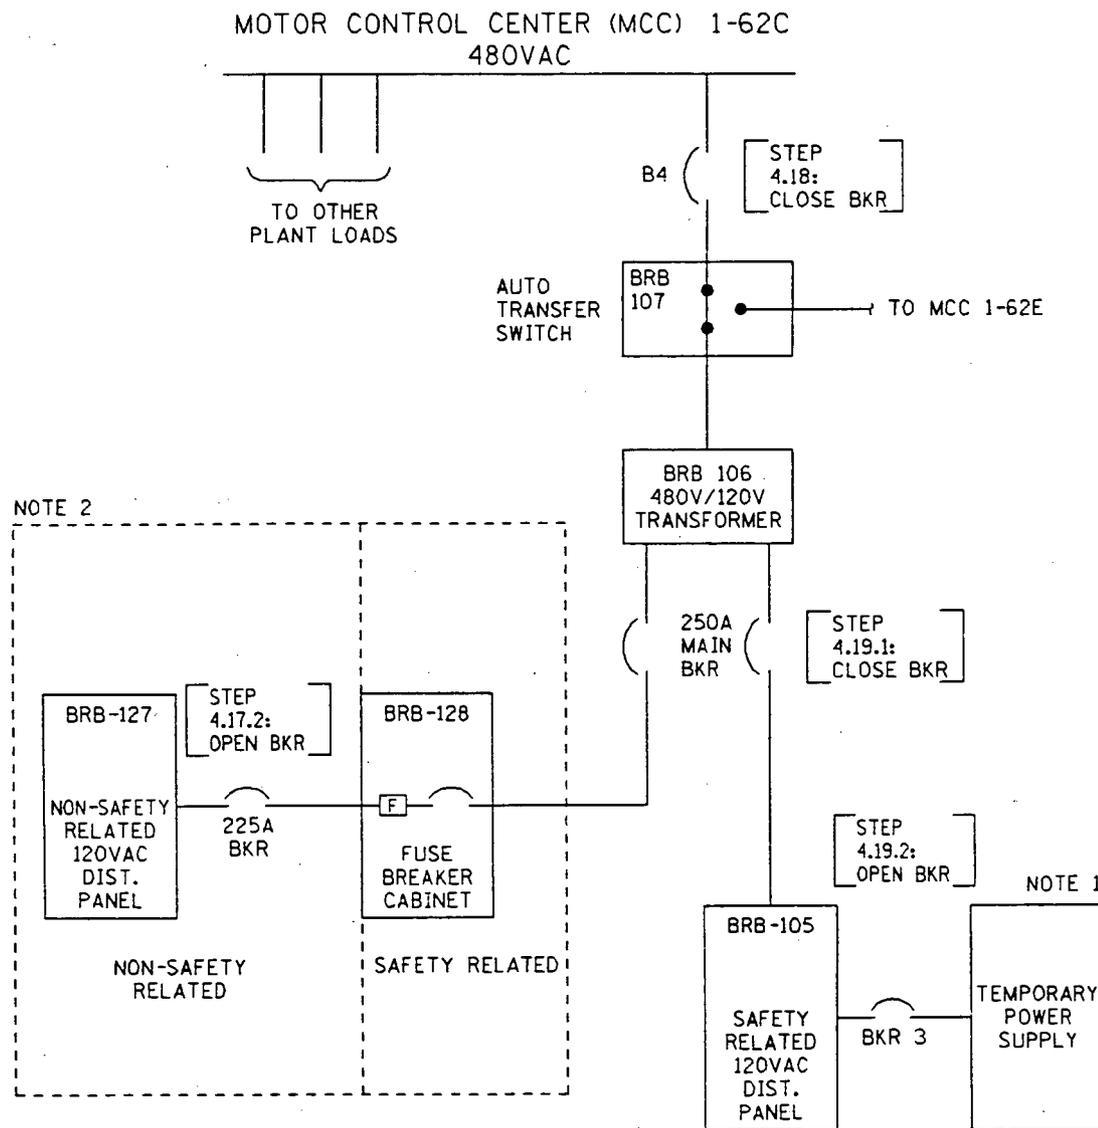
FIGURE 1

DCR 2417 was implemented to move non-safety related loads from the existing safety related 120 volt alternating current (VAC) distribution panels [BU], BRA-105 and BRB-105, to new non-safety related distribution panels, BRA-127 and BRB-127, refer to figure 1. Prior to DCR 2417, each non-safety related load had to be individually isolated from its safety related power supply. DCR 2417 provides one isolation point per train between the non-safety related 120 VAC distribution panels and their respective safeguards power supplies.

Please note that steps 4.17 and 4.18 were on the bottom of page 11 of procedure DCR 2417-02 while step 4.19 was at the top of page 12. For your convenience, the procedure step number and a description of the required action is shown in brackets next to its associated breaker in Figure 1.

At this time, the NAO was under the impression that he was only required to do steps 4.17.2, 4.19.1, and 4.19.2, i.e, those steps which required placement or removal of a danger tag or hold card. At approximately 2123, the NAO entered the B battery room and proceeded with steps 4.17.2 and 4.19.2. When he performed step 4.19.2 prior to performing step 4.18, he isolated all power to BRB-105. The electricians who were already in the room and were watching the NAO knew he had isolated all power to the bus. However they were unable to act quick enough to warn him. Annunciators in the control room immediately alerted the operators to the abnormal condition.

The event occurred as a result of a communication error between the Control Room Supervisor and the NAO. The Control Room Supervisor was of the impression that the Auxiliary Operator was aware of what procedure steps had been completed and what steps needed to be performed. The NAO was of the impression that he was only required to place the danger tag and hold card that were given to him and to remove a danger card.

Discussions were held with the individuals involved concerning the importance of clear communication. Furthermore, this report will be included as part of the required reading material for all operators.
