REGULATORY INFORMATION DISTRIBUTION SYSTEM (RIDS)

SUBJECT: LER 92-004-00:on 920321,Train B containment ventilation isolation occurred,constituting ESF.Caused during performance of design change procedure to replace test relays.LER will be routed to personnel.W/920413 ltr.

Docket 50-305
Operating License DPR-43
Kewaunee Nuclear Power Plant
Reportable Occurrence 92-004-00

TITLE (4) Containment Ventilation Actuation (ESF) Due to Containment Ventilation System Startup During Performance of Design Modification

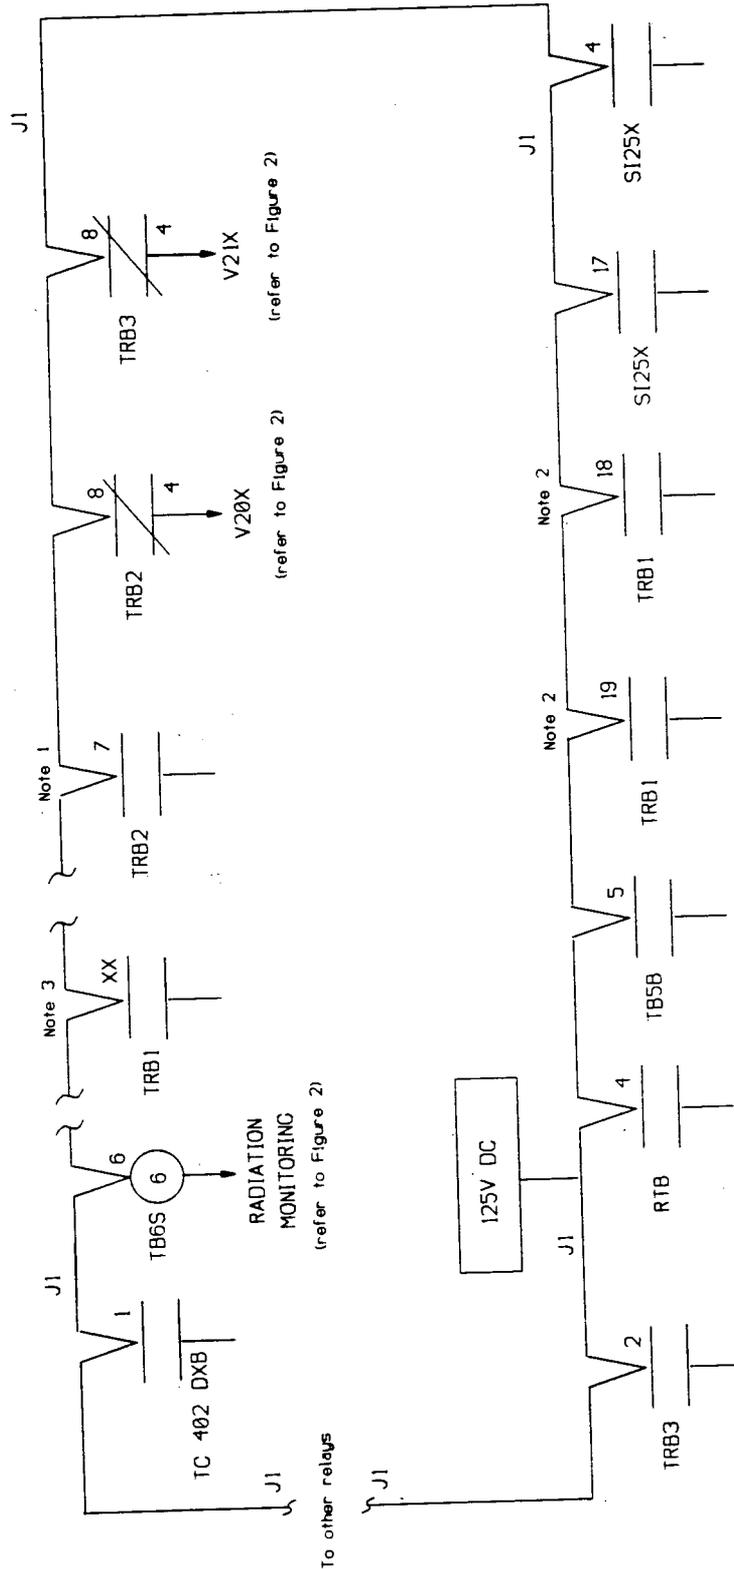
Figure 1

This event occurred during the performance of design change procedure DCR #2279-69, "TRB1/TRB4 Relay Replacement/Addition." The purpose of the design change was to replace test relay TRB1, and to install a new test relay, TRB4. To replace relay TRB1, the power lead (J1) to the TRB1 contacts was lifted (refer to note 2 and 3 on figure 1). This interrupted power to various relays including relays V20X and V21X in the Train B containment ventilation isolation circuitry. Power to the radiation monitoring circuitry for both A and B trains was not interrupted.

Conditions at time of event

- Note 1 - TRB1 contact 8 was not re-energized yet, therefore, TRB2 contact 7 was not powered
- Note 2 - J1 was re-connected to TRB1 contact 19 and then to contact 18 which then supplied power to relays V20X and V21X.
- Note 3 - the leads were lifted from relay TRB1 contacts 13, 5, 14, 6, 15, 7, 16, and 8, respectively. Contacts 19 and 18 shown separately

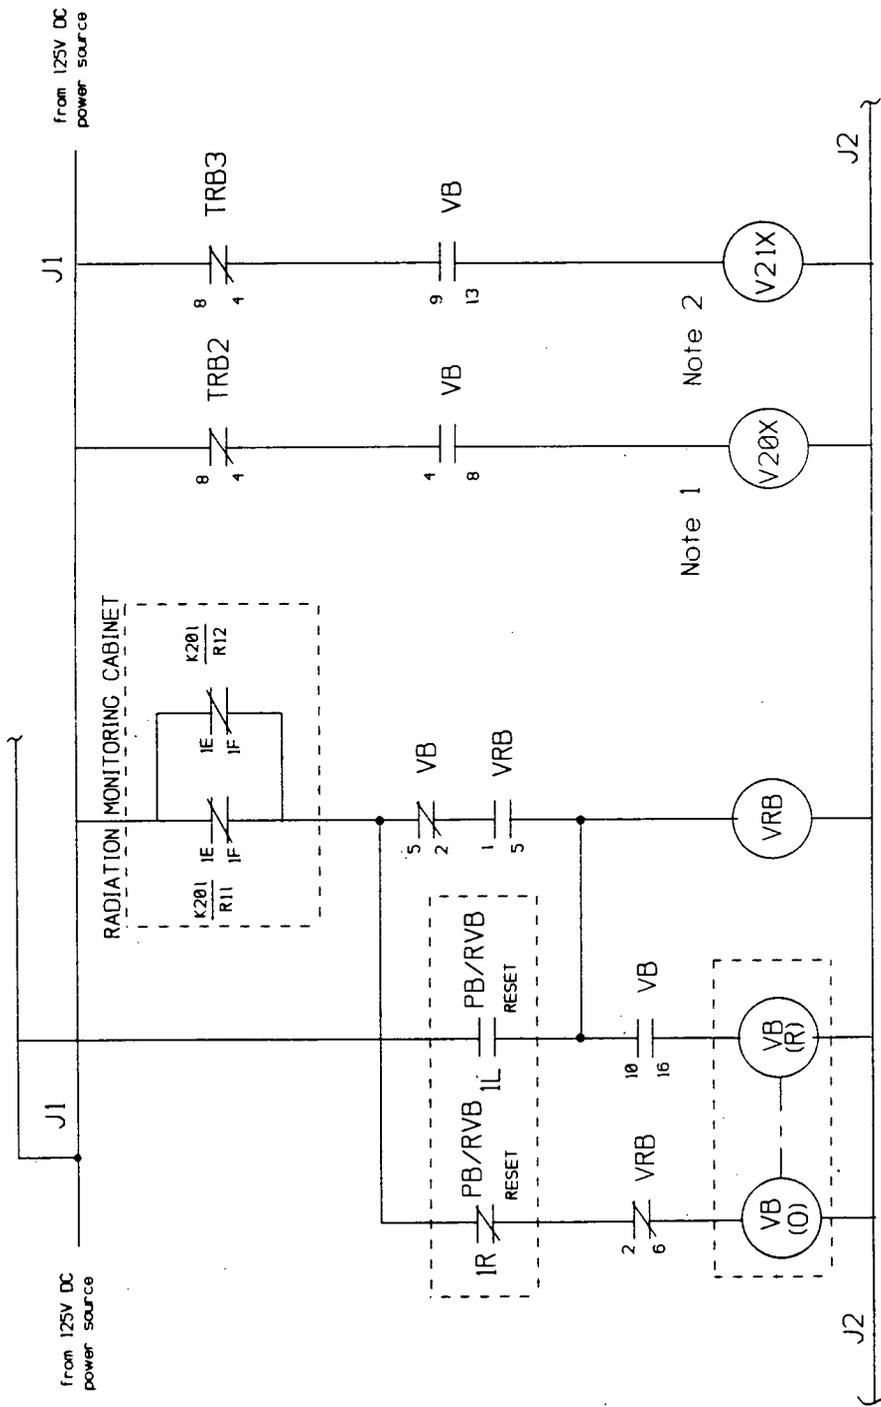
Figure 2

Note 1
Note 2

Note: 1. V20X Initiates Containment Vent Isolation
2. V21X Initiates alarms only
