November 8, 1977
IE Bulletin 77-05

ELECTRICAL CONNECTOR ASSEMBLIES

TRIP REPORT
by
W. R. Rutherford

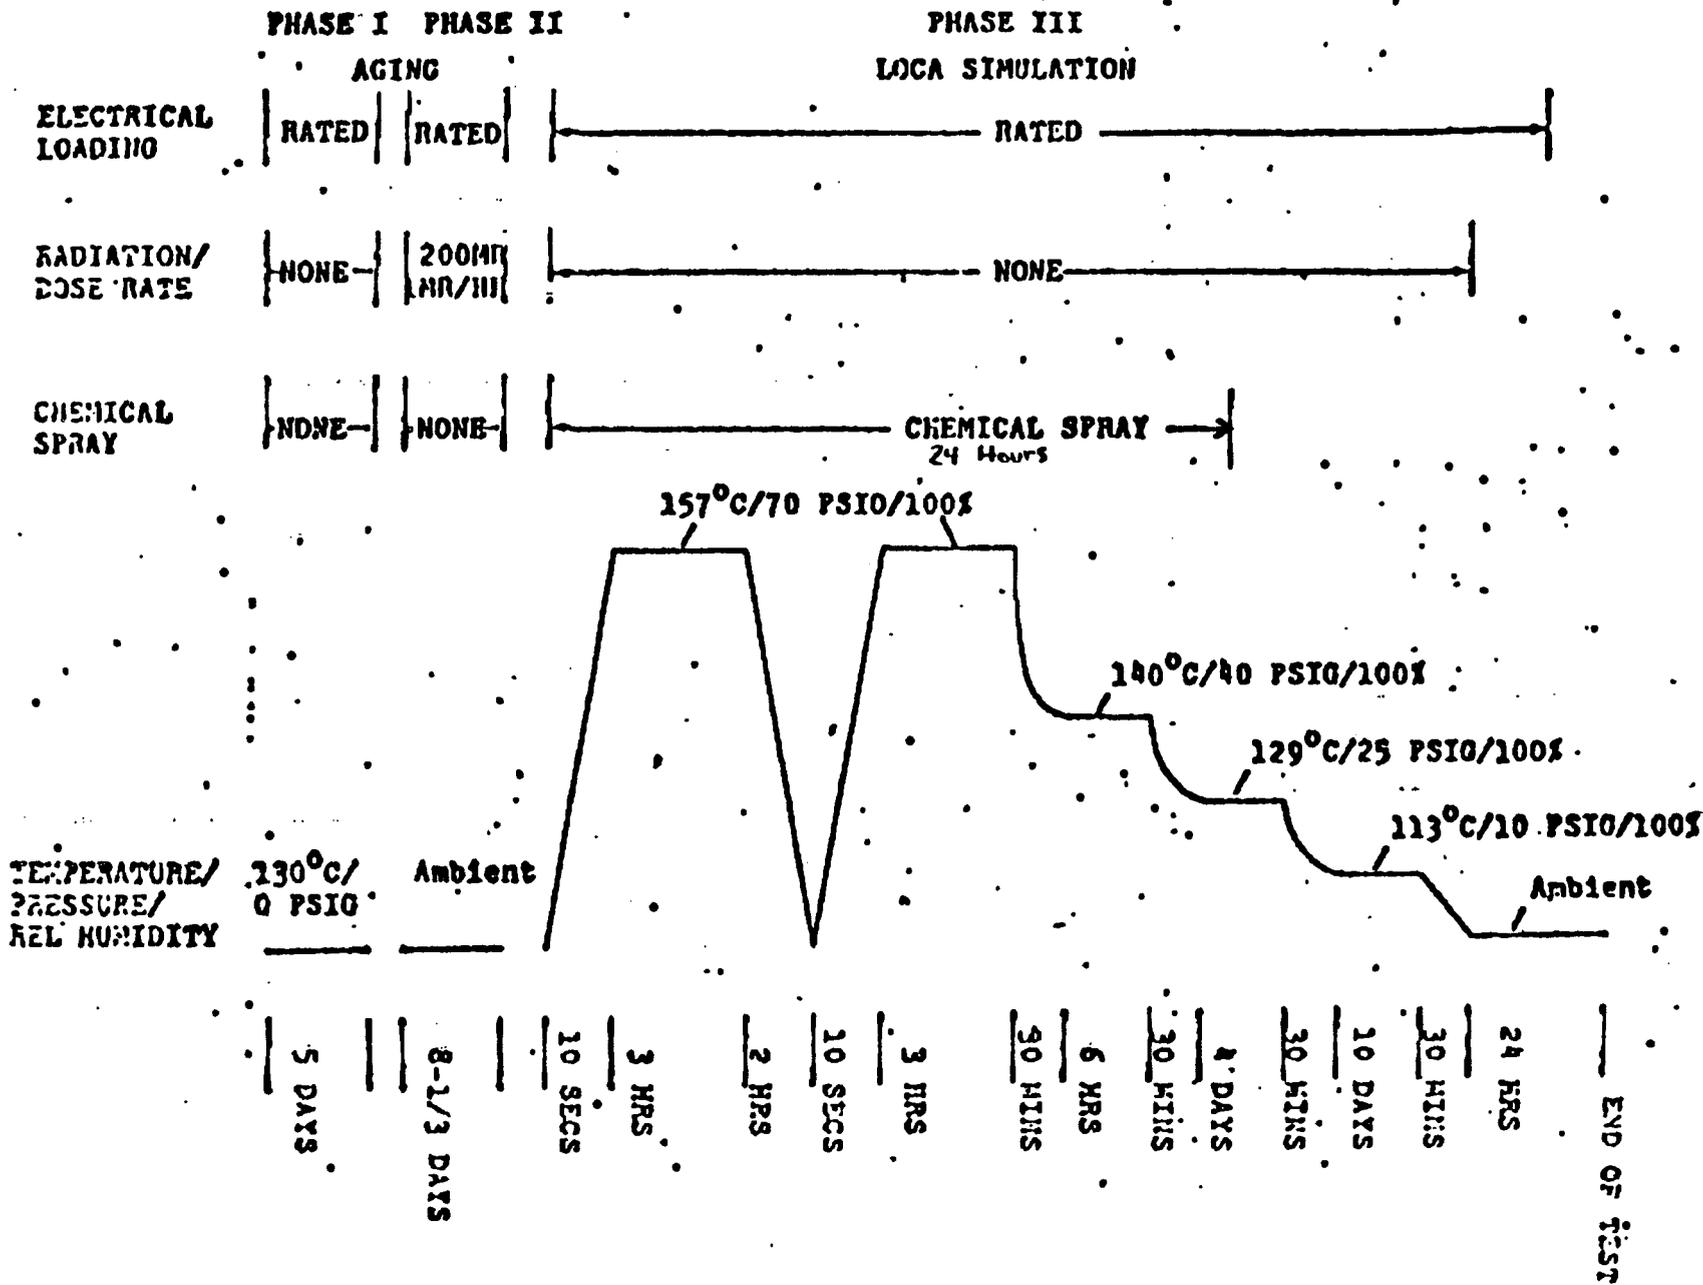
Figure 1

The three tests performed by Sandia were composed of two sequential and one simultaneous exposure to LOCA environments. In each case the equipment was exposed to radiation and thermal aging prior to operating under the simulated LOCA conditions. Figures 1 and 2 describe the test profiles for sequential and simultaneous tests respectively (Sandia tests were designed to study synergistic effects). Each of the tests satisfy the intent of IEEE 323-1974. The assemblies were electrically loaded to 20 amperes and 600 volts at the start of the tests. Insulation resistance and capacitance measurements were recorded during the tests to indicate damage.

SEQUENTIAL TEST PROFILE

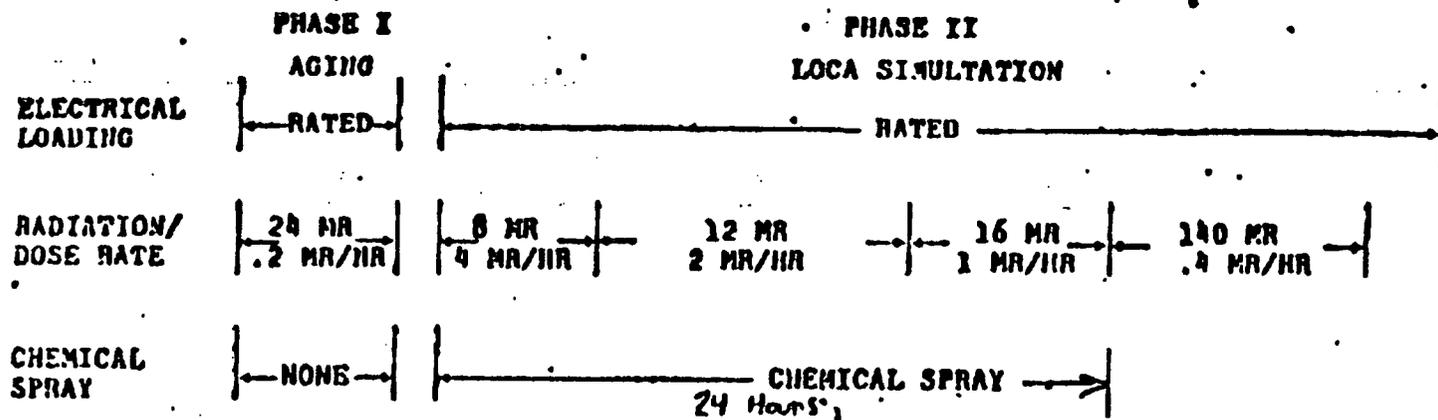
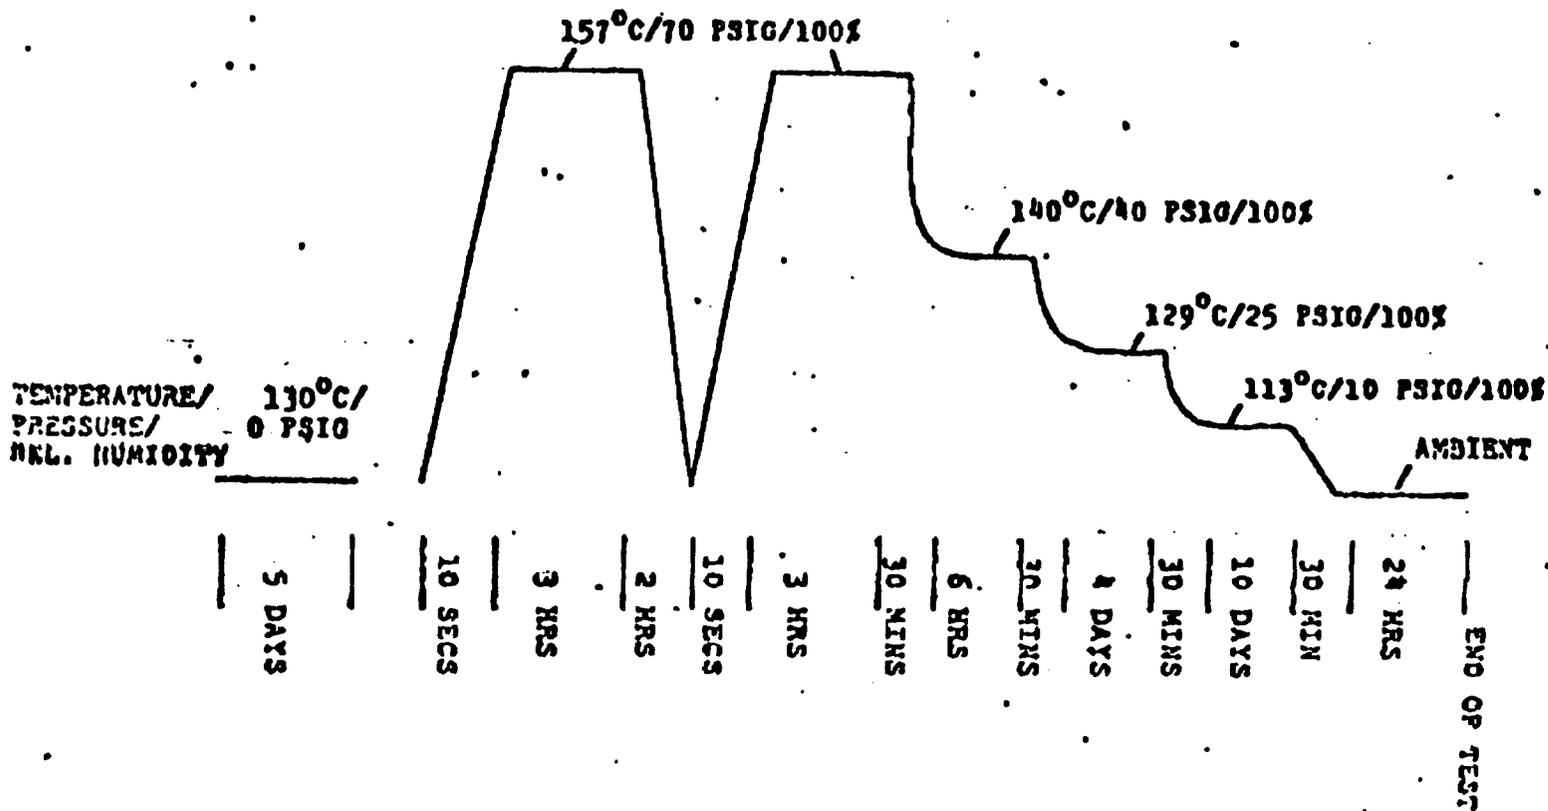
Figure 2

SIMULTANEOUS TEST PROFILE
