SUBJECT: Monitoring Well Inventory No. 38-EH-2169-00, Walter Reed Army Medical
Center, Washington D.C., 18-22 September 2000

MONITORING WELL INVENTORY NO. 38-EH-2169-00
WALTER REED ARMY MEDICAL CENTER
WASHINGTON D.C.
18 - 22 SEPTEMBER 2000

EXECUTIVE SUMMARY
MONITORING WELL INVENTORY NO. 38-EH-2169-00
WALTER REED ARMY MEDICAL CENTER
WASHINGTON D.C.
18 - 22 SEPTEMBER 2000

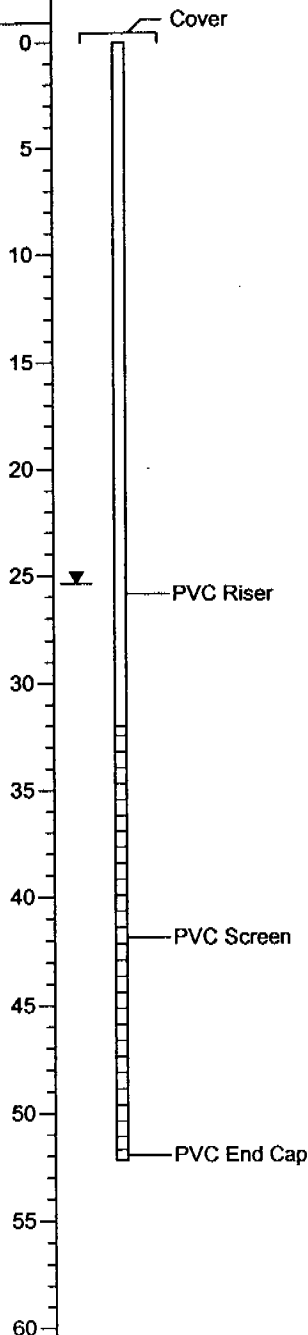
LOG OF MW- RUM 1

Protective casing flush mount.

Well is not labeled on the inside, but is labeled on the outside.

Measuring point is clearly marked.

Protective casing 0.15' below flush with surface, 8" diameter and is in good condition.

Concrete surface pad 2' diameter is in good condition.

Riser pipe 2" PVC in good condition, locking cap, good condition.

Measuring point top of PVC. Top of screen seen by video, seam shown at 31.75'. Screen 2" PVC in good condition, clean and functional. Slot type fine/horizontal.

Sediment or debris not observed

Water level measured at 25.35' from measuring point.

Area around well is clean, secure, free from erosion, cracks.

Depth to bottom from measuring point, 50.40'.

1. Install lock.

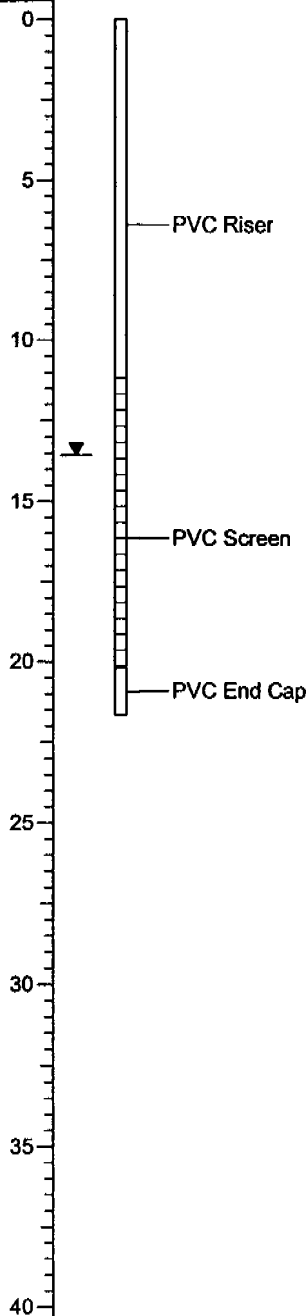
LOG OF MW- 9

Original well modified by removal of above ground casing. Flush mount casing installed later.

Well is labeled on the inside, but not labeled on the outside.

Measuring point top of PVC and is clearly marked.

Protective casing flush with surface, 8" diameter and is in good condition

Concrete surface pad 2' diameter is in good condition.

Riser pipe 2" PVC in good condition, locking cap, good condition.

Top of screen seen by video, seam shown at 11'-3" and 2" PVC in good condition, slot type fine/horizontal.

Water level measured at 13.45' from the measuring point.

Sediment or debris were not observed.

Area around well is clean, secure, free from erosion, cracks.

Depth to bottom from measuring point, 21'-3".

1. Install lock.

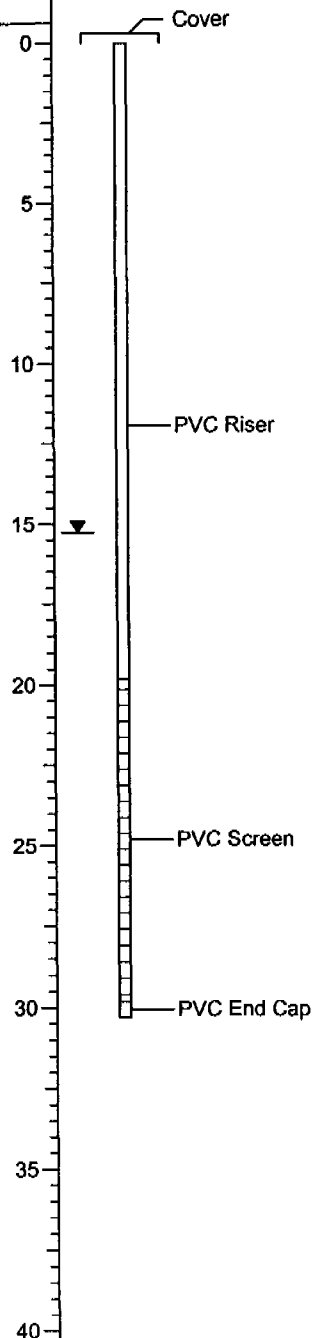
LOG OF MW- 11

Protective casing flush mount in good condition. Not secure due to space limits.

Well is labeled on the inside MO.88.2217 AEHA 11, but not labeled on the outside.

Measuring point is clearly marked.

Protective casing flush with surface, 8" diameter and is in good condition.

Concrete surface pad 2' diameter is in good condition.

Riser pipe 4" PVC in good condition.

Measuring point top of PVC and top of screen seen by video, seam shown at 20.0'. Screen 4" PVC in good condition, functional. Slot type fine/horizontal.

Water level measured at 15.27' from measuring point.

Sediment, debris, and objects observed, possible abandoned bailer and cord.

Area around well is clean, secure, free from erosion, cracks.

Depth to bottom from measuring point, 29.80'.

1. Trim PVC riser and install expandable cap.
2. Remove sediment and debris.
3. Install lock.

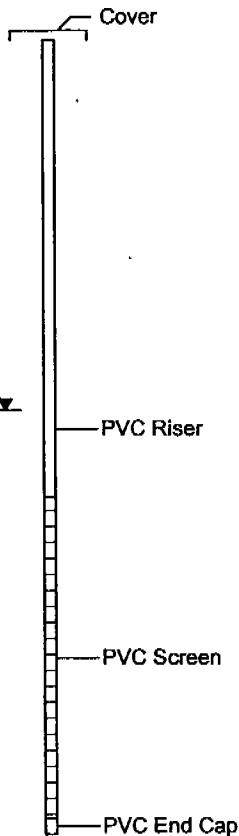
LOG OF MW- 88-2444

Original well modified by removal of flush mount casing. Water valve access casing installed during paving of street.

Well is labeled on the inside, but not labeled on the outside.

Measuring point is clearly marked.

Water valve protective casing flush with surface, 6" diameter. A cover was obtained and temporarily installed until a proper flush mount casing can be installed.

Street paving is in good condition.

Riser pipe 4" PVC in good condition, locking cap, lock, good condition.

Measuring point top of PVC. Top of screen seen by video, seam shown at 14.25'. Screen 4" PVC in good condition, clean and functional but some sediment observed. Slot type fine/horizontal.

Water level measured at 11.54' from measuring point.

Area around well is clean, secure, free from erosion, cracks.

Depth to top of sediment from measuring point, 23.0'.

1. Repair protective casing.
2. Remove sediment and debris.

1. Decommission per recommendation in reference 1.2.
