**Subject: April 2011 Inspection Report, Cameco Resources, Permits 603 & 633**

**APRIL 2011 INSPECTION REPORT  
DISTRICT 1/LAND QUALITY DIVISION**

**COMPANY:** Cameco Resources (CR), Highland Ranch, Permit #603  
& Smith Ranch, Permit #633

**DATE OF INSPECTION:** April 20 & April 21, 2011

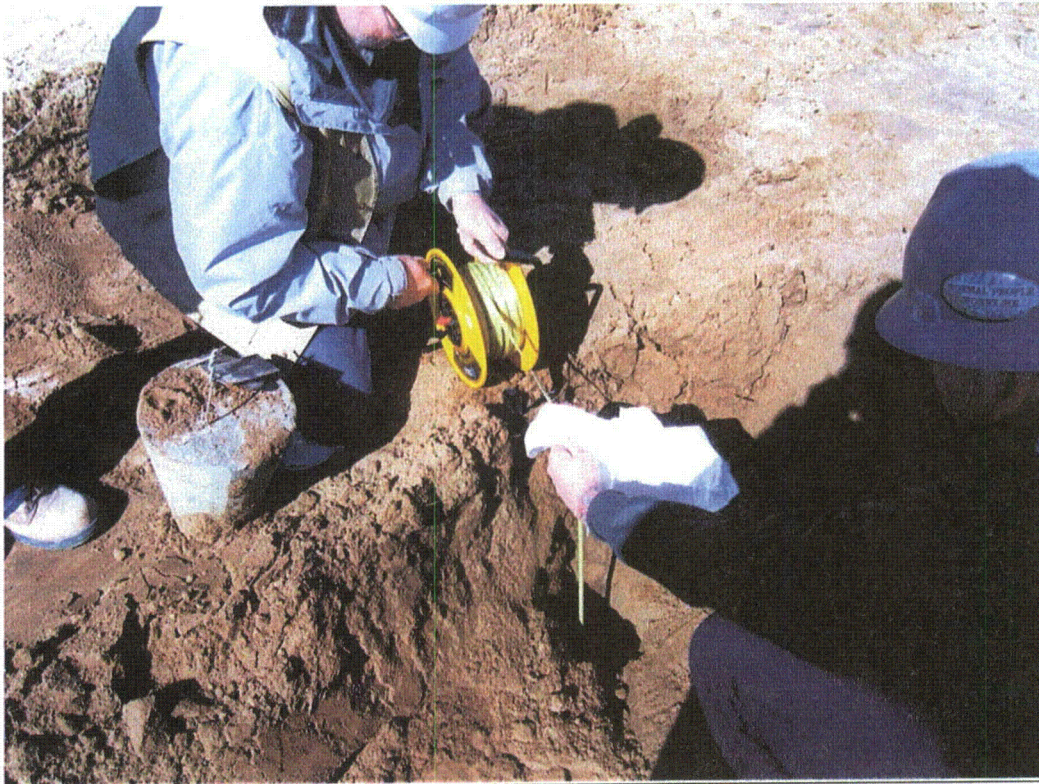
- 1 The abandoned drill holes inspected for the depth to the seal (drilling mud) were found to be at significant depths below surface varying from 46 to 198 feet below surface. CR states that the drill mud although filled to the top of the hole settles back to the static water level. During the investigation, groundwater was only encountered in two holes and it was questionable whether or not the water was associated with an aquifer or with the drill mud.

*Figure 2 – Measuring depth to plug gel*

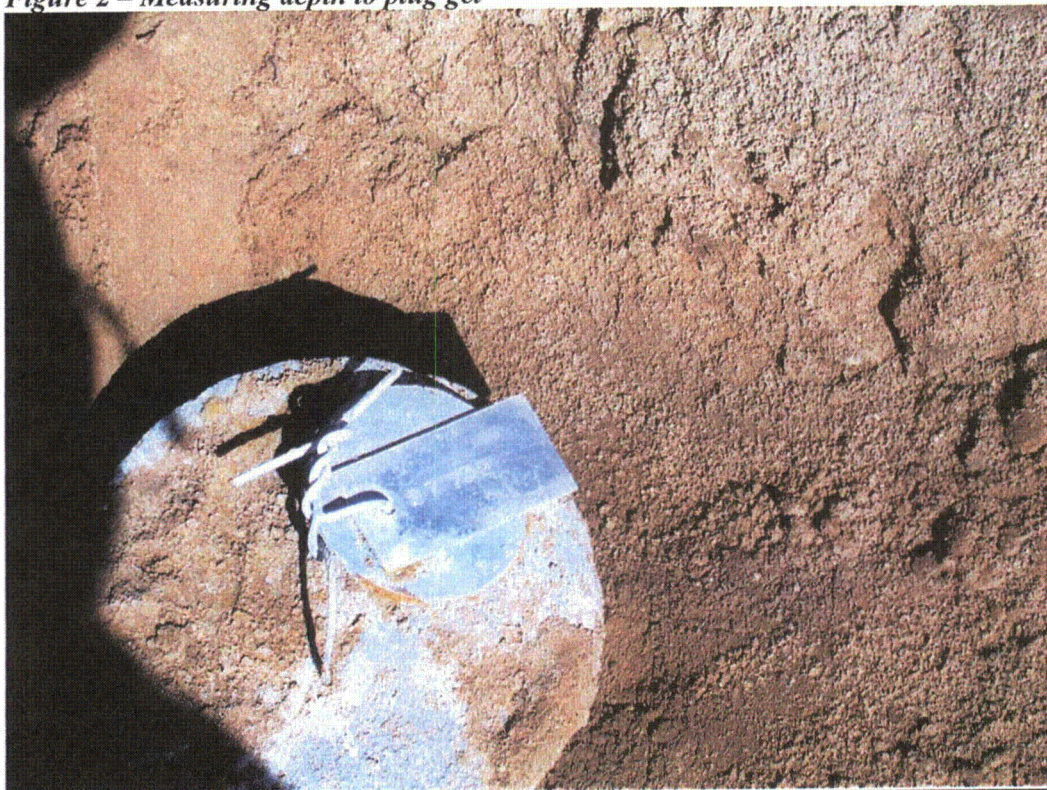
*Figure 3 – Concrete cap from Well #732*

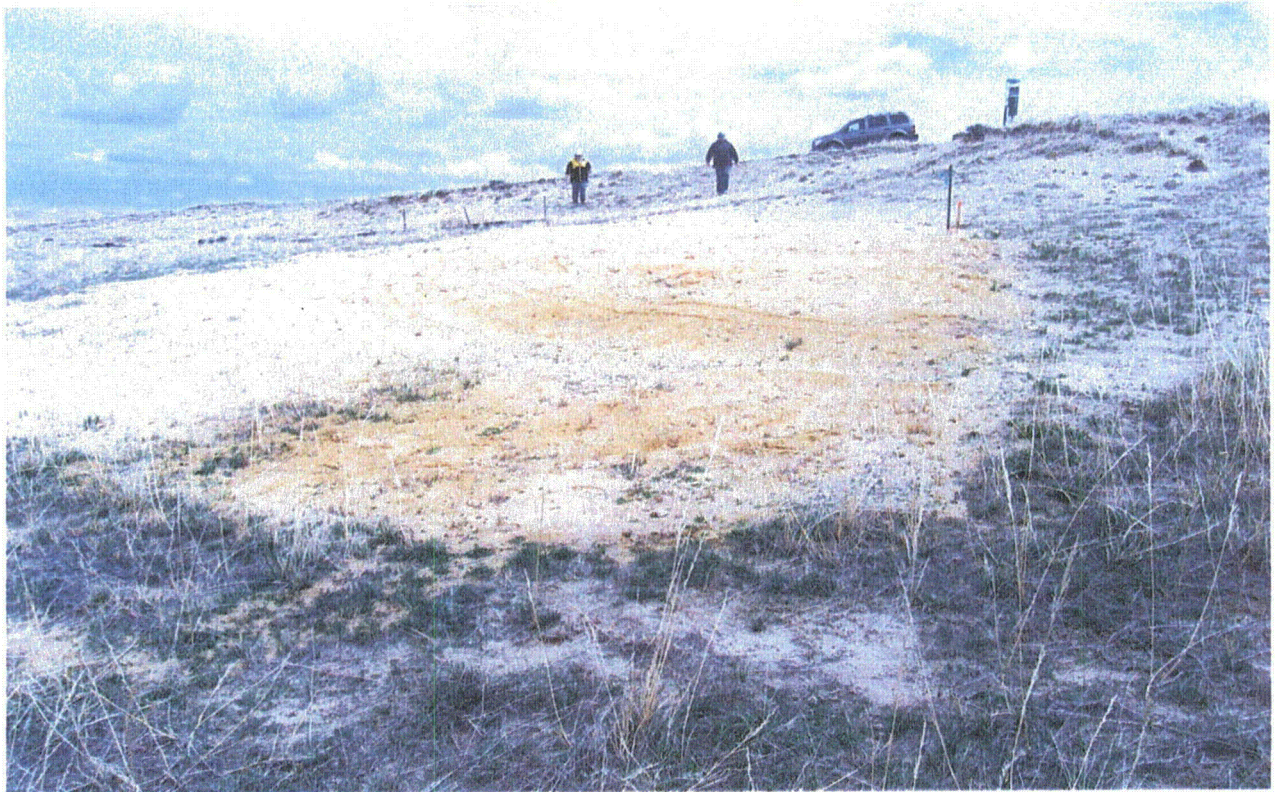
It was noted that very little sediment control was installed throughout the entire mine unit disturbance (**Figures 9a & 9b**). Silt fence was noted in two shallow drainages in poor repair, filled with sediment (**Figures 10a & 10b**). As a result of the poor effort in controlling erosion, sediment was washing onto native, unstripped areas throughout the wellfield development area.

- 3 Significant deficiency in sediment and erosion control continues to be a very high concern for LQD at the SHRUP mine sites. The lack of sediment control in the Mine Unit 10 development areas and the lack of sediment controls associated with exploration/delineation drilling activities on and/or adjacent to the permit boundaries are a repeat violation that LQD has tried to impress upon the operator as a serious problem. The inspectors have encountered numerous instances of sediment on native areas as a result of mining related disturbances. According to the WEQA, § 35-11-415 (b)(viii), *"The operator...shall...prevent, throughout the mining and reclamation operation...the pollution of surface and subsurface waters on the lands affected..."* and according to the Wyoming Land Quality Division Noncoal Rules and Regulations (R&R), Chapter 3, Section 2(c)(i)(A), *"All topsoil or approved surface material shall be removed from all areas to be affected in the permit area prior to these areas being disturbed..."*. The disturbance in Mine Unit 10 does not include adequate sediment control with significant sediment being deposited on native areas. Also, the exploration/delineation drill sites associated with CR's drilling activities in the southwest area of the permit does not include adequate sediment control resulting in sediment and drilling mud depositing on native areas. Therefore, enforcement action is recommended.

**Figure 9a** *Disturbance area on slope without sediment control*

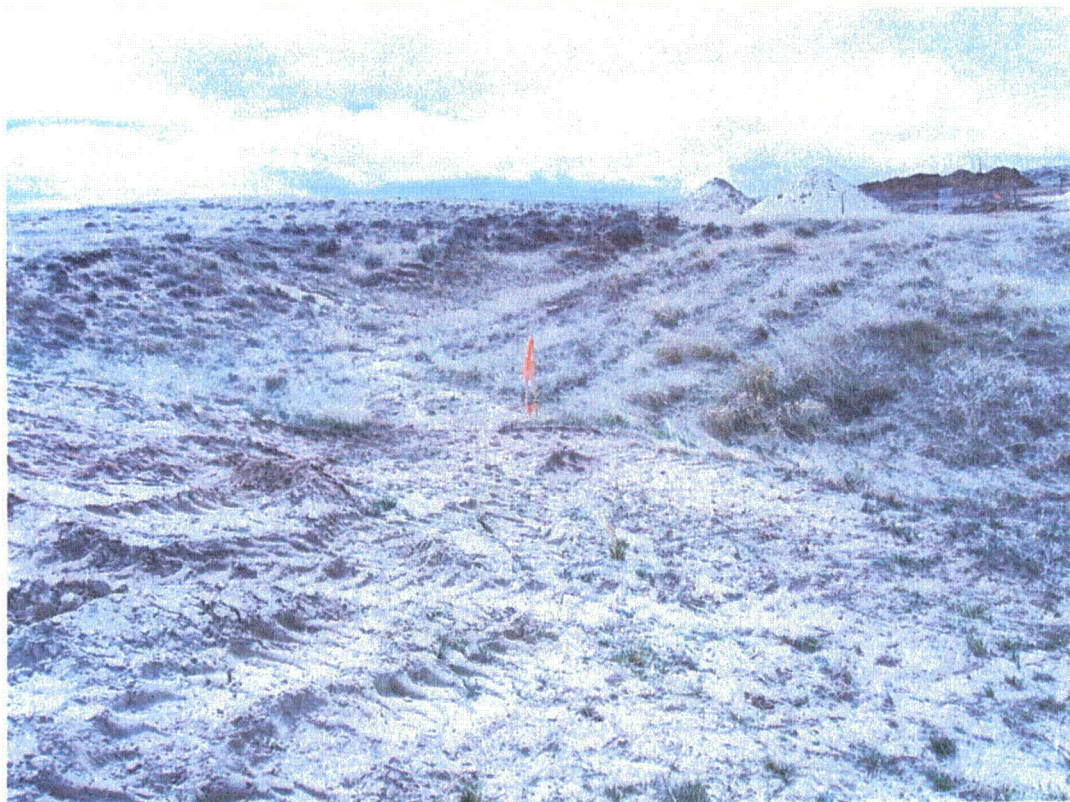
**Figure 9b** *Disturbance in drainage without sediment control*
