Report of Japanese Government  
to the IAEA Ministerial Conference on Nuclear Safety  
- The Accident at TEPCO's Fukushima Nuclear Power Stations -

June 2011

Nuclear Emergency Response Headquarters  
Government of Japan

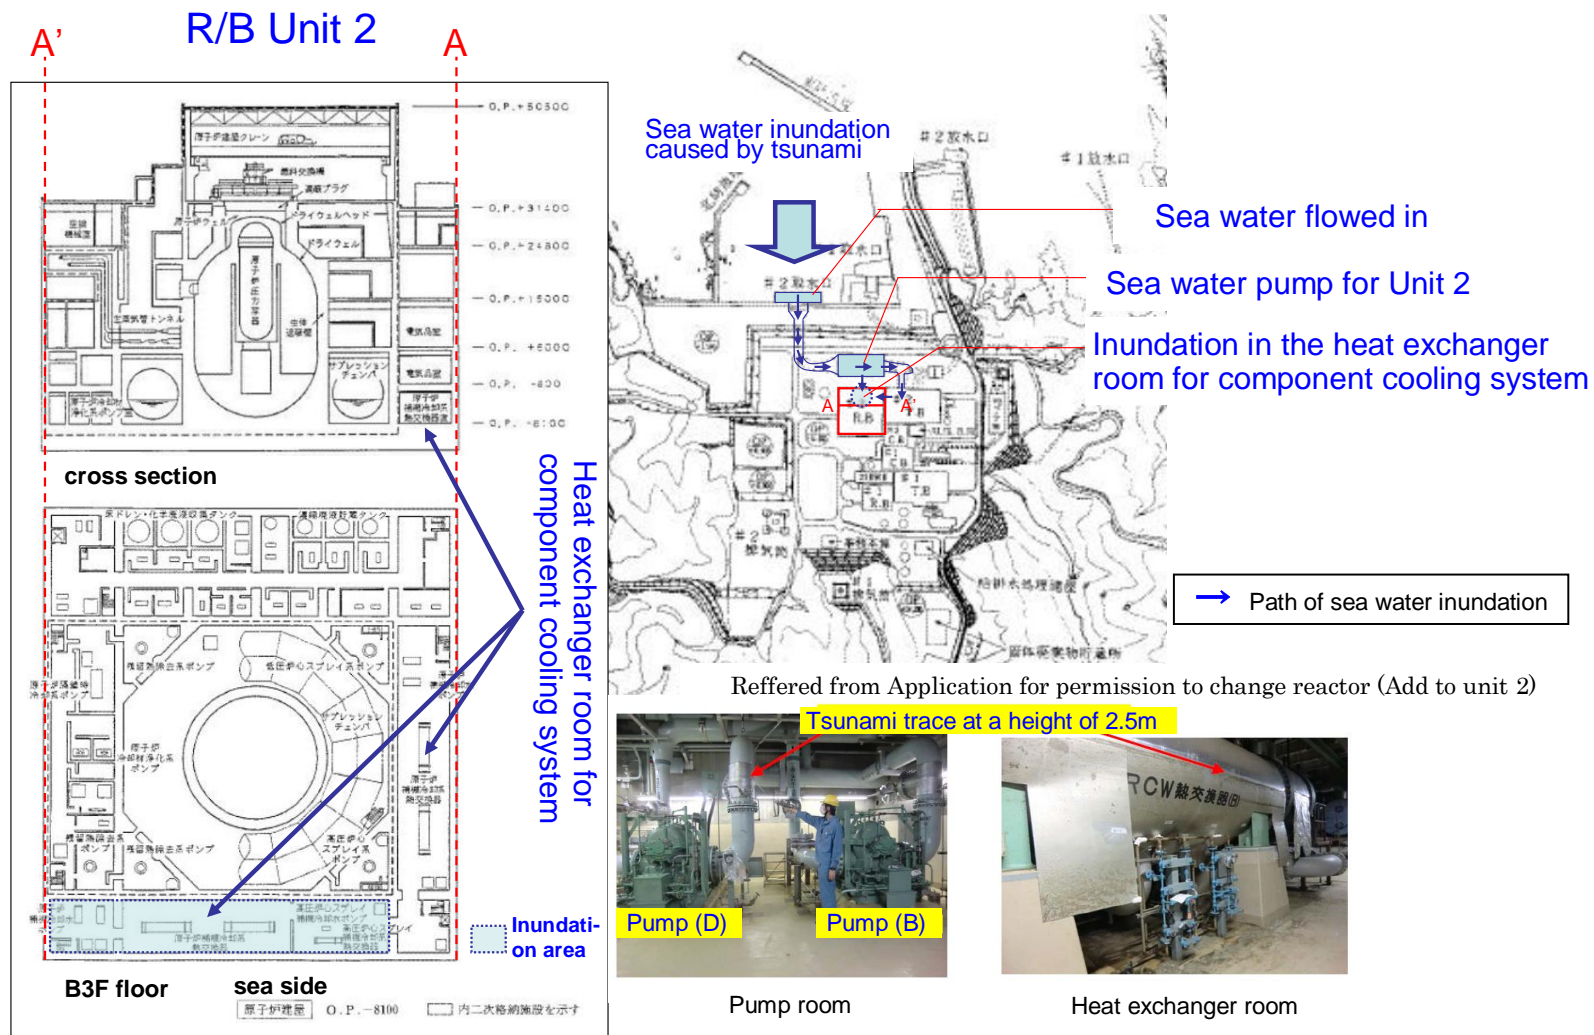
Fig. III-3-5(a) Inundation in the heat exchanger room for a component cooling system (1) at Onagawa NPS.

[ Inundation pathway to Heat exchanger (B) room for component cooling system ]
