Subject: Draft Letter Report, Status and Results from Intermediate-Scale Grout Tests  
(Deliverable 14003.01.007.440)

**BONDING AND CRACKING BEHAVIOR AND RELATED  
PROPERTIES OF CEMENTITIOUS GROUT IN AN  
INTERMEDIATE-SCALE GROUT MONOLITH**

**U.S. Nuclear Regulatory Commission  
Contract NRC-02-07-006**

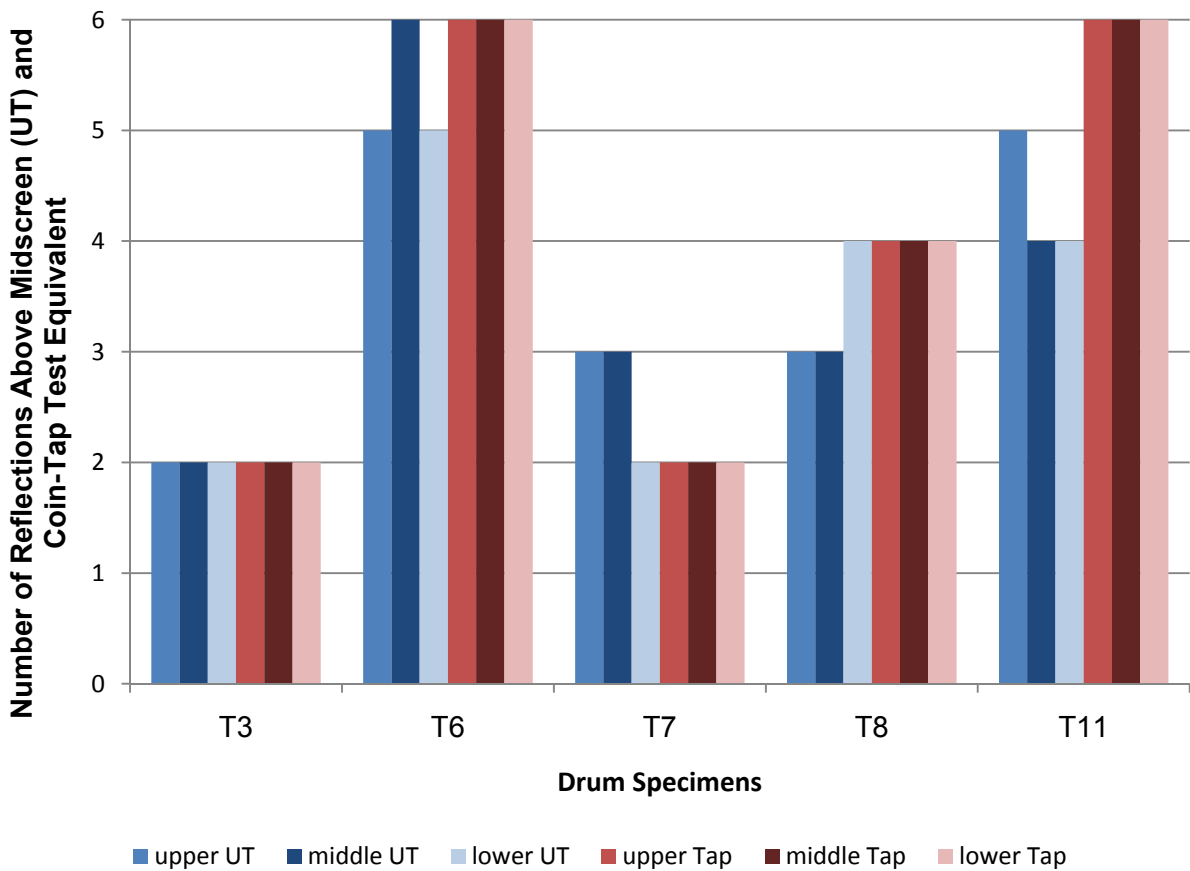
Figure 2-3. Ultrasonic and Coin-Tap Test Results for Each Lift Within Five Drum Grout Specimens. High Values Suggest Air Gaps and Low Values Suggest the Absence of Air Gaps.

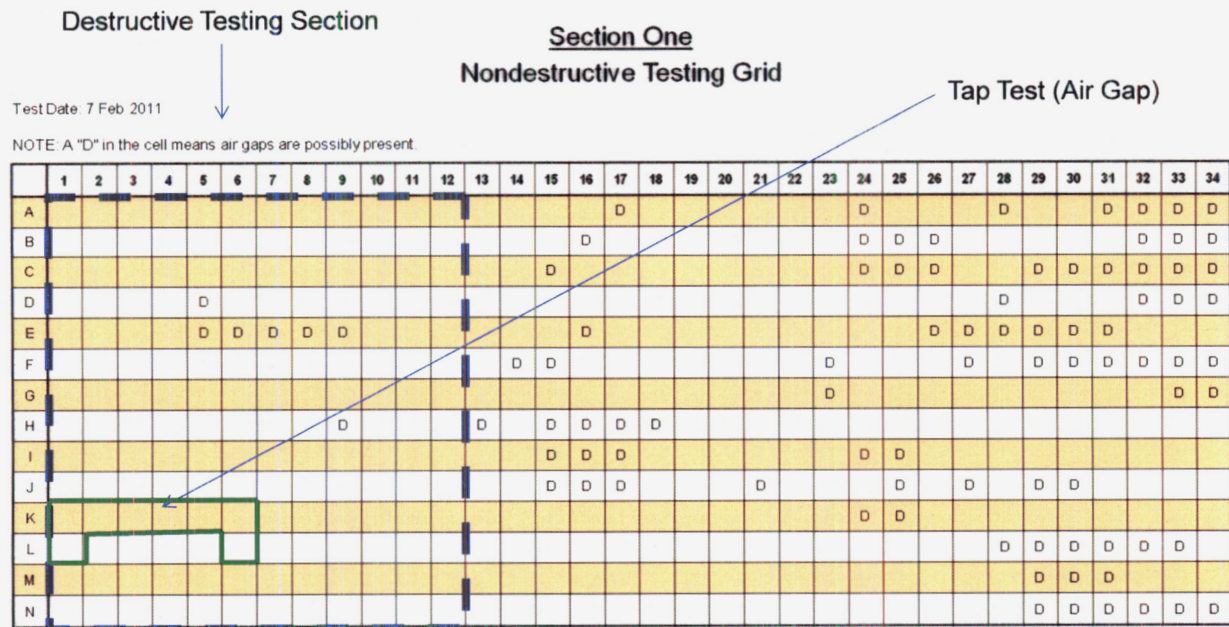
Figure 2-5. Illustration of the Section One Grid on the Tank Wall Shows Cells Where an Air Gap Was Detected (D) Between the Tank Wall and the Grout Using Ultrasound, Regions Where the Coin-Tap Test Indicated Possible Air Gaps, and a Representative Region Free From Air Gaps That Could Be Destructively Removed for Additional Analysis. Grid Cells Are 5 × 5 cm<sup>2</sup> [2 × 2 in<sup>2</sup>].

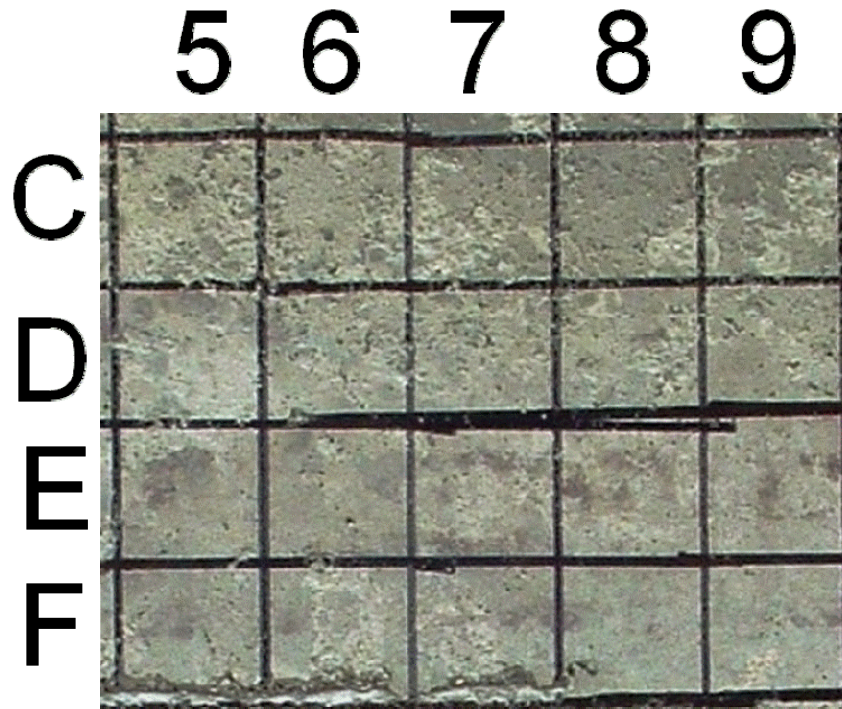
Photographs of Section One grout regions C5–F9 (Figure 2-11) and G5–J9 (Figure 2-12) show that much of the surface is smooth, indicating very close, if not intimate, contact with the tank wall. Photographs of Section Three grout regions C89–F92 (Figure 2-13), G90–J95 (Figure 2-14), A92–D98 (Figure 2-15), and J85–N90 (Figure 2-16) illustrate variations in surface condition ranging from smooth to rough.

Figure 2-11. Photograph of Section One Grout Near the Base of Lift 3, Which Was Predicted by Ultrasonics To Be Free From Air Gaps. Much of the Lift 3 Surface in the Lower Half of the Photo Is Smooth. Near the Top, There Is More Pitting. Evidence of Preexisting Grout Splatters From Prior Pours Is Observed.

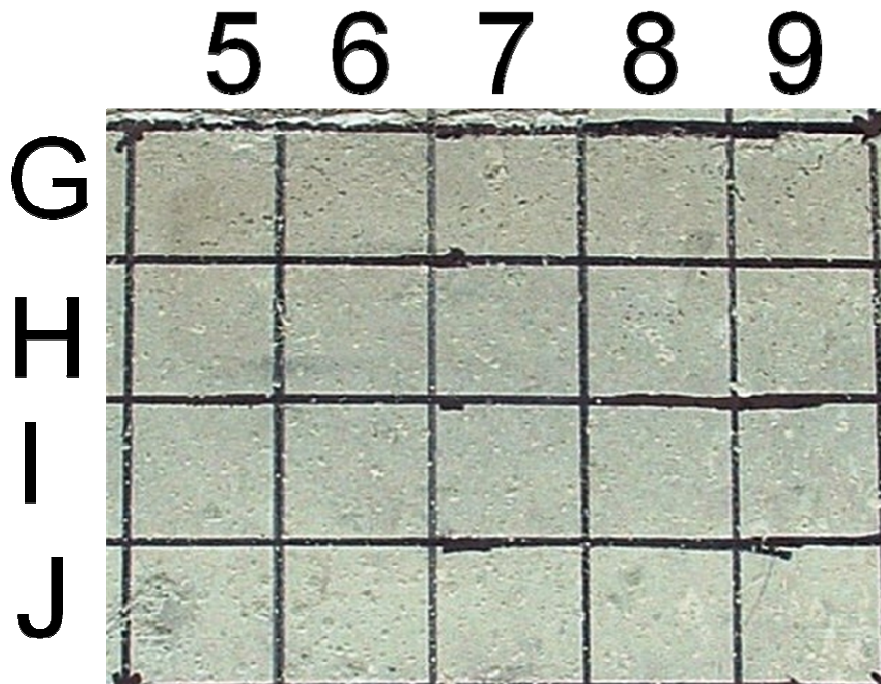
Figure 2-12. Photograph of Section One Grout at the Top of Lift 2, Which Was Predicted by Ultrasonics To Be Free From Air Gaps. Most of the Lift 2 Surface Is Smooth. Few Grout Splatters Are Observed.

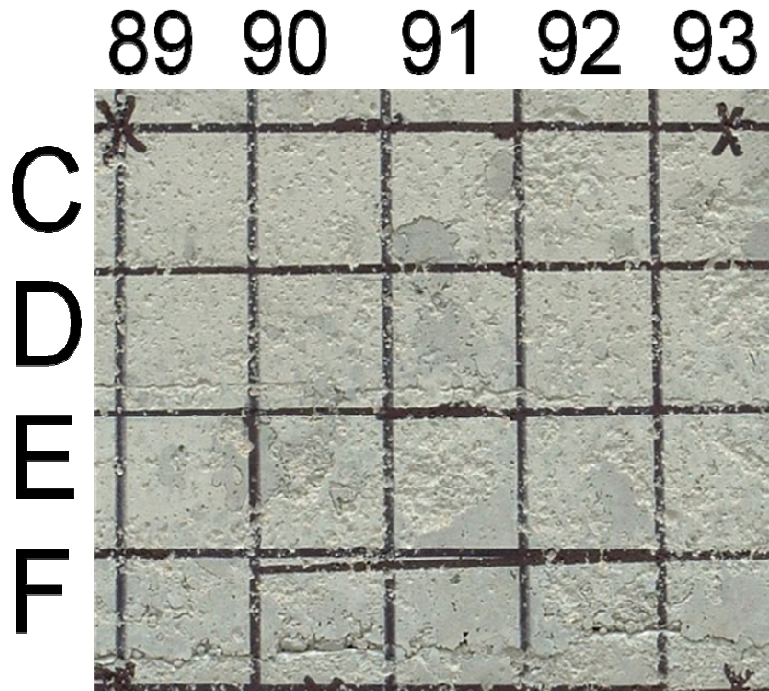
Figure 2-13. Photograph of Section Three Grout, Which Was Predicted by Ultrasonics To Have Air Gaps. Much of the Surface Is Pitted and Rough. Evidence of Preexisting Grout Spatters From Prior Pours Is Observed.

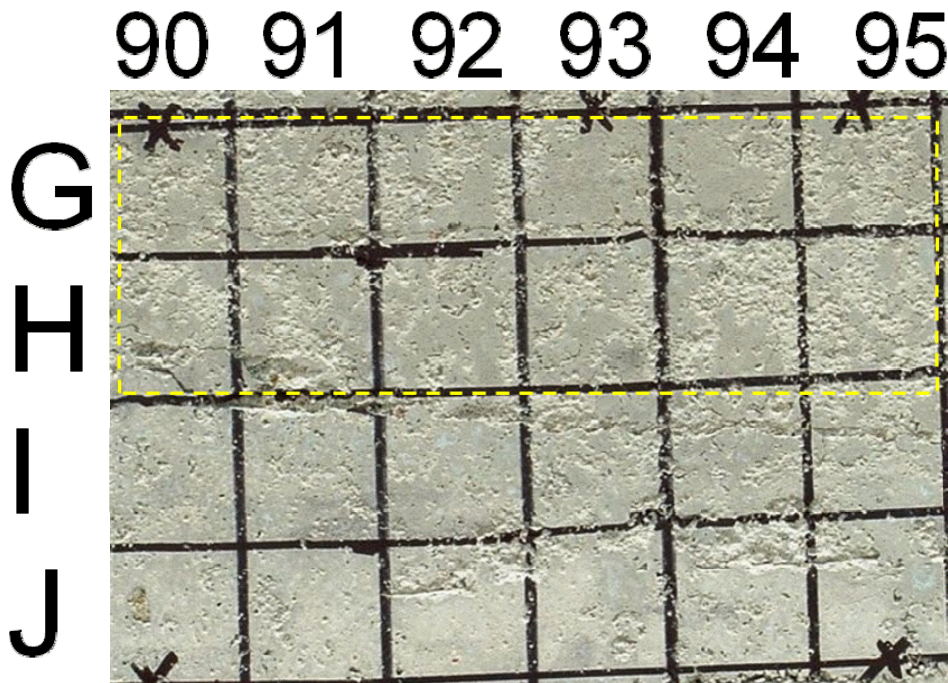
Figure 2-14. Photograph of Section Three Grout, Which Was Predicted by Ultrasonics To Have Air Gaps. Most of the Surface Is Pitted and Rough and Cracks Are Present. The Dashed Outline Encloses an Area Where the Coin-Tap Test Indicated Air Gaps Were Present.

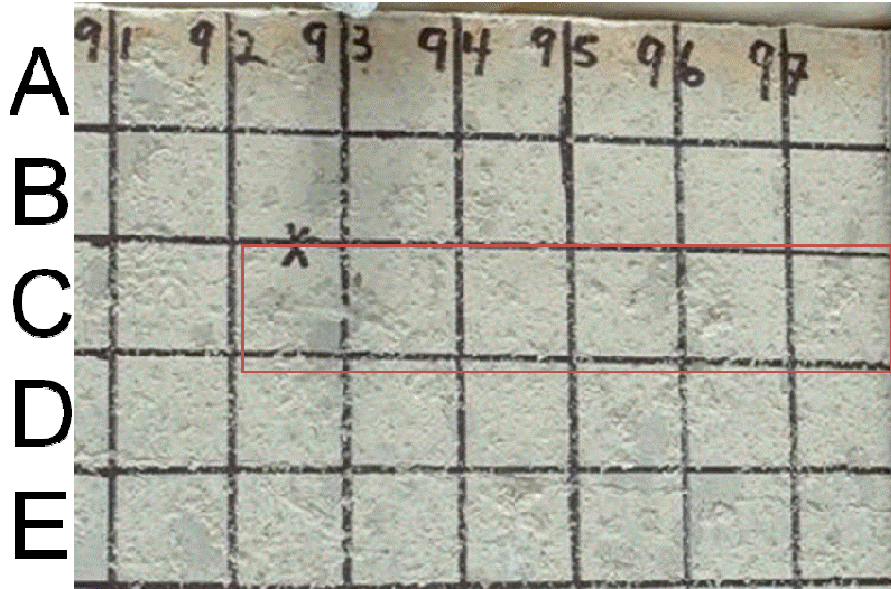
Figure 2-15. Photograph of Section Three Grout, Which Was Predicted by Ultrasonics To Have Air-Gaps. Much of the Lift 3 Area Is Rough. However, Ultrasonics Indicated That the Outlined Area Was Free From Air Gaps, Even Though it too Is Rough. Evidence of Preexisting Grout Spatters From Prior Pours Is Observed.

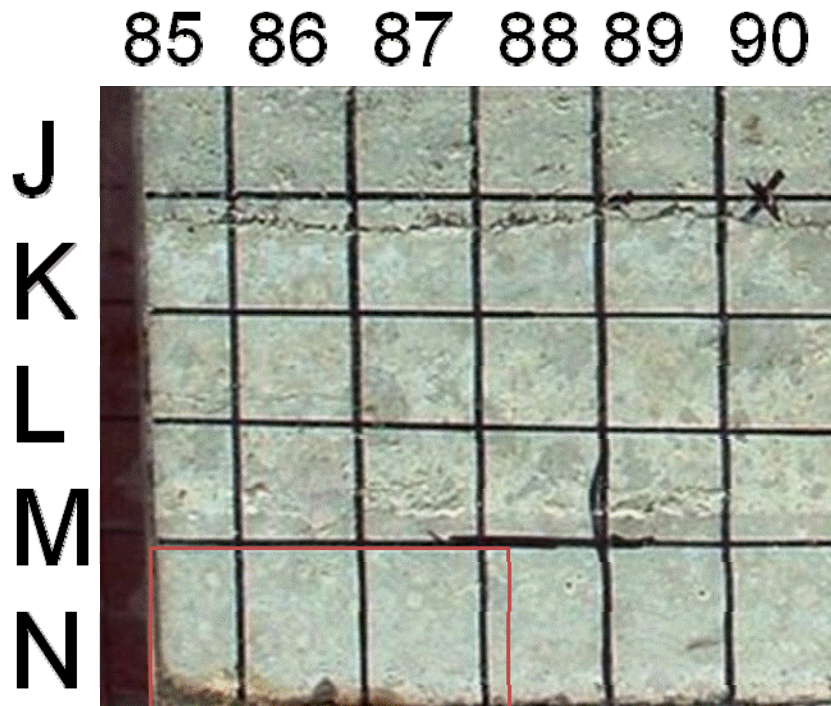
Figure 2-16. Photograph of Section Three Grout, Which Was Predicted by Ultrasonics To Have Air Gaps. Lift 1 Is Smoother Than Lifts 2 and 3, and Ultrasonics Indicated That the Outlined Area, Which Is Smooth, Was Free From Air Gaps. Evidence of Preexisting Grout Spatters From Prior Pours Is Observed Above This Level.

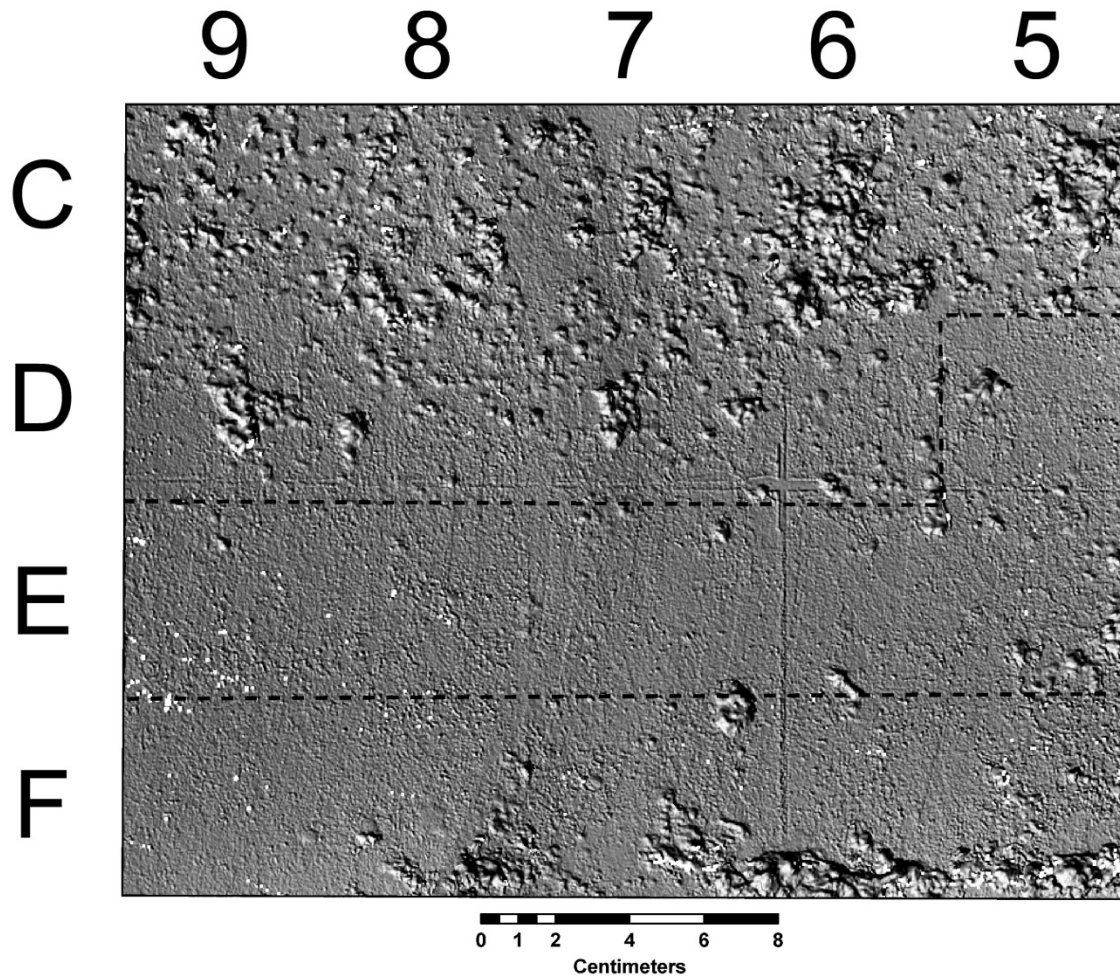
Surface roughness of the interior tank wall is produced by the relative thickness of the adhering grout material. Thickness of the adhering grout material generally ranges from a few millimeters to less than 0.1 mm [0.004 in] (Figure 2-17). Surface roughness varies with location and sometimes appears to reflect grout stratigraphy (Figures 2-17 and 2-19), although not uniformly so [Figure 2-17(a), rows D, E, and F; Figure 2-18(a), rows C, D, E, and F]. Where tank wall sections have been removed, smooth surfaces are often observed along the lower portion of a lift.

**Figure 2-17(a). Dynamic Structured Light Data, Presented as DSR of a Portion of the Upper Lift (Lift 3) Exposed on the Interior Surface of the Section One Steel Tank Wall (See Figure 2-11). Ultrasonic Testing Predicted the Relatively Smooth Area Bounded by the Dashed Lines To Have Air Gaps; Relatively Rough Areas Above and Below Were Predicted To Be Free From Air Gaps. Rough Areas Correlate to the Pitting Described in Figure 2-11. Maximum Vertical Relief of Grout Remnants Is Approximately 2 mm [0.078 in] Relative to the Surface of the Steel Plate. Observe That Column Order Is Reversed Compared With Figure 2-11; the Inner Surface of the Tank Wall Presents a Mirror Image of the Exposed Grout Wall. The Faint Horizontal (Middle of Image) and Vertical (Center Right) Linear Features Were Guidelines Lightly Drawn on the Tank Wall With Soapstone; the Intersection Is Highlighted With a Paint Marker [See Figure 2-17(b)]. The Lines Do Not Correspond to Nondestructive Evaluation Sampling Grids. Drawn Prior to Collecting DSL Data, the Marks Visible in the DSR Attest to the Method's Sensitivity.**

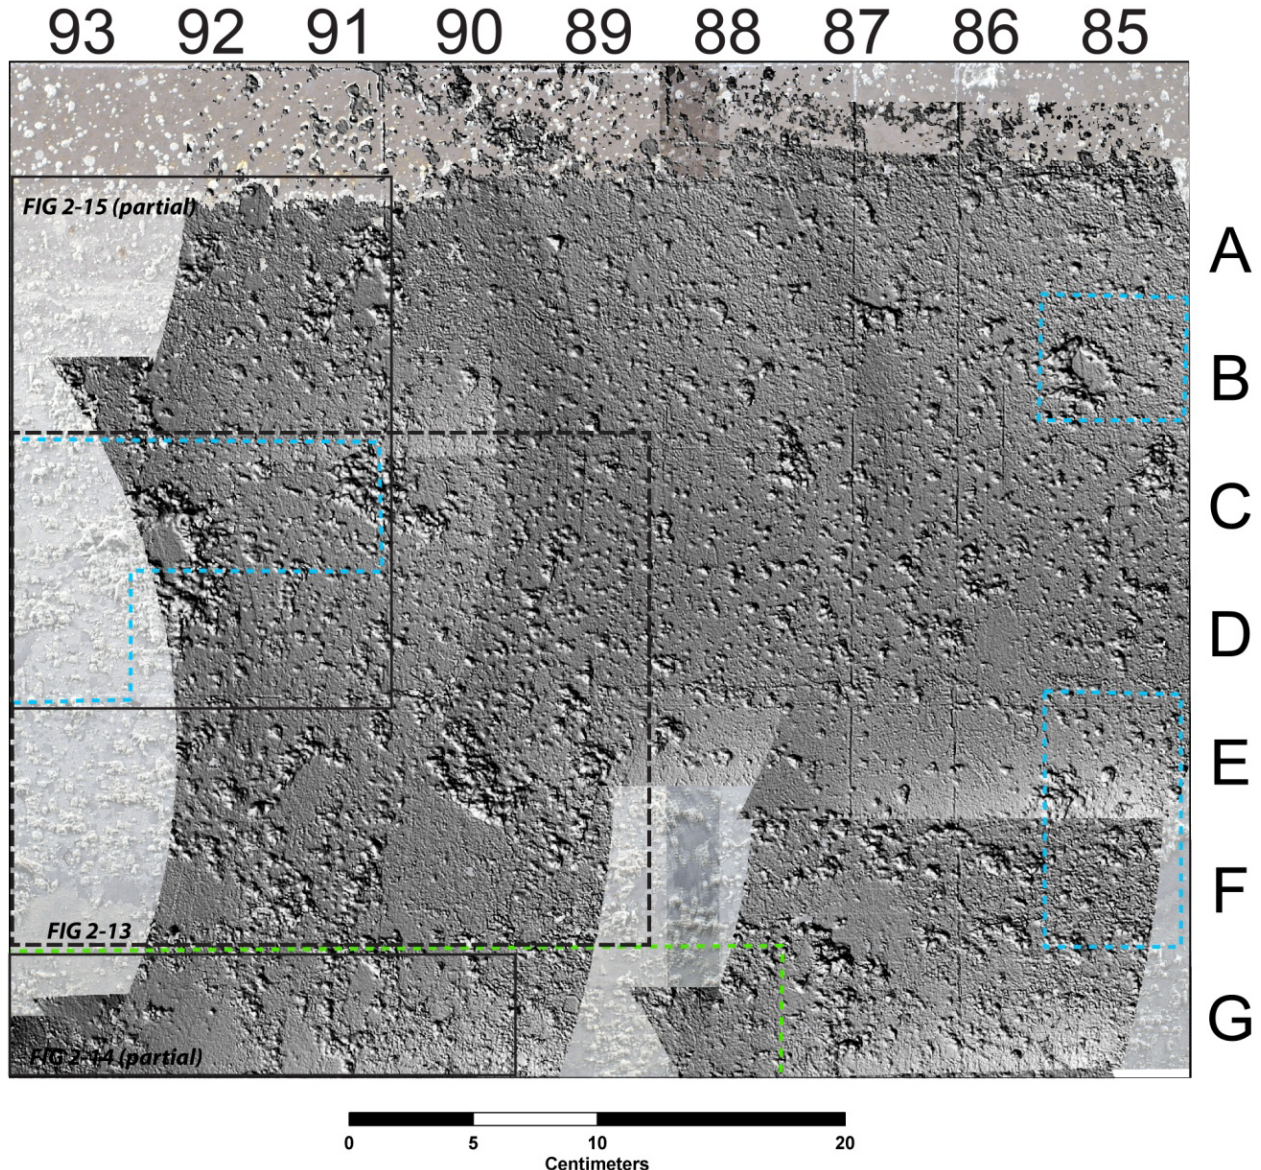
**Figure 2-18(a). DSR Mosaic of a Portion of the Interior Surface of the Section Three Wall. Areas of no Data Show a Semi-Transparent Version of the Photomosaic Shown in Figure 2-18(b). Figure 2-18(a) Incorporates the Area of Figure 2-13 (Dashed Black Line), and Portions of Figures 2-14 and 2-15 (Black Lines as Labeled). Dashed Blue Lines Encompass Areas Predicted by Ultrasonic Testing To Have Air Gaps. Dashed Green Lines Show Areas Predicted by Coin-Tap Testing To Have Air Gaps. The DSR Shows This Portion of the Tank Wall To Be Generally Rough, With Little or no Difference in Appearance Relative to Ultrasonic Testing Results. Smooth Areas Exist as Isolated Patches. Smooth Areas Appear To Be Most Common in the Lower Portion of the DSR (Rows E, F, And G). Rows A–F Show Lift 3, and Row G Shows the Uppermost Portion of Lift 2. Row G Also Contains the Only Area Predicted by the Coin-Tap Method To Have an Air Gap. The Uppermost Portion of the Image, Above Row A, Shows a Portion of the Spattered Tank Wall That Is Located Above the Surface of the Monolith [See Figure 2-18(b)].**

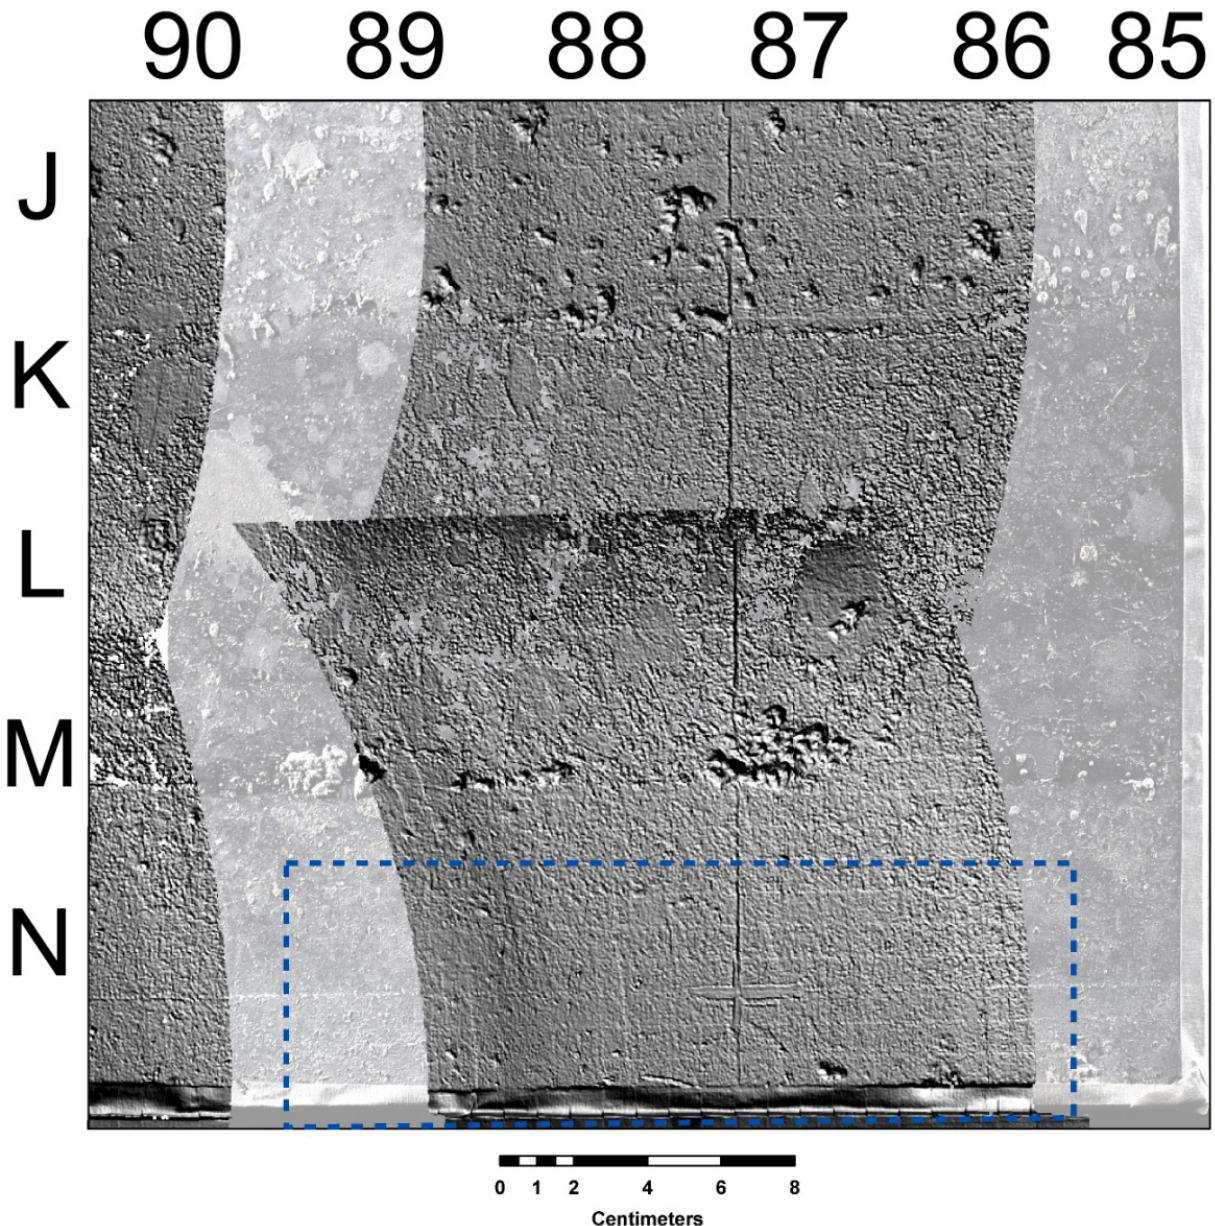
**Figure 2-19(a). DSR Mosaic of a Portion of the Interior Surface of the Section Three Steel Tank Wall, Including Portions of the Area Shown In Figure 2-16. Areas of no Data Show a Semi-Transparent Version of the Photomosaic Shown in Figure 2-19(b). The Area Within the Dashed Blue Line Is Predicted by Ultrasonic Testing To Have an Air Gap; the Remaining Area Was Predicted To Be Free From Air Gaps. The Area Is Commonly Smooth, With Rough Areas in Rows J And M. The DSR Shows the Area Predicted To Be Not Bonded (Dashed Blue Rectangle) Is Relatively Smooth, With Very Small Topographic Relief. Soapstone-Inscribed Guidelines, As Described in Figure 2-17 Are Clearly Visible.**
