**SUBJECT: NRC SPECIAL INSPECTION REPORT NO. 70-1113/2011-006 AND NOTICE
OF VIOLATION**

Special Inspection Team Charter
Global Nuclear Fuel - Americas
Failure to Maintain Mass Control in HEPA Filter Housing

The purpose of the special inspection was to inspect and assess the facts surrounding the failure to maintain mass control within the uranium dioxide (UO₂) sinter test grinding station high efficiency particulate air (HEPA) filter enclosure. The objectives of the inspection were to: 1) review the facts surrounding the failure to maintain mass control within the UO₂ sinter test grinding station HEPA filter enclosure; 2) assess Global Nuclear Fuel – Americas (GNF-A)'s response to the higher than anticipated UO₂ mass in the HEPA enclosure; and 3) evaluate GNF-A's immediate and long term corrective actions to prevent recurrence.

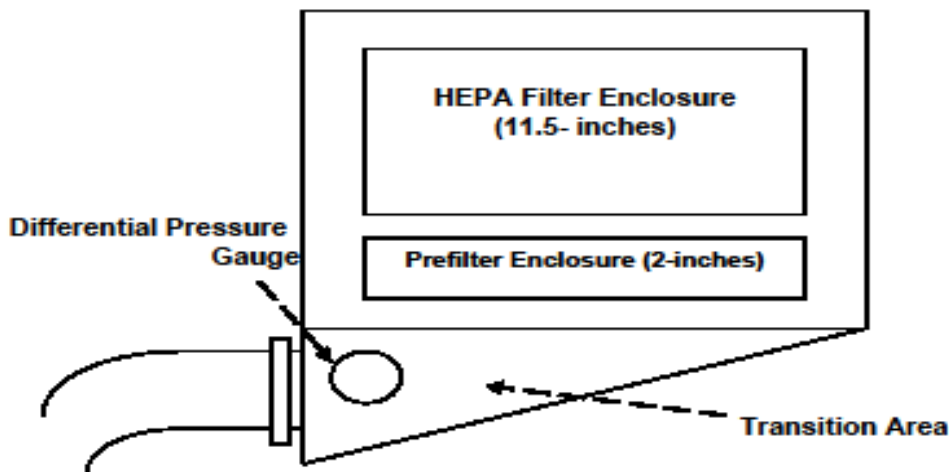
Figure 1: Example of Sinter Test Grinder Filter Housing

This event description was independently developed and validated by the team using a review of records, logs, and interviews of personnel directly involved with activities prior to and during the failure to maintain mass control within the uranium dioxide (UO₂) sinter test grinding station high efficiency particulate air (HEPA) filter enclosure. Refer to Figure 1 for additional information.

Upon discovery of the additional material in the transition section of the enclosure, the licensee shutdown the UO_2 sinter test grinding station and the other grinders in the facility to assess the extent of condition. GNF-A cleaned out the HEPA filters attached to the other grinders as a part of extent of condition activities. The licensee did not observe any additional instances with accumulated mass greater than safety limits for HEPA enclosures that utilized mass control as a criticality safety control. The other grinders also had a different design that included specific equipment to catch the grinding dust. The licensee subsequently resumed operations of the others grinders however the UO_2 sinter test grinding station remained shut down. The licensee completed a root cause evaluation on March 17, 2011, and began implementing corrective actions.
