SUBJECT: Submits relief request RR2-1 to allow continued plant operation w/two pin hole leaks in 3/4 inch ASME Code Class 2 chemical injection weldment.

KEWAUNEE

RELIEF REQUEST NO. RR2-1 TO ALLOW CONTINUED
PLANT OPERATION

Relief Request RR2-1

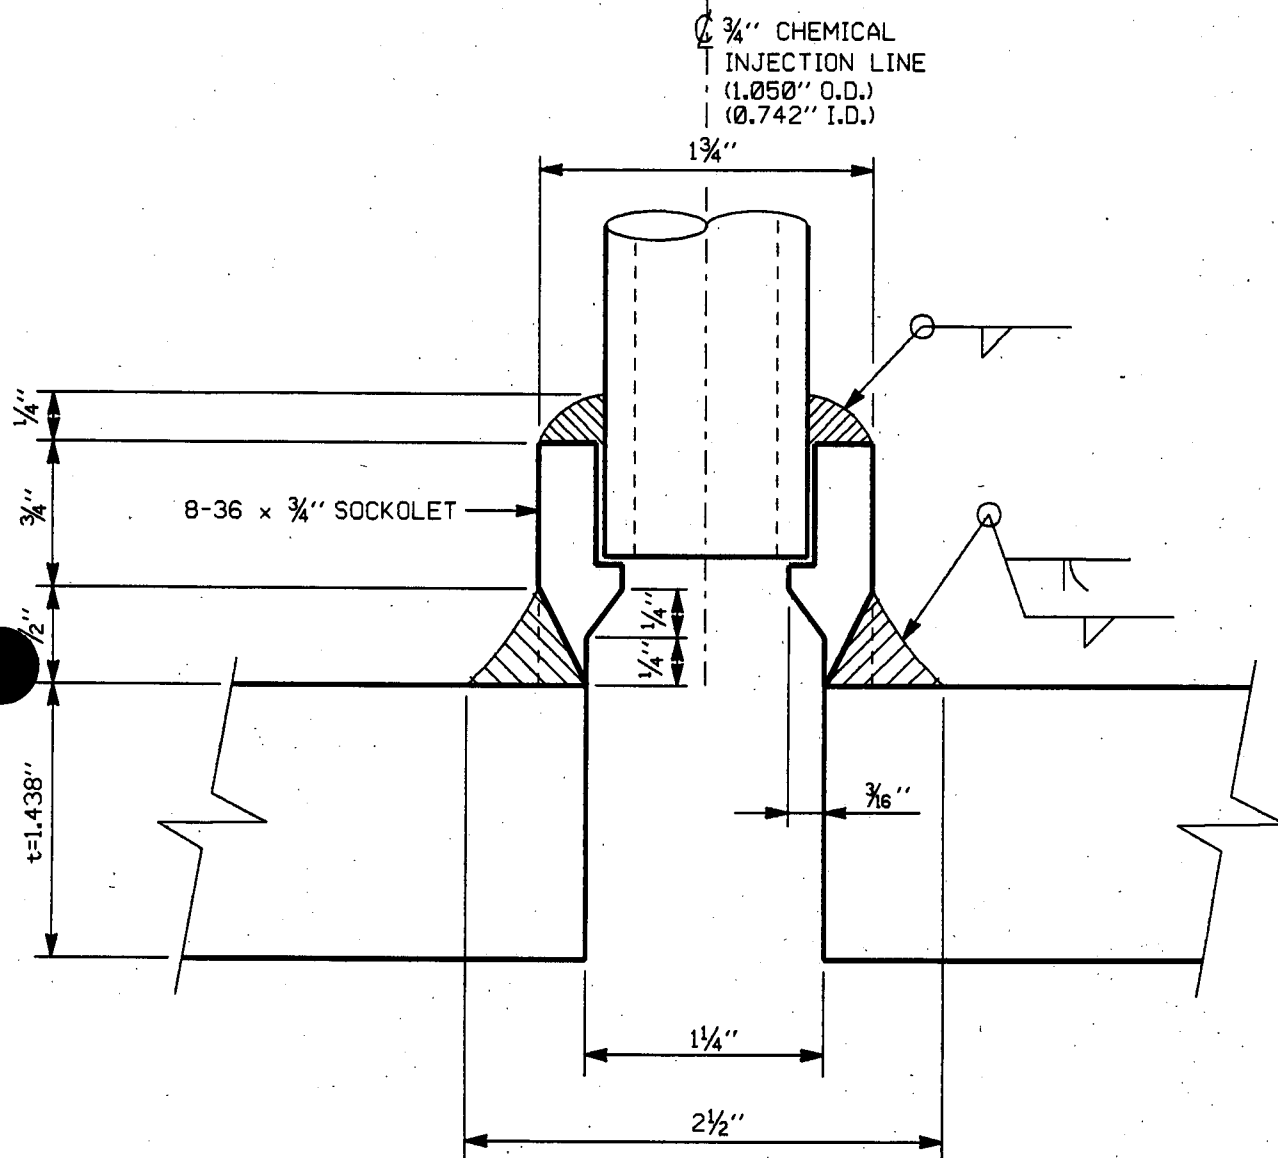
FIGURE 1

BASED ON FIELD MEASUREMENTS
 AND RADIOGRAPHS

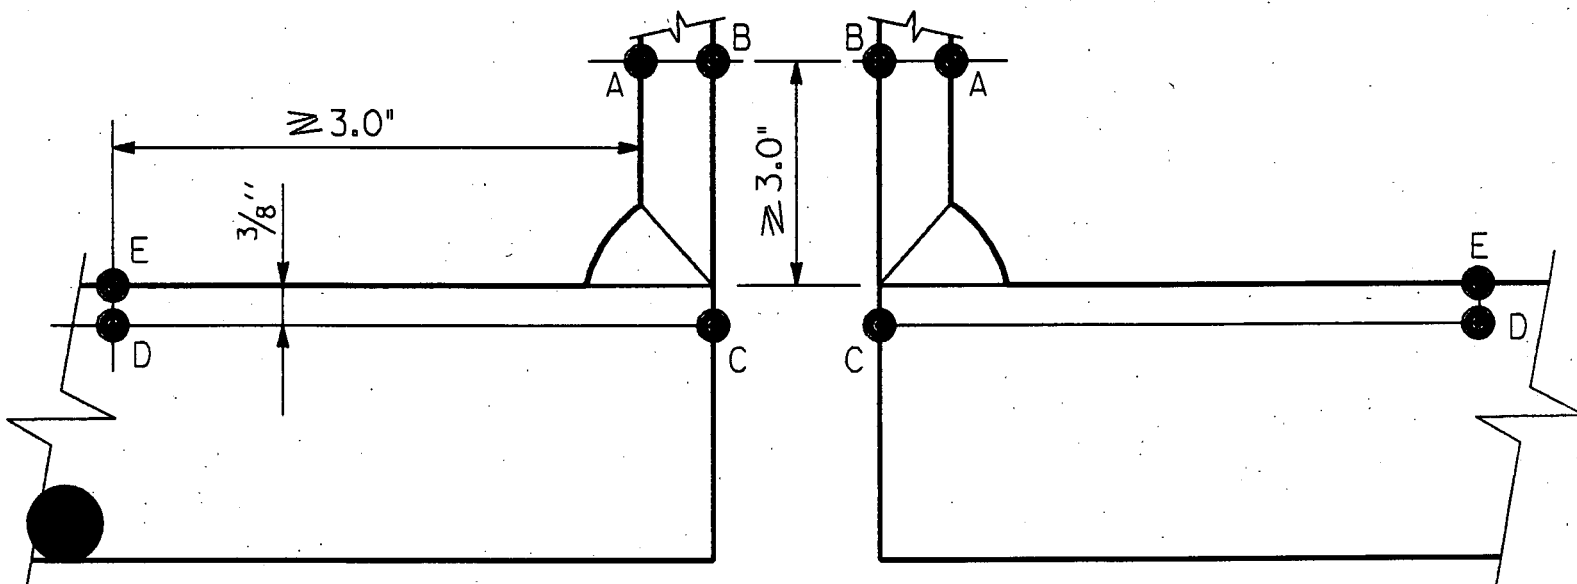
FIGURE 2A
NO SCALE

The double wall/tangential - double wall view provided a profile of the sockolet, weldment, and a portion of the machined opening adjacent to the outside wall of the feedwater piping. The machined opening in the feedwater piping was visible on the film for a depth of approximately 3/8" from the outside diameter. The inside diameters of the sockolet and visible portion of the machined opening in the feedwater piping were smooth, indicating no evidence of erosion or corrosion at this branch connection.

A small amount of root weld undercut was visible on the inside diameter of the sockolet, as well as a slight opening at the edge of the weld at the outside surface. This condition was visually examined and characterized as cluster porosity at a start-stop point in the sockolet weldment. This condition was caused during the initial fabrication process. Our current NDE vendor judged this condition to be structurally stable.

EXAMINATION VOLUME:
A-B-C-D-E

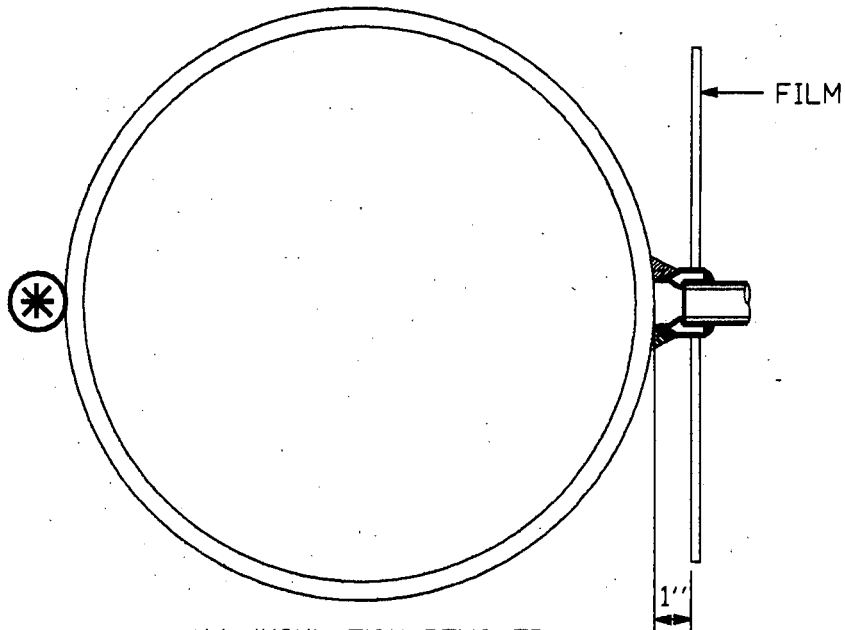
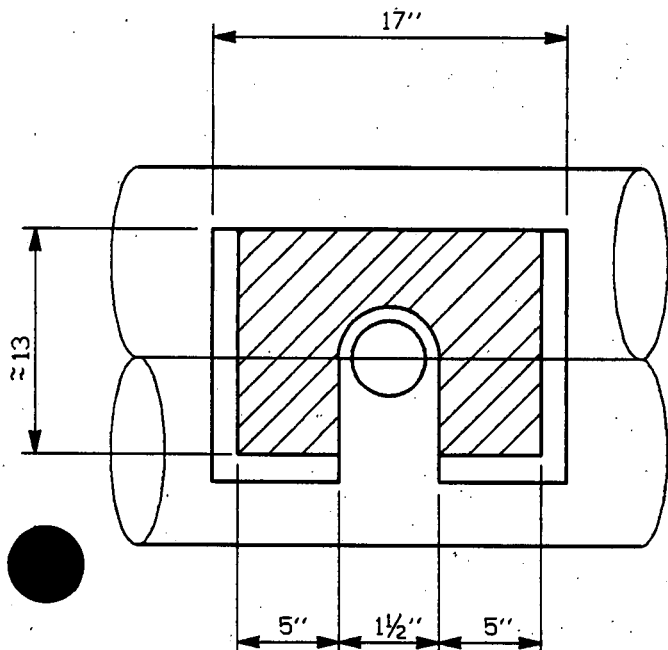
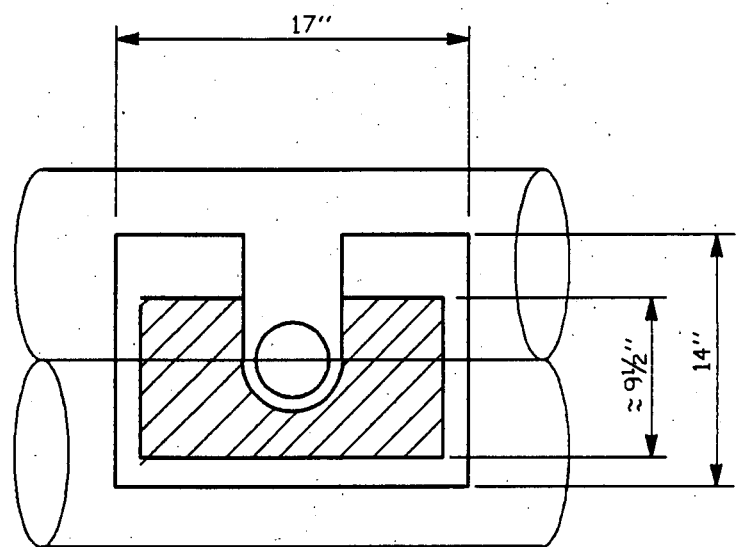
FIGURE 2B

ALL INSULATION REMOVED.
DOUBLE WALL CONTACT METHOD.

FILM PLACEMENT
HASH MARKS INDICATE
APPROXIMATE AREA OF INTEREST

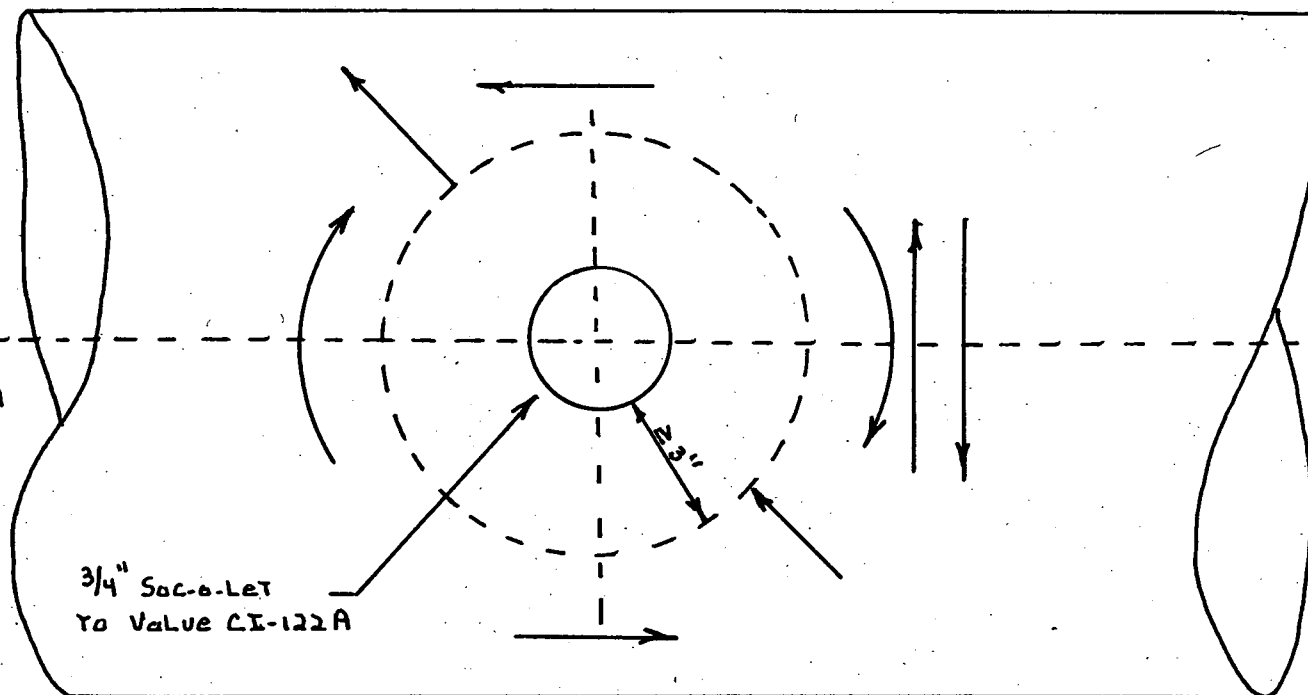
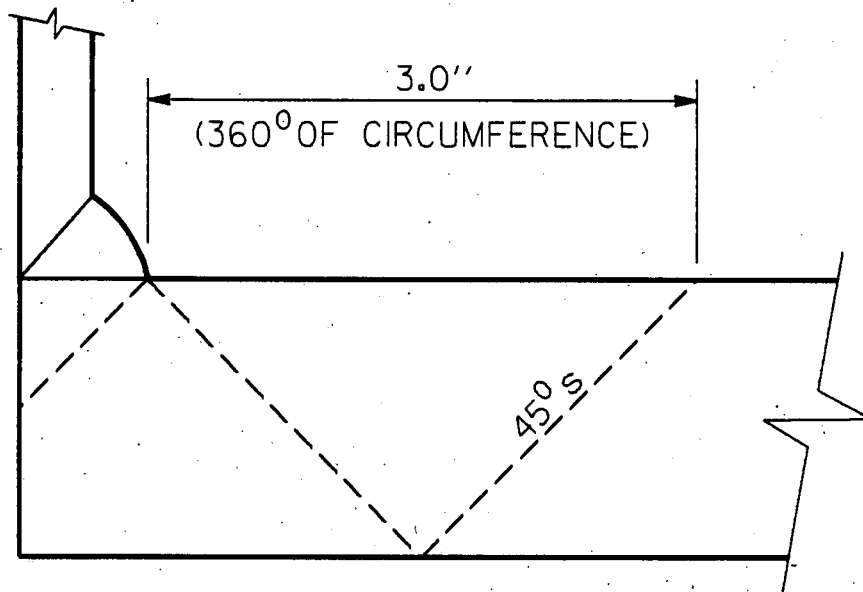
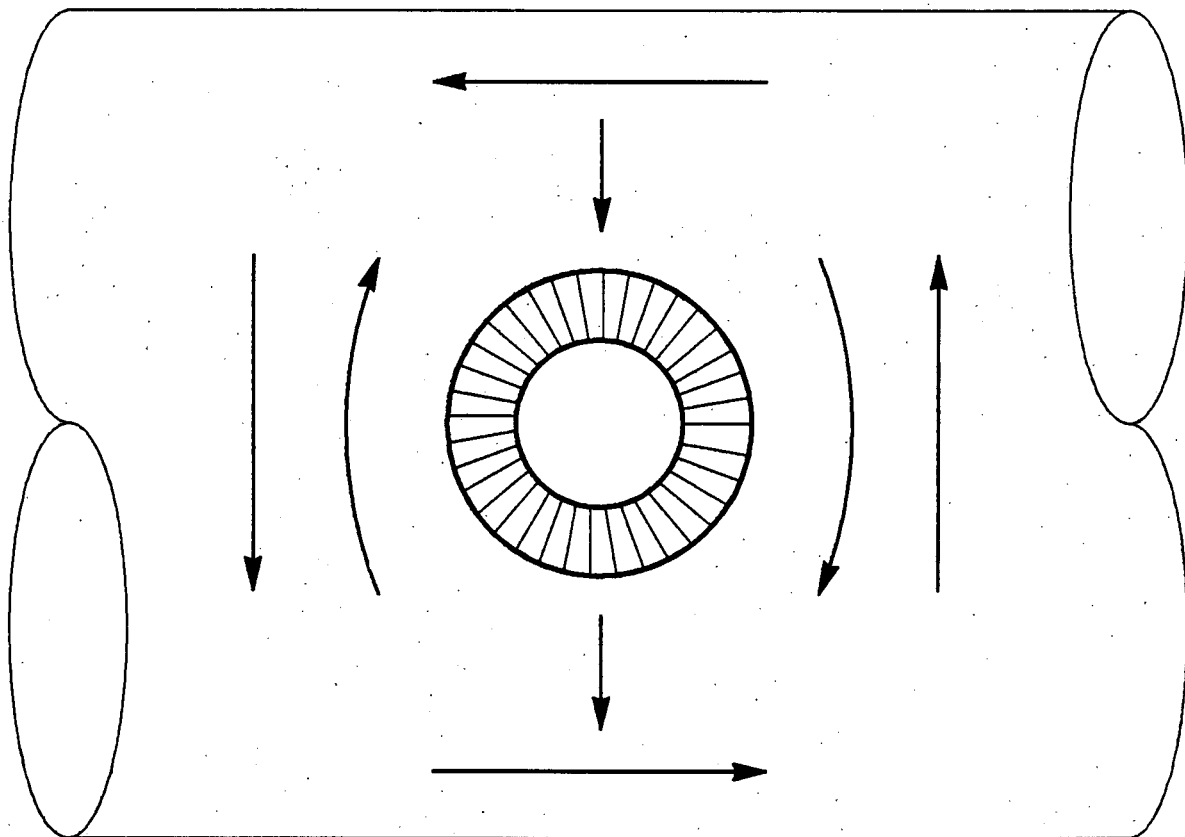
FIGURE 3C

An ultrasonic examination was performed to determine if planar flaws existed in the base metal of the 16" the main feedwater piping below the steam leakage from the sockolet weld downstream of the 3/4" chemical injection line to valve CI-122A. Refer to Figures 3A, 3B, and 3C for the documentation of the UT exam.

Eight separate scans at various calibration sensitivities and at various calibration block temperatures revealed no indications in the base metal of the 16" Feedwater Piping located underneath the leaking 3/4" sockolet weld.

DOTTED LINE INDICATES SCAN REGION

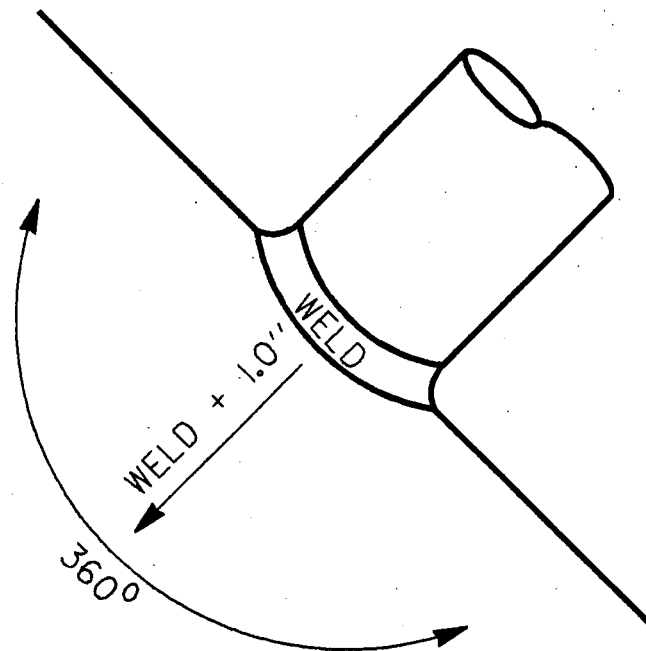
FIGURE 5

EXAMINATION METHOD:
MAGNETIC PARTICLE

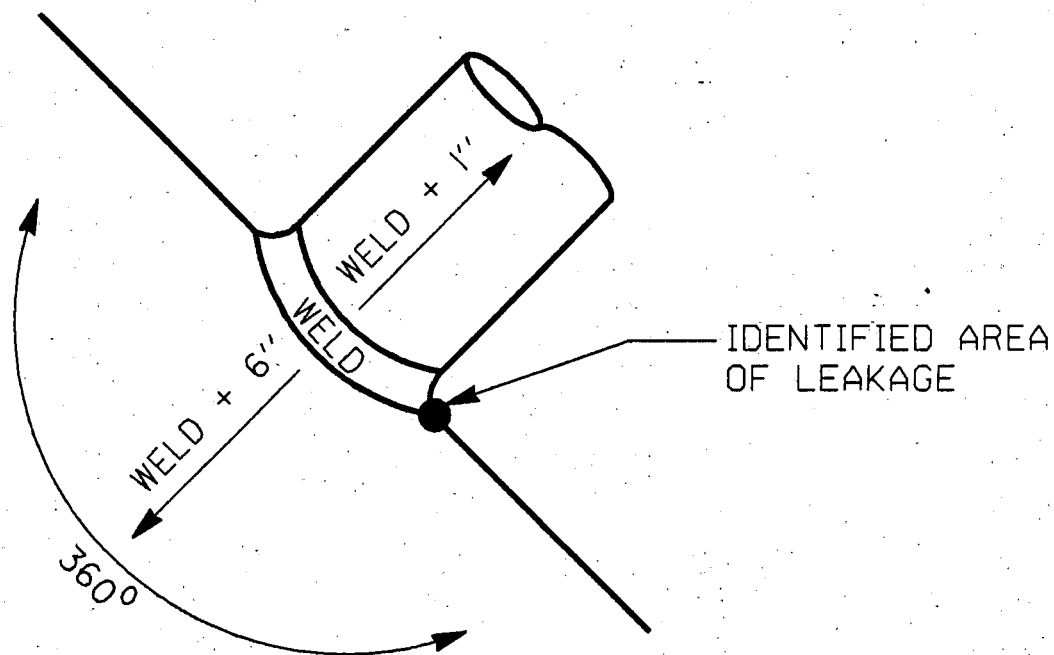
The degradation in the branch connection weld is characterized as being related to the welding process. The location of the leak is shown Figure 6. The leak path has been determined to be a network of connecting small regions of lack of fusion between weld passes and small clusters of porosity/inclusions in the fillet weld. This network is characterized as a torturous path having essentially no width or circumferential extent. Tangential radiography shows that the network originates in the root weld and extends through the base of the fillet weld to the toe of the fillet weld. Tangential radiography of the branch connection weld and double wall-single view radiography of the feedwater pipe/fillet weld confirm that the flaw has no width or circumferential extent; it exists in the through wall direction only and may be classified as two pin hole leaks. Consistent with this data, visual examination of the branch connection weldment conclusively revealed that the leak is located in a cluster of weld porosity. Our NDE/Welding contractor independently concluded and confirmed our assessment that the flaw originates in the root weld and consists of a network of small weld defects (e.g., porosity). This information suggests that the area of degradation is small with respect to the total weld volume and weld length and therefore does not affect the structural integrity of the component.

VT-1 EXAMINATION METHOD

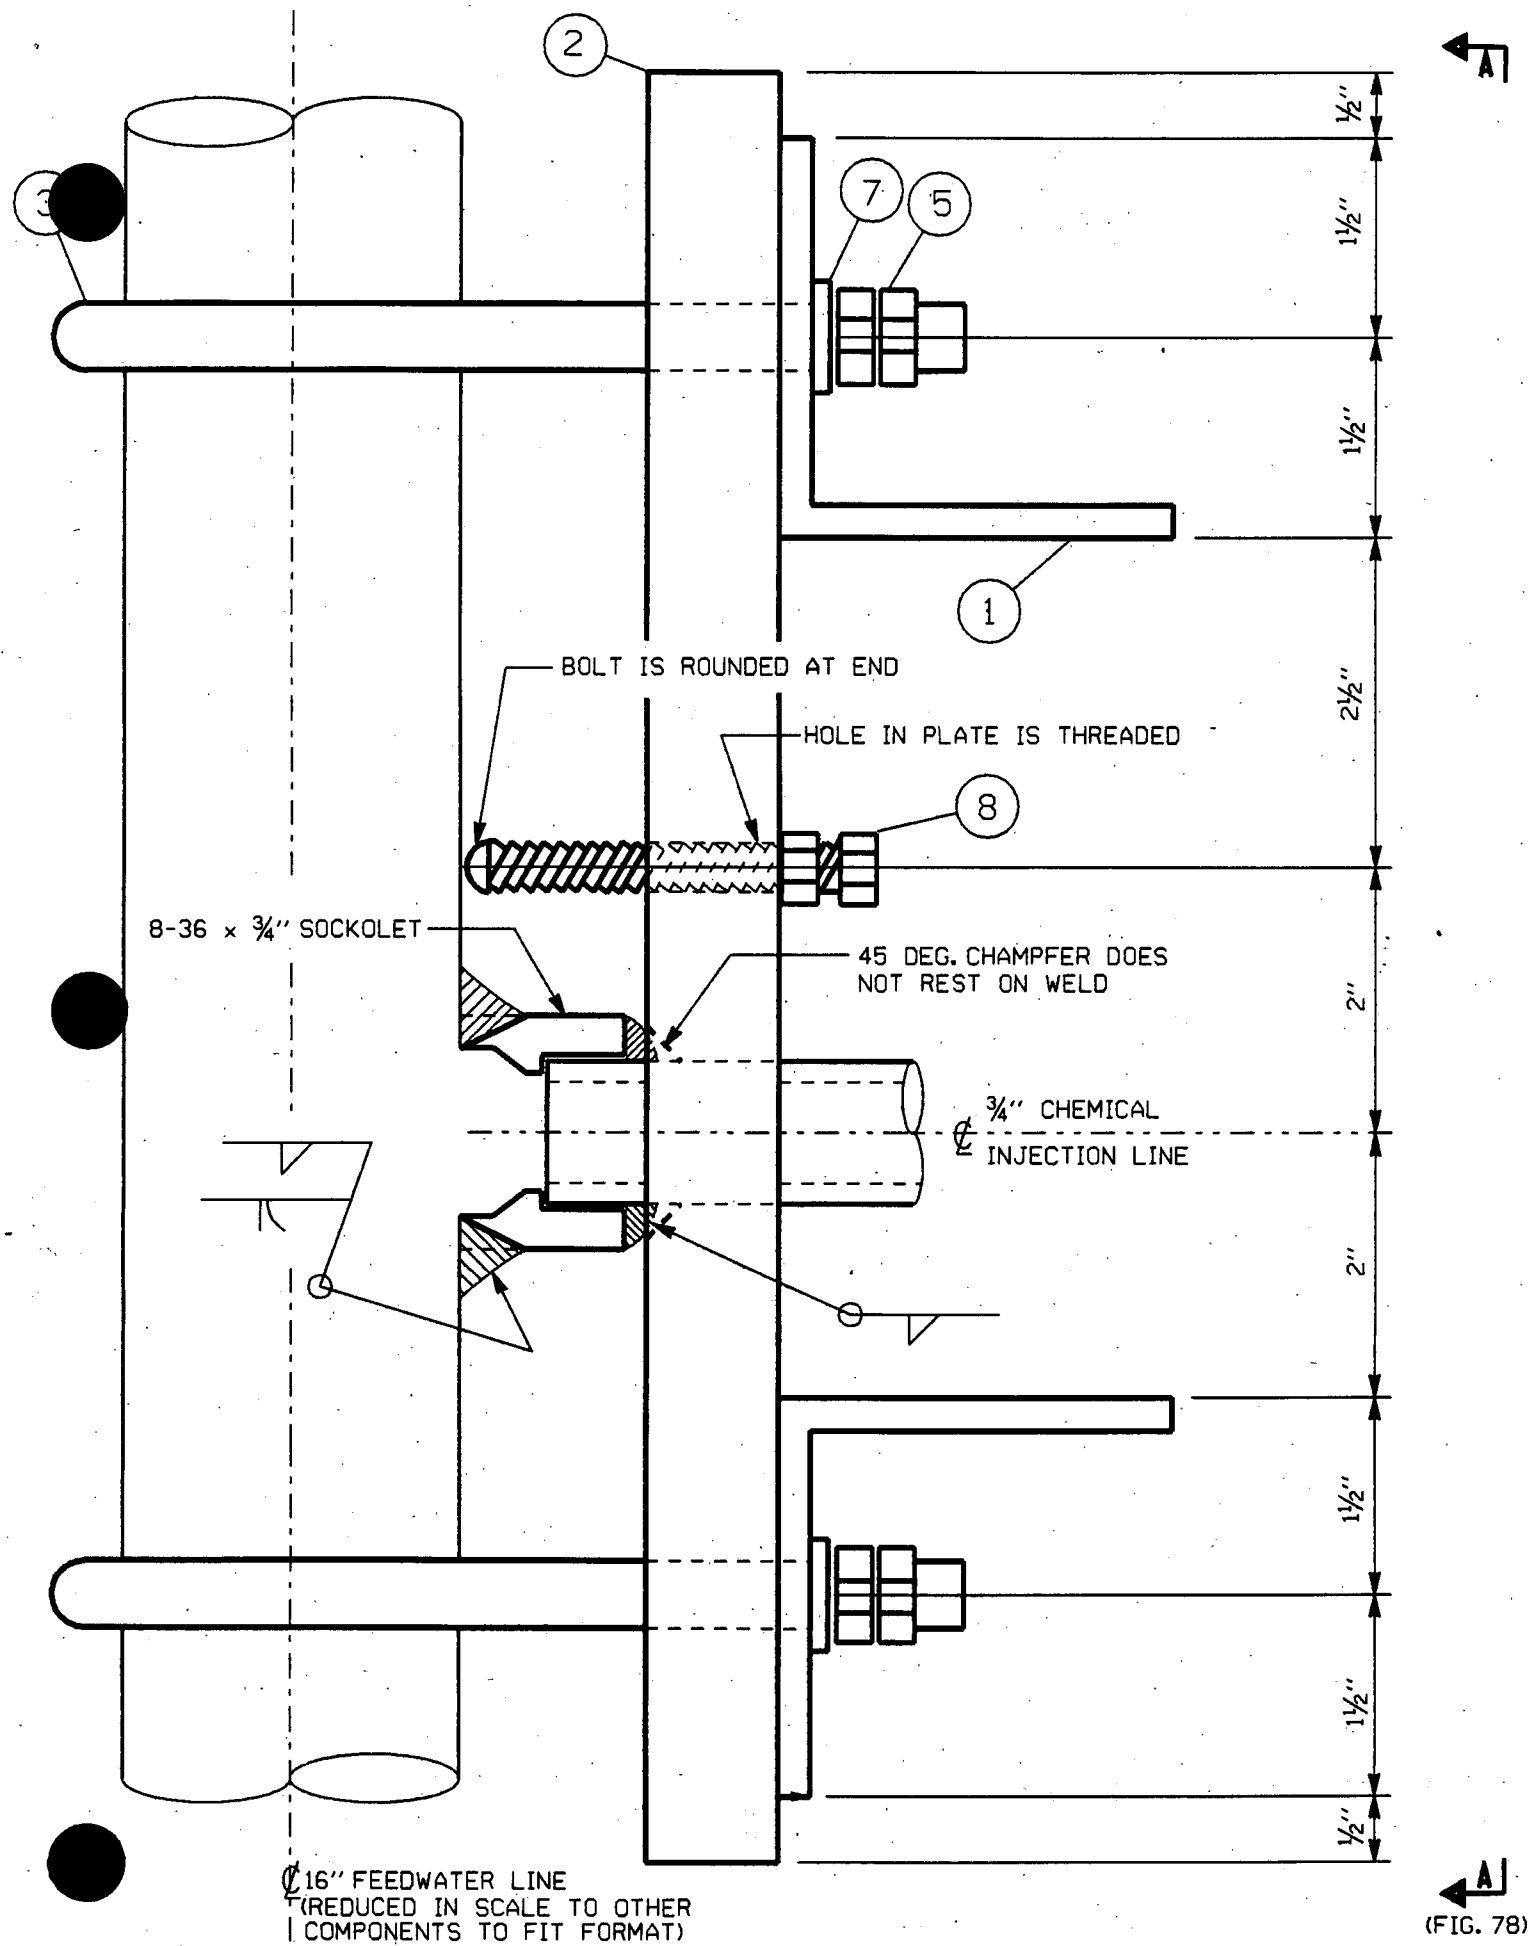
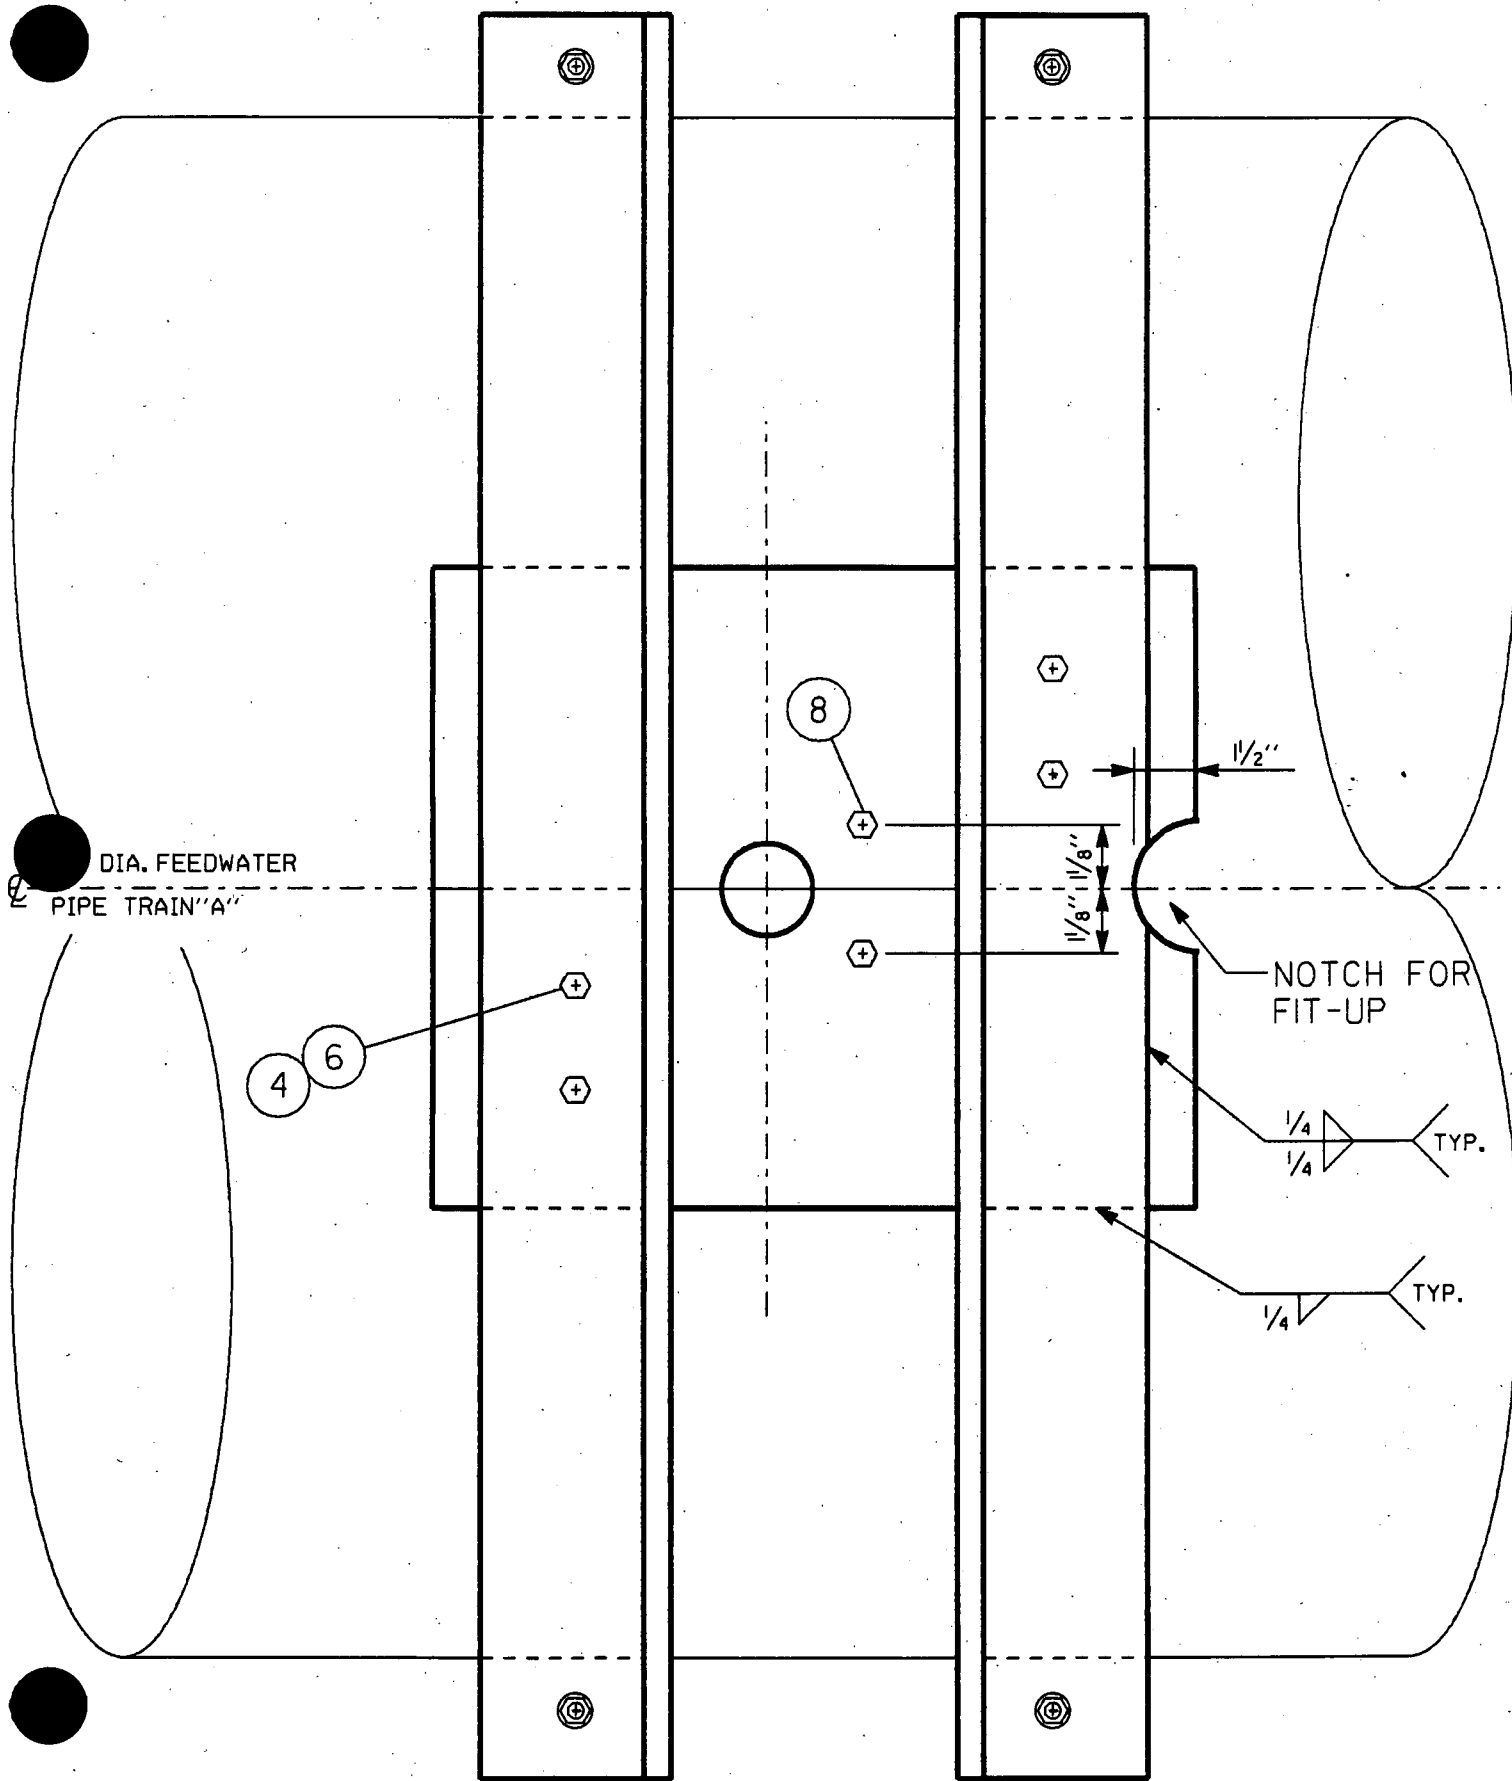
FIGURE 7B

WPS's assessment of the weld has determined that it has sufficient strength and margin to ensure continued, safe operation until the September refueling outage. However, in order to provide an added measure of safety, a temporary restraint has been installed. The purpose of the restraint device is to hold the fitting in place should the chemical injection sockolet to the A main feedwater line weldment fail. Note that the design has been modified slightly from that proposed in Reference 1; these changes were made to address an NRC concern with forces on the chemical injection pipe-to-sockolet weld and to limit compressive forces on the area of the flaw (a concern raised by the Plant Operations Review Committee). Further the bolted design permits easy removal should it be necessary after installation to accommodate additional NDE.

The restraint will be installed until the next plant shutdown when the chemical injection sockolet to the A main feedwater line weldment will be repaired/replaced.

- During installation, in the process of tightening the U-bolts, the restraint will be supported to keep the 3/4" pipe centered in the hole of the collar. The U-bolt nuts will be tightened 1/4 turn past tight. The spacer bolts will be adjusted to bring the top of the 3/4" pipe to sockolet weld within the collar chamfer and the lock nuts tightened. After installation, the U-bolts will be re-tightened as necessary to accommodate heating from contact with the FW pipe and double nutted to prevent loosening. Using this installation technique, the U-bolts and spacer bolts support the dead weight of the assembly and minimize any loads imposed by the assembly upon the sockolet.

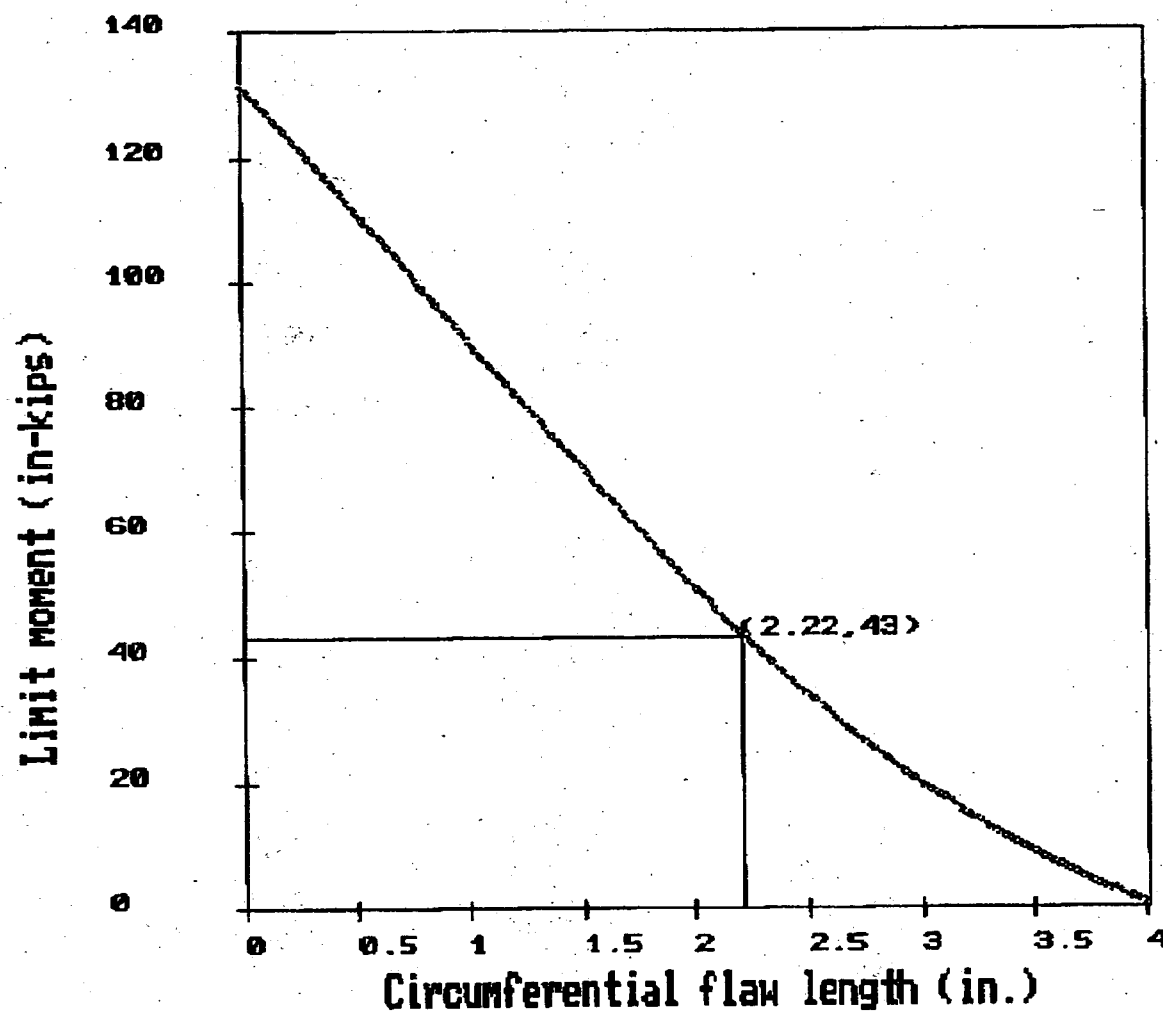
Figure 1

The detailed line loadings are not available at this time for the sockolet line, so the effect of a range of moments was investigated, as shown in figure 1. The results, as expected, show large moments are necessary to fail the line. A worst case loading was applied to the line for illustration, as seen in the figure. This loading was developed from the application of a load which would just meet the B31.1 criteria for Level D conditions, and even this load results in a very large through-wall critical flaw size. For a flaw which is not a through-wall flaw, a separate analysis was done, and the results for the same loading are shown in figure 2. Here we see that a flaw with a depth of 69 percent of the wall is needed for failure, assuming that the flaw extends all the way around the pipe.

WEP Sockolet - Bounding Loads

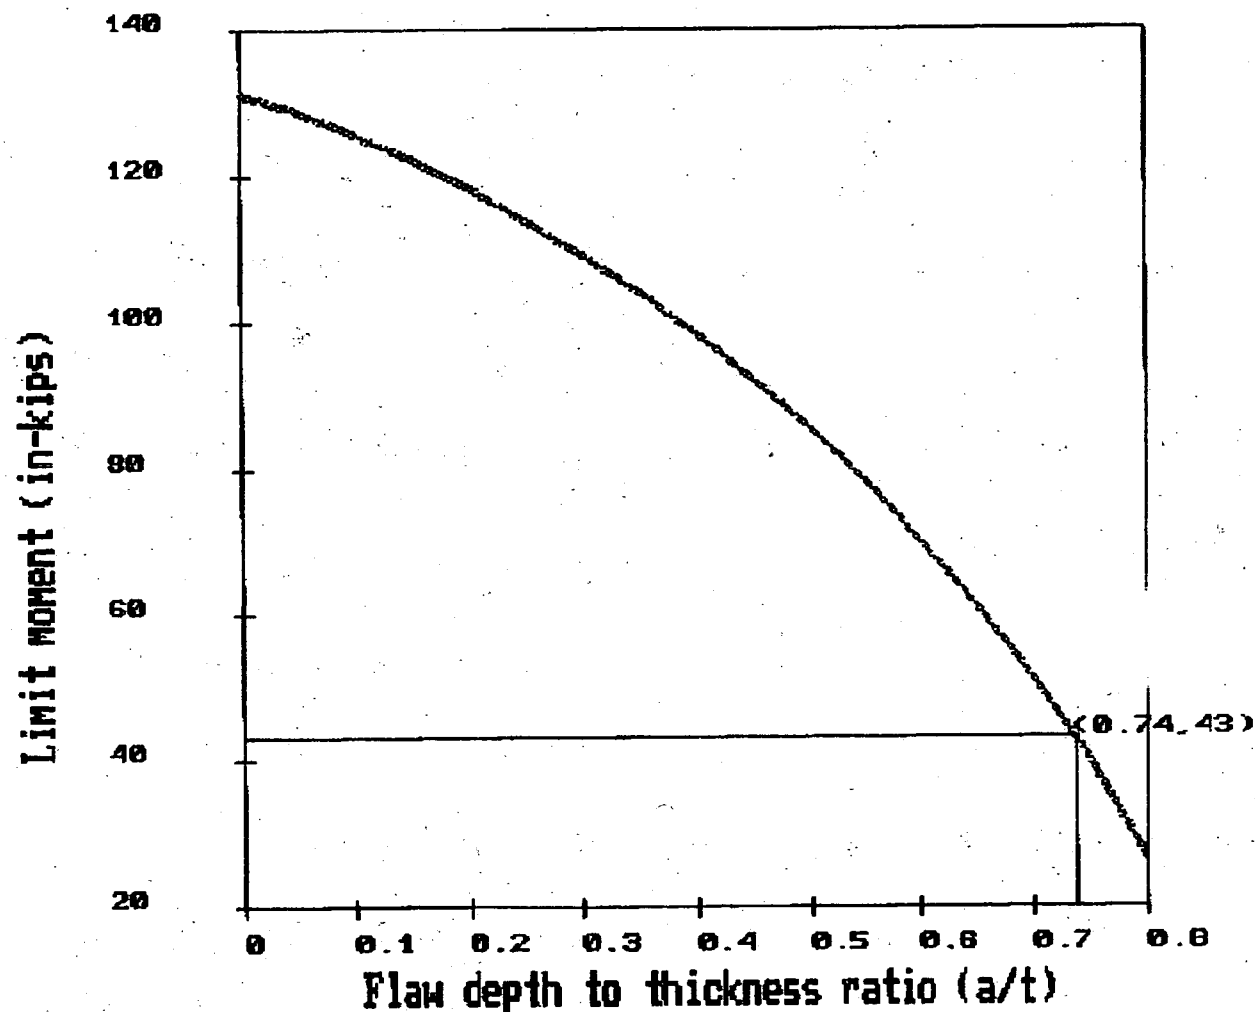
Figure 2

OD= 2.500 Thk=.625 F=1.20 F=.480E-01 Torque=30.8
MEP Sockolet - Bounding Loads

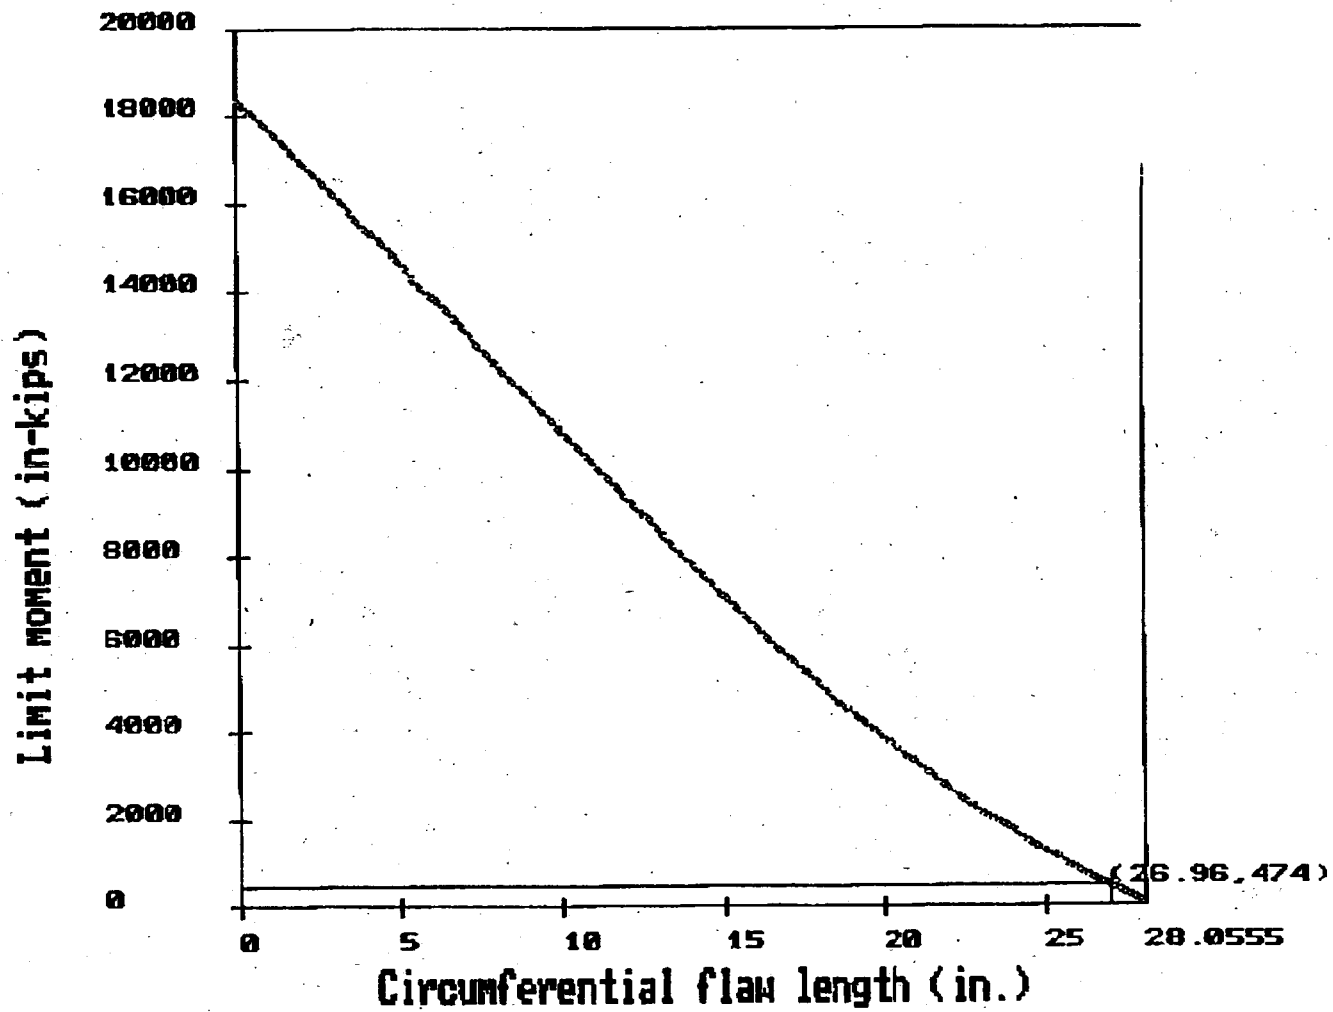
Figure 3

WEP FW line - normal

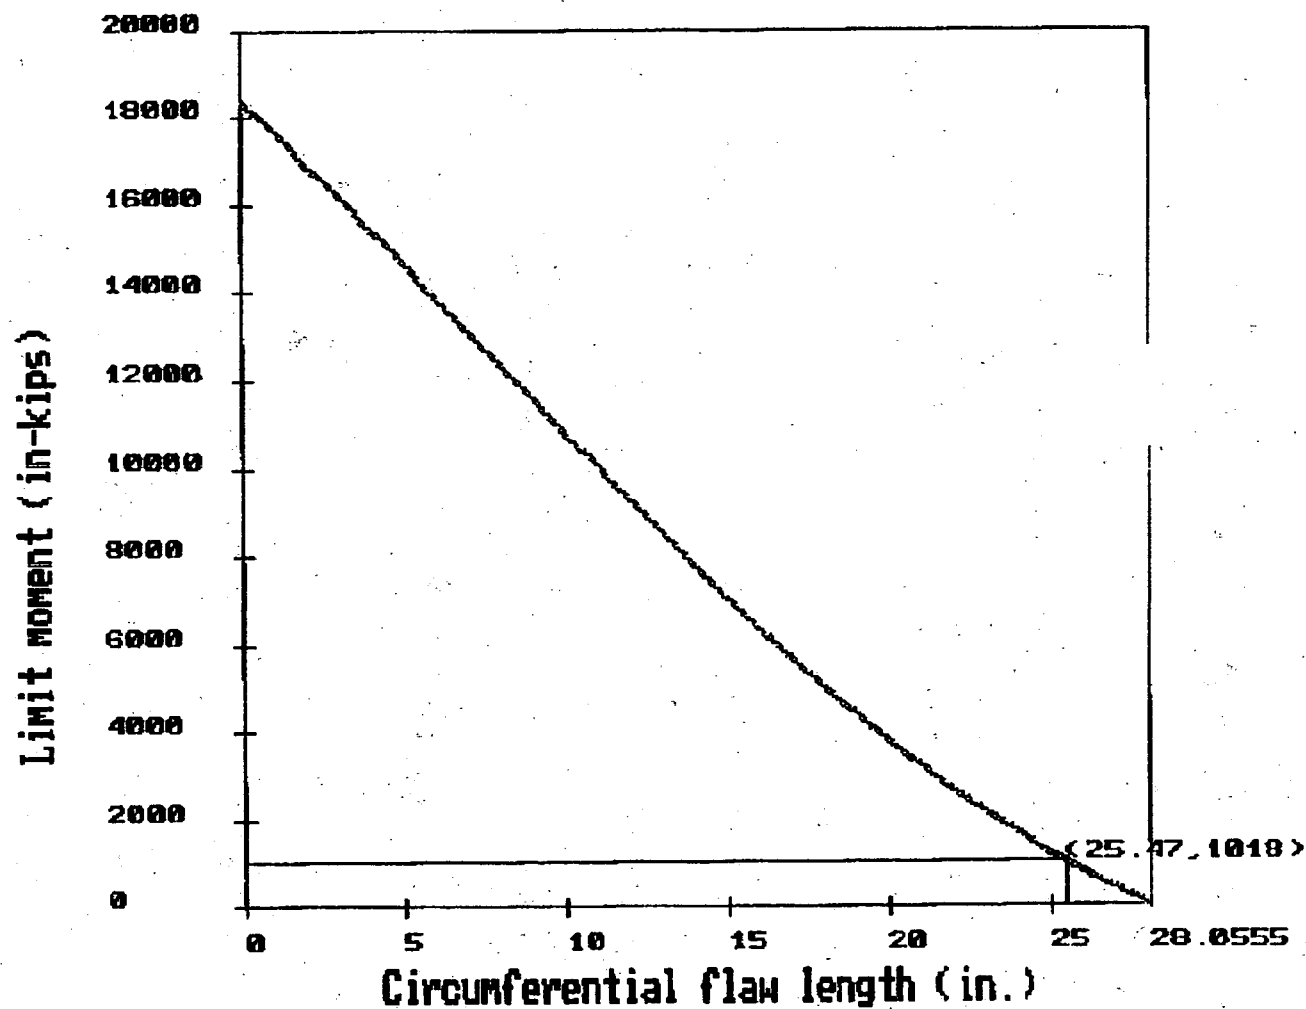
Figure 4

NEP FU line = dw + OBE

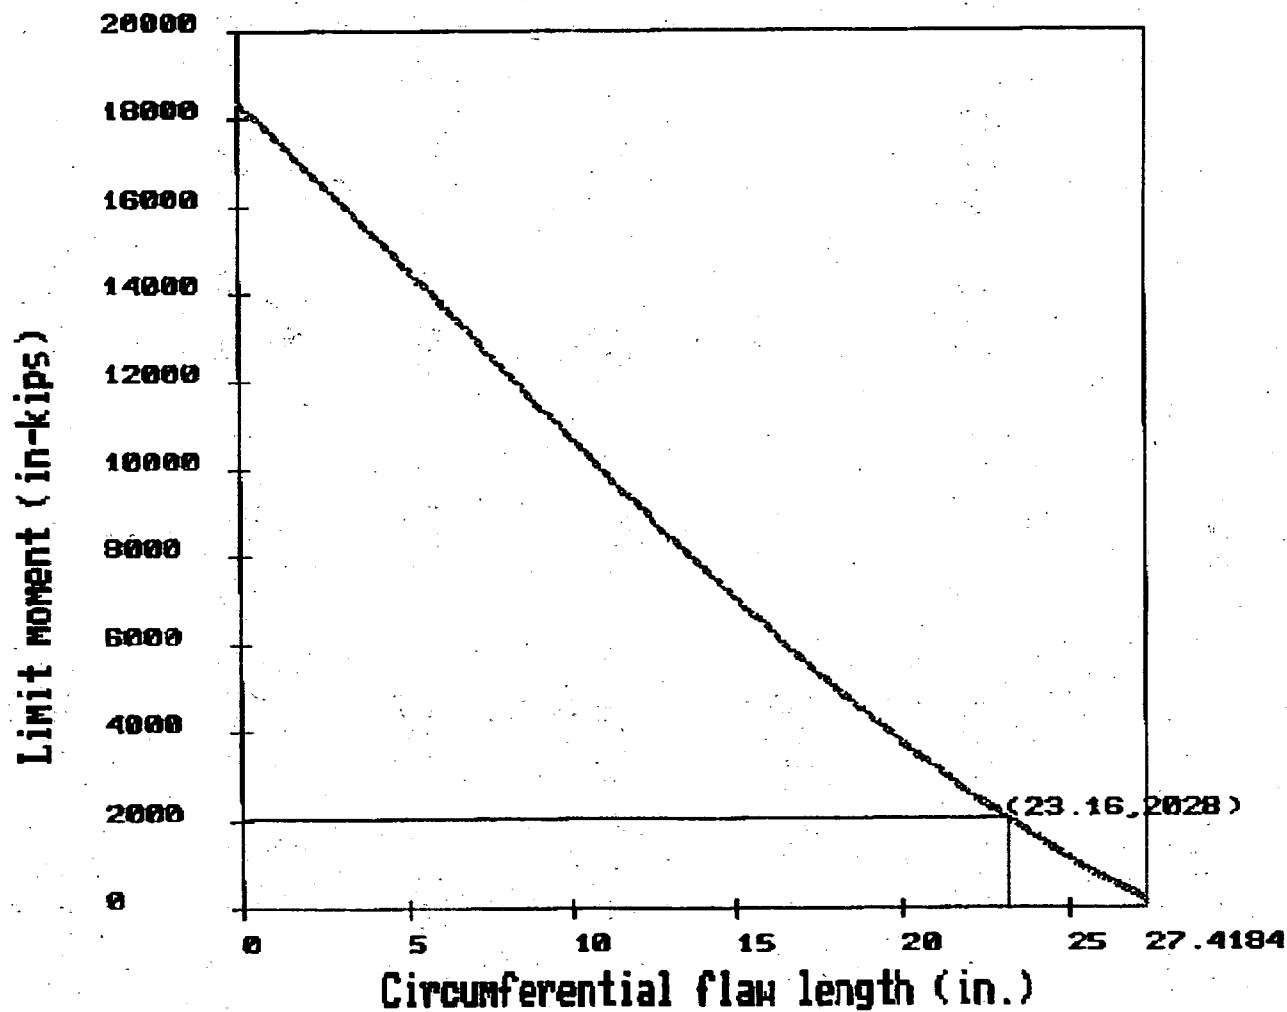
Figure 5

WEP FM line - DW + DBE

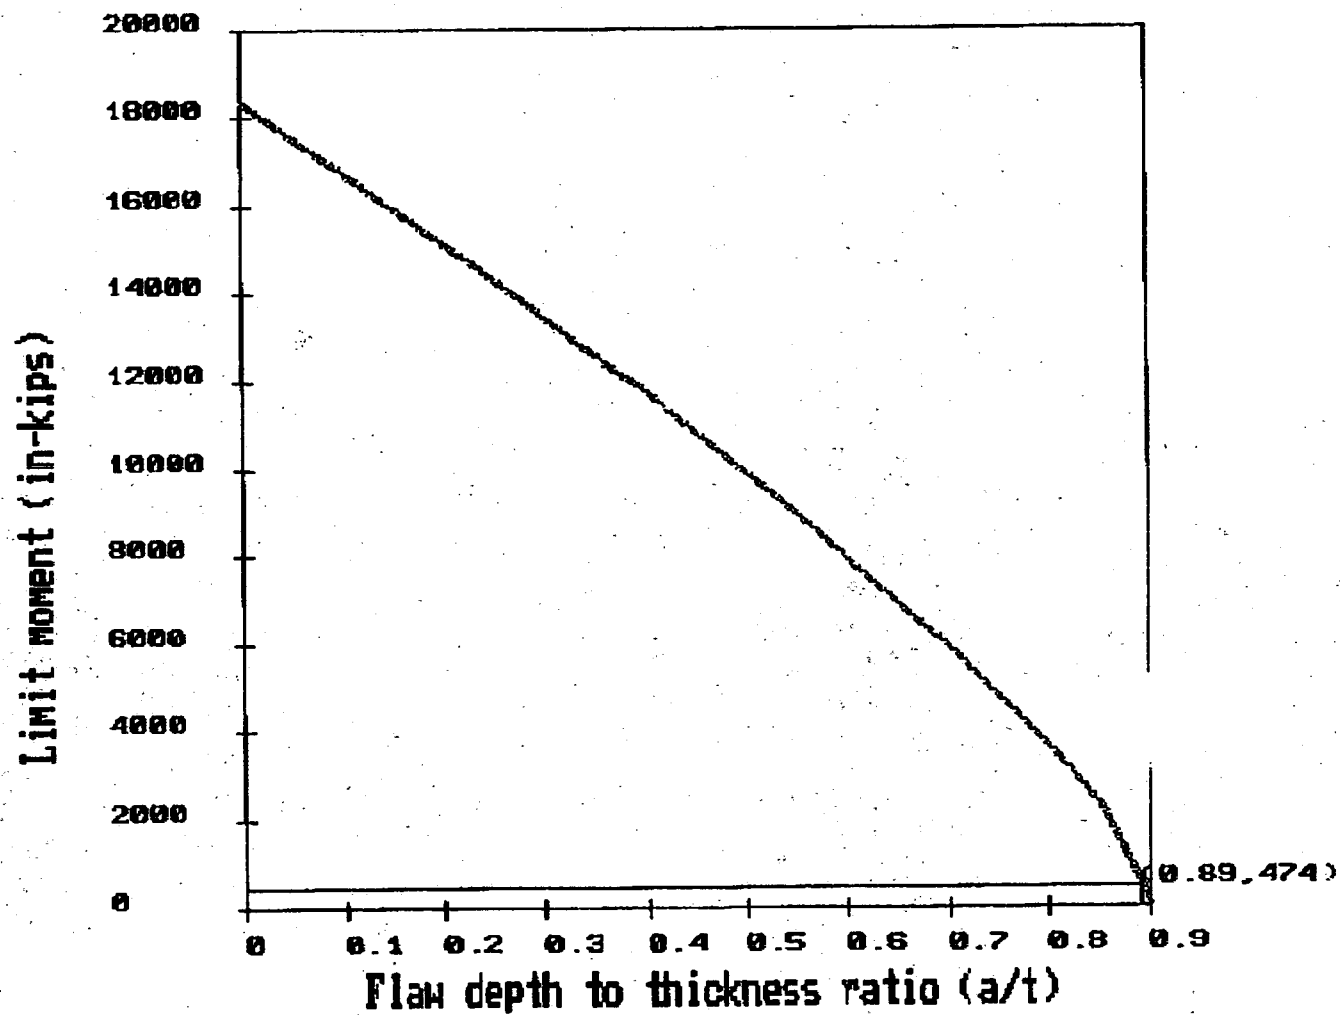
Figure 6

WEP FW line - normal
